Project No. 3117

FIELD REVIEW – March 29, 2018

DATE: April 4th, 2018
CLIENT: GOR-FAY REALTY COMPANY LIMITED
PROJECT: 197 & 201 WILBROD STREET, OTTAWA, ONTARIO

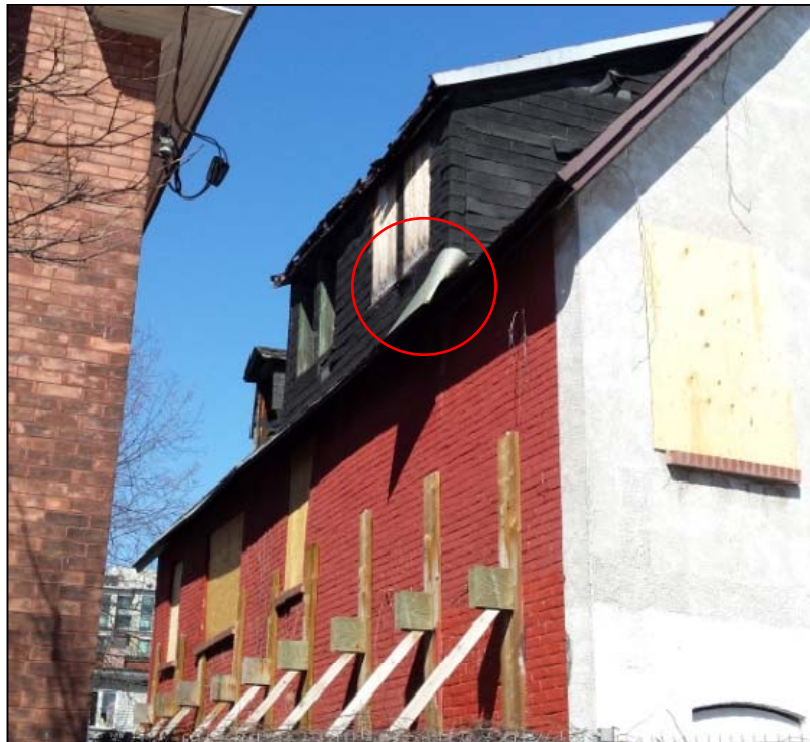
- A piece of sheet metal cladding on the south-west corner of the roof, noted in the last Field Review has not been removed. This and any other loose roof elements shall be removed to prevent possible injury to pedestrians or damage to the adjacent building. Refer to Image 1.

[Image 1: 197 Wilbrod St. Sheet Metal Cladding on West Roof](#)

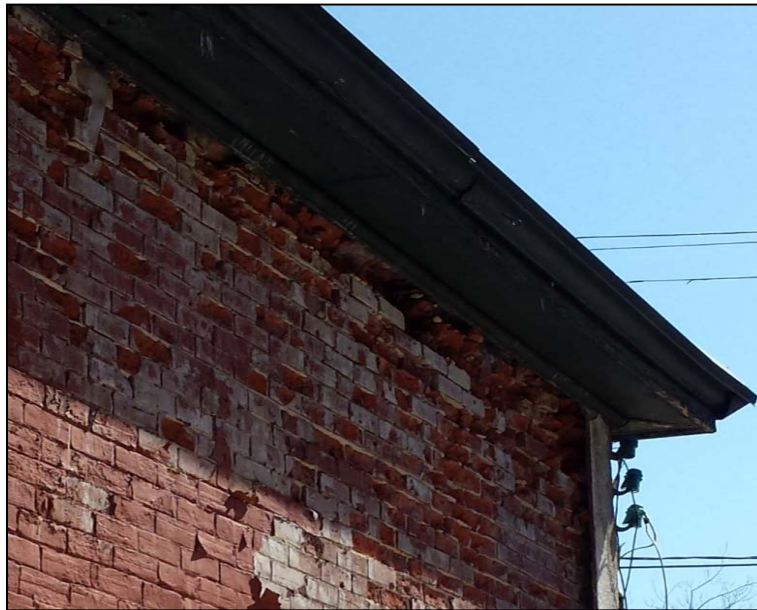
- Deterioration of brick veneer is occurring along the south-west corner wall since the last inspection conducted on February 27th, 2018. This shall be closely monitored as the brick veneer is adjacent to the roof truss support. Refer to Image 2.
- Minor crack propagation was recorded on the east wall, below the second story window, closest to south wall.
- Two additional monitoring points were added to ensure the angular tilt of the east wall is not changing. The angular tilt varies substantially at different points along the wall. This makes accurate monitoring of the wall performance difficult. The most significant tilt noted was 21 mm (outwards 1.4%) over a 1500 mm vertical distance at the south corner.

[Image 2: Spalling of Brick Veneer Fascia on South Wall of 201 Wilbrod St.](#)
