Old Railway Rideau River Pedestrian Bridge Structure No. 018600 Detailed Condition Assessment and Renewal Option Analysis Report

Detailed Condition Assessment and Renewal Options Analysis Report

November 2018

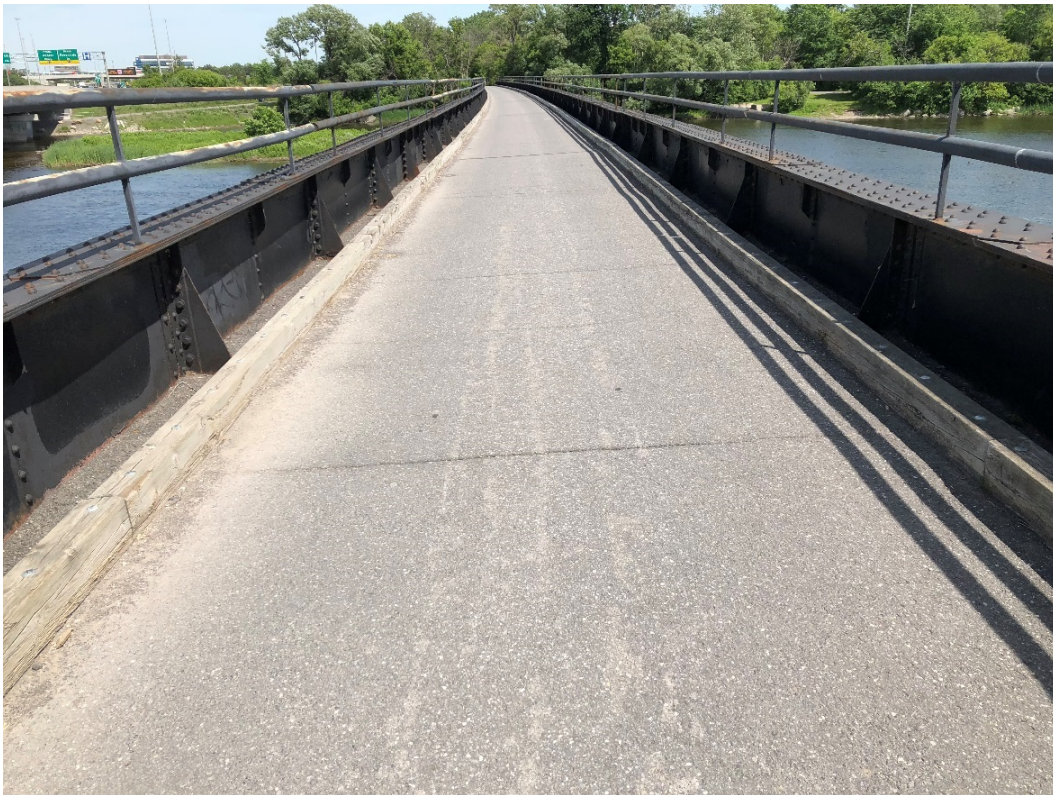
Photo 6 – Typical condition of asphalt wearing surface on the deck top, looking east. Note the light to severe isolated unsealed transverse cracks and light raveling throughout, with medium raveling on exterior of timber curbs.

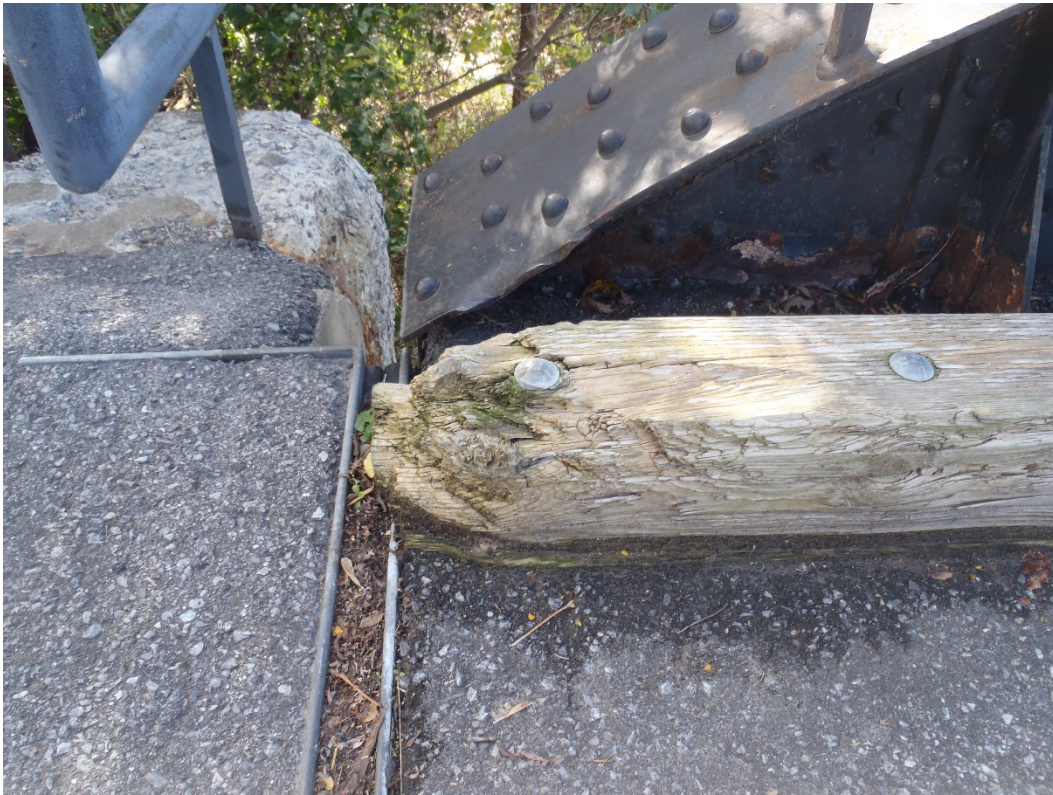
Photo 13 – Impact damage to the east end of the south timber curb.

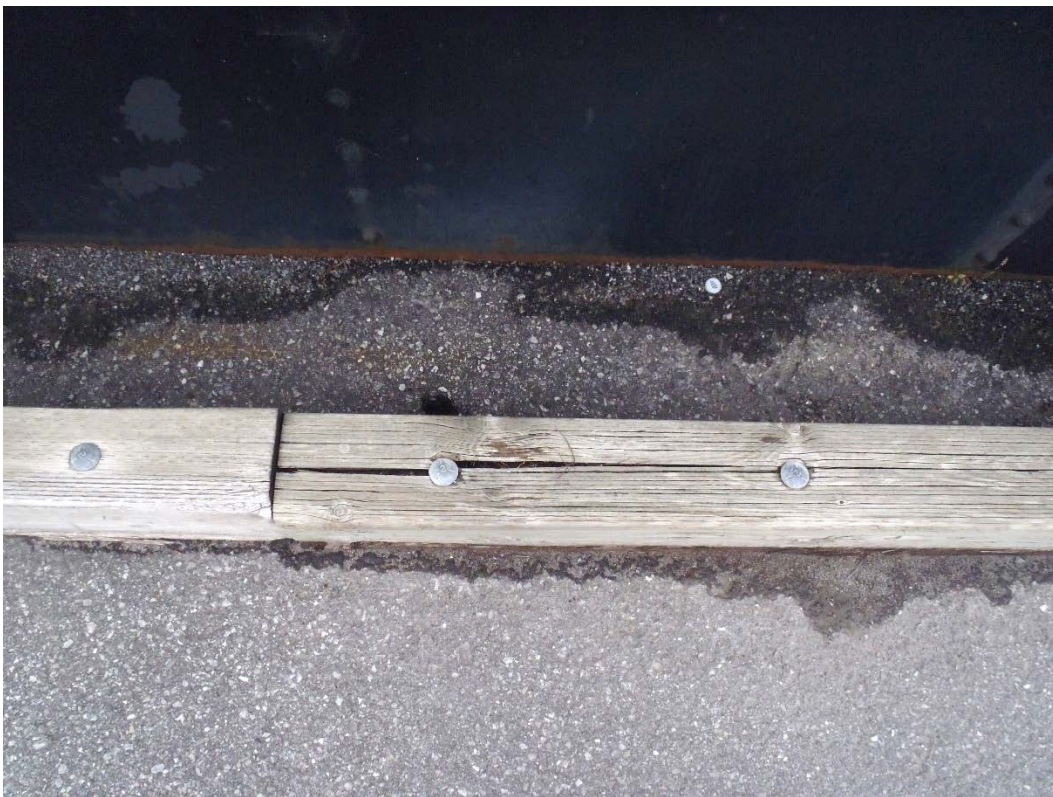
Photo 14 – Light to severe longitudinal splits in the curb from the bolts. Typical localized light weathering is also visible in the top and interior face of curb.

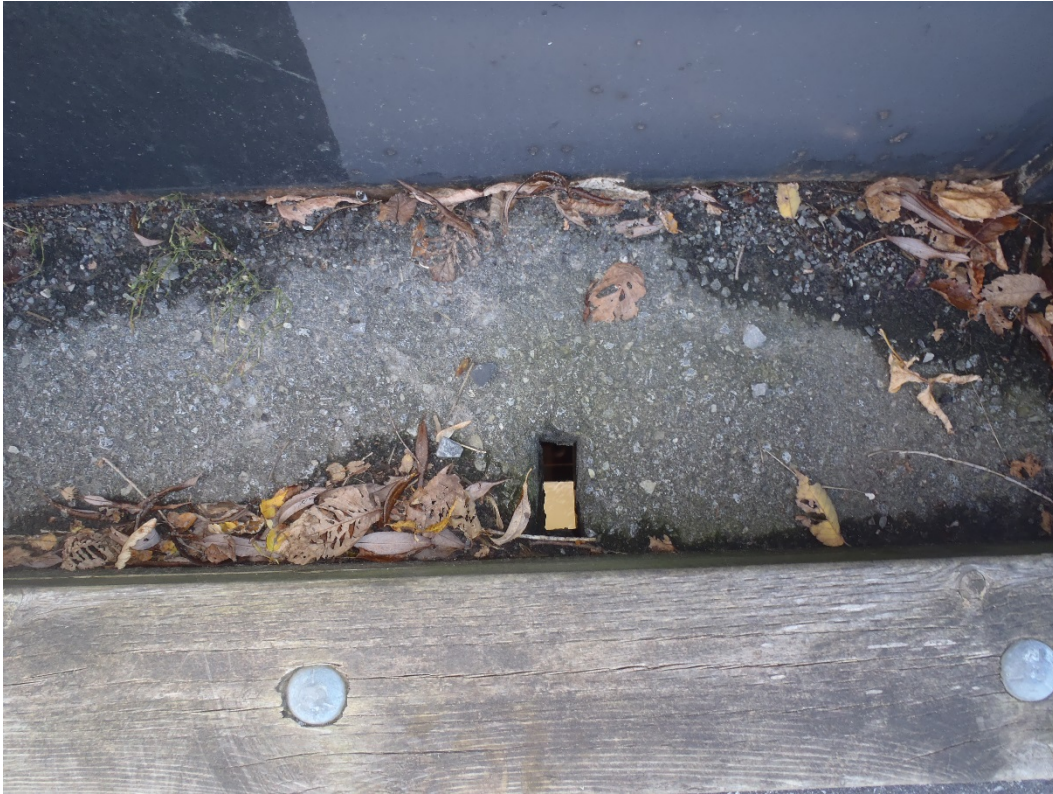
Photo 21 – Rectangular deck drainage openings located every 2 m on each side of deck. Note the medium to severe ravelling and wet staining of the asphalt along the girder web.

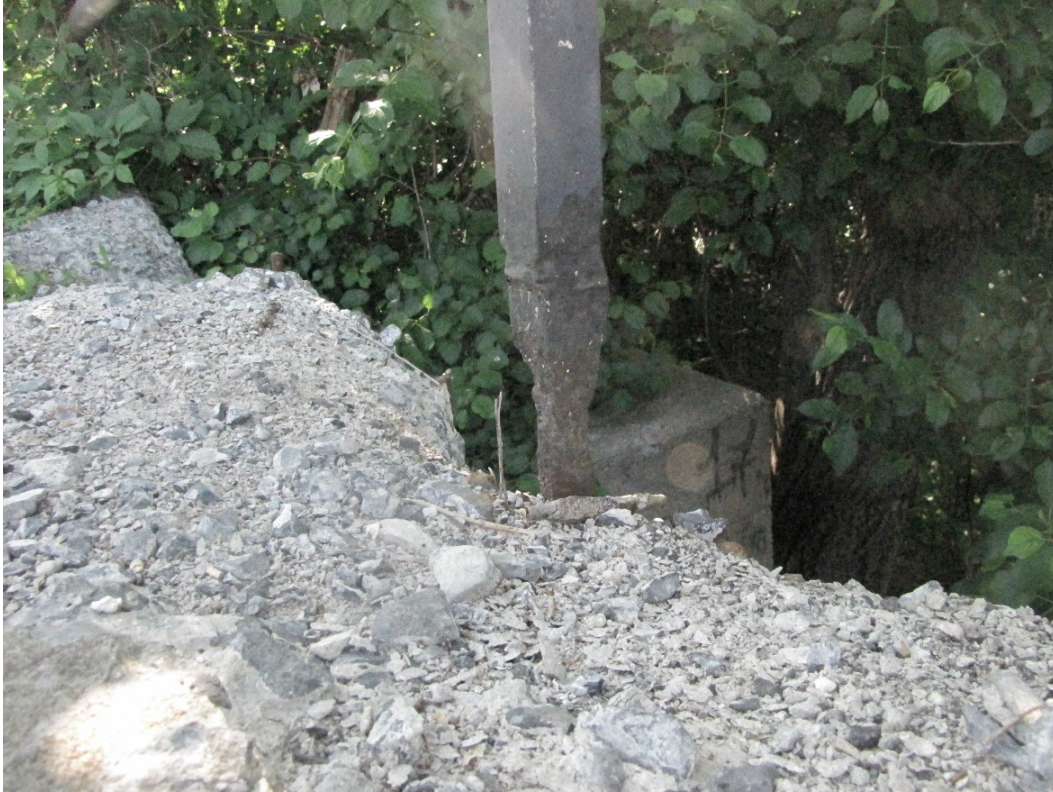
Photo 25 – Very severe corrosion with approximately 75% section loss at the base of a railing post on the southeast wingwall.

Although the approach railing replacement was included in the scope of work and costing for each renewal option in 2023 for simplicity of evaluating the renewal options, this work should be completed in 2019, as the extensive deterioration of the railing posts poses a potential safety concern for pedestrians.

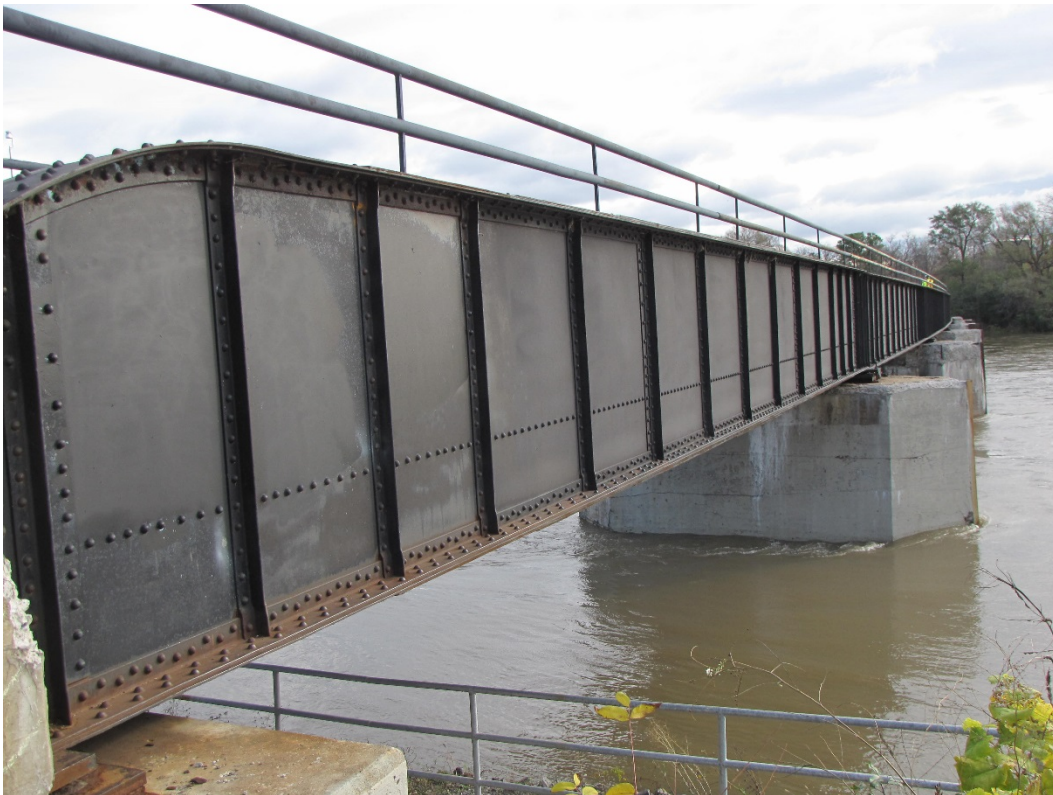
Photo 26 – Localized light corrosion on the exterior girder top of bottom flange and below the top flange.

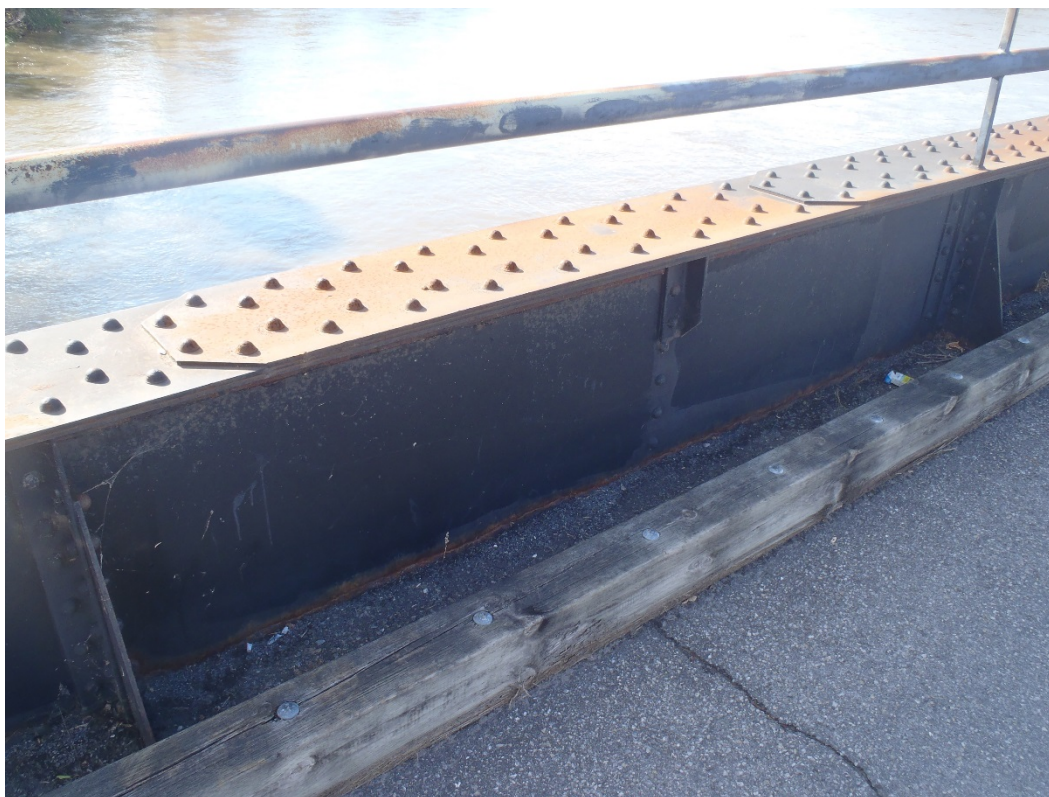
Photo 27 – Localized light corrosion on the top flange of the girder. Typical light to medium corrosion on the girder web and knee braces (i.e. vertical gusset plates) along the top of the asphalt wearing surface.

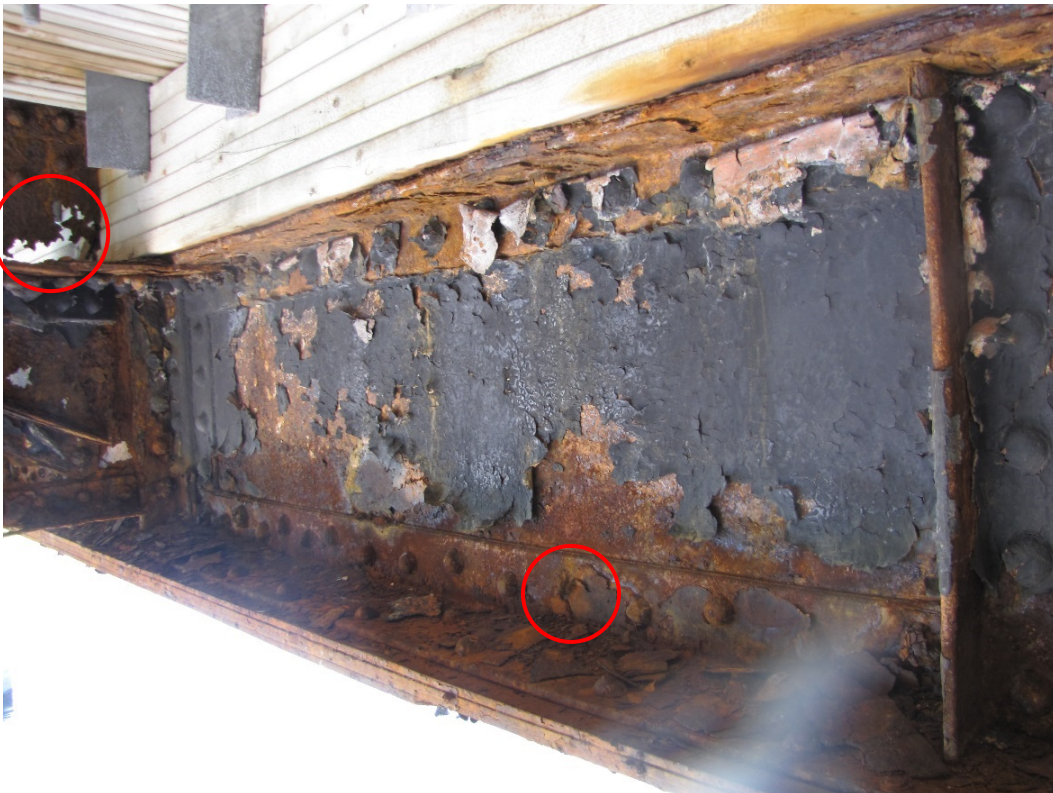
Photo 30 – Typical condition on the interior of the girder below deck. Medium to severe corrosion on the shelf angle below the ledger and bottom flange. Very severe corrosion and perforations in the vertical gusset plate. Corrosion with up to 100% section loss on rivet heads. Typical coating failure with widespread peeling paint.

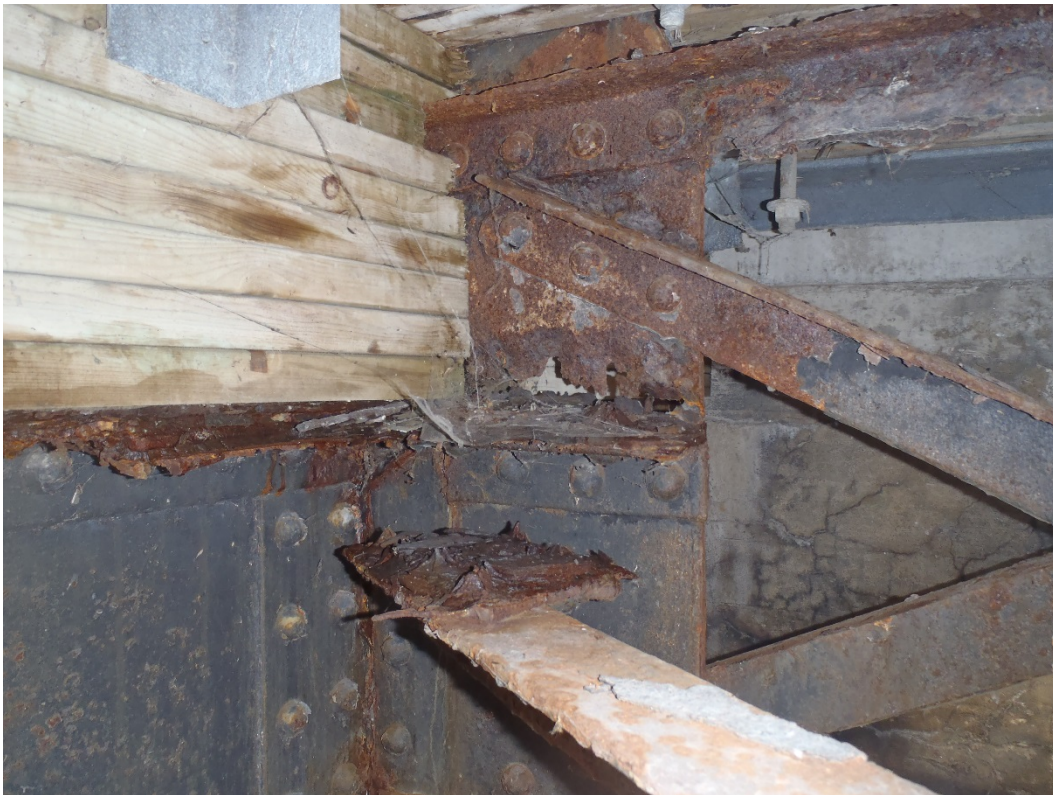
Photo 38 – Very severe corrosion with complete perforation across the vertical gusset plate and detachment of the lateral brace from the horizontal gusset plate at the south end of the west abutment cross-frame.

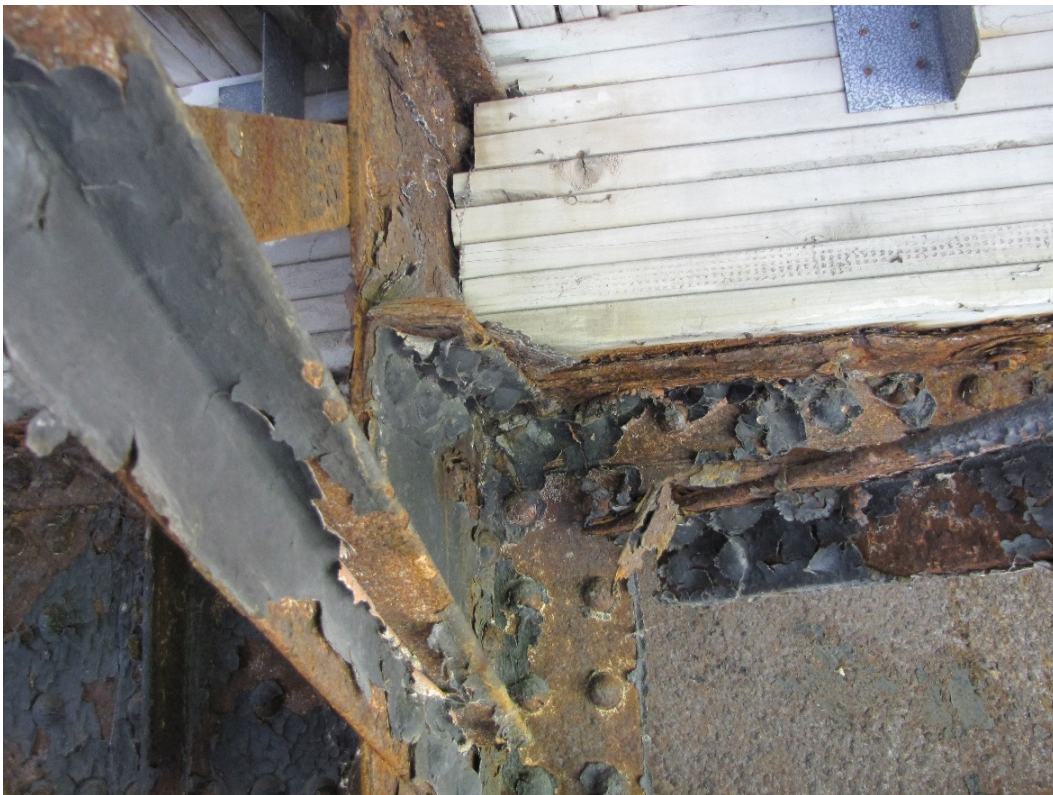
Photo 40 – Very severe corrosion on the horizontal gusset plate and lateral brace at the cross-frame in the bay just west of Pier 6, resulting in detachment of the lateral brace.

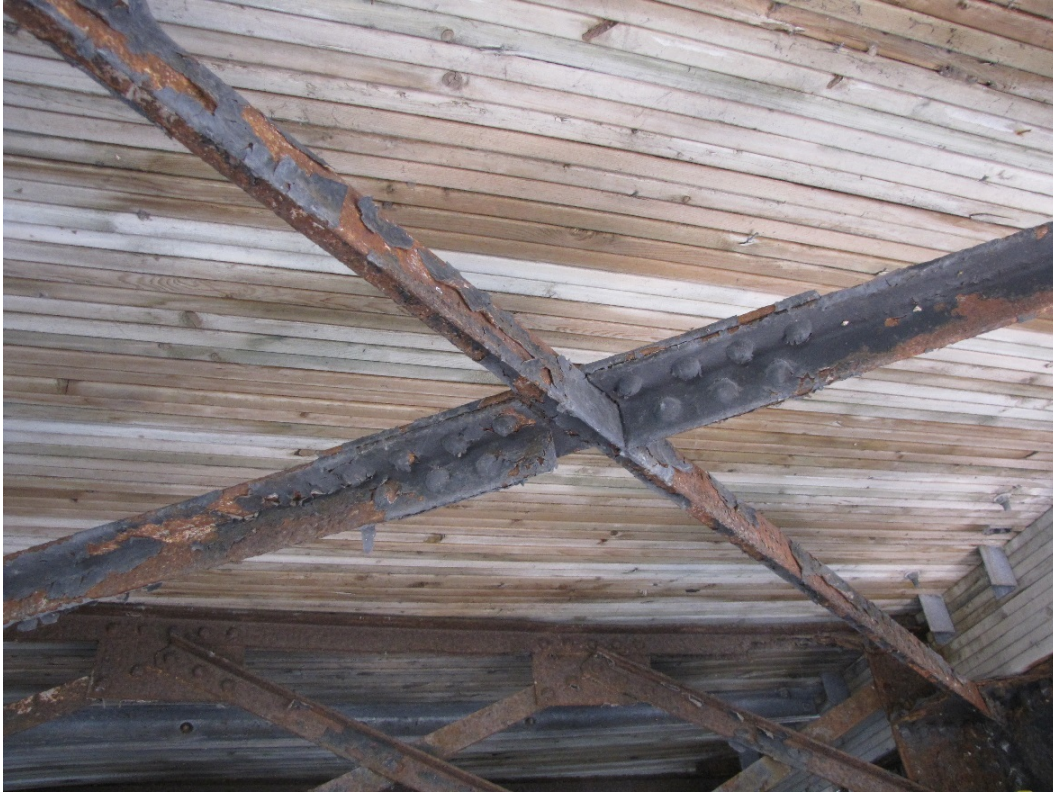
Photo 41 – Typical condition of the lateral bracing. Note the widespread coating failure and light to medium corrosion throughout.

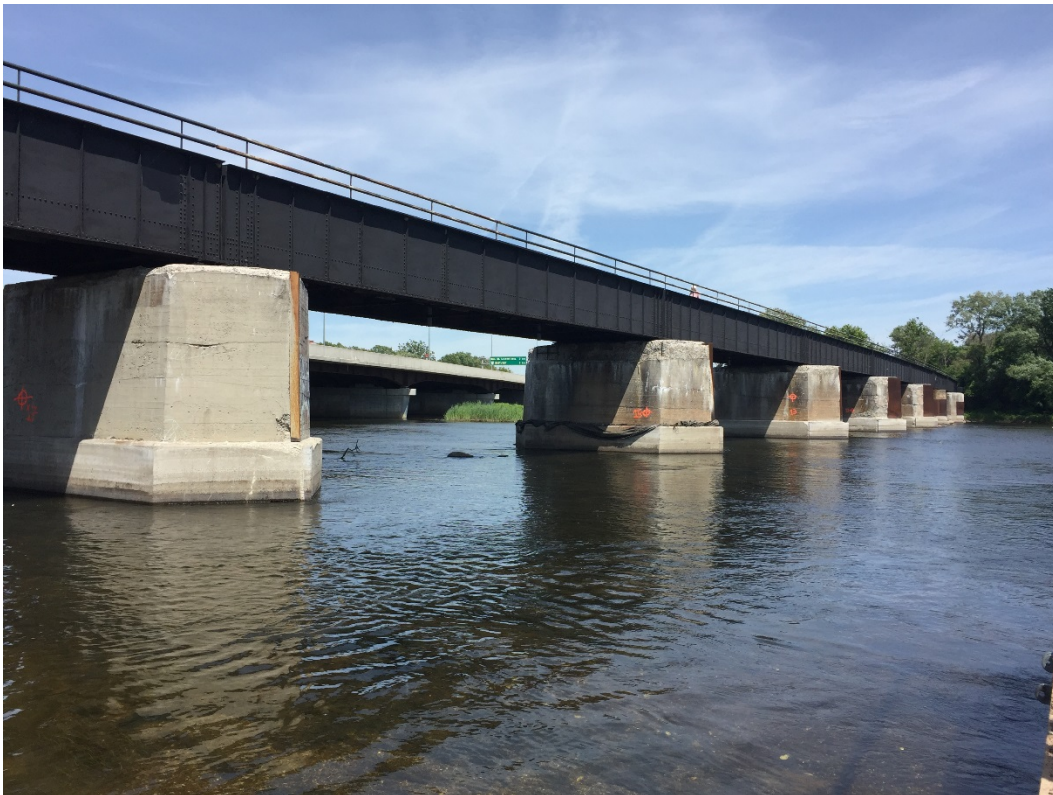
Photo 42 – South elevation of the exterior girders webs; coating in generally good condition.

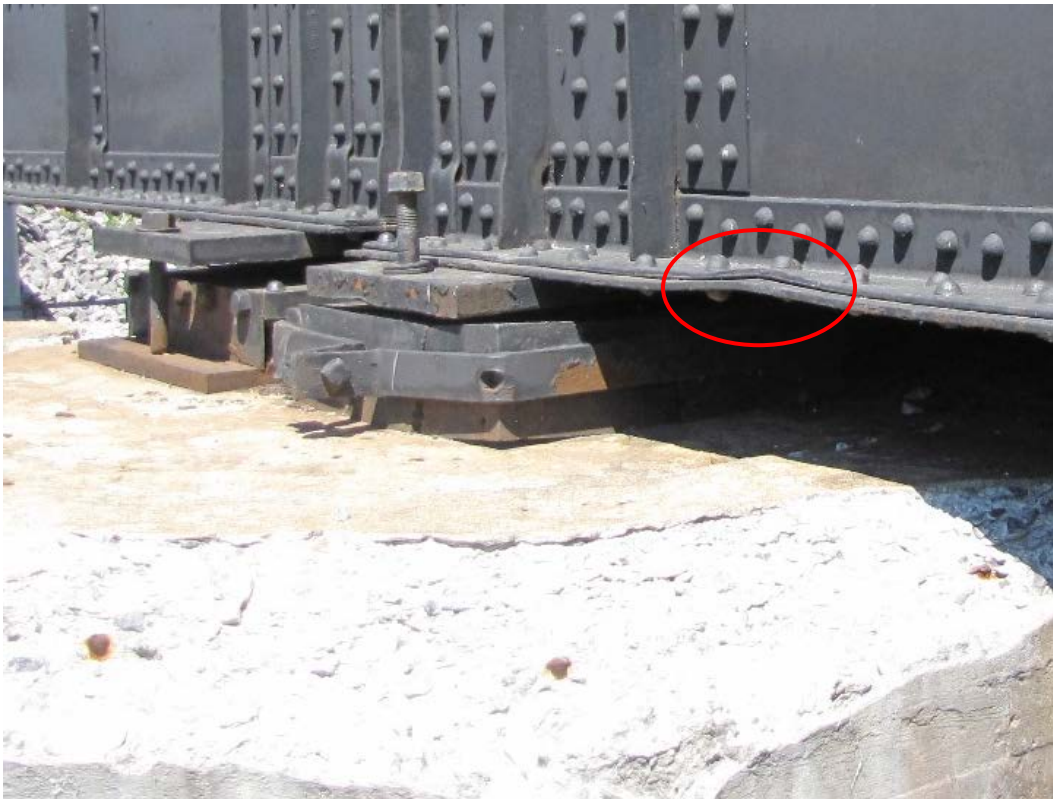
Photo 46 – Southeast bearing on Pier 7 is cracked and was previously temporarily repaired with a clamping device. Note the deformation on the bottom flange of the south girder.

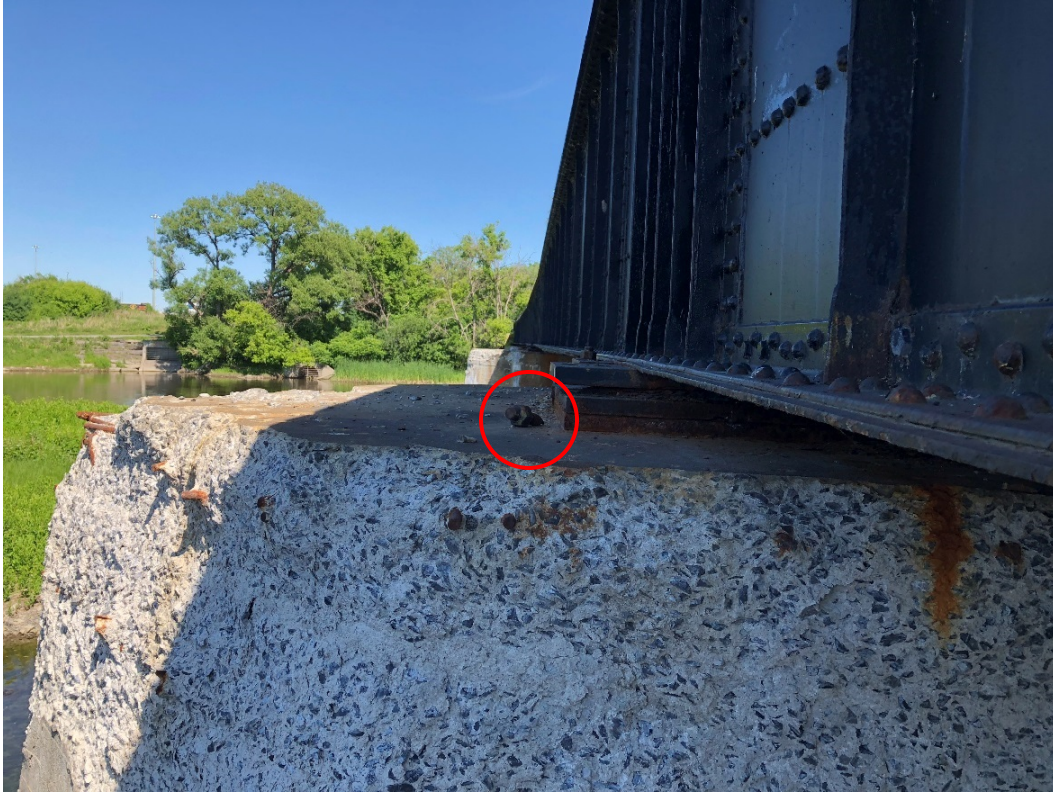
Photo 47 – Northwest bearing anchor bolt on Pier 4 has sheared off. Note the extensive concrete disintegration with exposed corroded reinforcing steel at the top of the pier shaft and bearing seat.

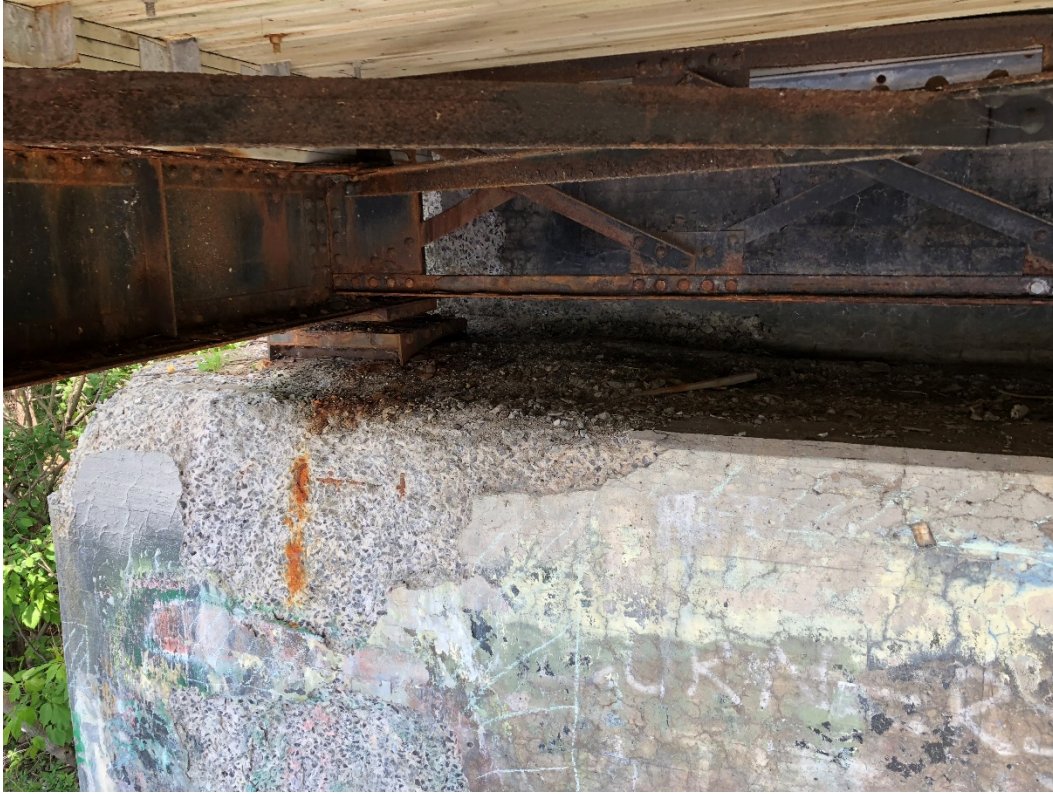
Photo 49 – Very severe disintegration at the top of the east abutment wall and bearing seat at the north end.

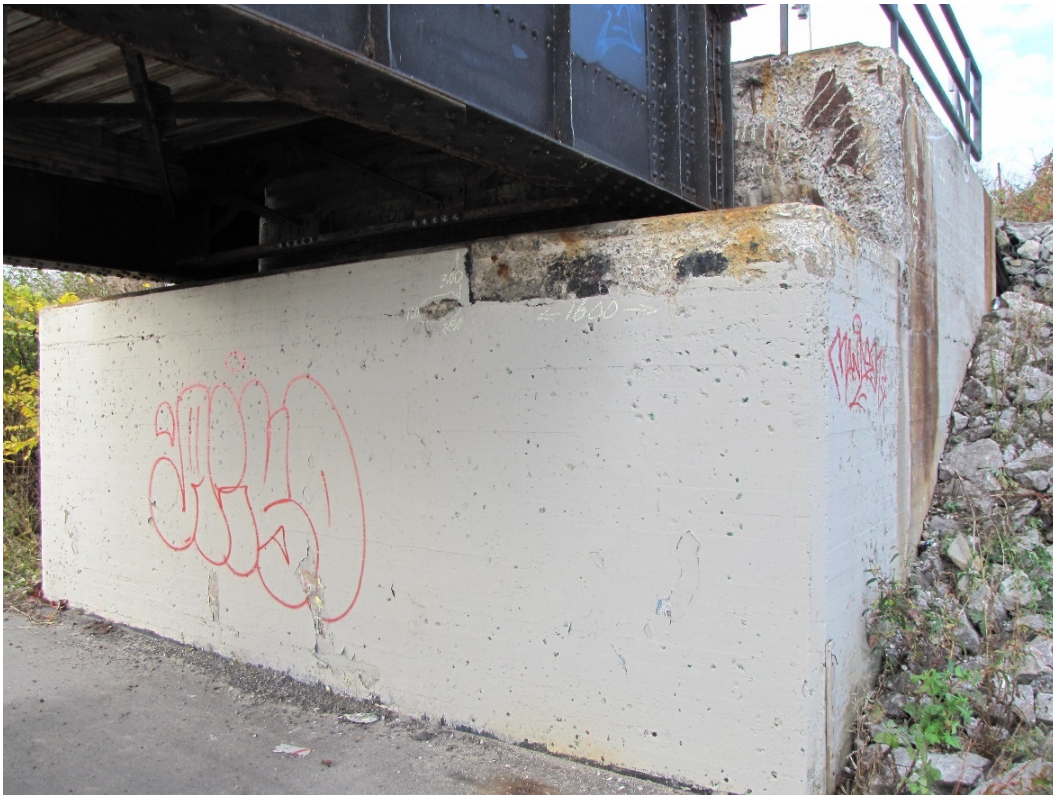
Photo 52 – Localized area of very severe disintegration in the west abutment wall and very severe disintegration and delamination with exposed corroded rebar on the north end of the ballast wall.

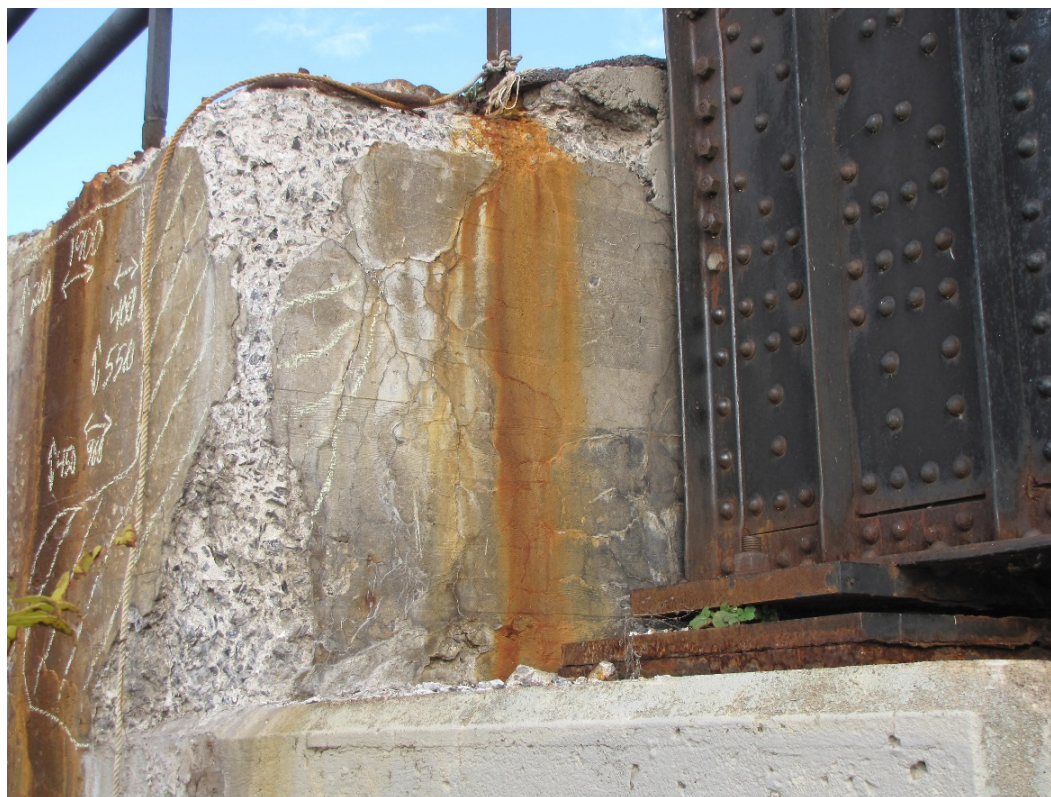
Photo 54 – Severe to very severe disintegration and delaminations with exposed corroded rebar at the south end of the ballast wall and southwest wingwall.

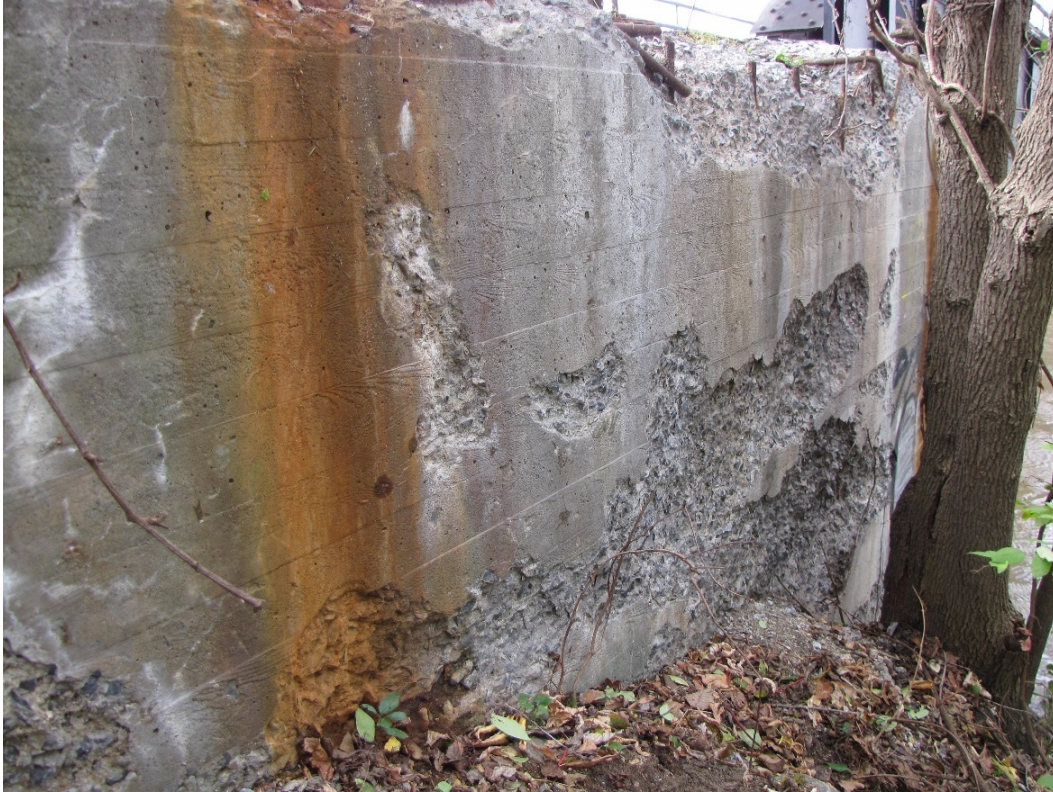
Photo 59 – Extensive areas of medium to very severe disintegration with exposed corroded rebar and hairline to narrow wet and efflorescence stained map cracking on the northeast wingwall.

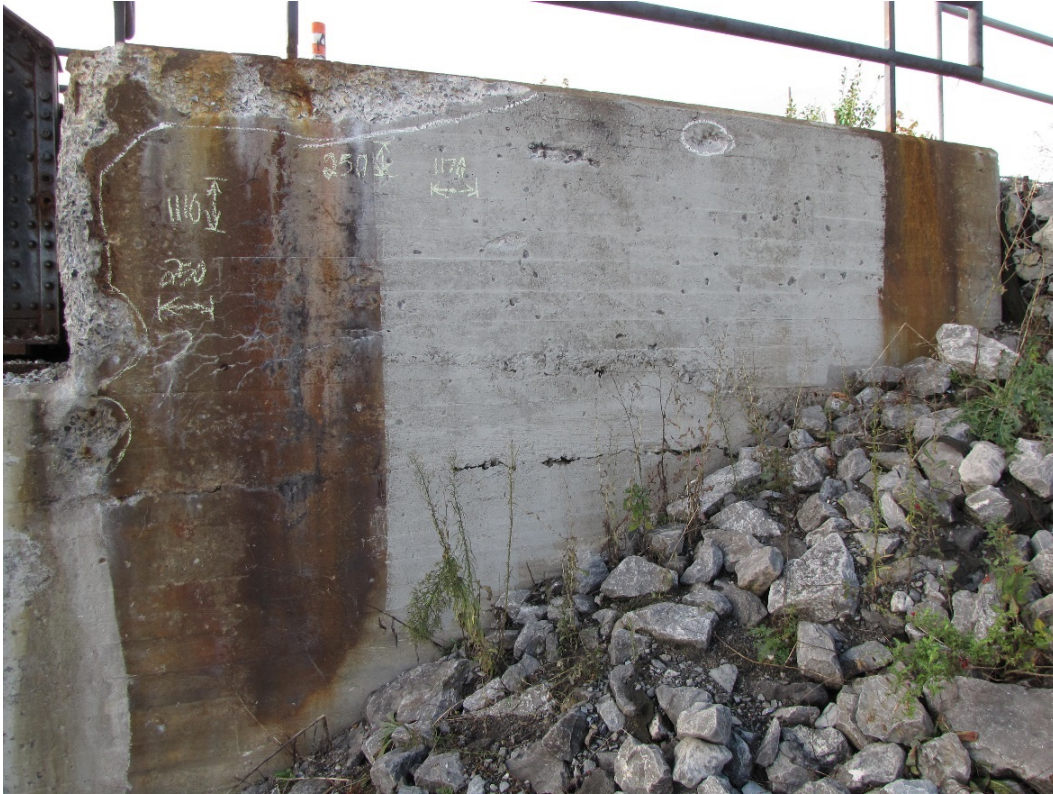
Photo 61 – Medium to very severe disintegration and delamination with exposed corroded rebar on the northwest wingwall. Localized area of efflorescence stained hairline to narrow map cracking.

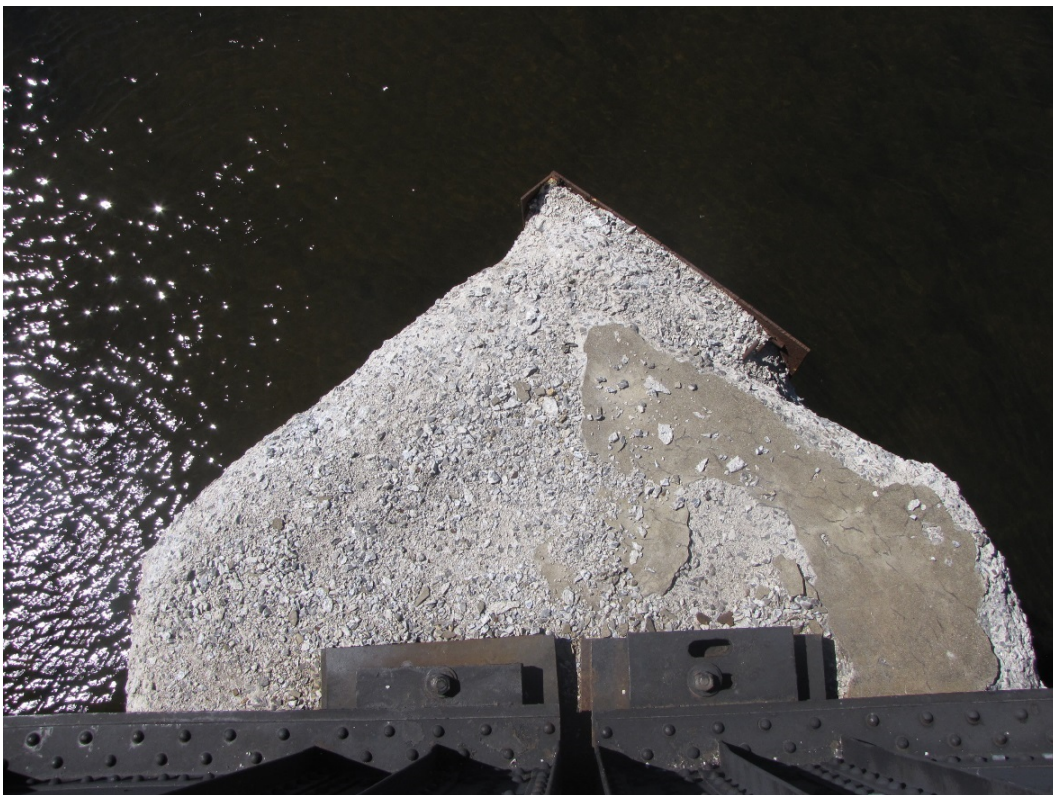
Photo 66 – Pier 4, south end. Severe to very severe disintegration and delamination on the bearing seat up to the bearings.

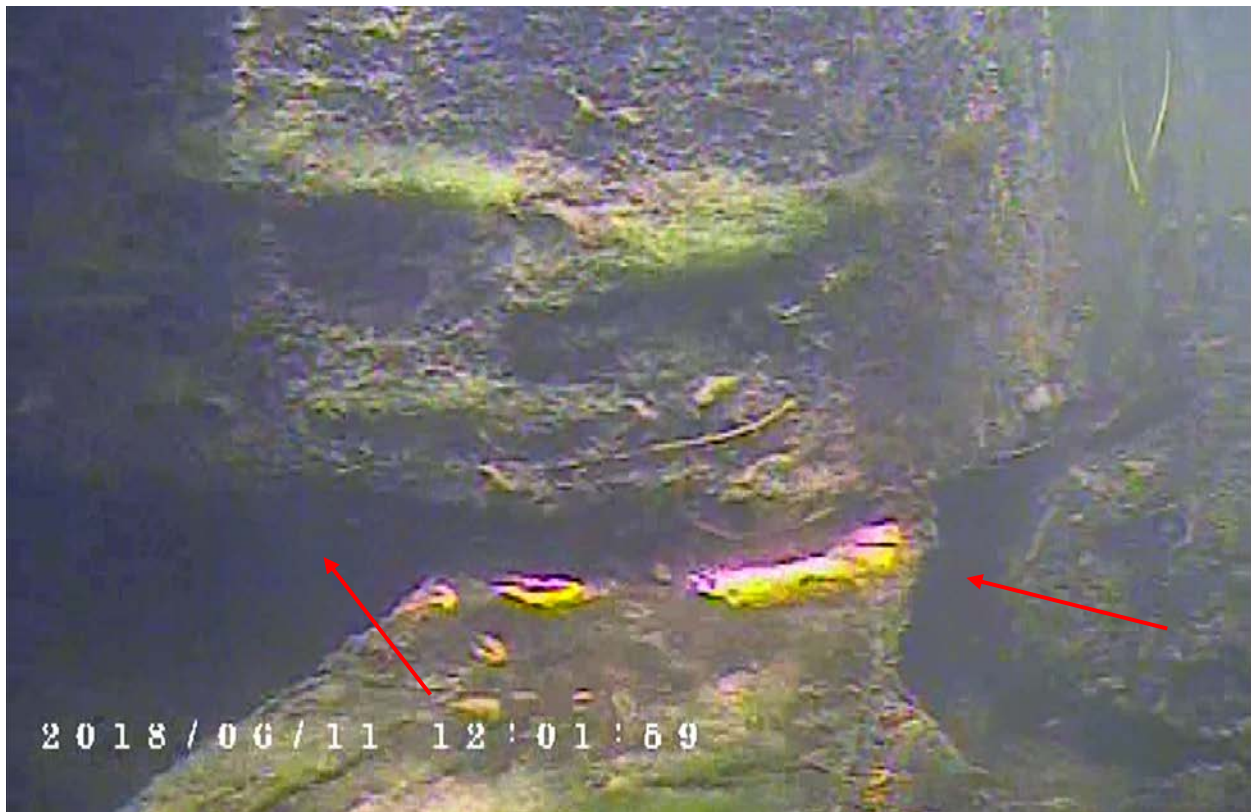
Photo 70 – Pier 6. South end of the footing is undermined by approximately 450 mm on each face.

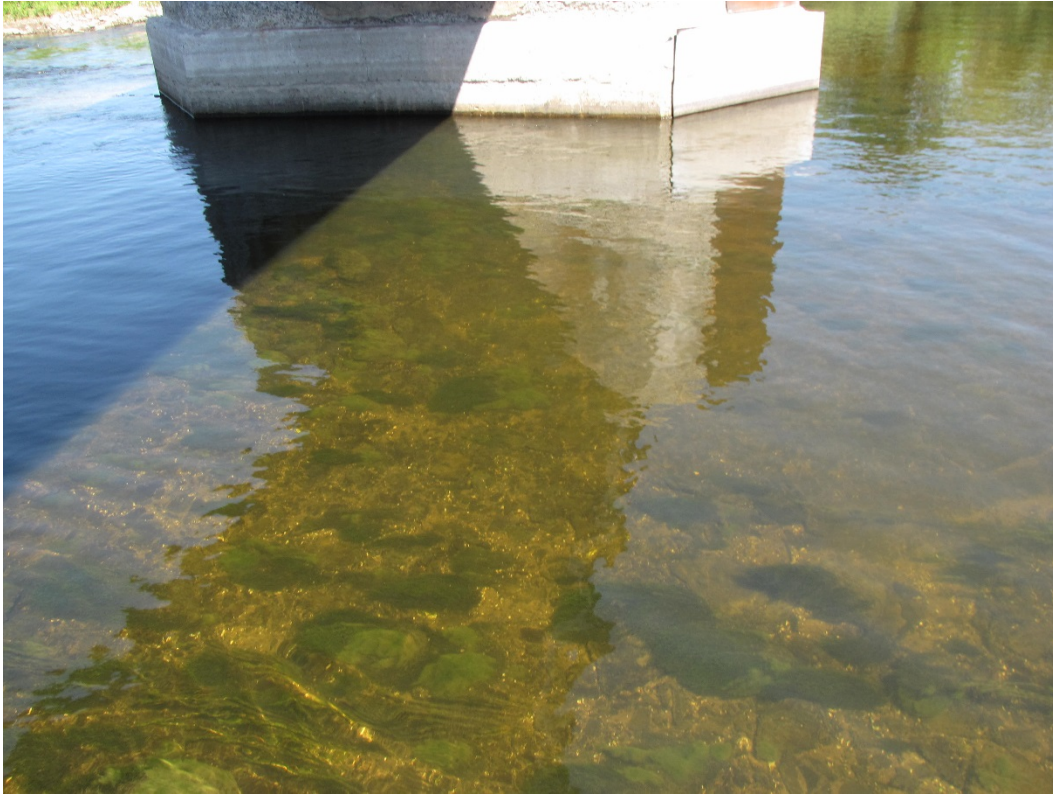
Photo 75 – Typical shallow water depth across the waterway between piers. Riverbed consisting of bedrock or with a shallow layer of silt and sand on bedrock.
