December 3, 2021

Project No. 21159

RE: Hintonburg Pumping Station Ruins  
 Structural Condition Assessment Report and Options Analysis

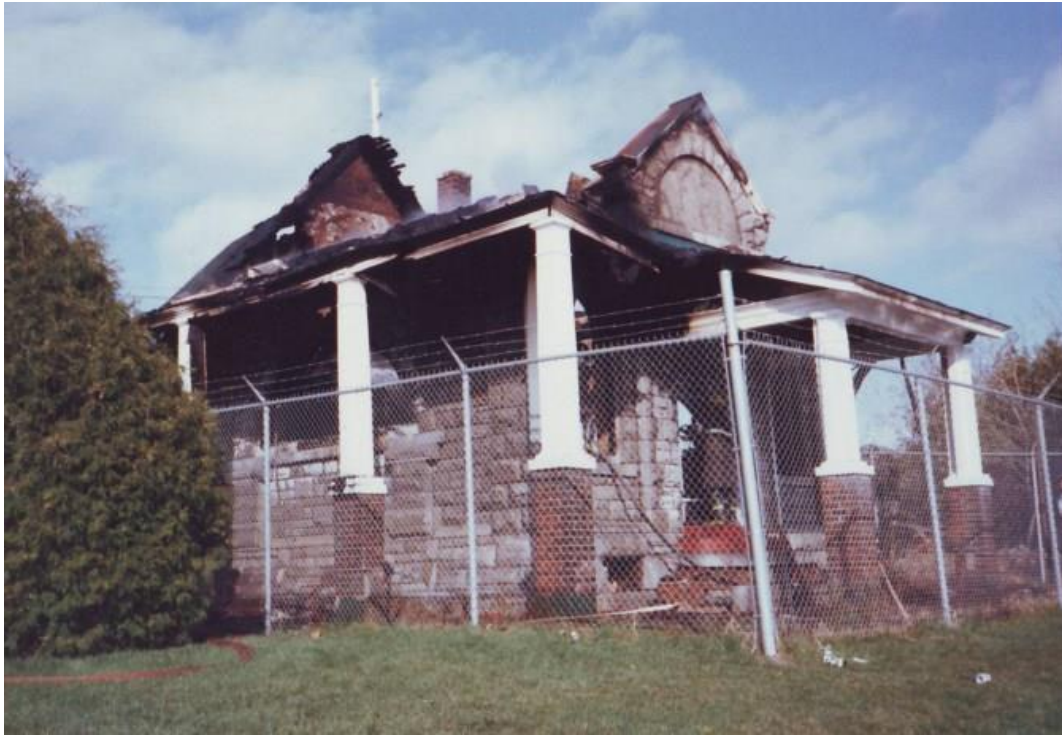
A restoration project took place in 1980, however in 1989, a fire destroyed the interior of the building and caused the roof structure to collapse. Partial masonry wall collapse occurred during the 1989 fire, and subsequently as a result of exposure to the elements. The Hintonburg Pumping Station has been abandoned ever since and the structure has been left exposed to the elements, with only the masonry elements remaining.

Figure 2: Hintonburg pumping station after 1989 fire

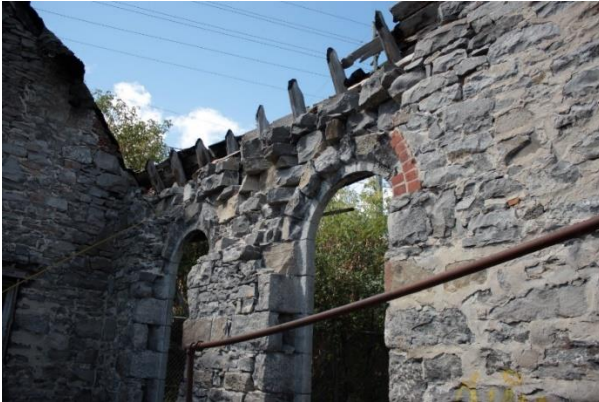
The north wall of the west wing had areas of localized collapse of the inner masonry wythe above the two arched windows and above the bricked-in archway at the center of the north wall. The masonry construction is of a high quality with good keying seen around the arched windows, but the wall is not adequately protected at the top from moisture. Water infiltration at the roof level has deteriorated the core of the

masonry wall and washed out the mortar joints, leaving large voids. This has resulted in a loss of structural integrity and the partial collapse of the inner wythe.

Figure 7: Collapsed inner wythe above arched windows [JCAL 2021]

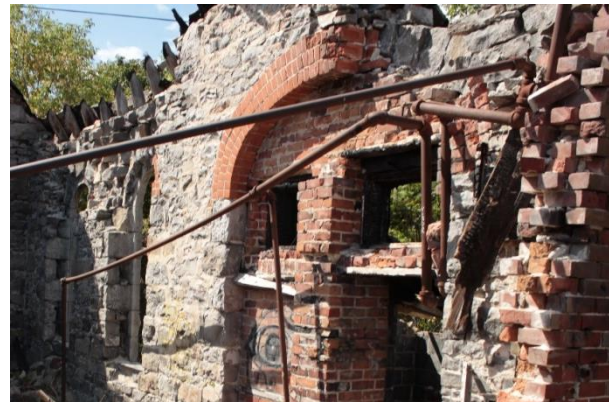
Figure 8: Collapsed inner wythe above archway [JCAL 2021]

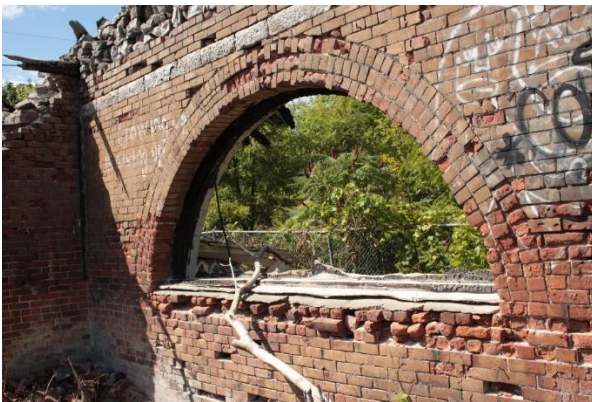
The large semi-circular arch window on the east wing portion of the north wall is one of the remaining character-defining elements which is still largely intact. The limestone exterior wythe is in fair condition. This area appears to have been repointed with Portland cement mortar, which is incompatible with the original lime mortar. The bricks on this portion of wall are severely deteriorated, particularly below the window sill, where many bricks are missing and displaced. The remaining bricks in general were in poor condition, with fractures and spalls observed throughout the wall. Void joints were predominant above the arch. The lack of mortar in these joints and poor condition of the remaining brick has severely reduced the structural integrity of the wall. Furthermore, with the collapse of the roof structure and east wall, there is a potential for a lack of lateral support. Depending on the heights and geometries of the restored walls, rebuilding the return at the northeast corner should be considered for lateral stability.

Figure 9: North window arch [JCAL 2021]

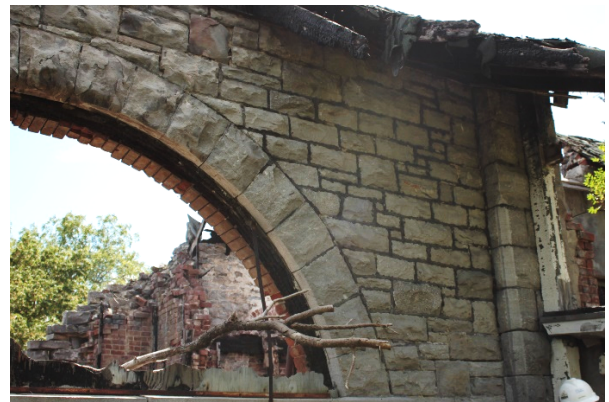
Figure 10: Repointed limestone masonry around arch [JCAL 2021]

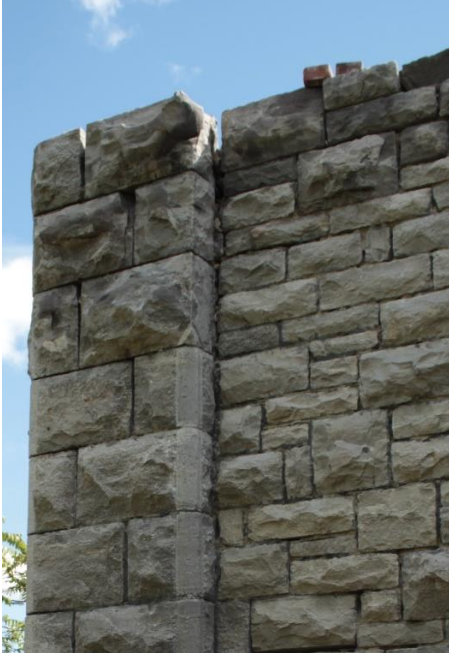
The vertical joint along the northeast corner of the structure has debonded and the corner appears to be separating from the structure, particularly at the top of the wall. Inspection of the mortar joints on the north wall found that these were only about 25 mm deep. The joints were void behind the face-pointing; these had likely been washed out by water infiltration due to the lack of protection at the top of the wall.

Figure 11: Detached northeast corner [JCAL 2021]

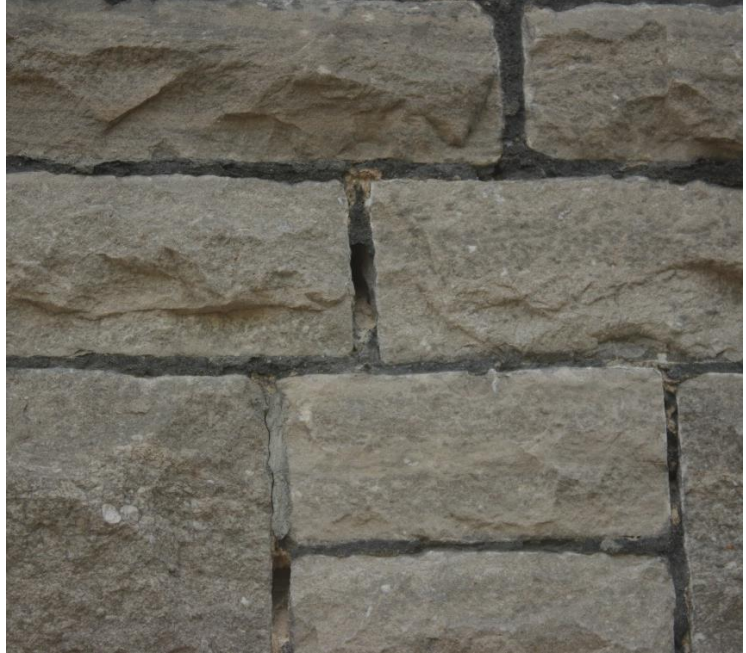
Figure 12: Mortar condition on exterior wythe of north wall [JCAL 2021]

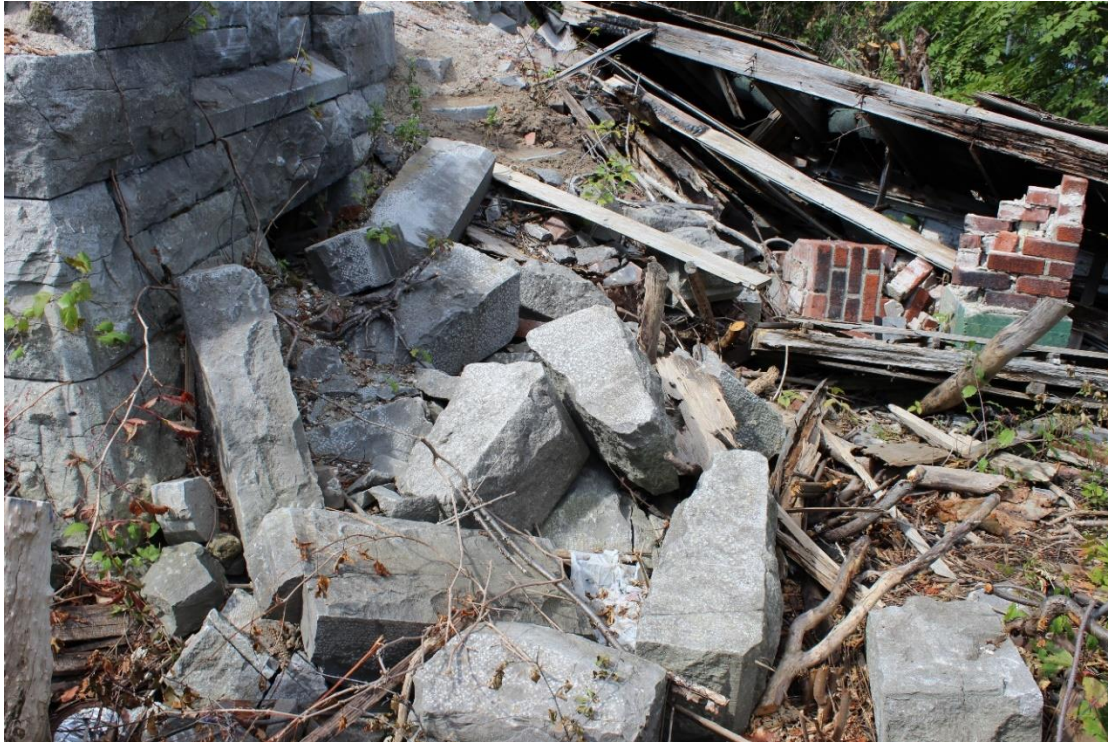
The east wall of the building has collapsed, to below existing window sill level. The condition of the double wythe masonry wall below this level is similar to that of the north wall, east wing. Portions of the brick piers which previously supported the verandah, the rounded stone steps at the center of the wall and two partial basements openings remain. The collapsed stone on the east side of the building may be salvaged to reconstruct other areas of the masonry walls, or to rebuild some portion of this wall.

The brick piers have collapsed, however, the fallen brick remains on site and may be salvaged to reconstruct areas of the building, if it is in good condition, in order to replace like-for-like materials. The rounded stone steps could not be fully inspected as these were covered in debris and sand, but the visible portions of the stones appeared to be in fair condition.

Figure 13: Remaining features of east wall, including brick piers, stone steps, and basement [JCAL 2021]

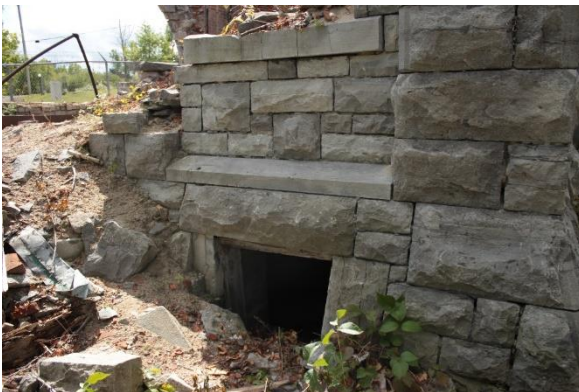
Two partial basements were found on either side of the stone steps. The floor above the southern basement had collapsed. The north basement extended about 2 m into the building and was about 1.5 m deep. Investigation of this area found that the foundation wall was constructed of limestone masonry. The wooden joist structure was still in place and appeared to be supporting the floor and debris above. Due to health and safety concerns, JCAL did not enter the basement. Given the exposure and quantity of debris on this floor structure, the condition of the wood floor structure is likely unsalvageable.

Figure 14: North basement on east wall [JCAL 2021]

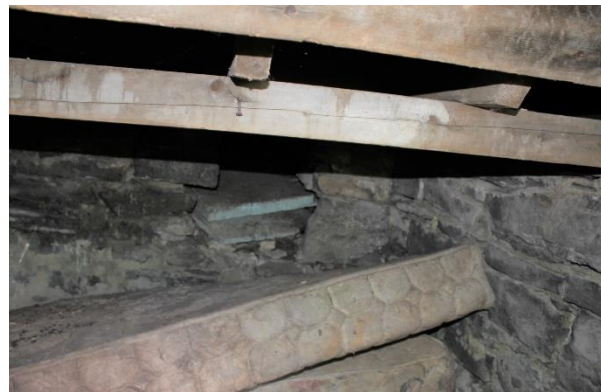
Figure 15: Basement interior [JCAL 2021]

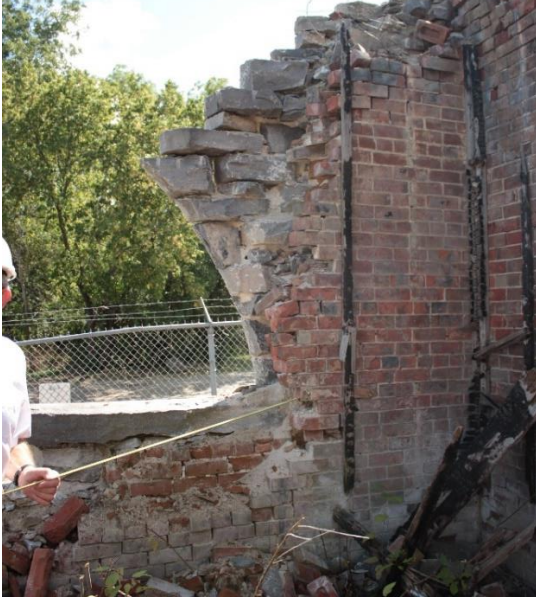
The large arched window on the east wing had partially collapsed. Since this window was constructed in the same manner as the north window, it may be possible to reconstruct the arch to its original form based

on existing evidence. Due to a lack of moisture protection at the top of the wall, most of the brick backup has deteriorated, particularly the core which was constructed from lower-quality common bricks. Open joints were seen on the exterior wythe of limestone masonry around the arch. The lack of mortar in the joints and large voids in the core of the wall is detrimental to the structural integrity of the wall and may result in further localized collapse of wall.

Figure 16: Collapsed east wing arch on south wall [JCAL 2021]

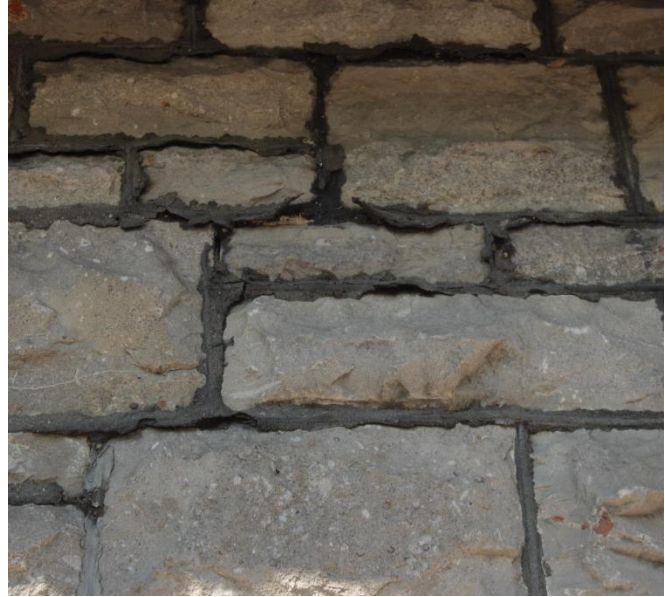
Figure 17: Portland cement repointing on south wall [JCAL 2021]

The inner wythe of the masonry wall has no protection from moisture infiltration at the top. Continued exposure to water has washed out the mortar joints at the top of the inner wythe and likely the core, which is not visible. This has also exposed the masonry to freeze-thaw damage. The lack of mortar in the joints has allowed stones to shift and fall off the wall.

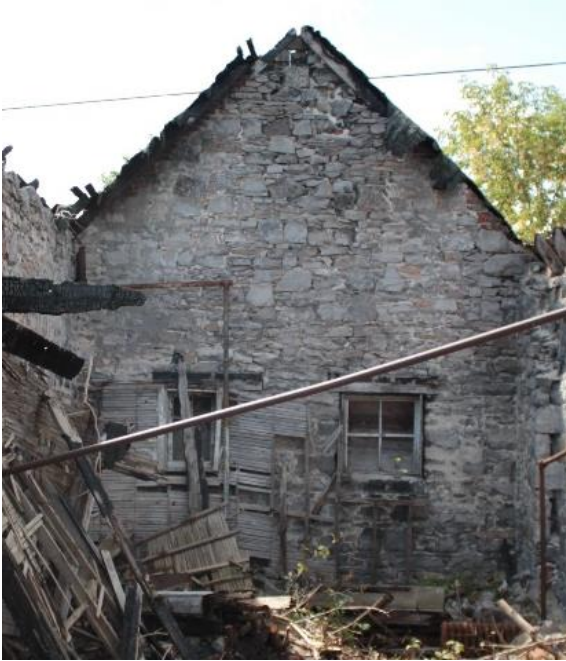
Figure 18: West wall interior [JCAL 2021]

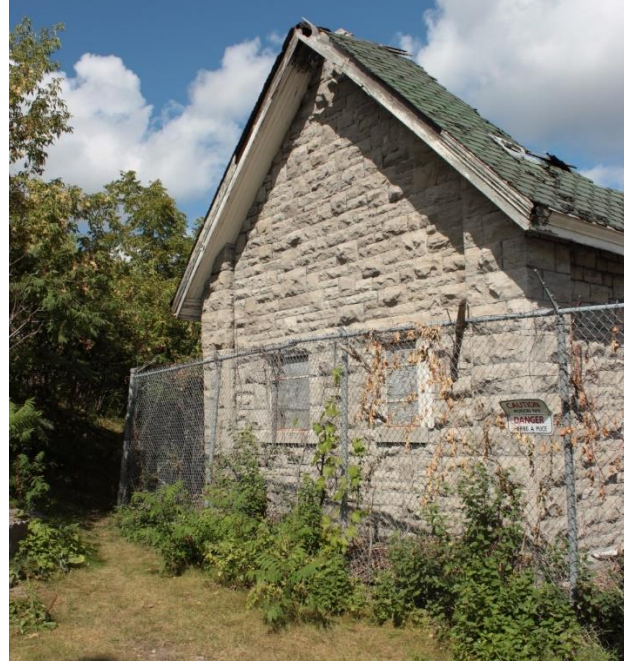
The exterior wythe of the west façade appeared to be in fair condition. What remains of the roof provides an overhang which protects the masonry below from moisture infiltration, except for the peak of the gable which is exposed. The Portland cement-based face pointing on the west wall is incompatible with the original materials.

Figure 19: West wall exterior [JCAL 2021]

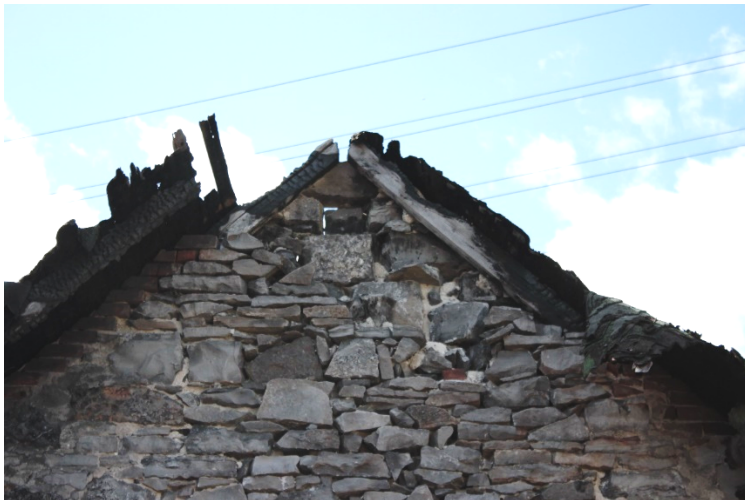
Significant deterioration was seen in the central third of the gable on the interior wythe. The joints in this section were void and several stones were missing near the roof peak. The loss of mortar in the joints has compromised the integrity of the wall and may lead to further collapse of the inner wythe. Some of the stone masonry in this section of wall may have also been exposed to high heat during the fire.

Figure 20: Void joints and displaced stones at gable peak [JCAL 2021]
