Tree Information Report:

629 Windermere

Municipal Crimson King Maple

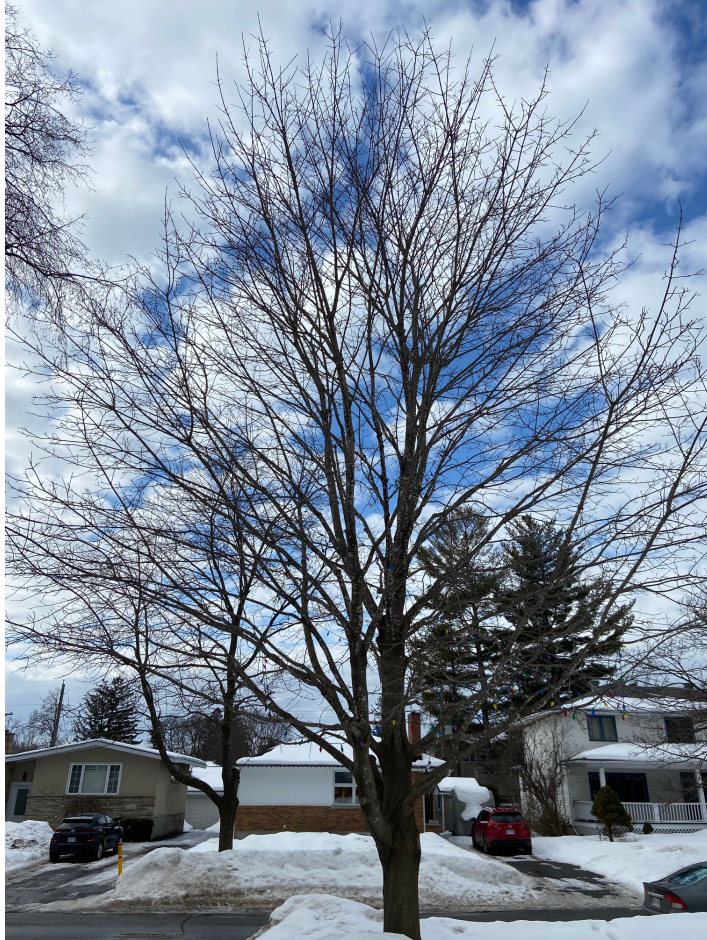
The tree is in good condition. It has a vigorous, full crown with few dead branches. It has one scaffolding branch which has become overdeveloped and is now competing with the central

stem for dominance. The union does not have any included bark, so it is not a significant risk of failing at this time. The tree is also young enough that this issue can easily be remediated via

reduction pruning or amputation of the limb. If these measures are not take, risk related to this branch will likely increase over time and eventually lead to failure—damage to the trunk could be extensive enough that the remainder of the tree is no longer viable, leading to removal.

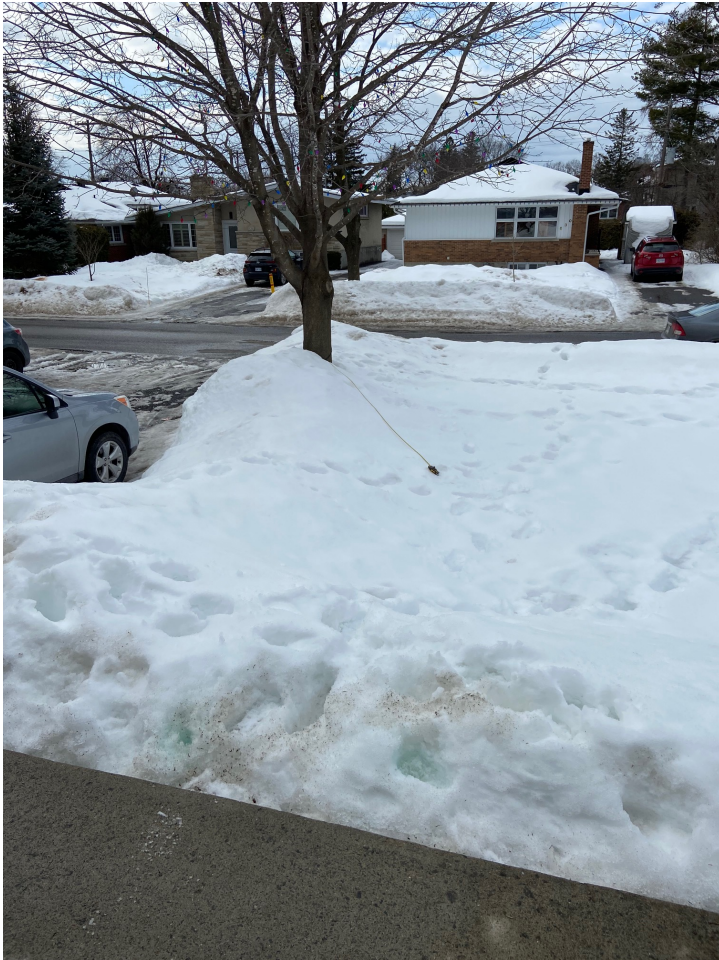
³ Demonstrated with measuring tape in image below.

Plans for the addition do not require any incursion into the CRZ of the tree and potential impact is limited. Fencing shall be erected to protect the CRZ of the tree from potential damage during construction. This fencing shall be erected at a distance of 410cm from the trunk³ of the tree along the eastern and northern side. The CRZ is already impacted by a driveway to the south and

a road to the west, so protection in these portions of the CRZ would have no meaningful effect. Fencing shall be installed along the edge of the driveway and along the curb. No construction activities⁴ are permitted within the fencing.
