## Tree Information Report for 422 Hartleigh Avenue, Ottawa

The owner is applying for a permit to demolish the existing structure and build two attached two-story residential units.

**Inspection date:** 2023-03-01

The objective of this report is to identify all protected trees on this and adjacent properties whose Critical Root Zones (CRZ's) fall within the area of construction and to provide strategies for tree preservation during development and construction.

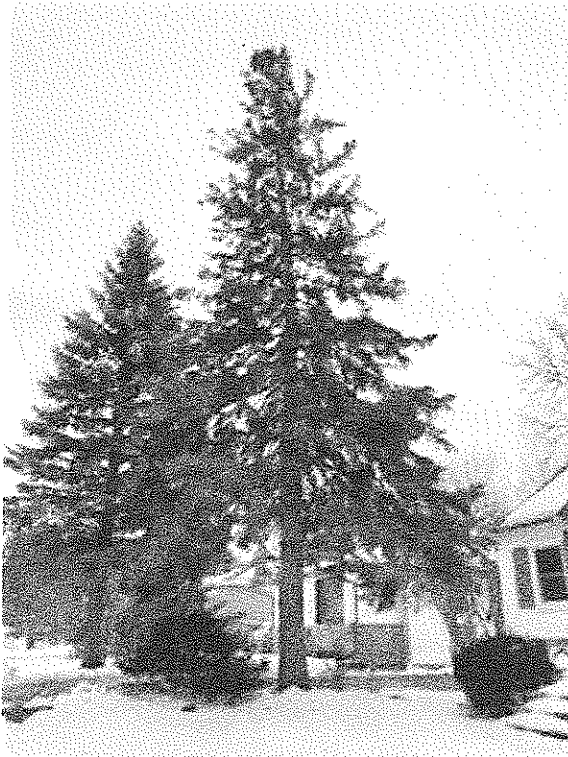
Photo 1 White Spruce in Centre

This is a mature White spruce. See photos 1 and 2, p. 3

There is some die-back of smaller branches. There are a few dead branches and one hanger.

Roots may be restricted by the nearby paved driveway at 426 Hartleigh Ave.

The proposed plan shows very little encroachment into the CRZ, apart from the new driveway. Excavation for the new driveway may impact less than 20% of the CRZ. The tree should be able to tolerate this moderate amount of root loss.<sup>1</sup>

Provide protective fencing around the CRZ as indicated in Drawings #1 p 9 and #2 p 10.  
Follow all the Steps to Conserve Trees p 8.

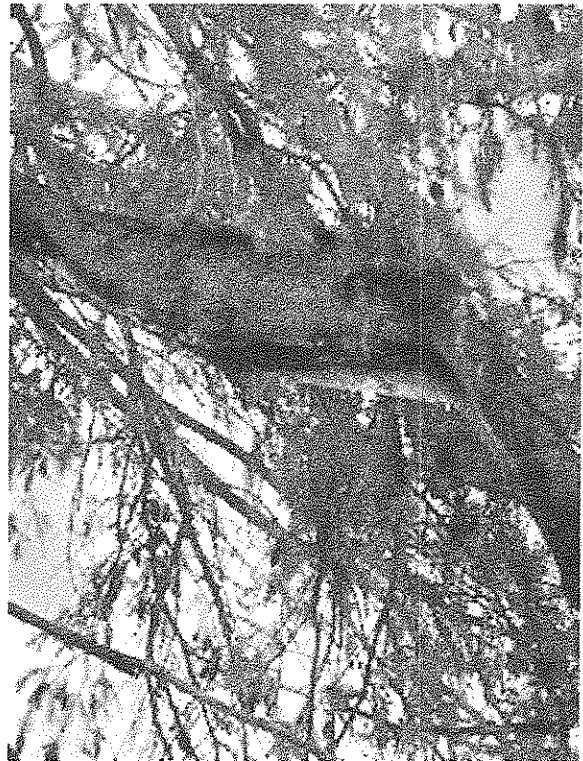
Photo 2 Branch with Unidentified Canker

There is a possible unidentified canker on one of the lower branches.

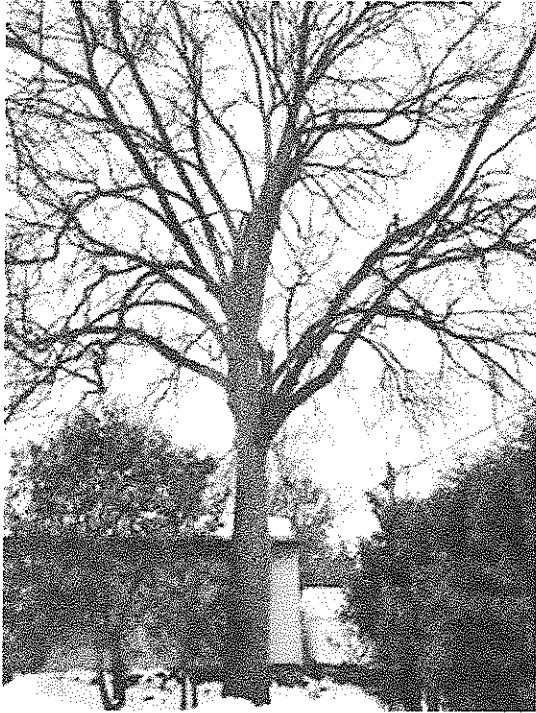
Photo 3 Mature Black Walnut

This is a mature Black walnut.

It has been cabled twice: one at ~9M: another one is broken.

While the tree is dormant at the time of inspection, I am familiar with this tree and this past summer foliage appeared to be normal.

The tree is generally healthy and should be protected before construction begins.

Approximately 15% of the CRZ will be impacted by the construction. While it may not affect the stability of this tree it may cause some decline.

Erect a fence around the CRZ as shown in Diagrams #1 p. 9 and #2 p.10 and follow "Steps to Conserve Trees" in this report.

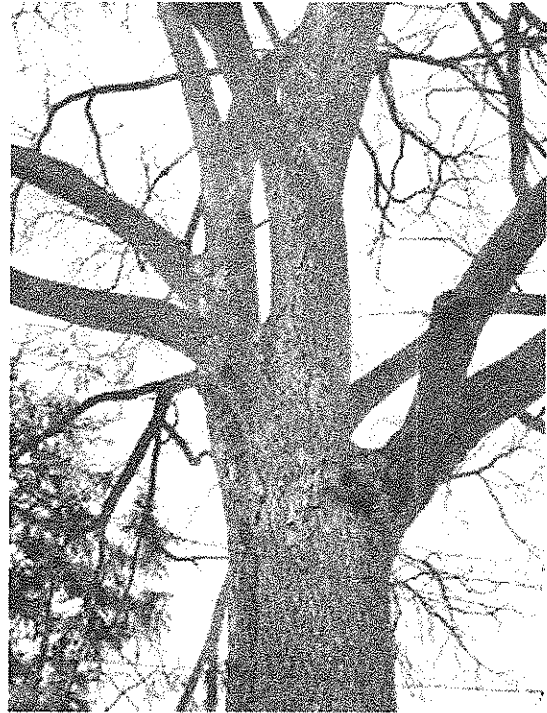
Photo 4 First Fork

There are co-dominant stems with included bark and one weak attachment.

No visible cavities, cracks or splits. There is a fissure in the bark along the main trunk on both sides from the fork down.

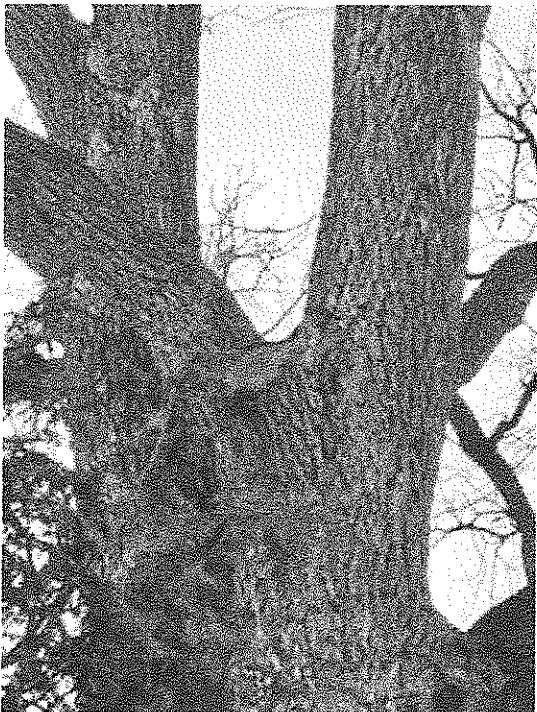
Photo 5 Previous Pruning

There are some old pruning wounds.

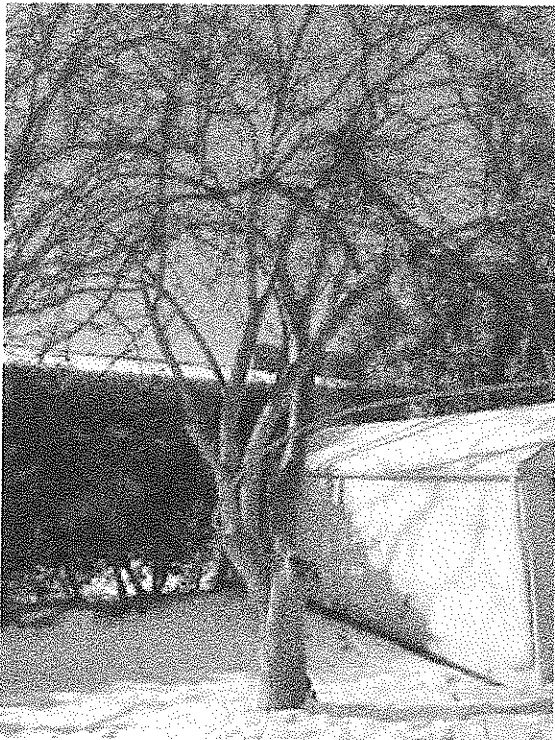
Photo 7 Apple tree

It has a double stem partially twisted and growing into each other.

It has co-dominant stems and included bark.

The tree is in poor condition.

The tree should be removed before construction begins.

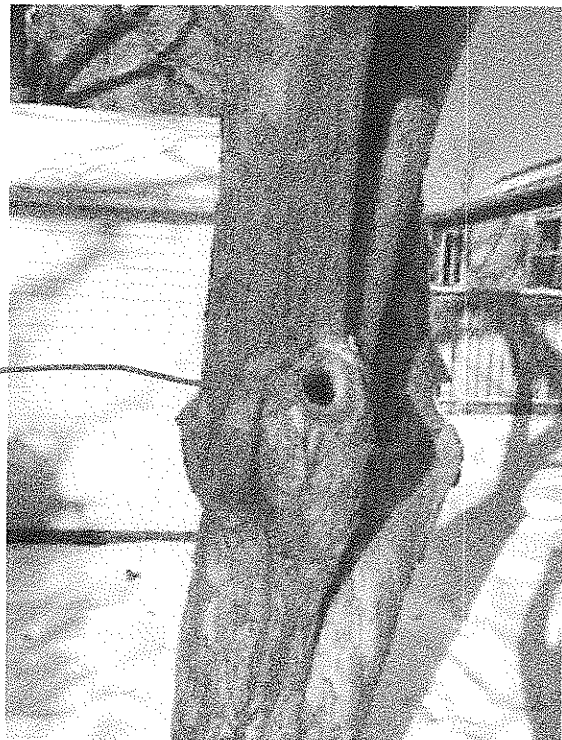
Photo 8 Deep Cavity

Previous pruning has left unhealed wounds and several deep cavities. See Photos 8 to 10, p 5.

One in Photo 8 is about 50 cm deep.

Malus species are poor compartmentalizers as exemplified by the cavities.

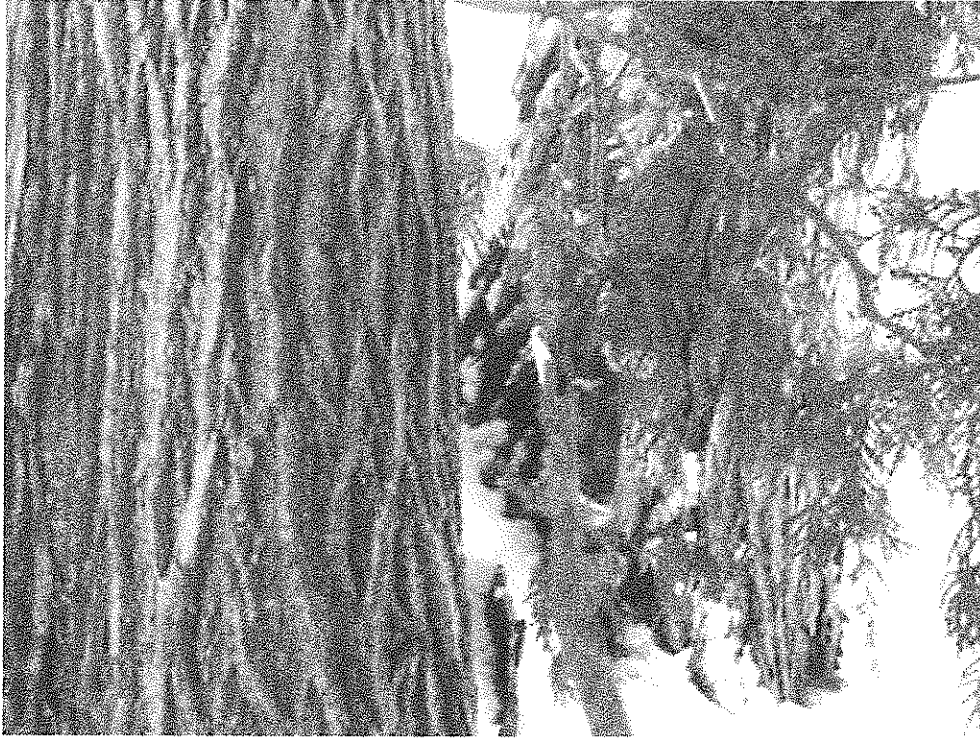
Photo 11 Tree #4 Slippery Elm with two stems.

There are actually two stems growing close together. See Photo 11, p. 7.

They appear to be in good condition although the canopies are thin.

The CRZ's are well outside the proposed limit of excavation and neither of these two trees should be affected by the development.

Protective fencing erected around the CRZ of the Black Walnut should be extended to include the exposed CRZ of these trees. See illustrations on Diagrams #1 and #2

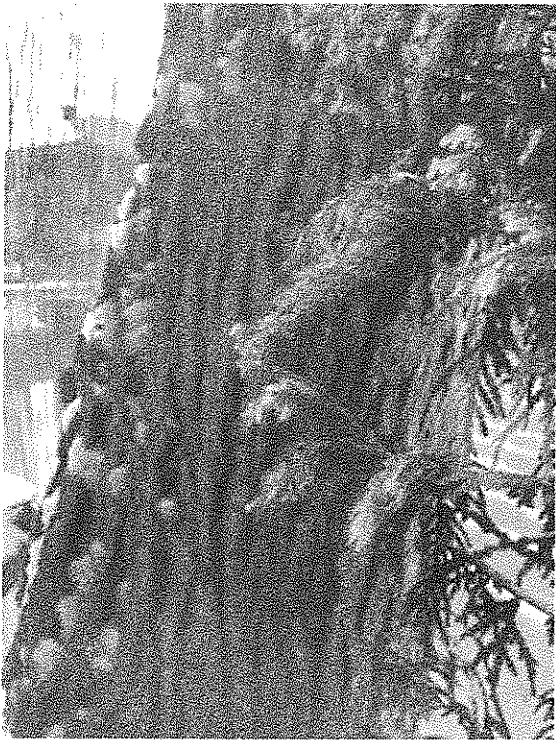
Photo 12 Largest of the Two Stems

Dbh of largest stem is 35 cm.
