## Tree Information Report

Submitted as part of Committee of Adjustment Application to the City of Ottawa

**Address:** 236 Woodroffe Avenue

**Date of Report:** February 9, 2023

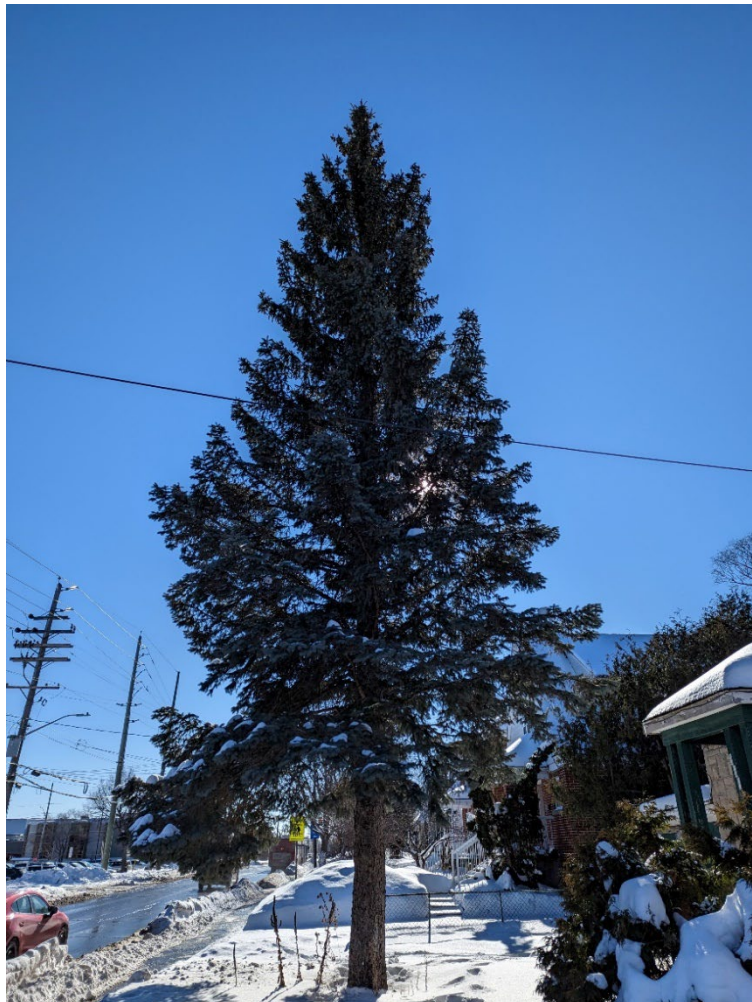
Figure 1 - Tree 1: City Colorado spruce – to be removed

Options were explored to retain **Tree 1**, but due to need for site access, capping of existing and installation of new services (see ‘Removals plan’ and ‘Site servicing plan’), as well as the shallow-rooting nature of spruces, it is the opinion of Dendron Forestry Services that best long-term outcomes for the urban tree canopy will be achieved by removing this tree and replanting after construction is complete. This will allow efforts to be focused on preserving the large mature trees at the back of the property.

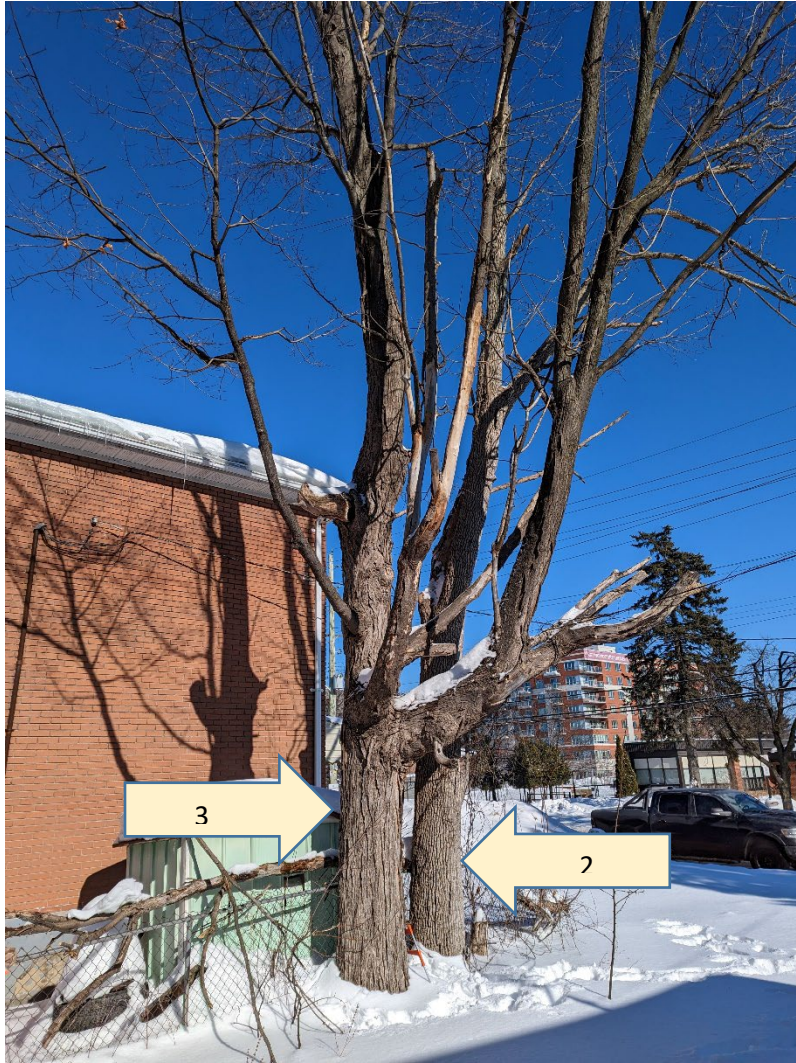
*Figure 2 - Trees 2 and 3 (indicated with arrows): Boundary – to be removed*

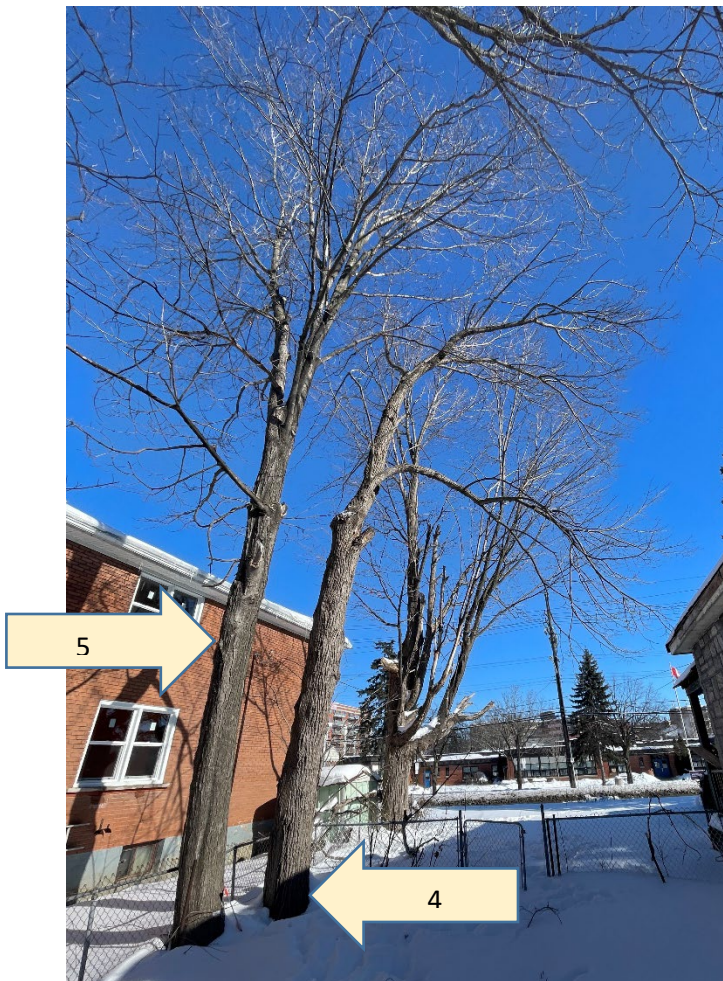
Figure 4 - Trees 4 and 5 (indicated with arrows): Boundary – Tee 4 to be removed and tree 5 to be retained

The roots of **Tree 5 and Tree 6** should be severed before excavation and installation of the driveway. A hydrovac system or airspade is to be used to expose the roots so they can be cleanly severed by hand, and this will be performed by a certified arborist. After excavation and during construction, the tree should be monitored for stability. Any roots to be severed for the installation of the stone entryway must also be cut by hand. Any required pruning for clearance will also be performed by a certified arborist.

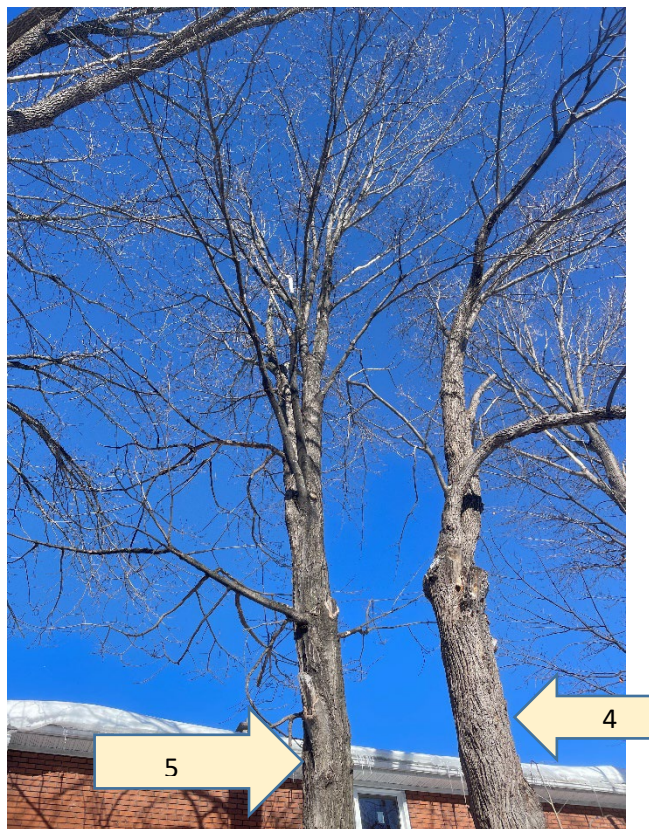
Figure 3 - Trees 4 and 5 (indicated with arrows)

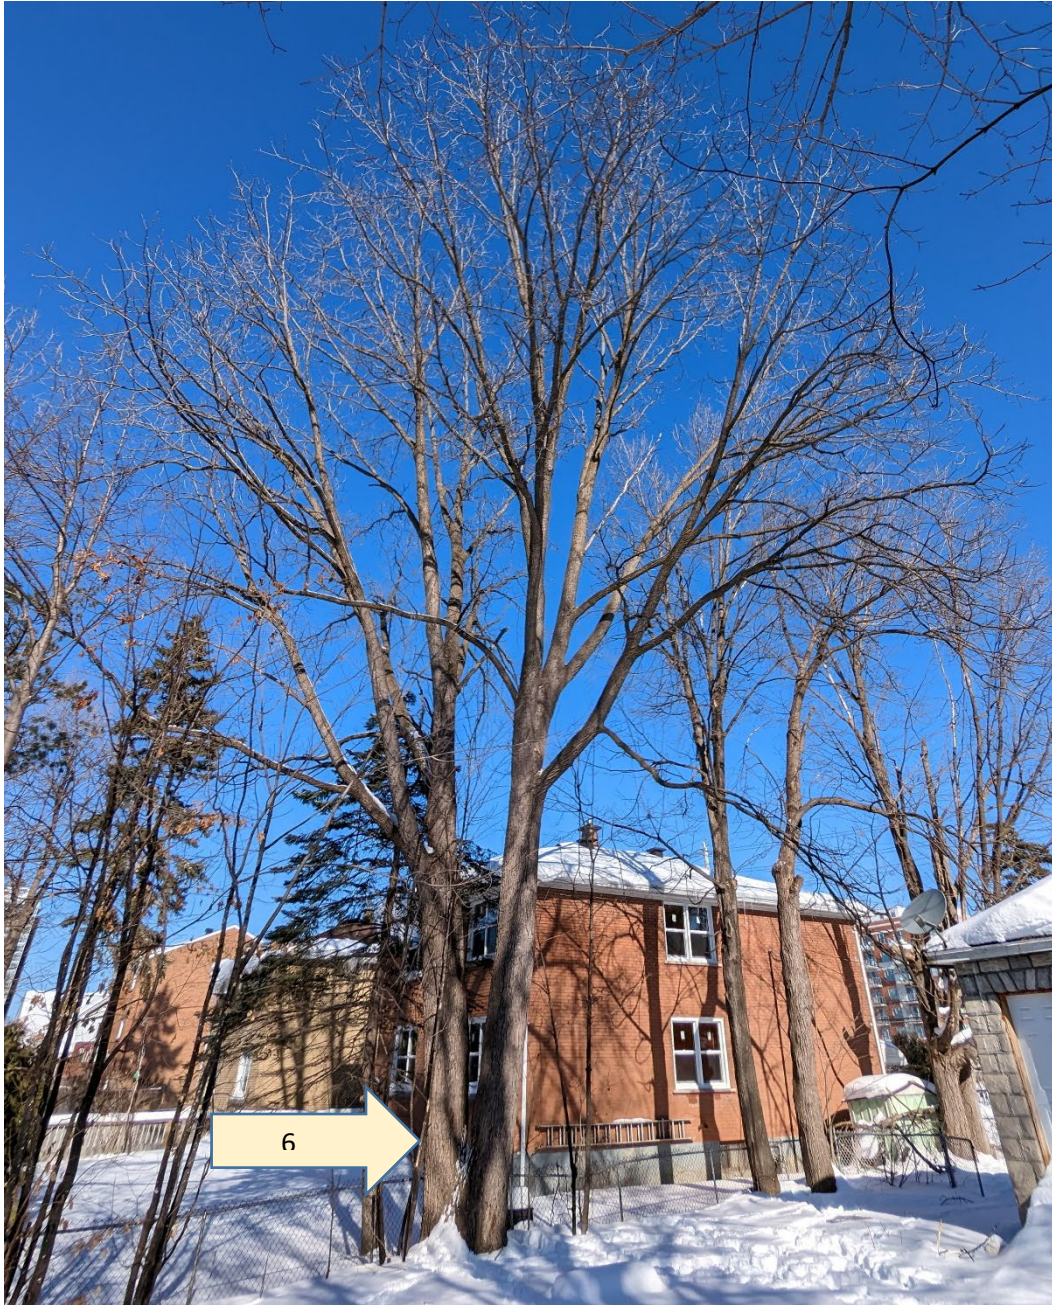
*Figure 5 - Tree 6: Boundary black walnut – to be retained*

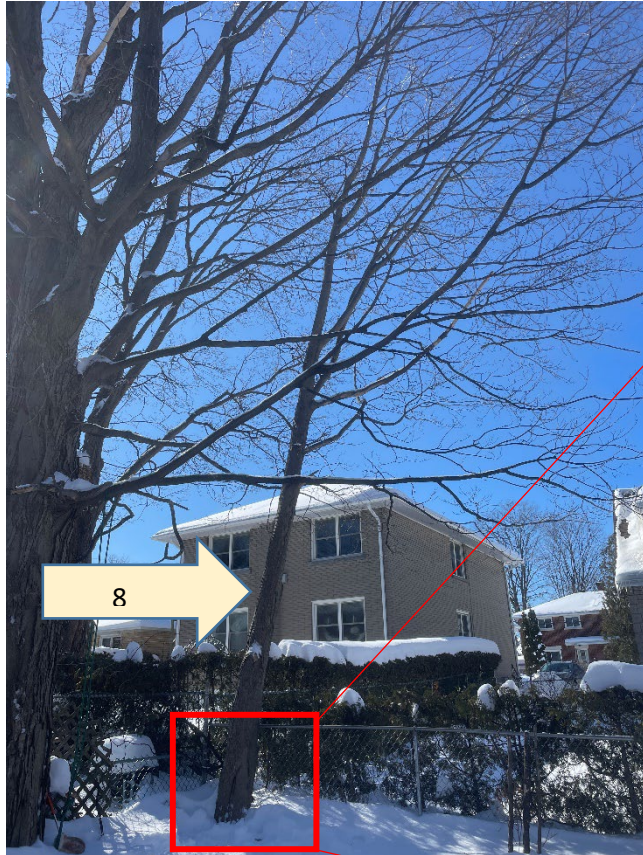
Figure 7 - Tree 8: Boundary – to be retained

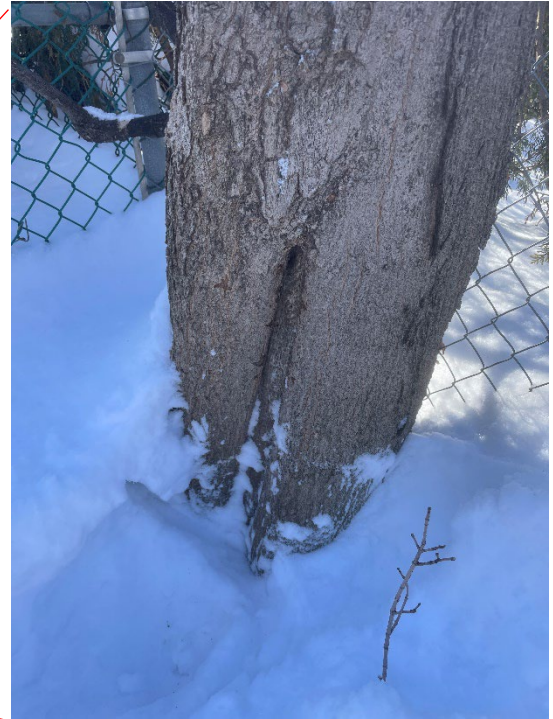
Figure 6 - Wound at base of Tree 8

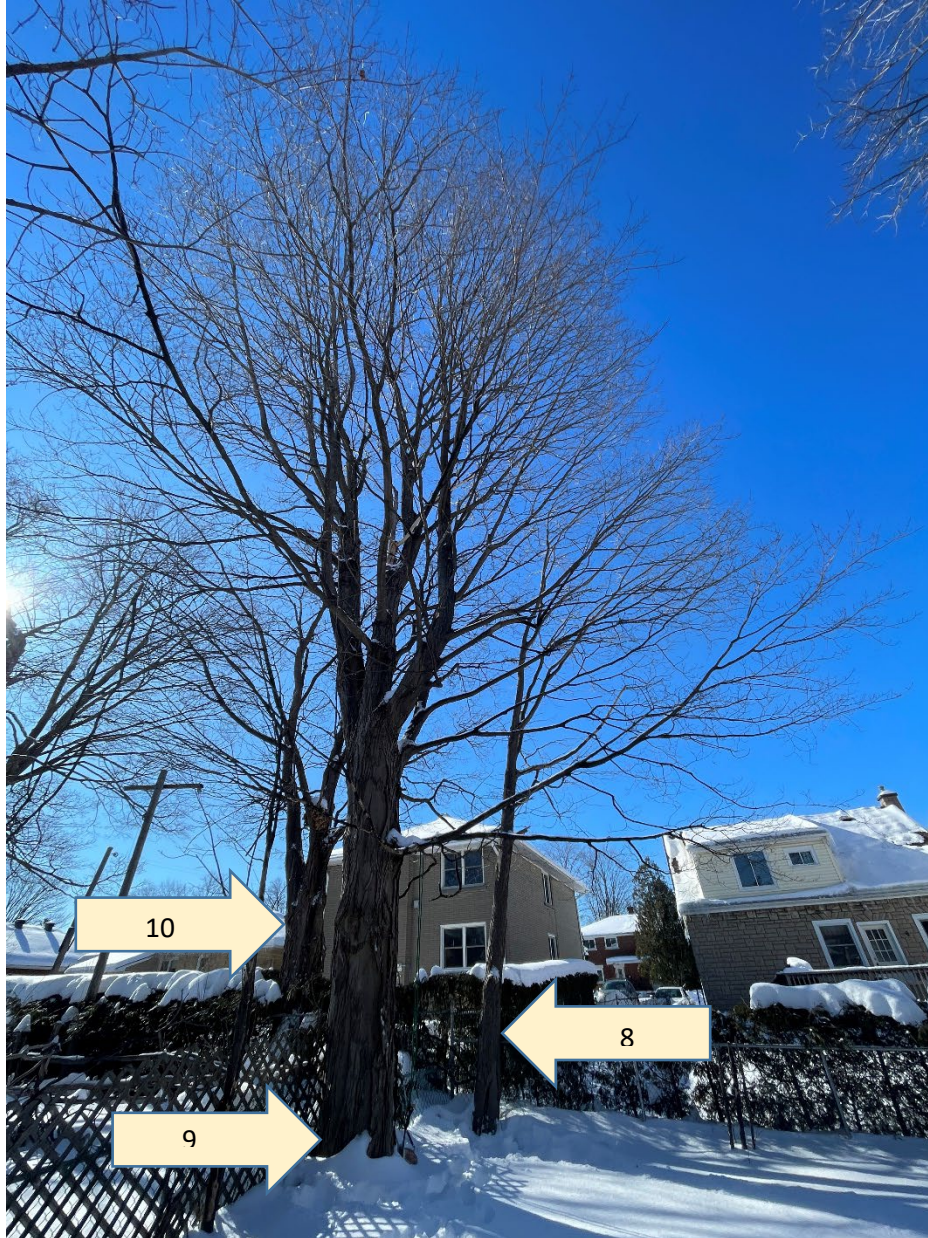
9	Sugar maple ( <i>Acer saccharum</i> )	75	Boundary	Good/Fair: 3 large codominant stems	Retain	Retain: protect as per the City of Ottawa Tree Protection Specifications (March 2021)
10 <sup>4</sup>	Sugar maple ( <i>Acer saccharum</i> )	70 (est.)	Adjacent – 237 Compton Ave	Fair	Retain	No action required

Figure 8 - Trees 8, 9 and 10 (indicated with arrows) – to be retained
