Old Railway Rideau River Pedestrian Bridge Structure No. 018600 Detailed Condition Assessment and Renewal Option Analysis Report

Contract No.
ISD17-7087
Work Order Package
No. 11316522

Detailed Condition Assessment and Renewal Options Analysis Report

November 2018

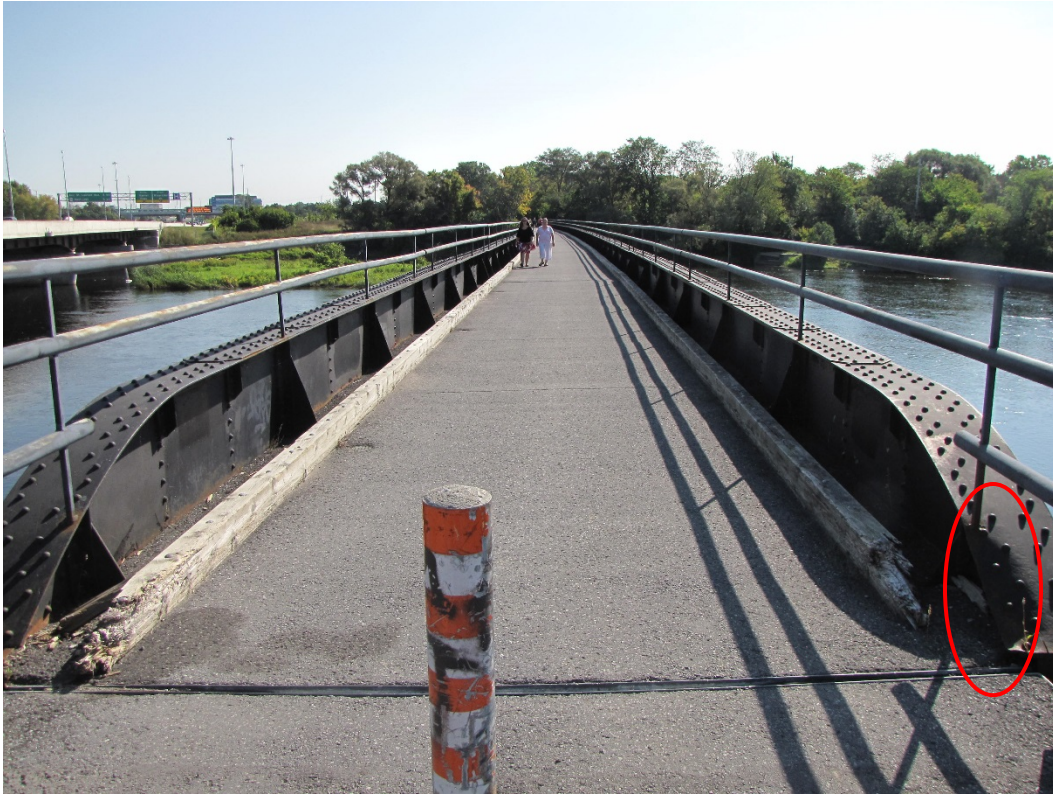
Photo 3 – West approach, looking east across top of deck. Impact damage to ends of timber curbs and top flange cover plate of south girder. Note transverse downslope of deck towards north and deck drains along interior of timber curb.

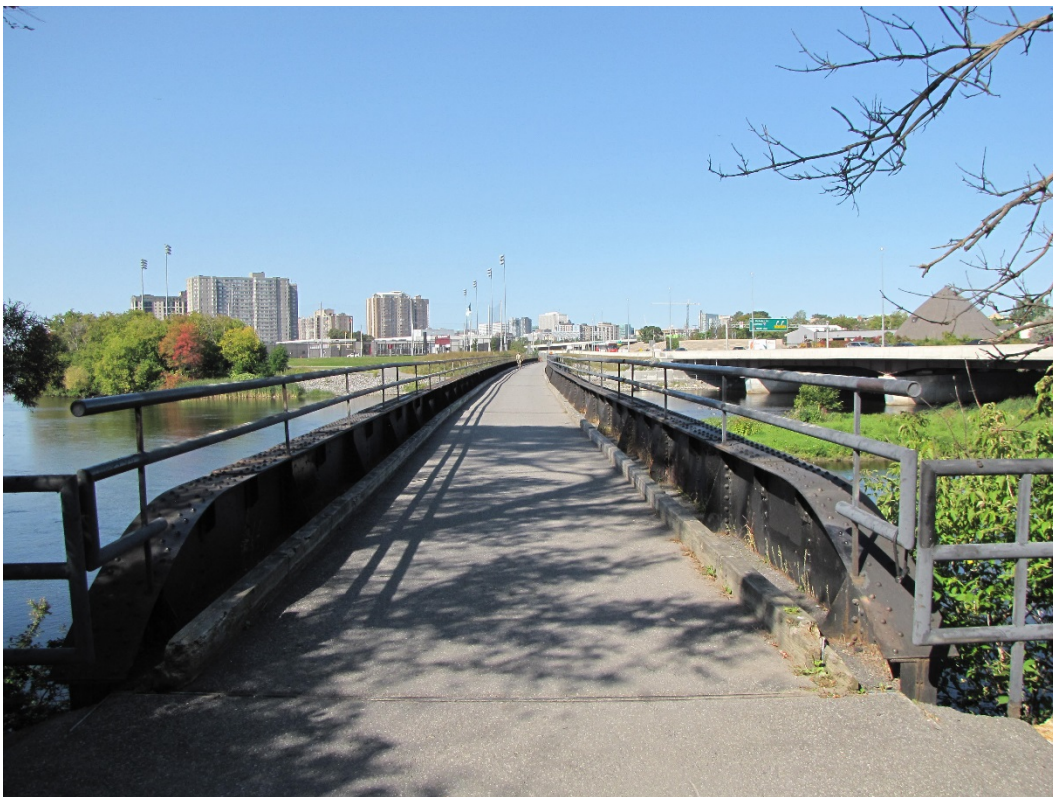
Photo 4 – East approach, looking west across top of deck. Impact damage to ends of timber curbs. Note horizontal curved alignment of the structure towards the north.

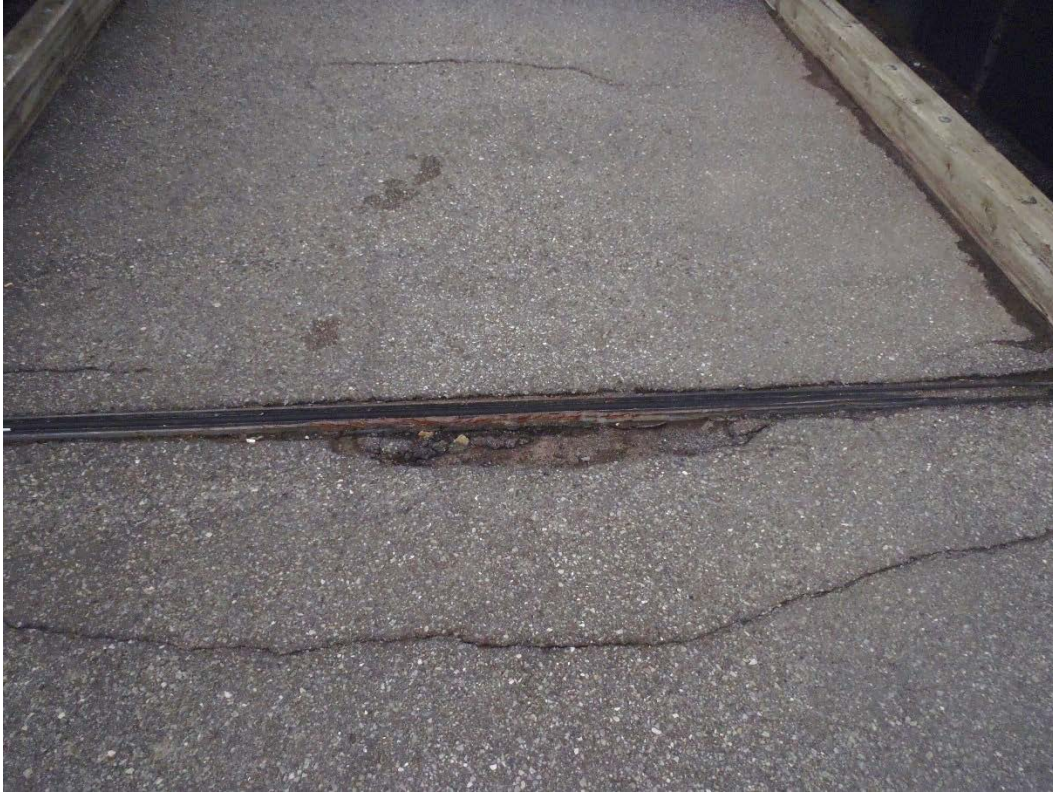
Photo 7 – Light to severe isolated unsealed transverse cracks and asphalt break-up with a pothole at the expansion joint at Pier 6.

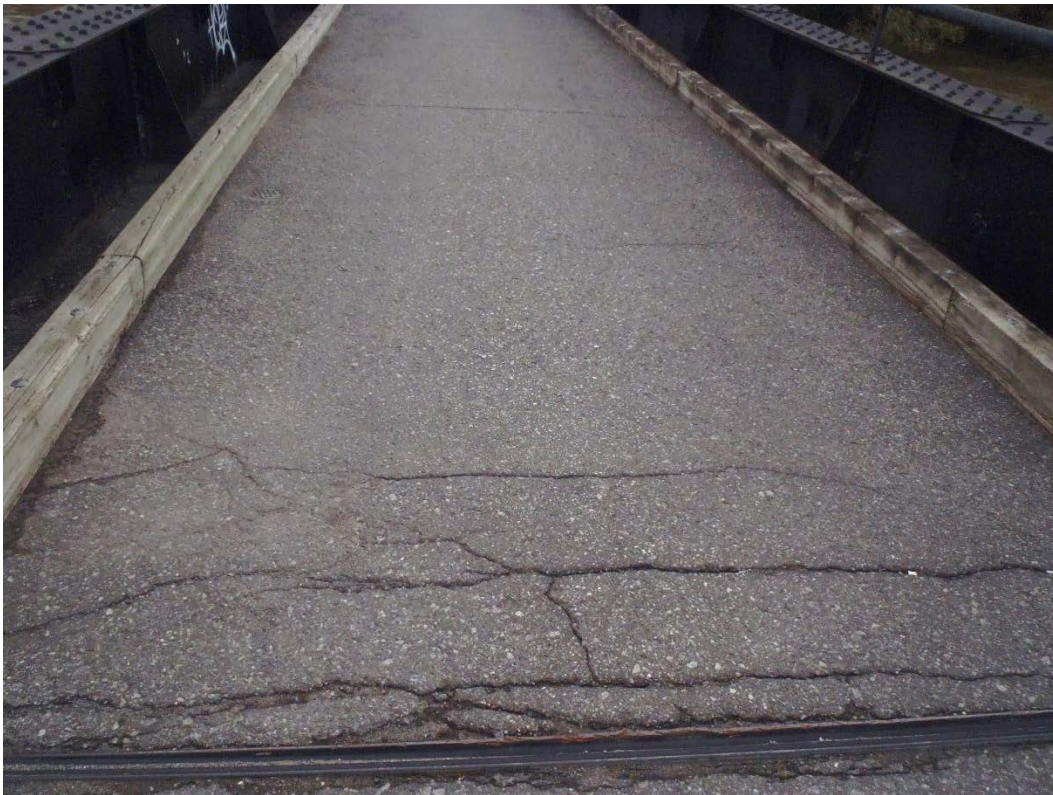
Photo 8 – Light to severe unsealed progressive edge cracks and isolated cracks at the expansion joint at Pier 3.

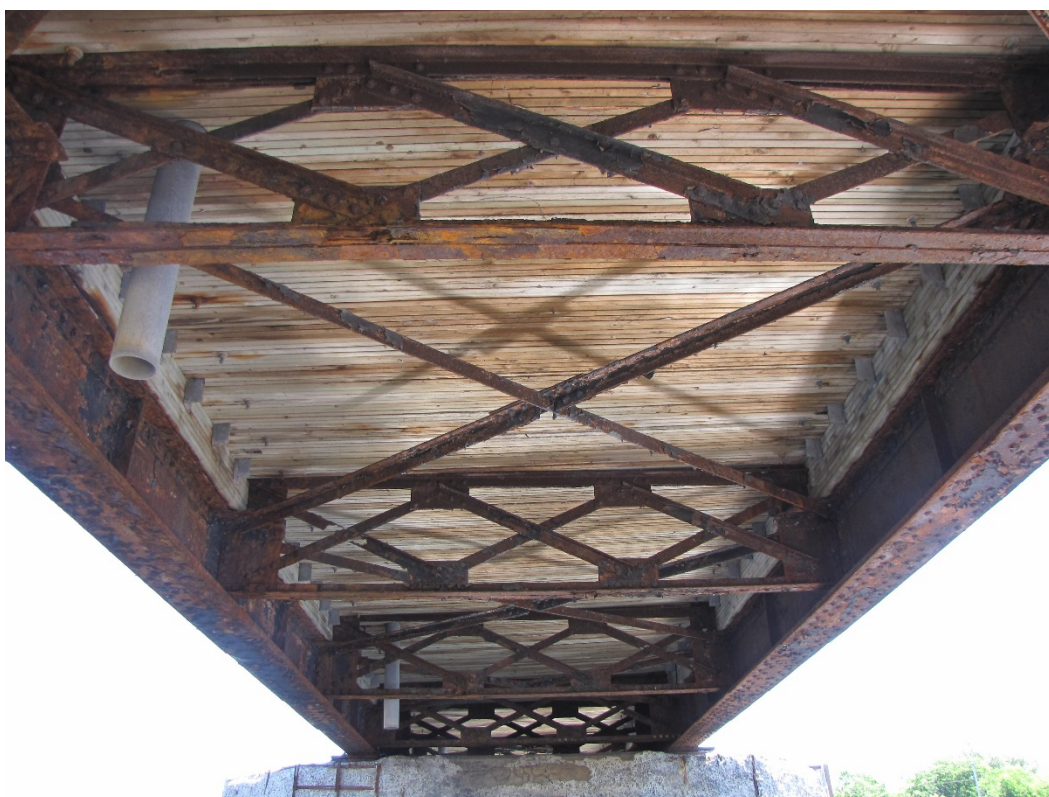
Photo 10 - Underside of Span 7, looking east. Areas of wet staining throughout the soffit of the laminated timber deck. Note water was observed penetrating through the laminated timber deck during the inspection, when raining.

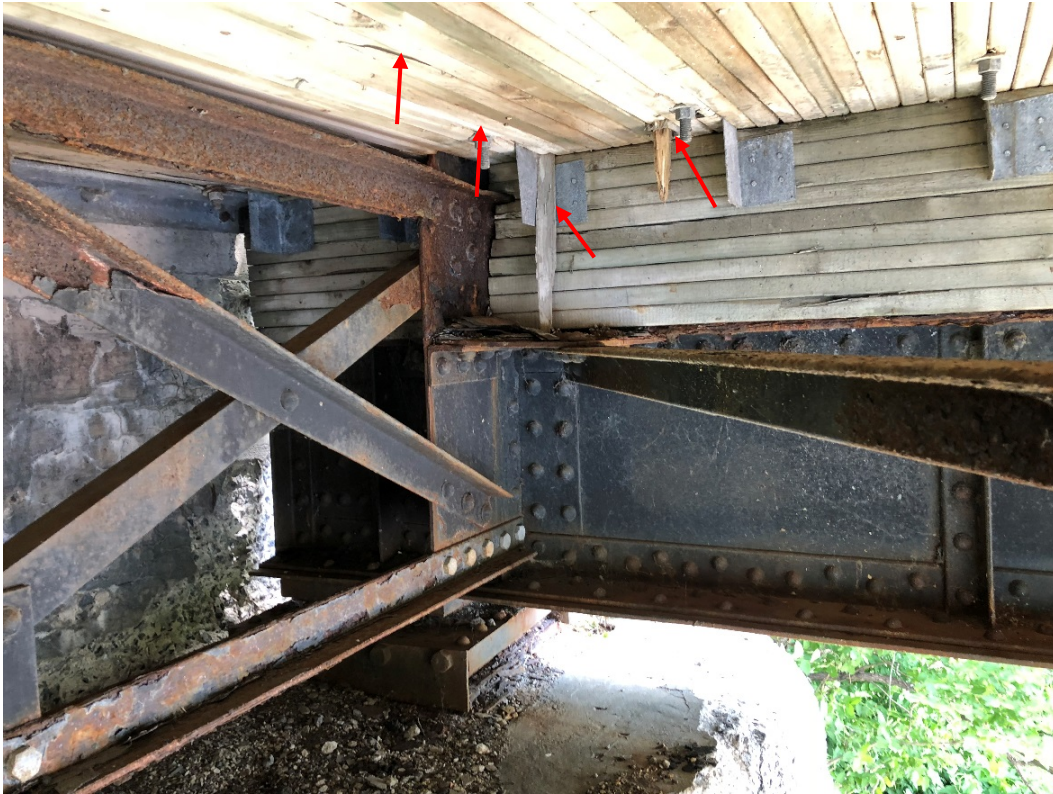
Photo 11 – Light to medium checks in the soffit and ledger and a severe split which has splintered a board in the soffit at the curb bolt. There is a piece of splintered curb timber lodged in the rectangular deck drain at the east abutment.

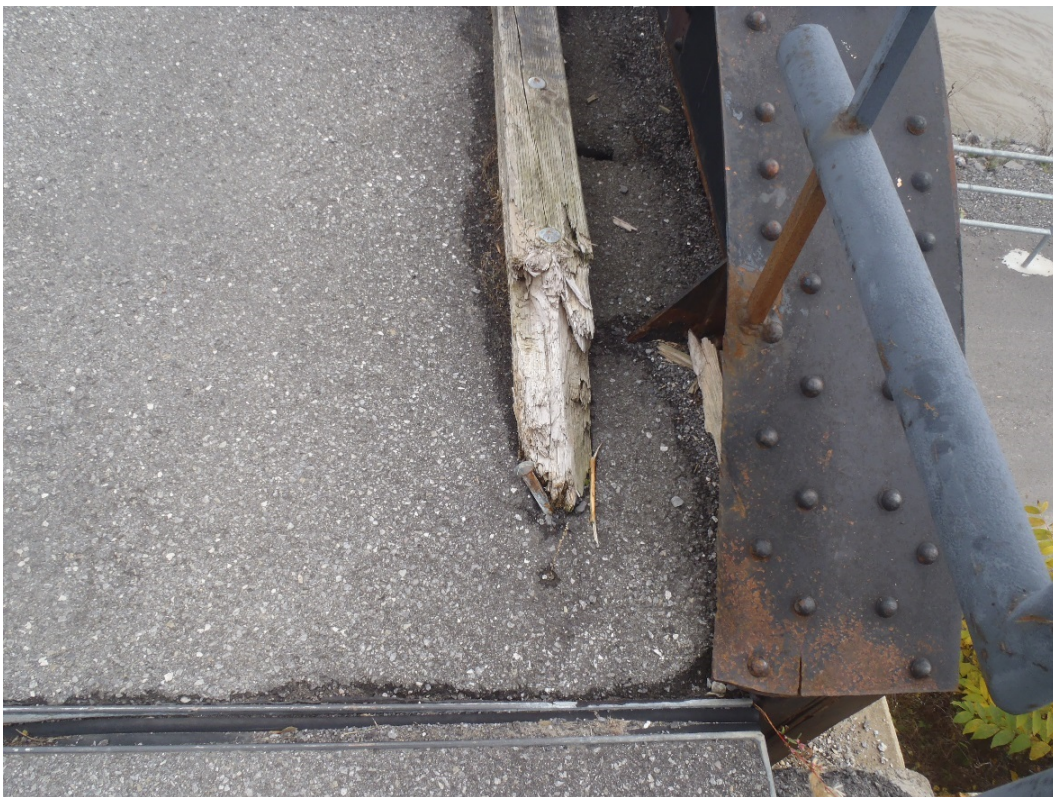
Photo 12 – Very severe impact damage to the west end of the south timber curb. Note the impact damage with cracking and light corrosion in the cover plate of the steel girder.

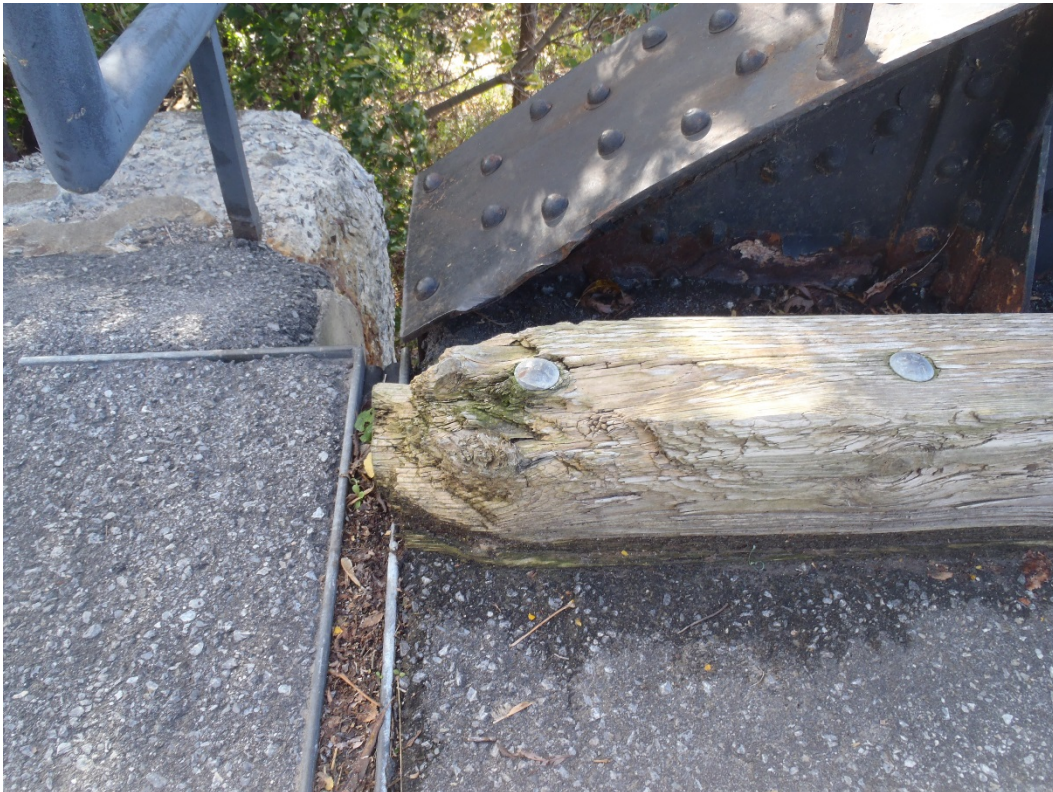
Photo 13 – Impact damage to the east end of the south timber curb.

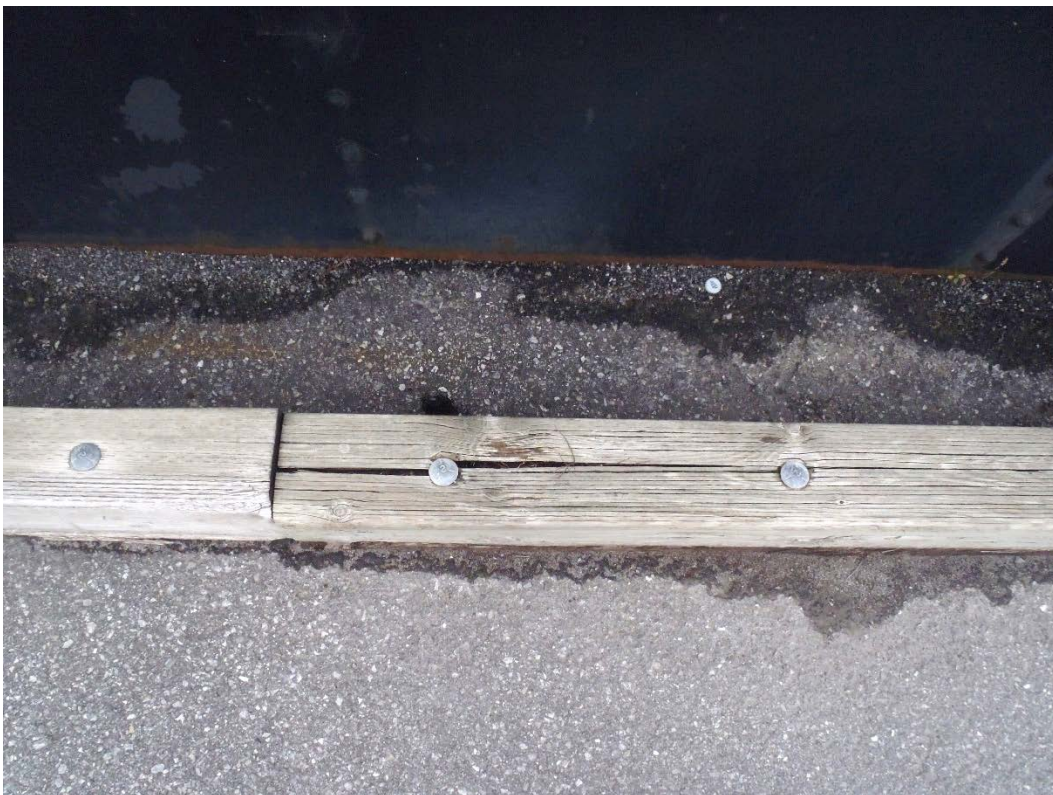
Photo 14 – Light to severe longitudinal splits in the curb from the bolts. Typical localized light weathering is also visible in the top and interior face of curb.

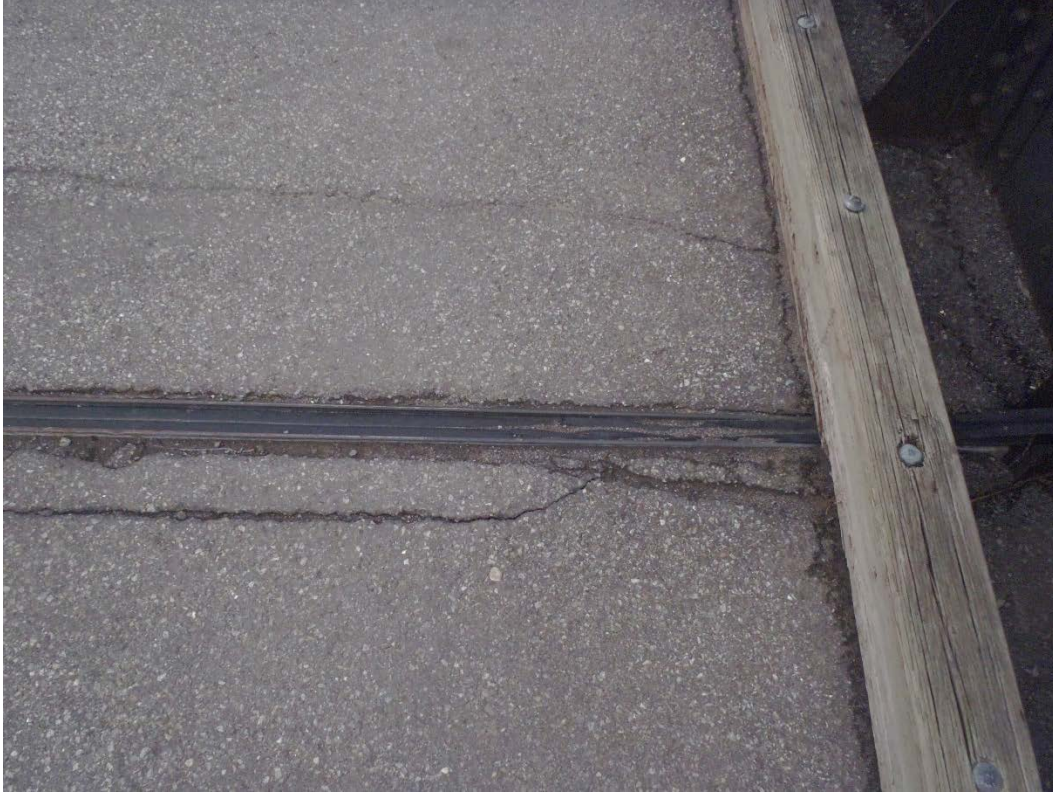
Photo 15 – Broken end of compression seal at Pier 2.

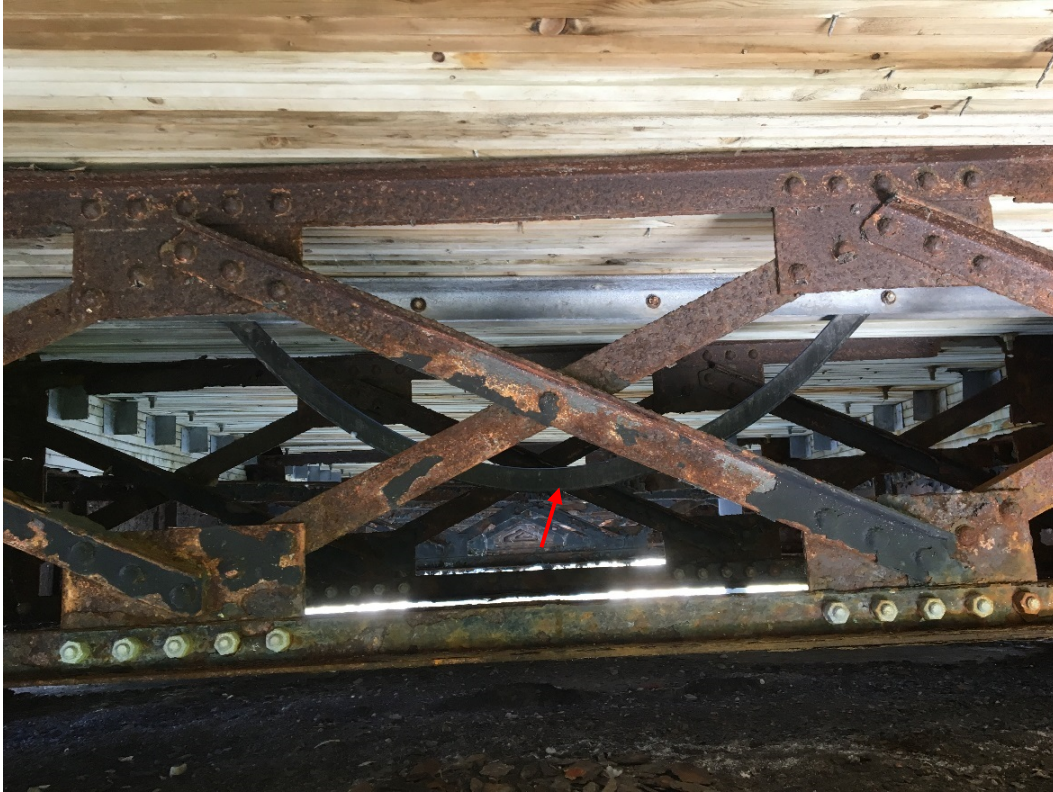
Photo 17 – Significant section of debonded expansion joint compression seal sagging below deck at Pier 4. Light to medium corrosion on expansion joint angle bolts.

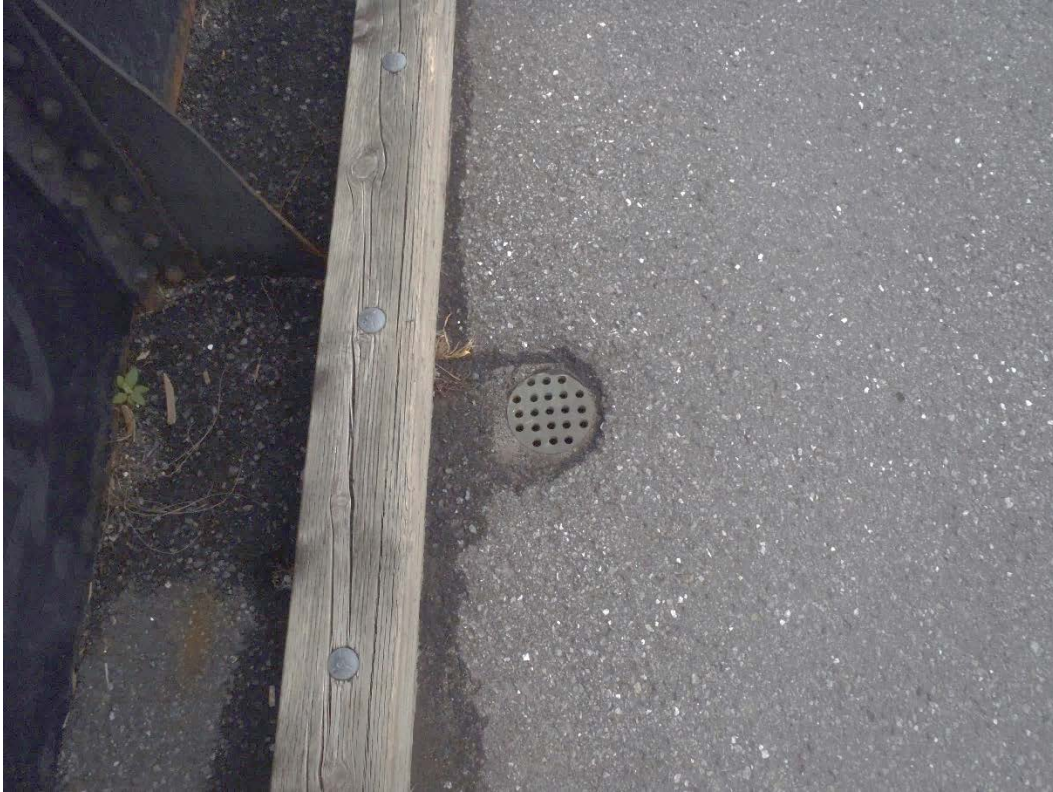
Photo 19 – Medium to severe raveling between the exterior face of the timber curb and girder web. Note typical good condition of deck drain gratings.

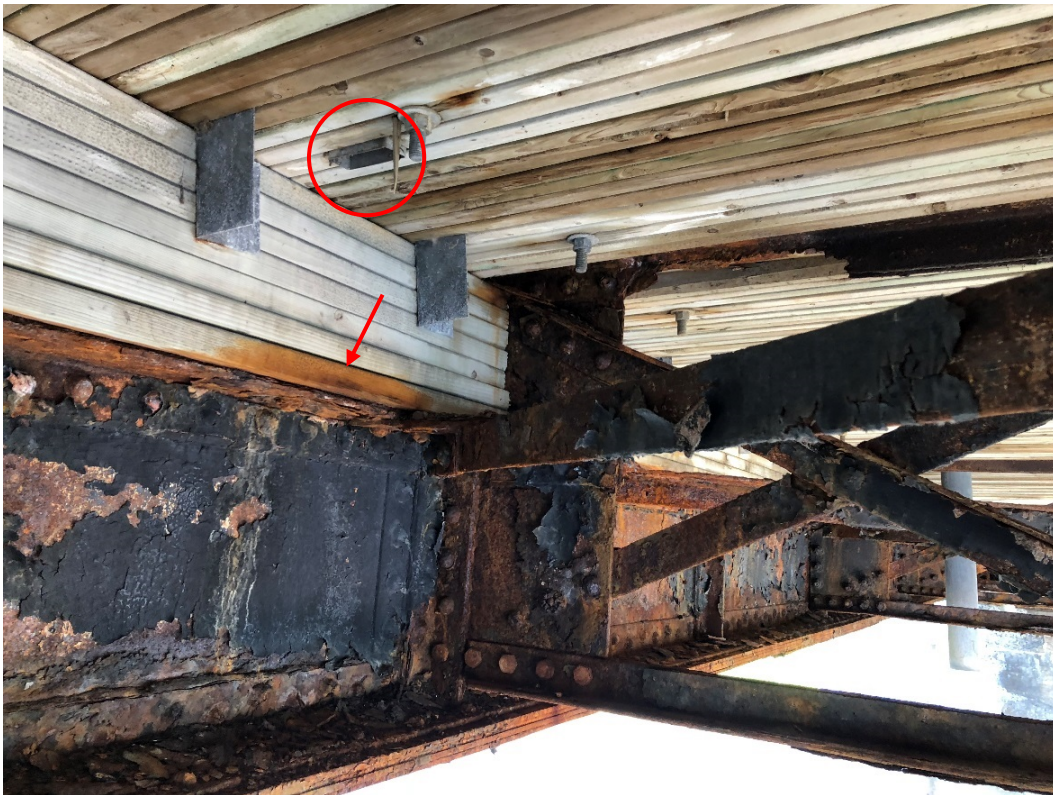
- The deck drainage openings (i.e. not deck drains) at 160 locations along the bridge have a significant performance defect as they do not have any downspouts and terminate just below the timber deck soffit, resulting in deck runoff draining directly onto the structural components below the drainage openings, which is directly exposing the structural steel below deck to deck drainage, including salt-laden runoff as the pathway over the structure is maintained during winter months.

Photo 22 – Rectangular deck drainage opening with no downspout. Note the corrosion staining on the timber ledger and severe corrosion on shelf angle below caused by deck runoff outlet directly onto structure components below.

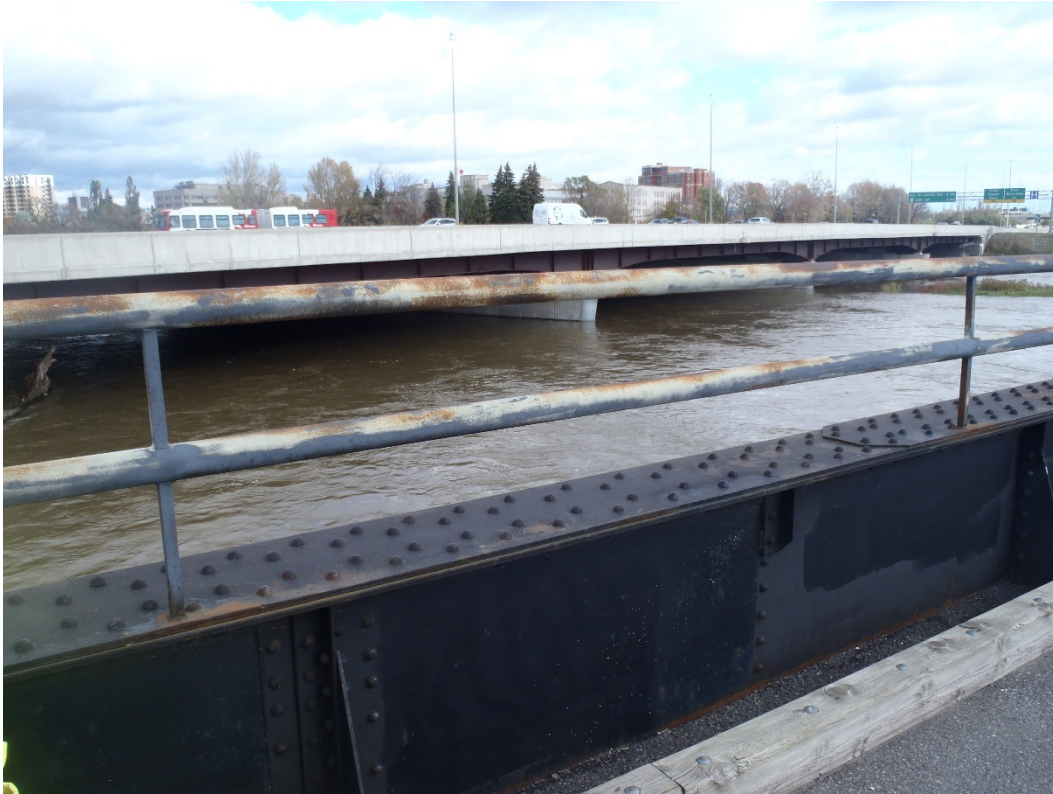
Photo 23 – Localized light corrosion throughout both steel rails and steel pickets on the steel pipe railings due to deterioration of the coating system.

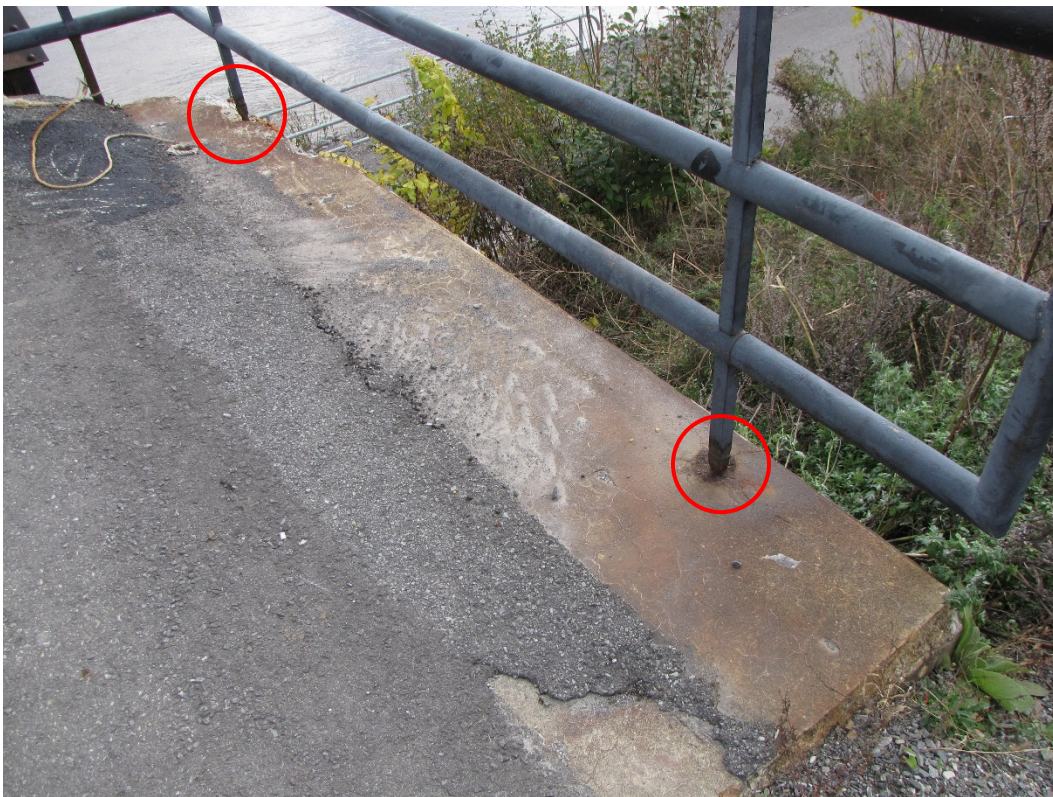
Photo 24 – Severe to very severe corrosion at the base of the approach railing posts embedded into the top of the concrete wingwalls.

Although the approach railing replacement was included in the scope of work and costing for each renewal option in 2023 for simplicity of evaluating the renewal options, this work should be completed in 2019, as the extensive deterioration of the railing posts poses a potential safety concern for pedestrians.

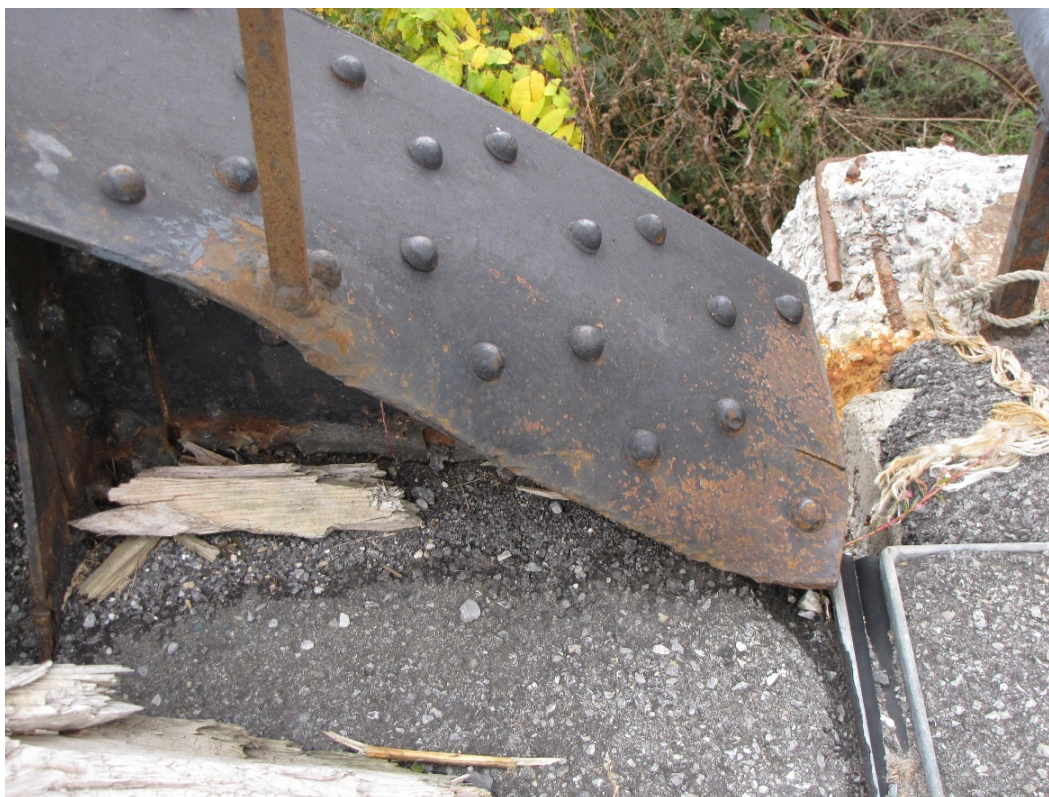
Photo 28 – Impact damage to the top of flange and light corrosion at the west end of the south girder.

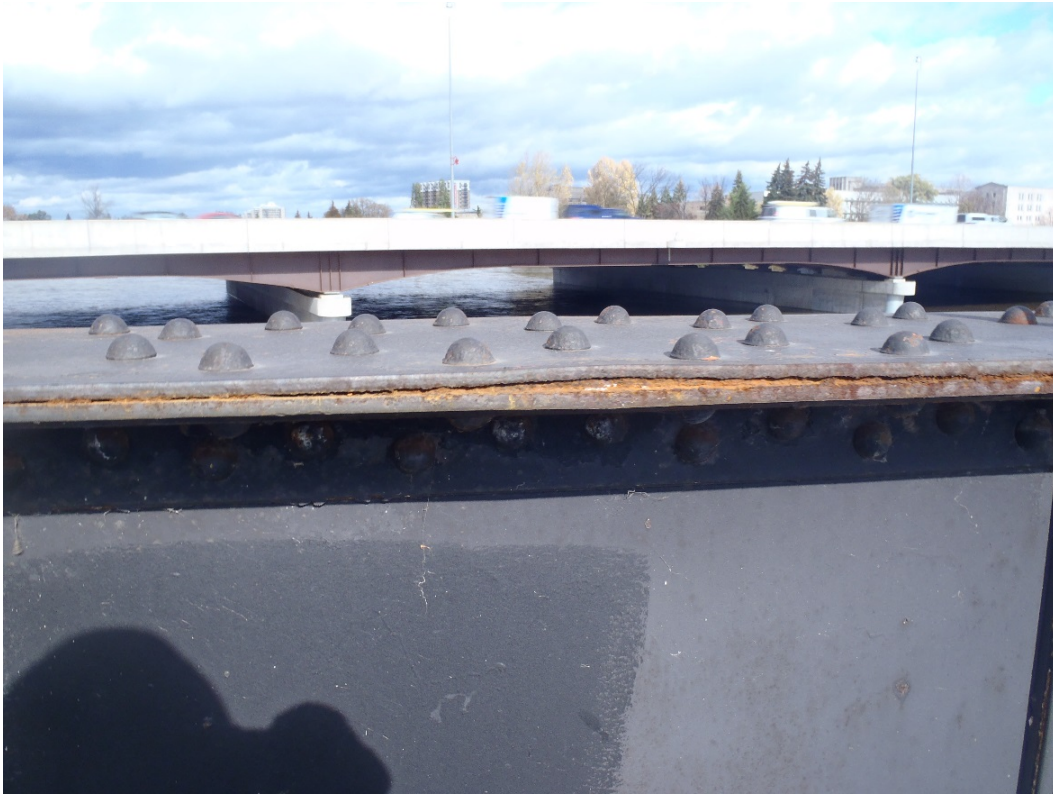
Photo 29 – Light to medium corrosion with rust jacking between cover plates on the top flange of the north girder.

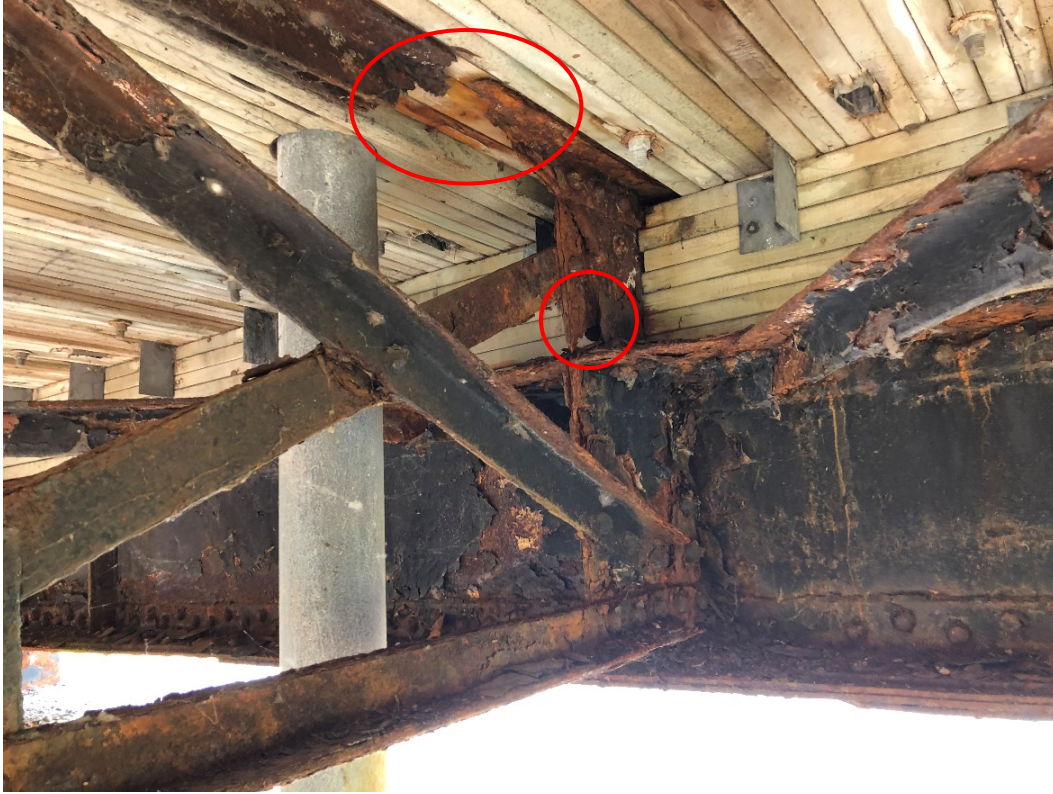
Photo 31 - 100% section loss in the top brace and vertical gusset plate of the cross-frame 2 bays east of Pier 1.

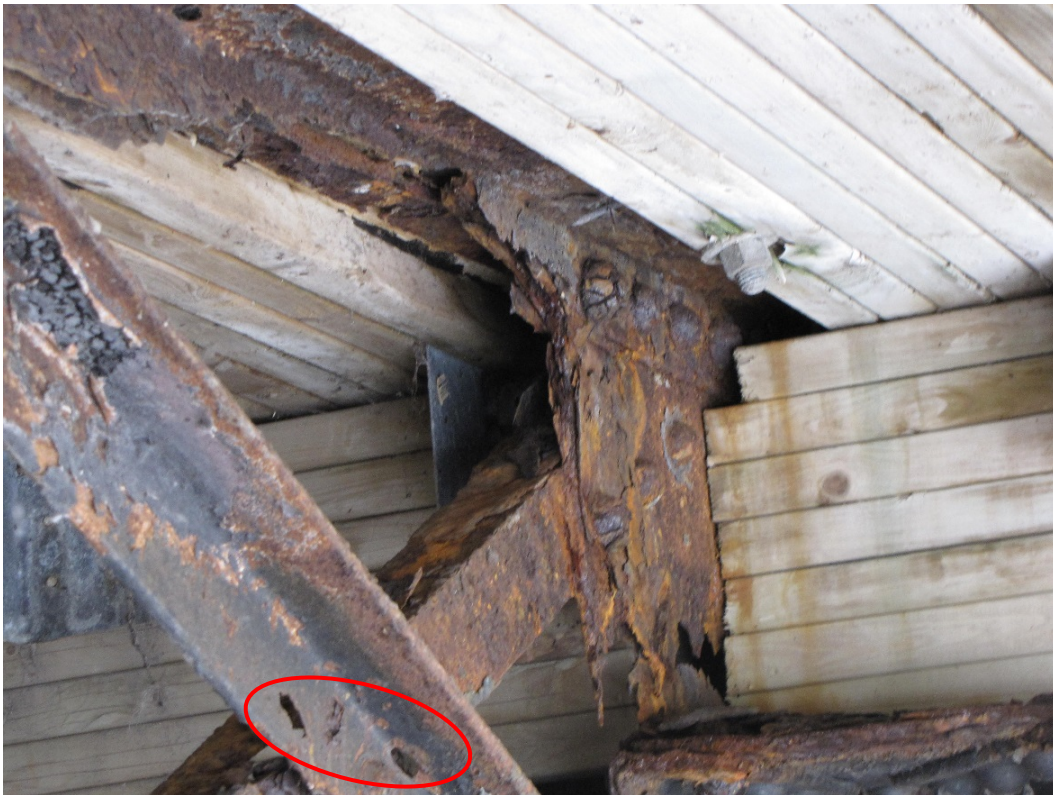
Photo 36 – Severe to very severe corrosion and localized or complete perforations in the diagonal brace, top brace, and vertical gusset plate at the north end of the west abutment cross-frame.

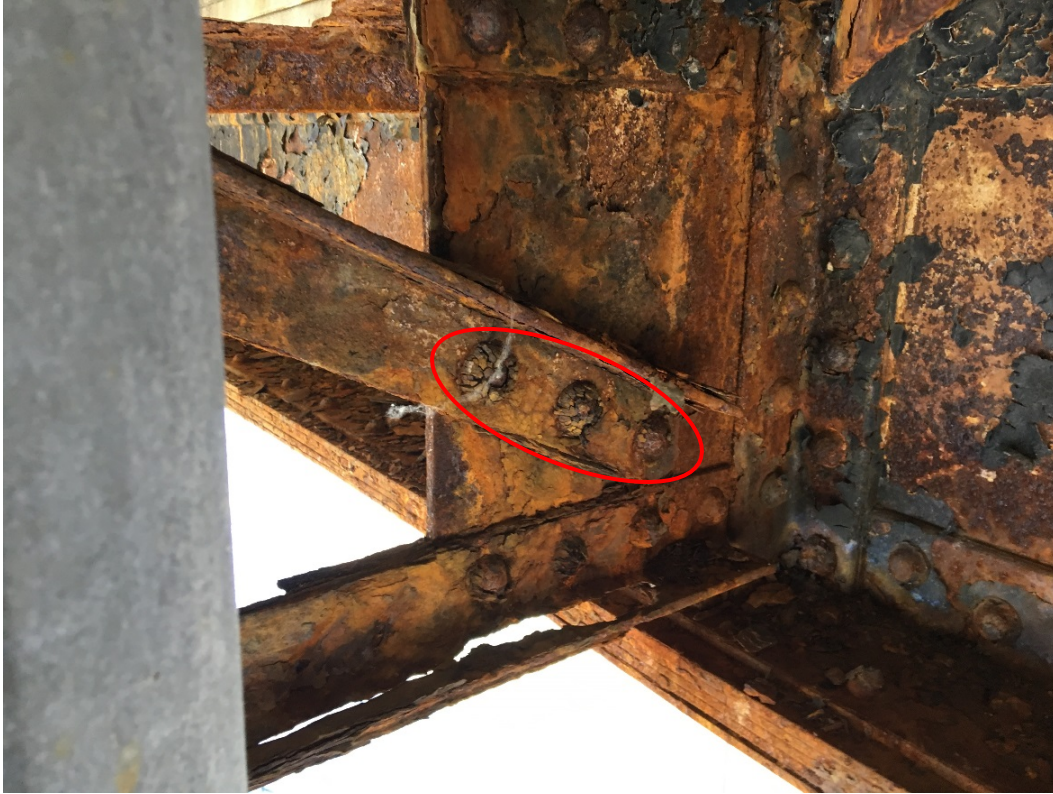
Photo 37 – Severe to very severe corrosion on the rivet heads a diagonal brace and very severe corrosion with perforation in the bottom brace.

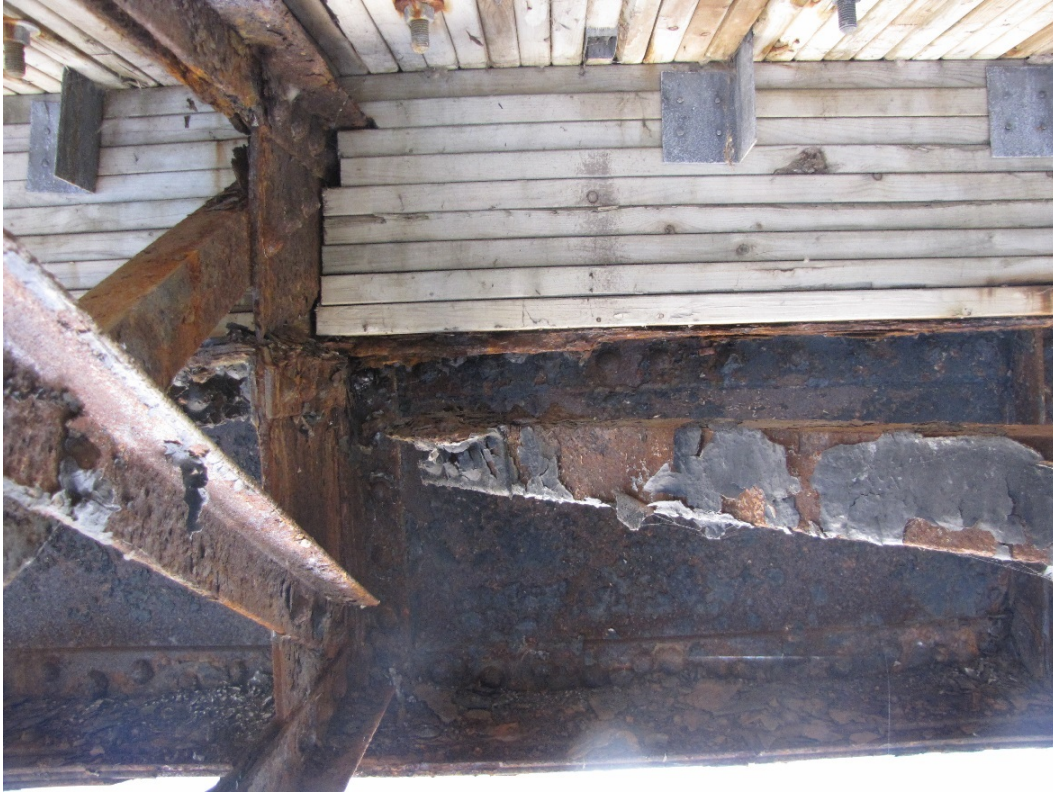
Photo 39 – Complete detachment of the lateral brace from the horizontal gusset plate at the cross-frame in the bay just east of Pier 6.

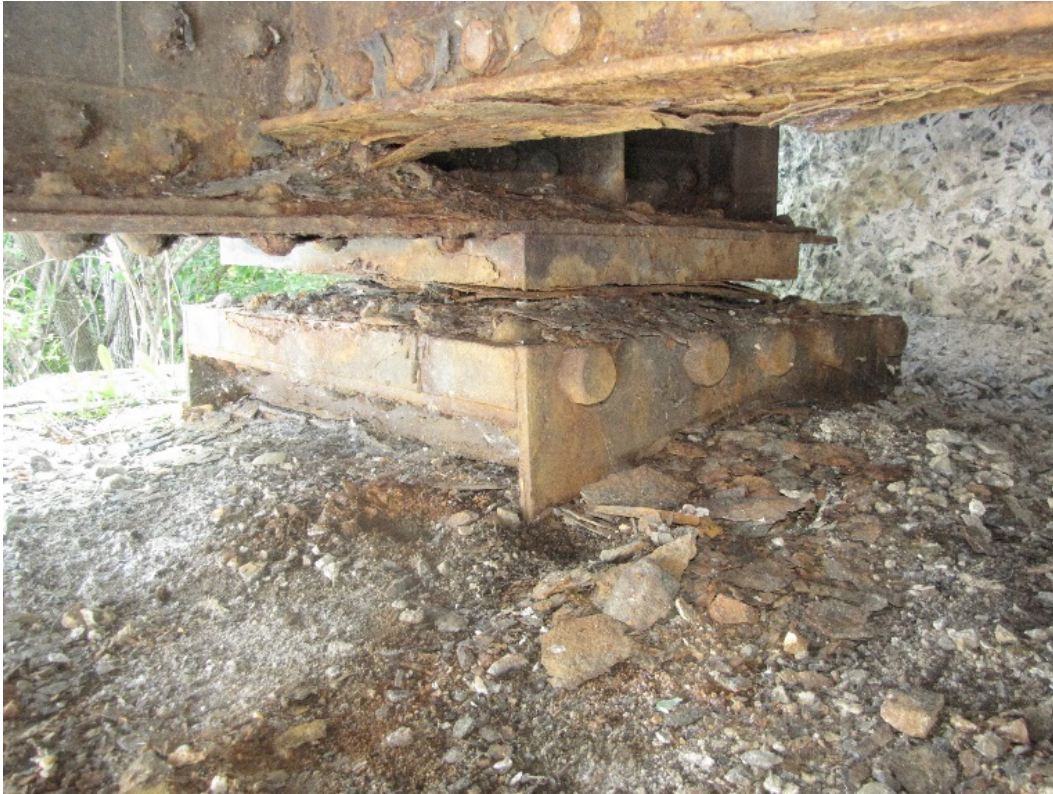
Photo 43 - Light to severe corrosion on the north expansion bearing of the east abutment. Note the significant accumulation of corroded steel and disintegrated concrete on the bearing and bearing seat.

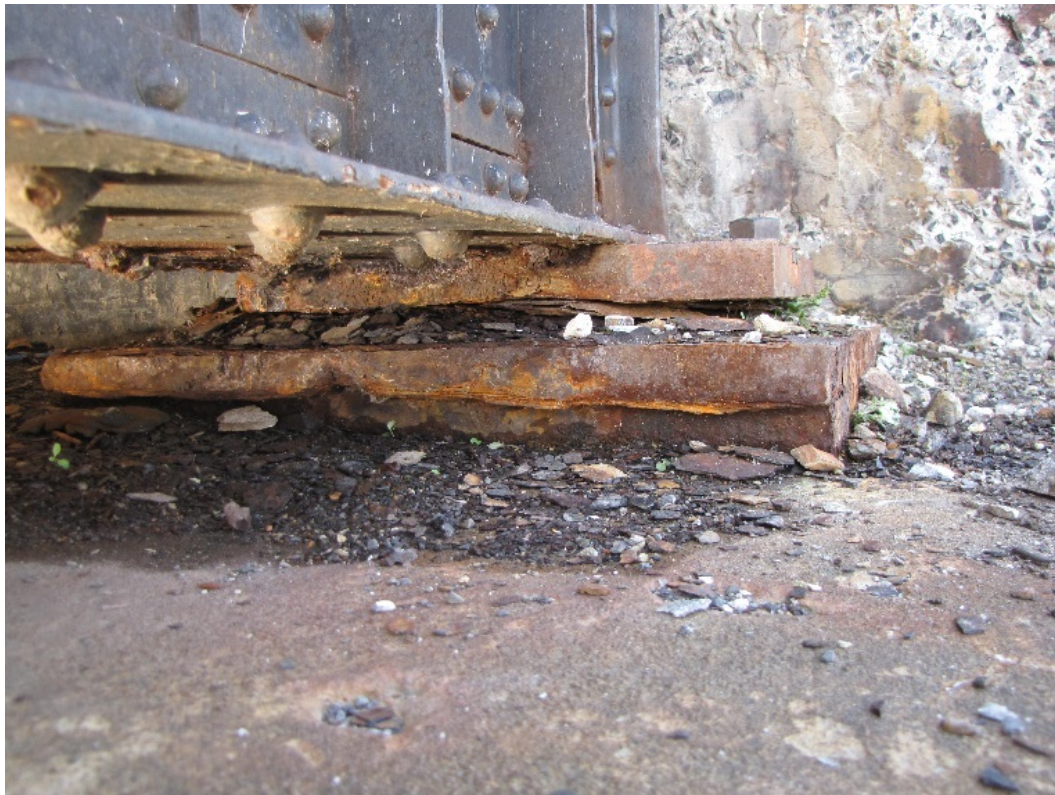
Photo 44 - Medium to severe corrosion on the north fixed bearing of the west abutment.

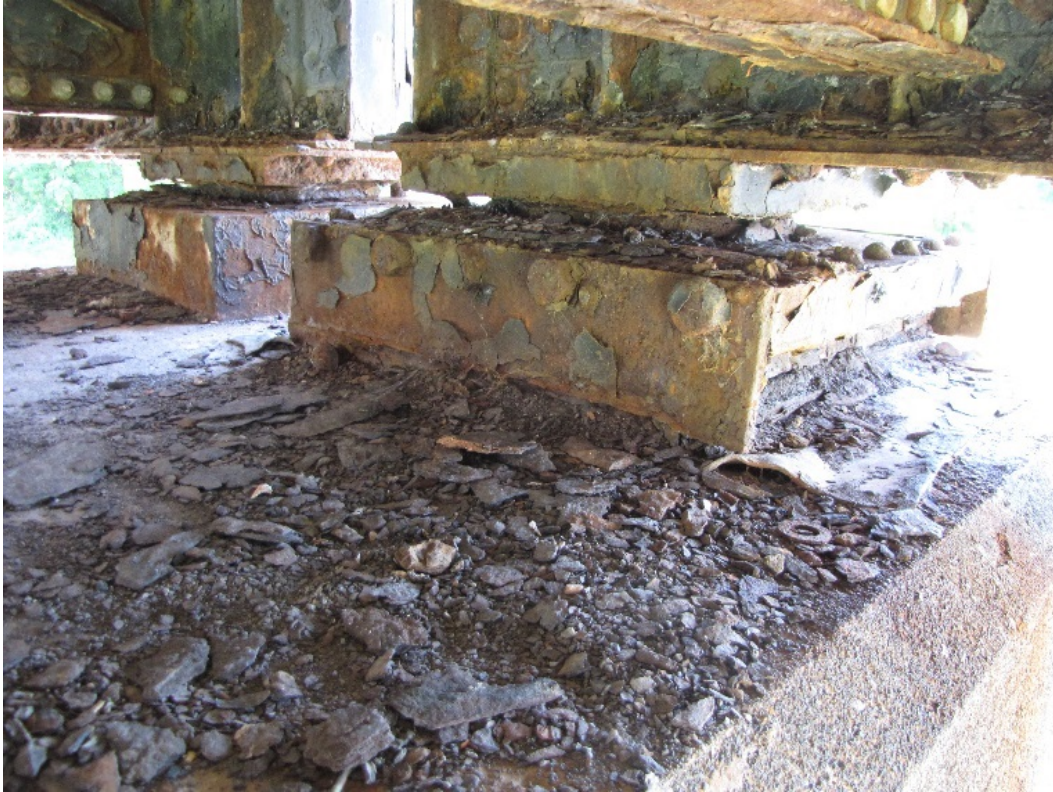
Photo 45 – Pier 2 south bearings. Widespread coating failure, medium to severe corrosion and significant accumulation of debris on top of the bearings and bearing seat.

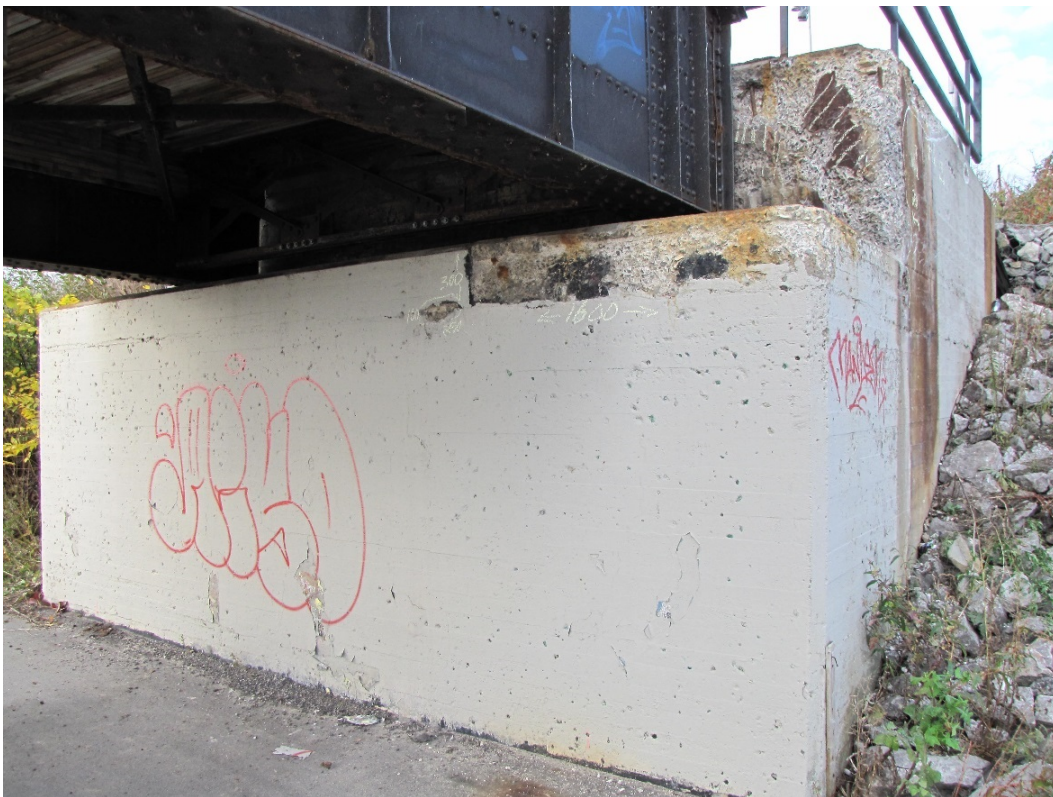
Photo 52 – Localized area of very severe disintegration in the west abutment wall and very severe disintegration and delamination with exposed corroded rebar on the north end of the ballast wall.

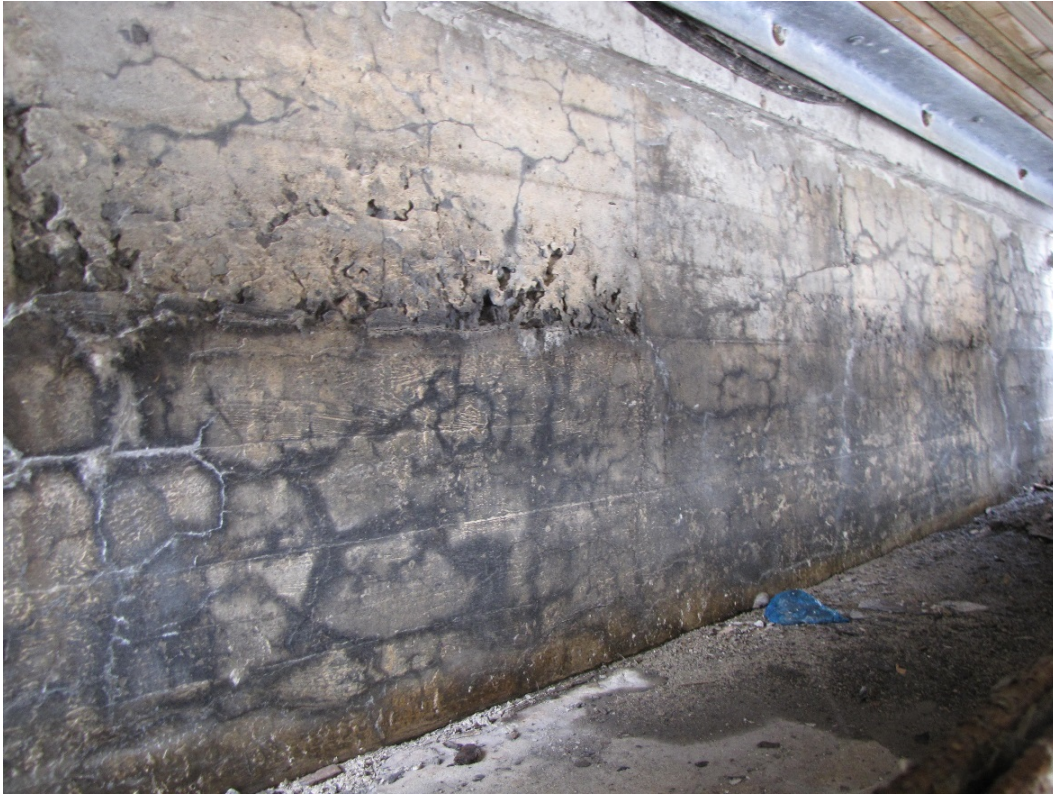
Photo 55 – Wet and efflorescence stained hairline to narrow map cracking throughout, wet staining and medium honeycombing in the west abutment wall.
