Old Railway Rideau River Pedestrian Bridge Structure No. 018600 Detailed Condition Assessment and Renewal Option Analysis Report

Contract No.
ISD17-7087
Work Order Package
No. 11316522

Detailed Condition Assessment and Renewal Options Analysis Report

November 2018

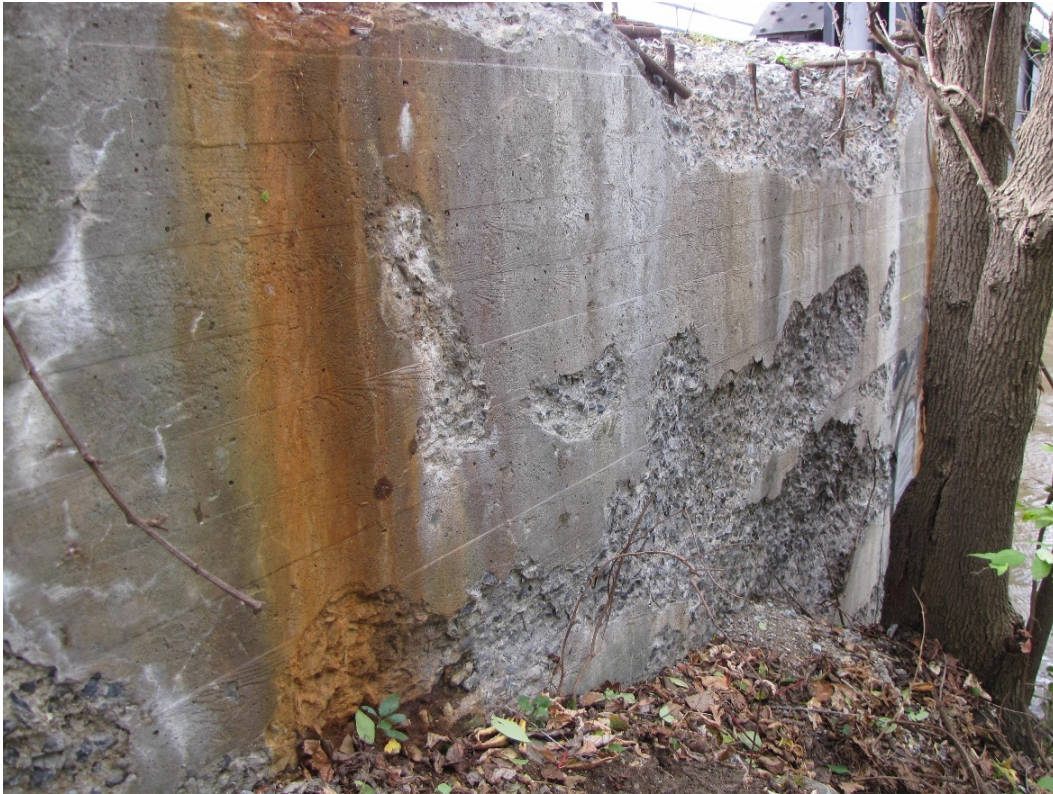
Photo 59 – Extensive areas of medium to very severe disintegration with exposed corroded rebar and hairline to narrow wet and efflorescence stained map cracking on the northeast wingwall.

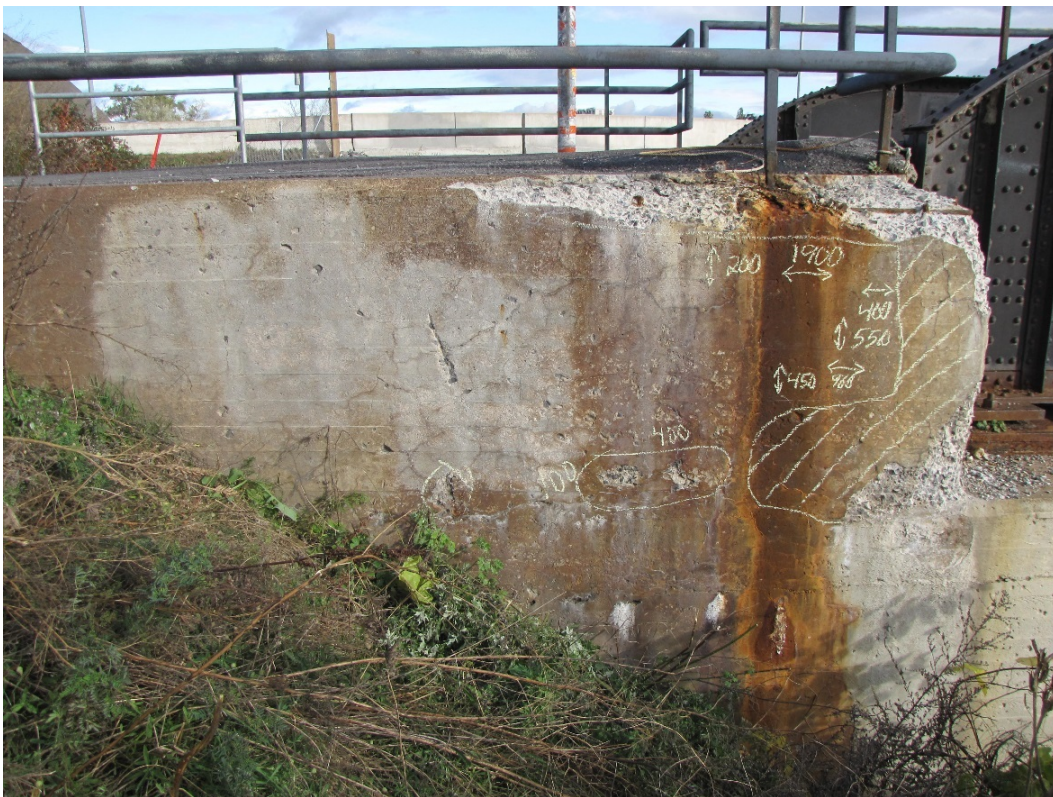
Photo 60 – Light to very severe disintegration and spalls with exposed corroded rebar and hairline to narrow wet and efflorescence stained map cracking on the southwest wingwall. Very severe delamination adjacent to the ballast wall.

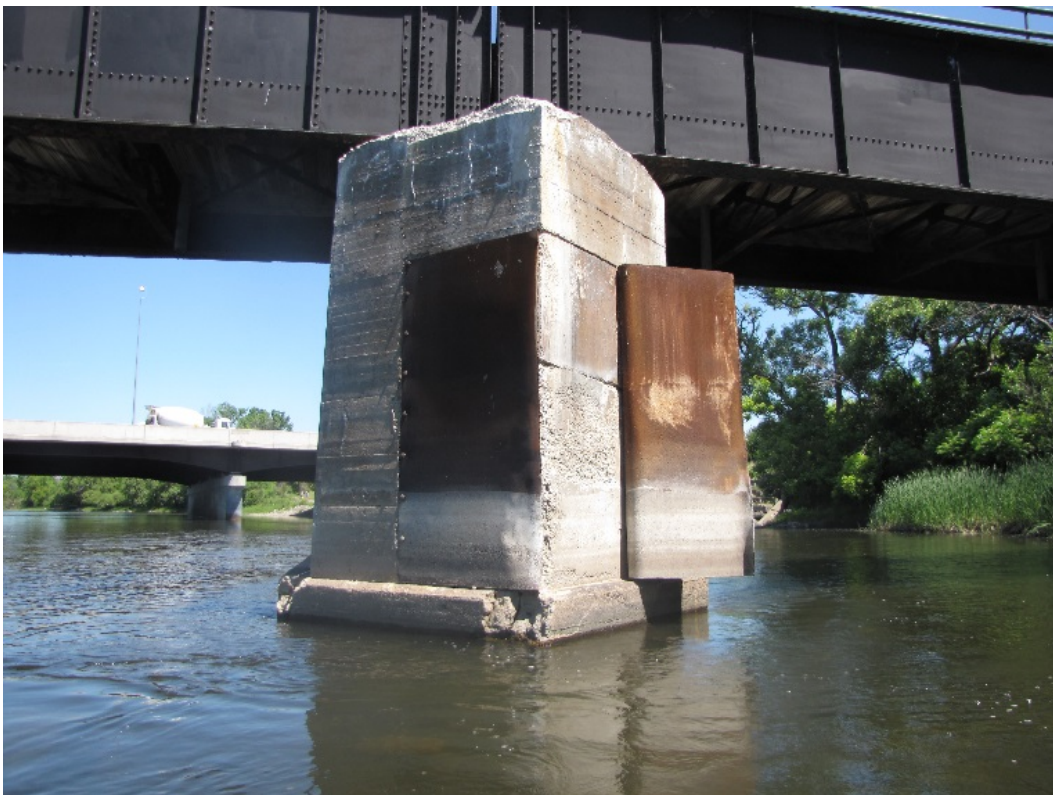
Photo 62 – Pier 1 steel nosing plate on southeast face is detached and folded back. Note lack of a steel nosing angle or plate on the upstream nosing of the footing with a very severe spall.

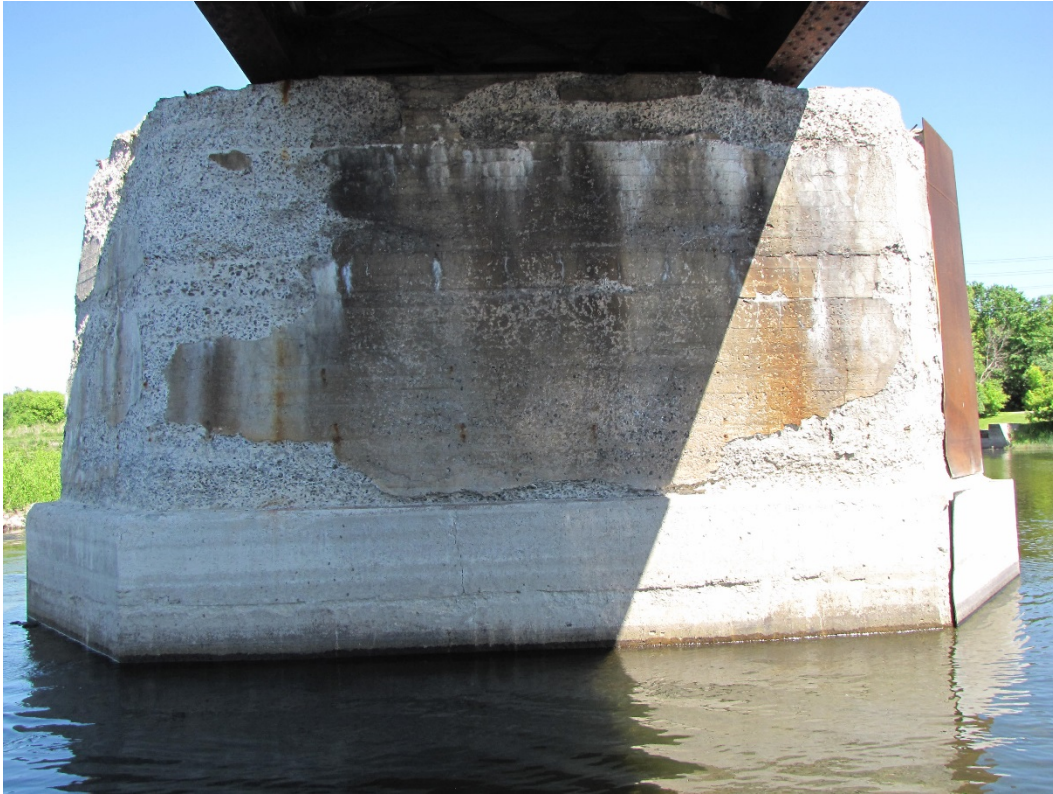
Photo 65 – Pier 4, west elevation. Severe to very severe disintegration with exposed corroded rebar throughout the face of the pier, wet and efflorescence staining, and localized rust staining.

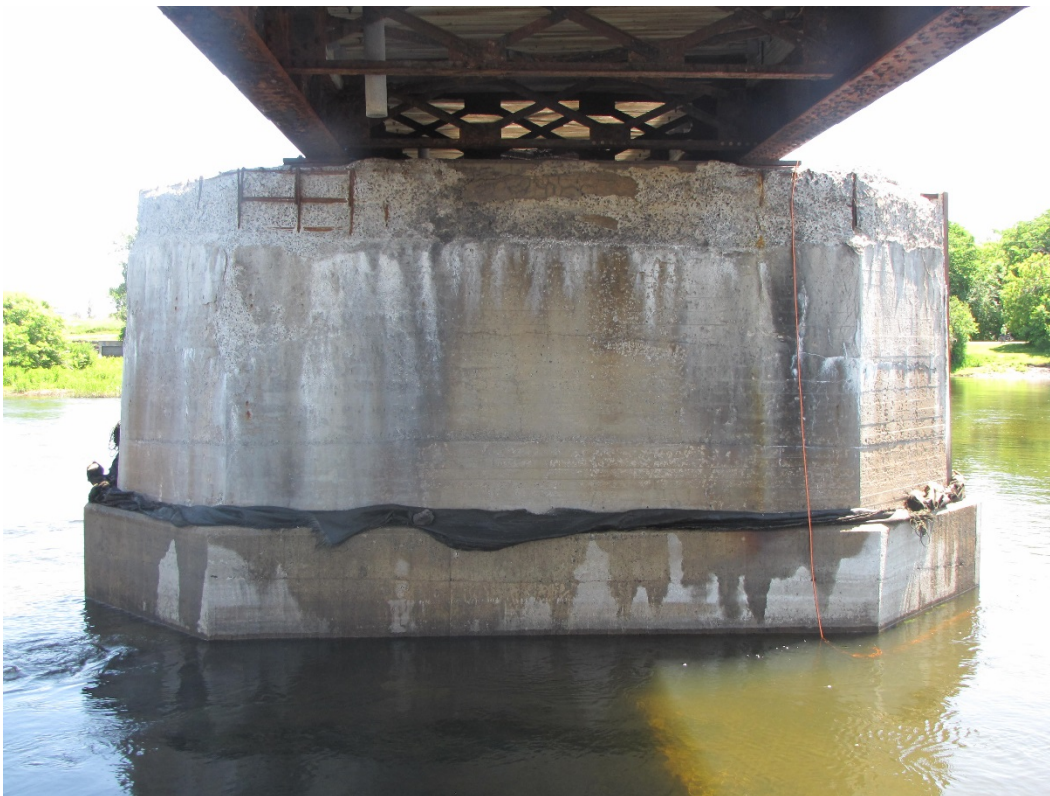
Photo 68 – Pier 6, west elevation. Extensive very severe disintegration with exposed corroded rebar, delaminations and efflorescence staining at the bearing seat, and map cracking with efflorescence.

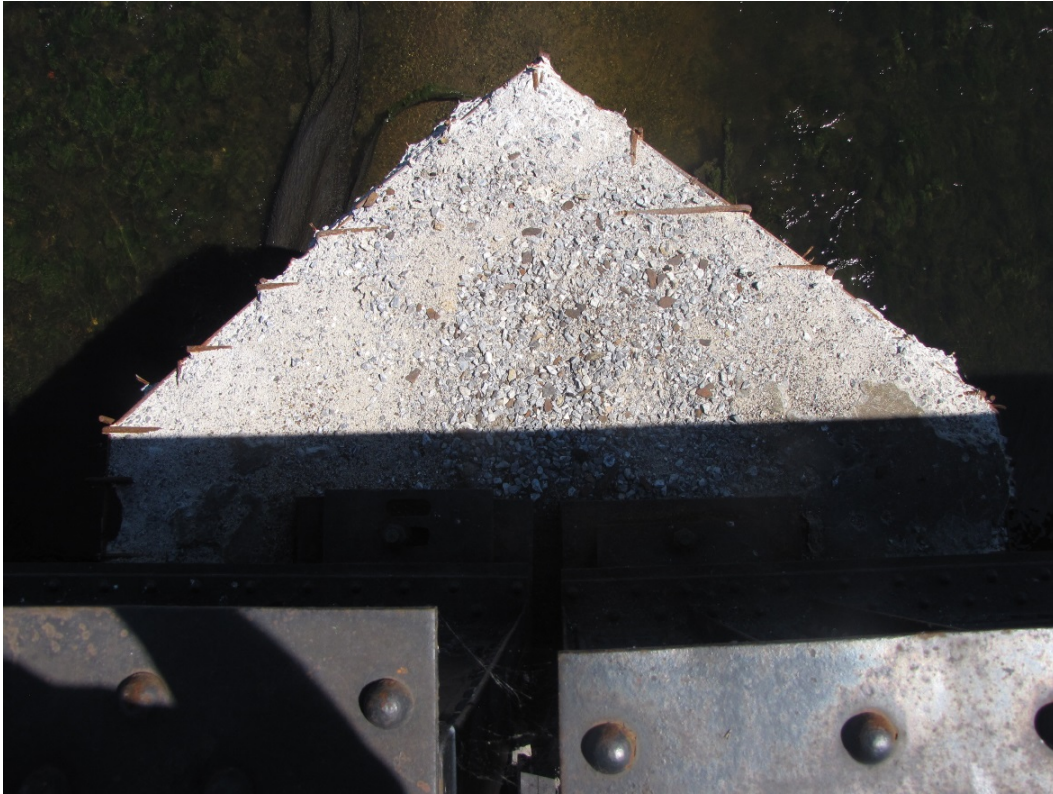
Photo 69 – Pier 6, north end. Very severe disintegration with exposed corroded reinforcing steel on the bearing seat up to the bearings.

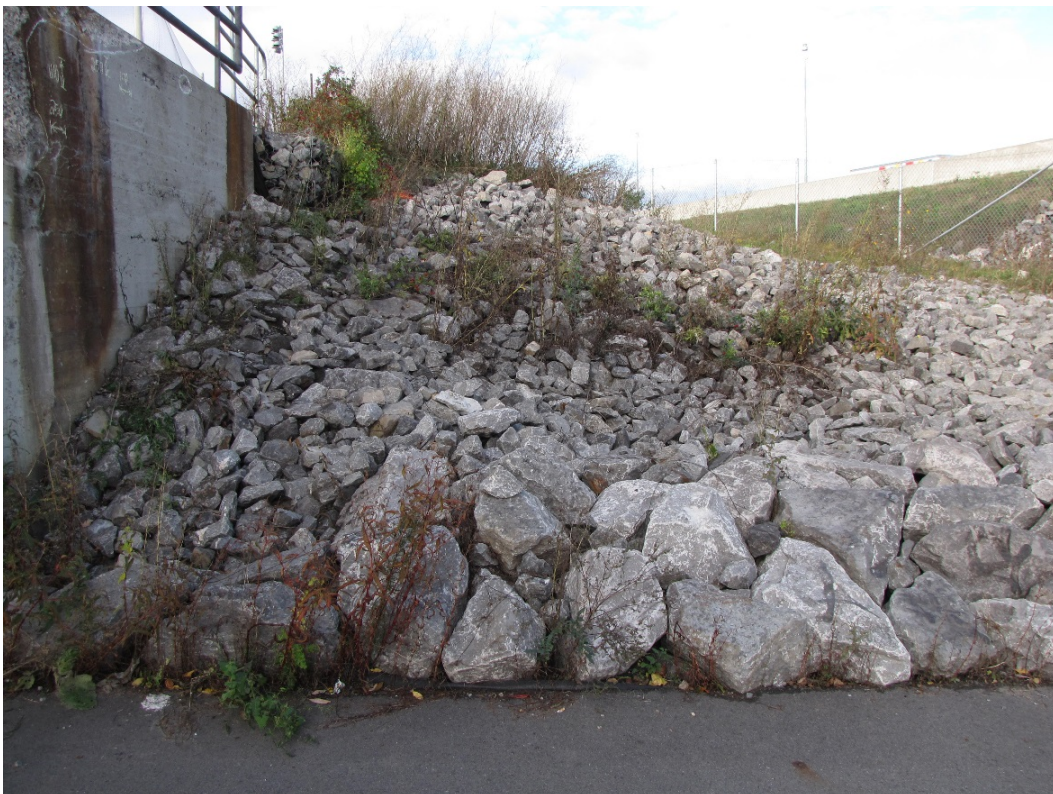
Photo 74 – Northwest embankment and rip-rap slope protection is in good condition.

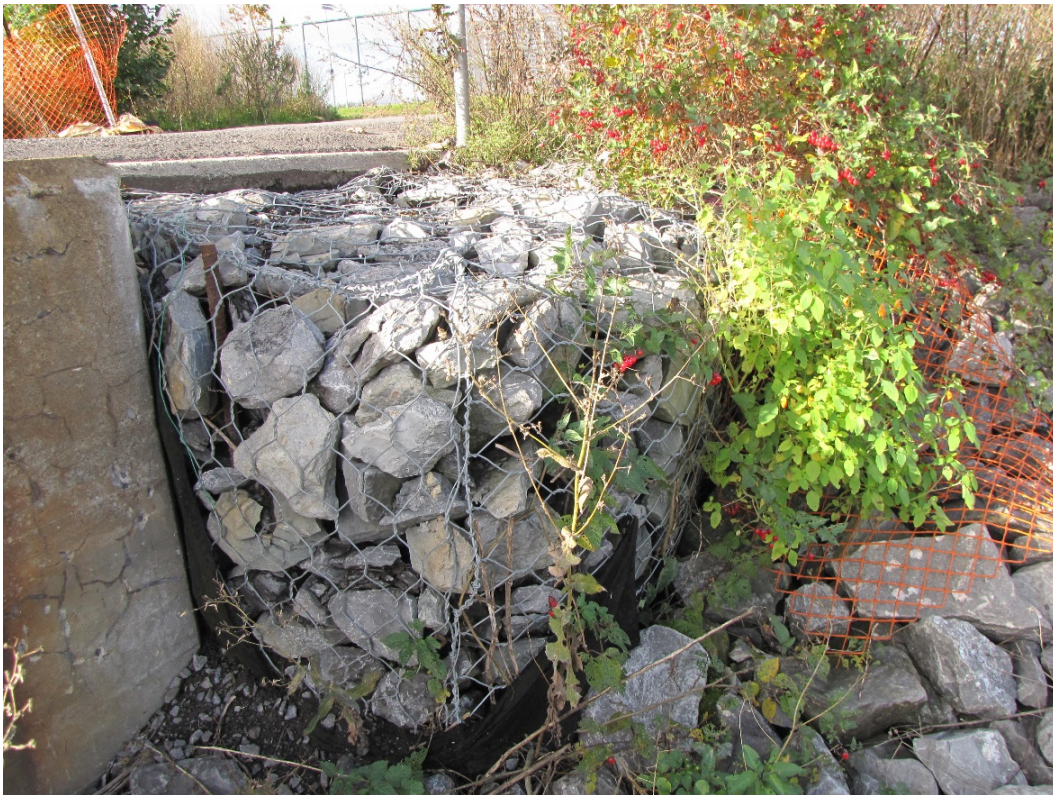
Photo 76 – Gabion basket retaining wall located at the end of the northwest wingwall is in good condition.

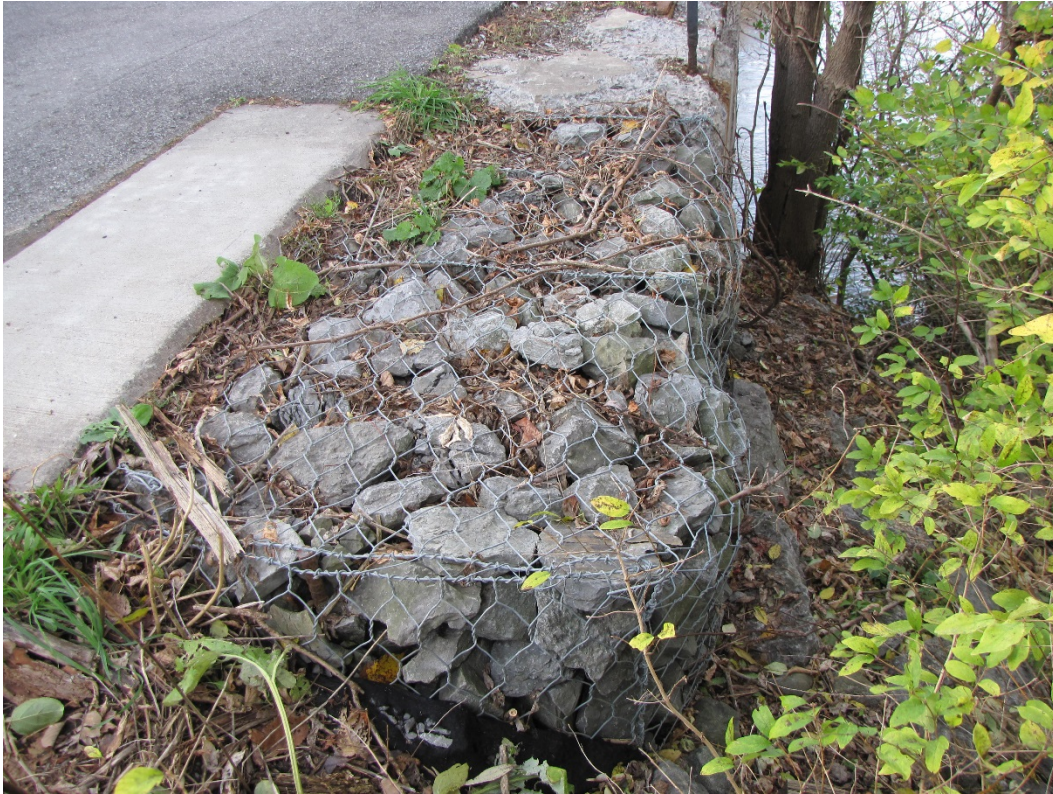
Photo 77 – Gabion basket retaining wall located at the end of the northeast wingwall with slight bulging.

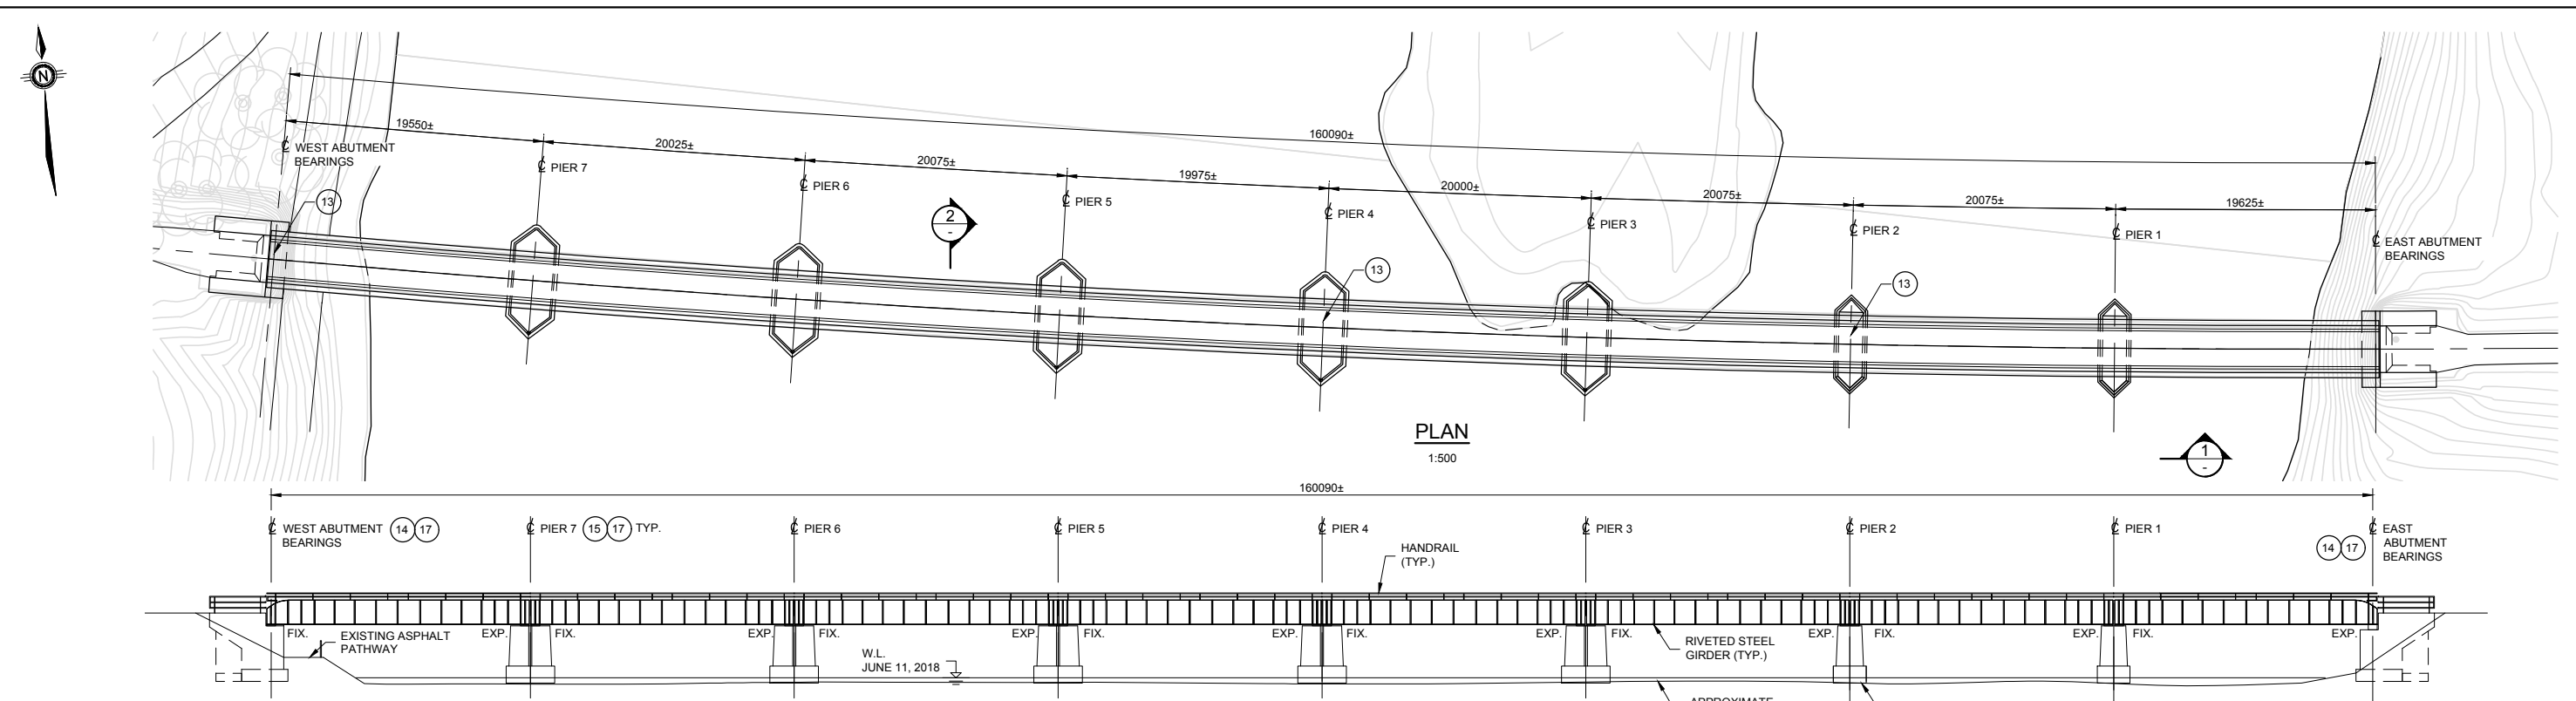
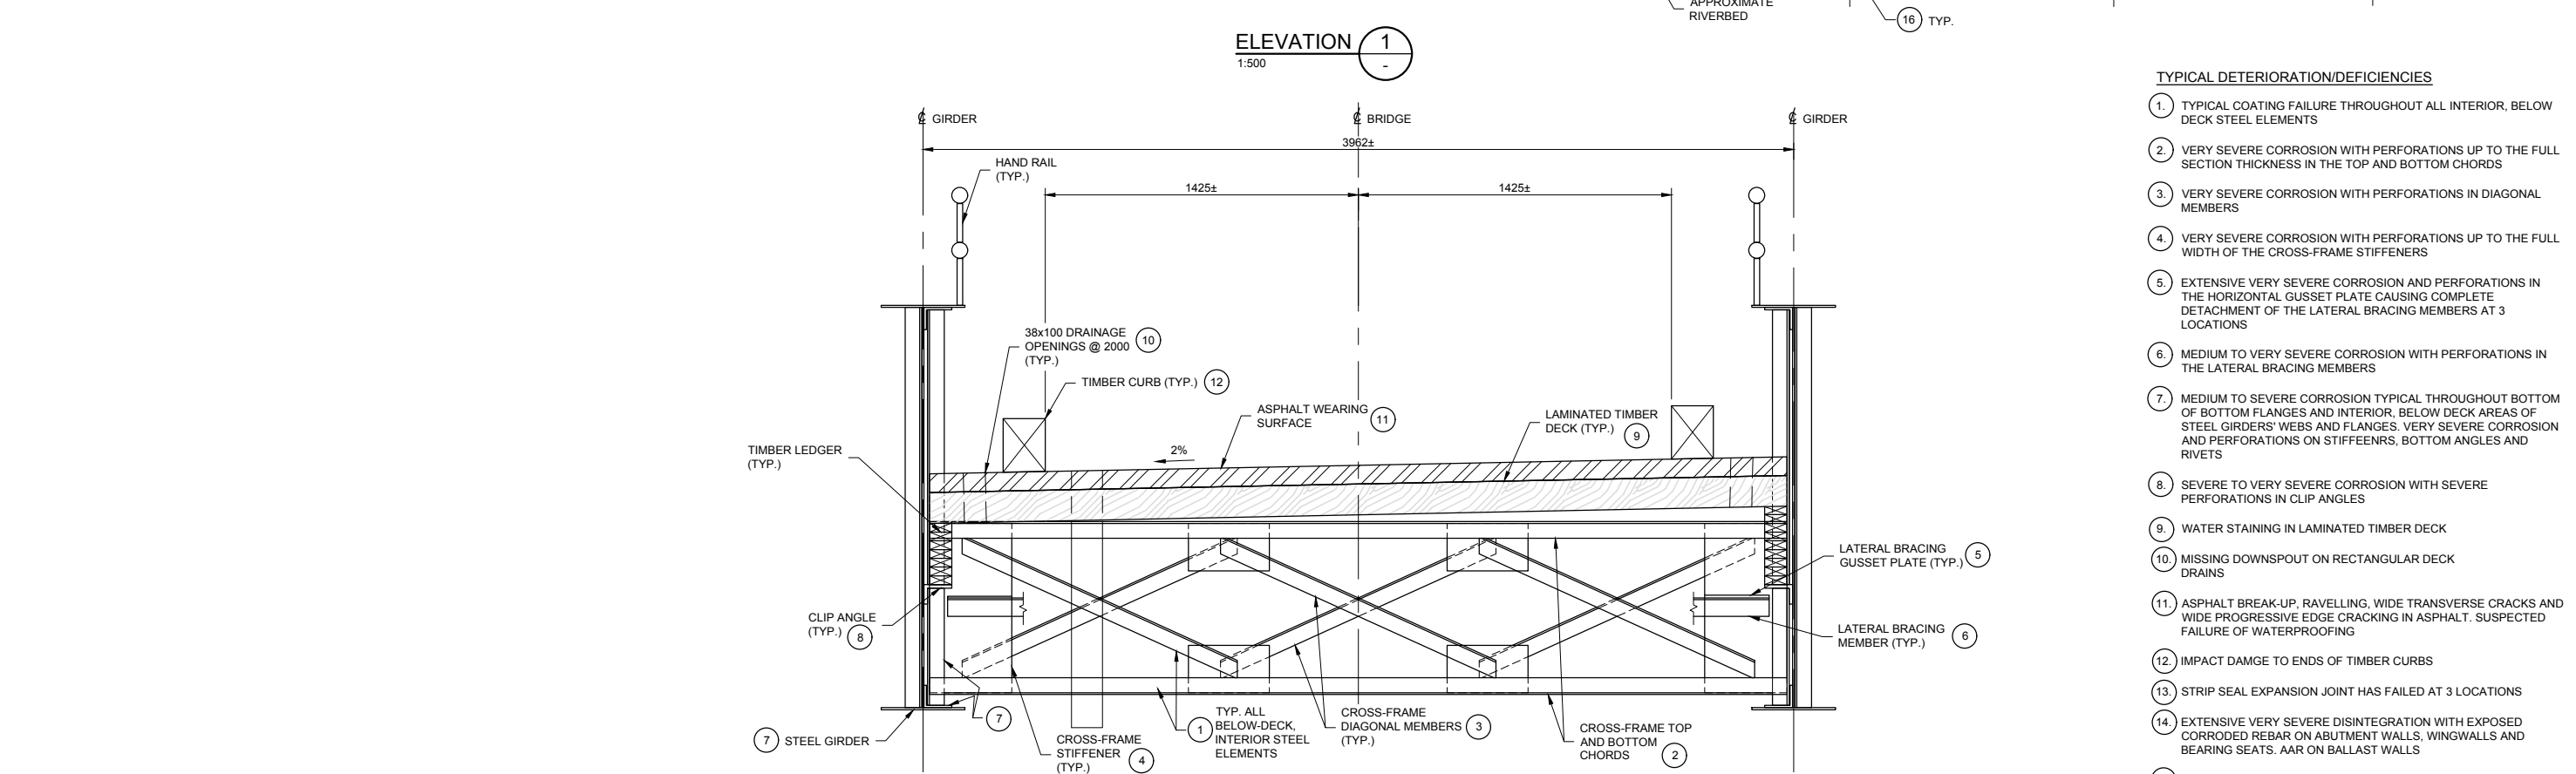
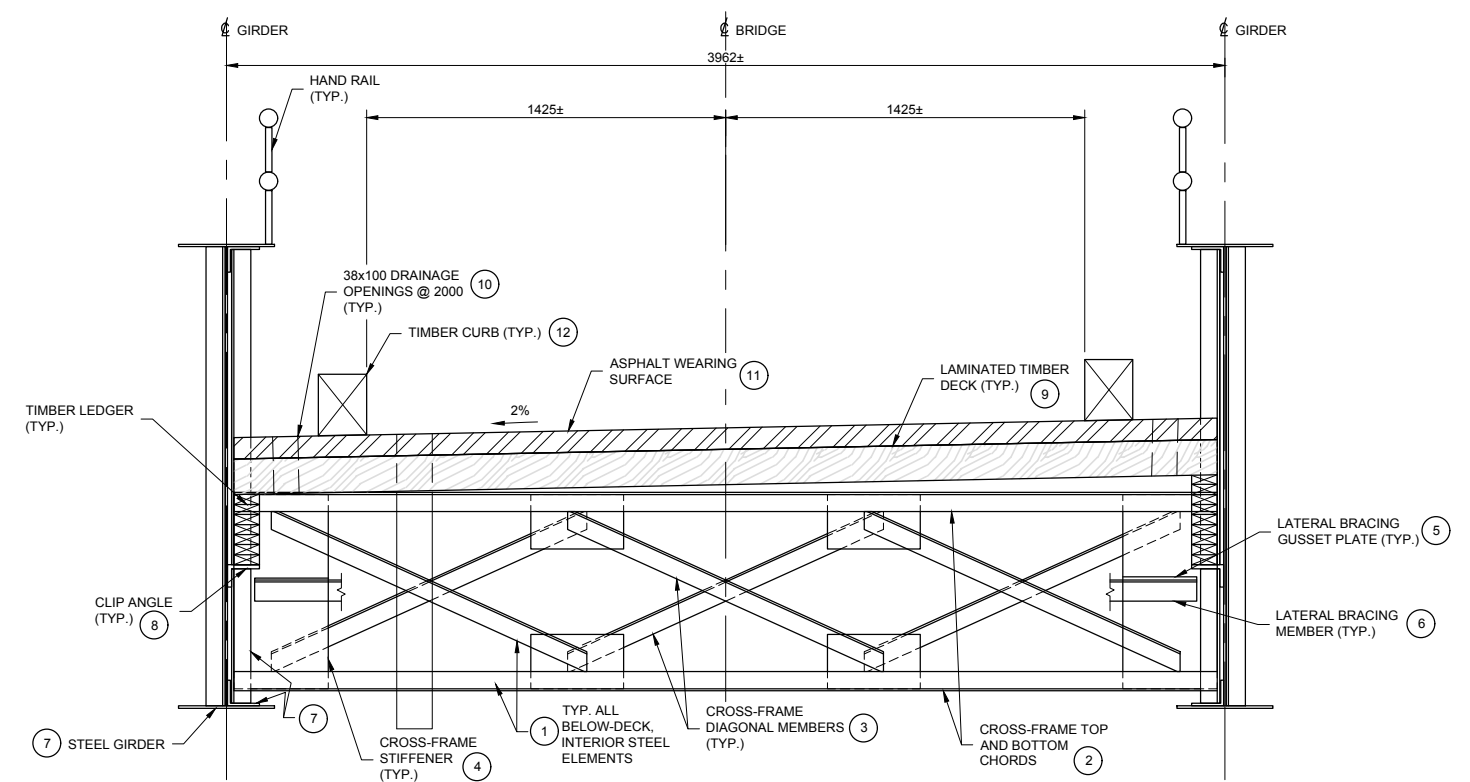
- TYPICAL DETERIORATION/DEFICIENCIES**
1. TYPICAL COATING FAILURE THROUGHOUT ALL INTERIOR, BELOW DECK STEEL ELEMENTS
 2. VERY SEVERE CORROSION WITH PERFORATIONS UP TO THE FULL SECTION THICKNESS IN THE TOP AND BOTTOM CHORDS
