December 3, 2021

Project No. 21159

RE: Hintonburg Pumping Station Ruins
 Structural Condition Assessment Report and Options Analysis

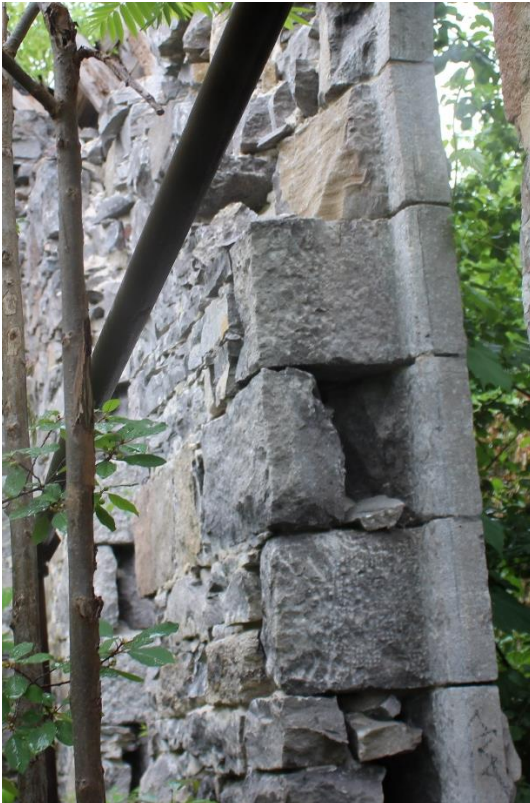
The exterior walls of the building are constructed using two distinct building techniques. The exterior rubble stone masonry walls of the west wing, as shown in Figure 4, consist of an outer and an inner wythe of stone separated by a rubble core. The two wythes are tied together with intermediate header stones spaced throughout the wall; these walls are roughly 450mm thick (18"). The core of the wall consists of stone rubble and lime mortar. On the east wing of the building, the limestone walls have a multi-wythe brick backup, with low quality bricks used for the core of the wall. Based on the remains of the structure seen on site, the interior was originally finished with lath and plaster.

Figure 5: West wing wall assembly [JCAL 2021]

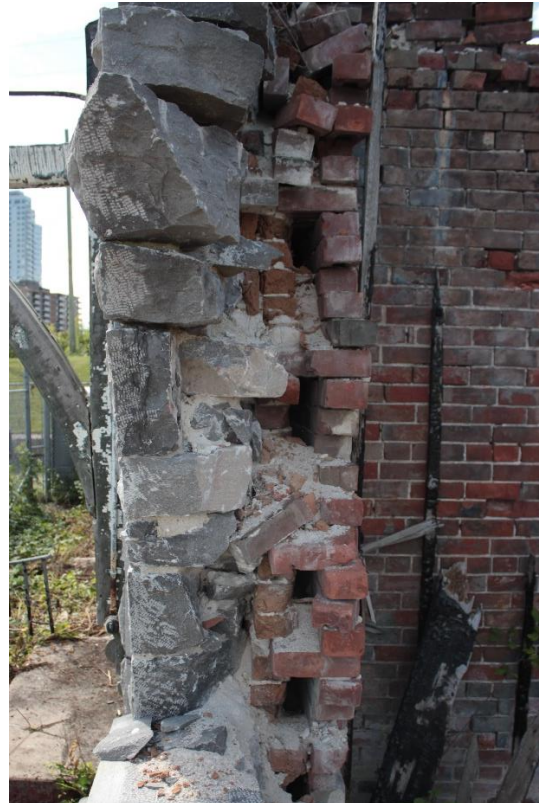
The brick masonry in the building, with the exception of the verandah piers, was all constructed from interior brick. In the era when this building was constructed, the method of brick production by firing in a kiln produced at least two types of brick masonry. The "stock" brick was the best quality and generally used for exterior construction, due to the higher compressive strength and lower porosity. The "common" brick had a lower compressive strength and higher porosity and did not weather well in exterior exposure. This brick was used only for interior conditions. Due to the partial collapse, much of the exposed interior brick masonry, especially in the wall cores, is deteriorating.

Figure 6: East wing wall assembly [JCAL 2021]

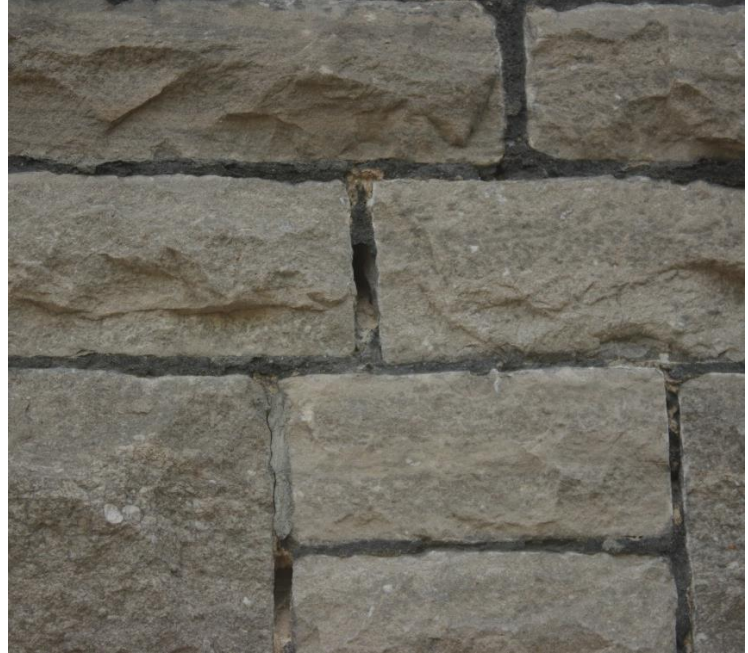
Figure 12: Mortar condition on exterior wythe of north wall [JCAL 2021]

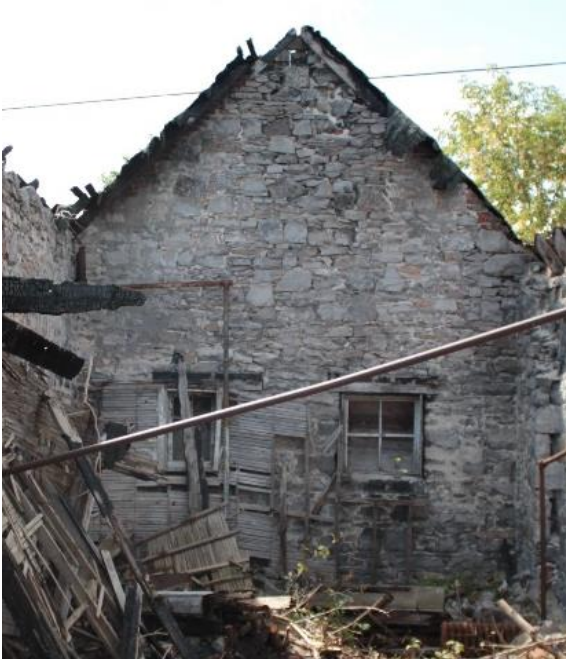
Figure 18: West wall interior [JCAL 2021]

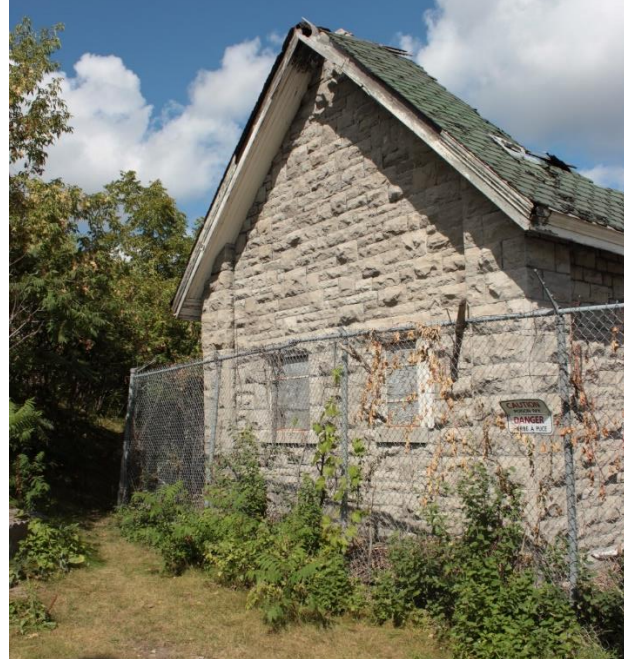
The exterior wythe of the west façade appeared to be in fair condition. What remains of the roof provides an overhang which protects the masonry below from moisture infiltration, except for the peak of the gable which is exposed. The Portland cement-based face pointing on the west wall is incompatible with the original materials.

Figure 19: West wall exterior [JCAL 2021]
