Appendix B – Photographs

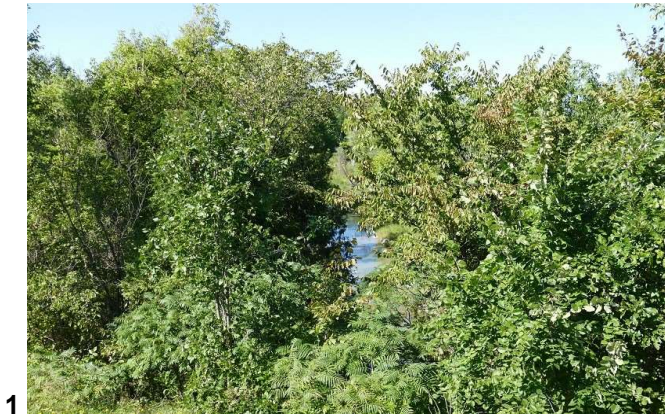
1

Beckett's Creek – views downstream (1) and upstream (2, 3) of mainstem as visible from Regional Road 174; views are partially obscured by trees and shrubs. Photo 2 shows evidence of slope failure on the southeast bank. Views downstream (4) and upstream (5) from Old Montréal Road. Steep embankments and gully erosion evident upstream (6) and downstream (7, 8) along Old Montréal Road.

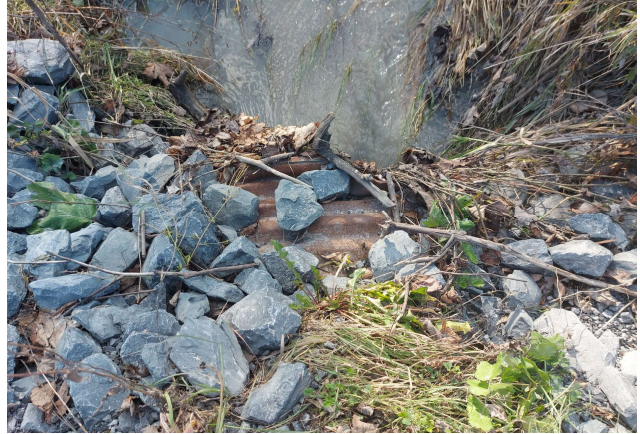
20

Beckett's Creek Tributaries – views downstream (18, 19) and upstream (20, 21) of various tributaries along Emmett Road. Photos 19, 21 and 22 show examples of culverts in need of rehabilitation.

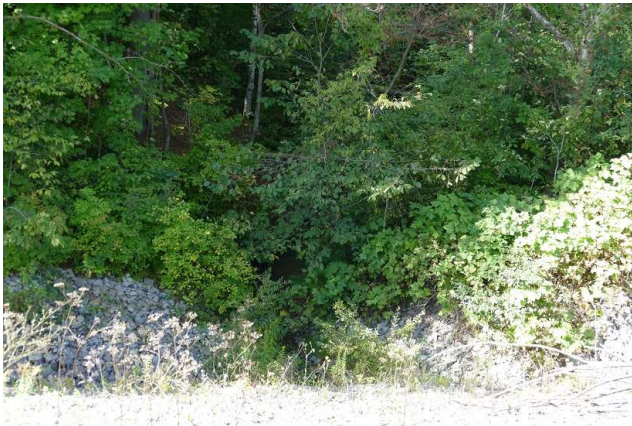
28

Beckett's Creek Tributaries – views downstream (23) and upstream (24) from Birchgrove Road north of Etienne Road. Views downstream (25) and across fields (26) from Sarsfield Road south of Beaton Road. Significant woodland visible on the horizon (26). Views downstream (27) and upstream (28) from Canaan Road, south of Oakwood Drive, showing very minimal flows.

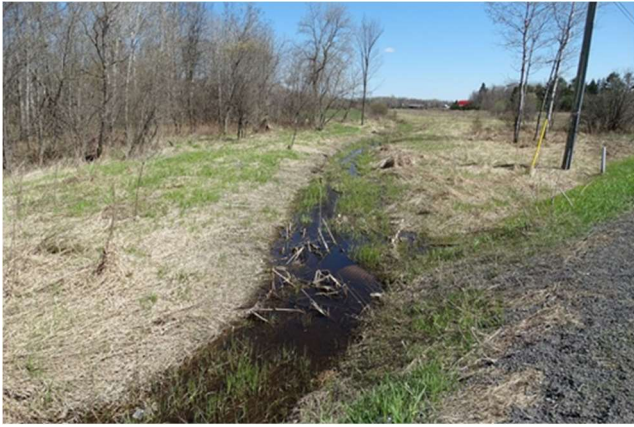
30

Municipal Drains – view of D. LeGault Drain downstream of Birchgrove Road showing submerged culvert (29). View of Beckett Creek Drain downstream (30) along Canaan Road north of Etienne Road. Culvert is perched, making fish passage difficult, and is rusted through in places (31). View of Beckett Creek Drain upstream from Etienne Road (32). View of Mercier Branch Drain north of Innes Road to the west (33) and east (34). Portion of drain has since been cleaned out (34). View of culvert, showing stagnant conditions, along Theodule Vachon Drain at Dunning Road (35).
