# Tree Information Report v2.0

Submitted as part of Building Permit Application for the City of Ottawa

**Address:** 514 Manor

**Date:** March 31, 2023

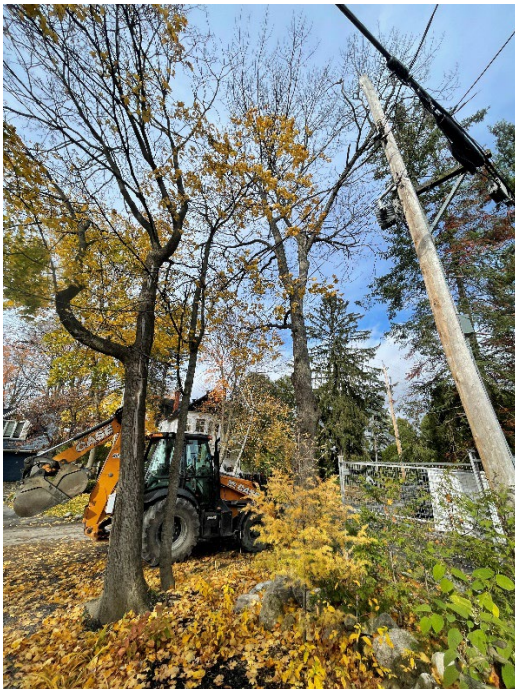
Figure 1: City-owned trees 3 (left) and 4 (right)

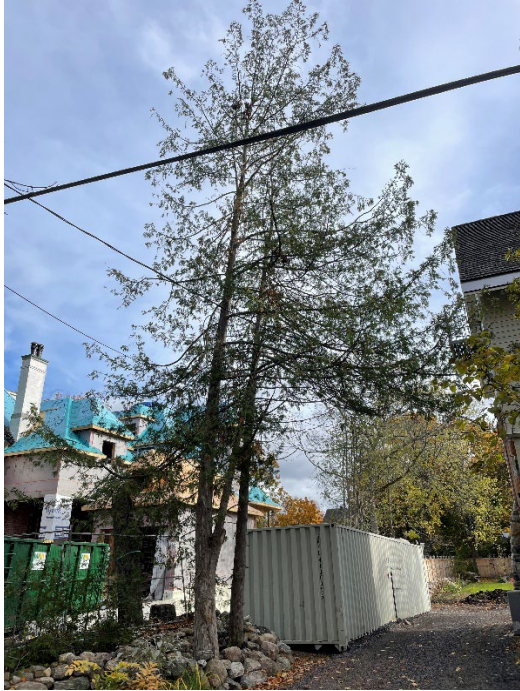
5	Eastern white cedar ( <i>Thuja occidentalis</i> )	37	Private – 514 Manor	Fair; thin crown	Retain	Retain and protect as per City of Ottawa Tree Protection Specifications (March 2021)
6	Eastern white cedar ( <i>Thuja occidentalis</i> )	37	Private – 514 Manor	Fair; thin crown	Retain	Retain and protect as per City of Ottawa Tree Protection Specifications (March 2021)
7	Eastern white cedar ( <i>Thuja occidentalis</i> )	30 (estimate)	Adjacent property – 510 Manor	Fair; thin crown, roots severed on adjacent property due to construction	Retain	Retain and protect as per City of Ottawa Tree Protection Specifications (March 2021)
8	Hackberry ( <i>Celtis occidentalis</i> )	35 (estimate)	Adjacent property – 510 Manor	Good; root damage on adjacent property by construction	Retain	Retain and protect as per City of Ottawa Tree Protection Specifications (March 2021)
9	Silver maple ( <i>Acer saccharinum</i> )	45 (estimate)	Adjacent property – 510 Manor	Good; possible root damage through soil compaction	Retain	No action required; far enough from proposed construction

*Figure 2: Cedar trees 5 and 6, to be retained*

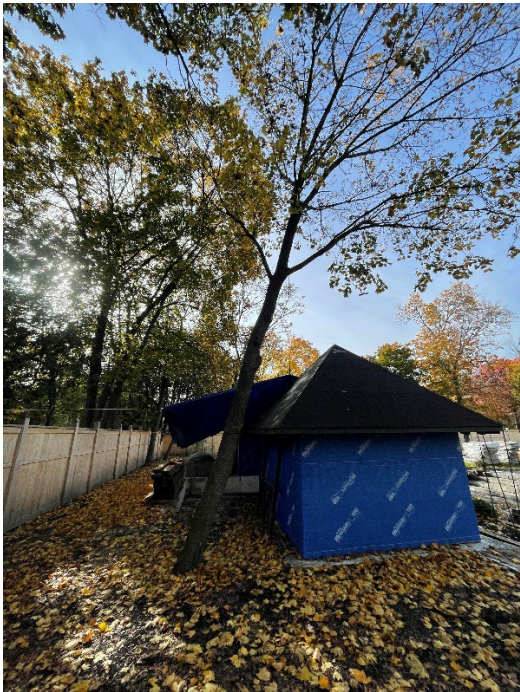
*Figure 3: Tree 12, Norway maple with lean*

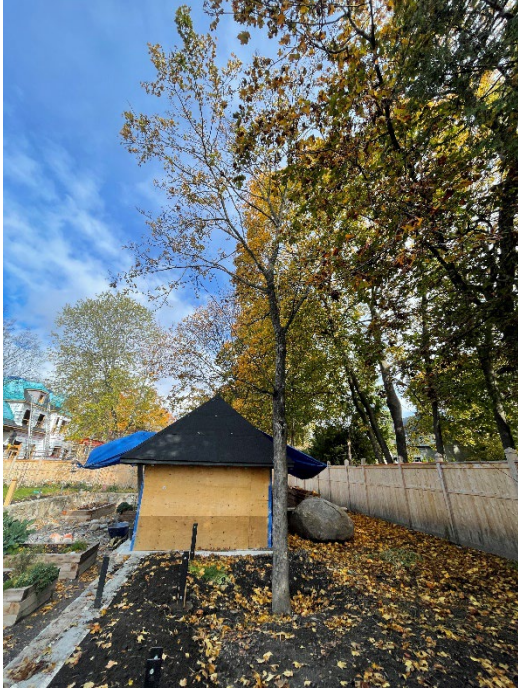
*Figure 4: Tree 17, Norway maple to be removed*

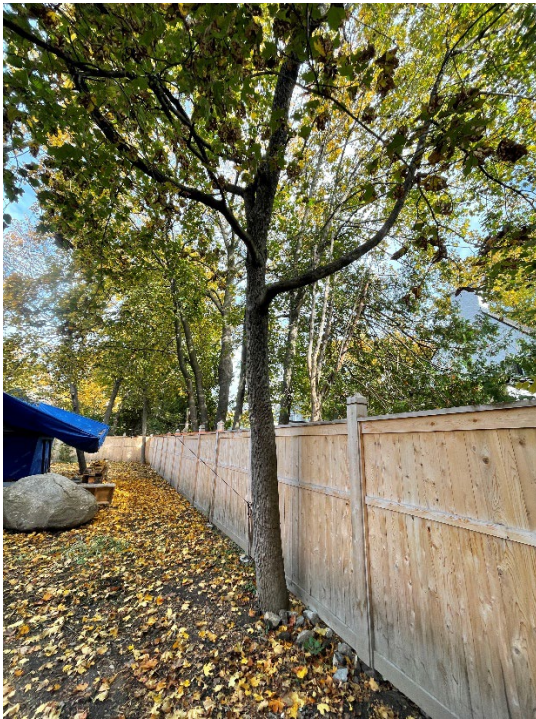
*Figure 5: Tree 14, Norway maple to be removed*

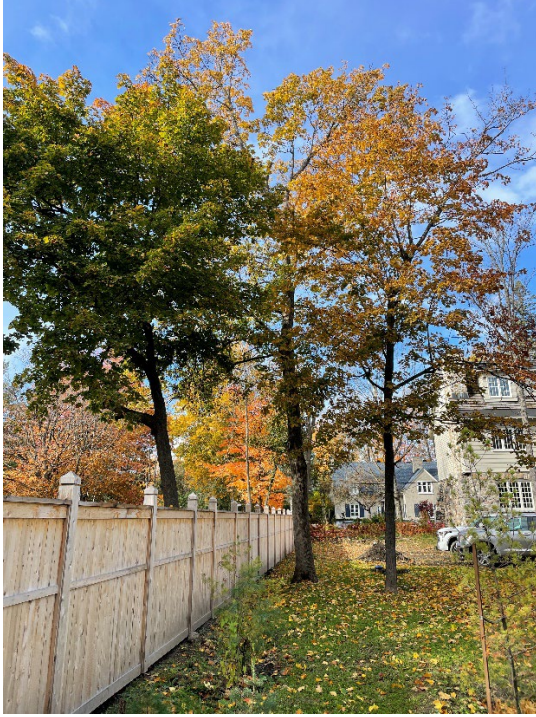
damage in old branch wound		
19	Norway maple ( <i>Acer plantanoides</i> )	40	Private – 514 Manor	Fair; poor wound closer, canker present	Remove	Remove based on health and invasive species – <b>Tree Permit required for removal</b>
20	Norway maple ( <i>Acer plantanoides</i> )	33	Private – 514 Manor	Fair/poor; cankers present in old branch wounds	Remove	Remove based on health and invasive species – <b>Tree Permit required for removal</b>
21	Bur oak ( <i>Quercus macrocarpa</i> )	32	Private – 514 Manor	Good; soil compaction within critical root zone	Retain	Retain and protect during all site works as per City of Ottawa Tree Protection Specifications (March 2021; reduce excavation within CRZ and pre-sever any roots prior to excavation); recommend soil aeration and deep root fertilizer a year after construction
22	Norway maple ( <i>Acer plantanoides</i> )	18	City	Good; slight lean towards road	Retain	No action required; far enough from proposed construction

*Figure 6: Trees 19 (middle) and 18 (right), Norway maples to be removed*

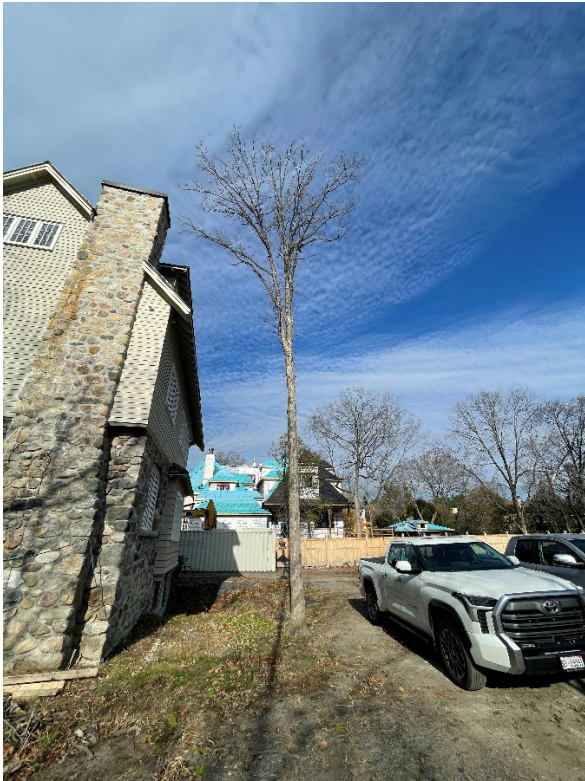
The addition to the main building will be built around the existing bur oak in the centre of the property. There is a shale layer in the upper soil layer which will allow for a reduced setback for excavation from

*Figure 7: Tree 21, bur oak to be retained*

the new foundation – the standard 1.2 m will not be required. The roots of the tree are to be preserved prior to any excavation, and the area should be avoided and mulched if used by pedestrian traffic. Recommendations for future care include deep root fertilizer a year post construction and ensure adequate moisture through a slow, deep watering system. Soil aeration and mulching would also be highly beneficial to the tree to help combat the effects of construction stress.

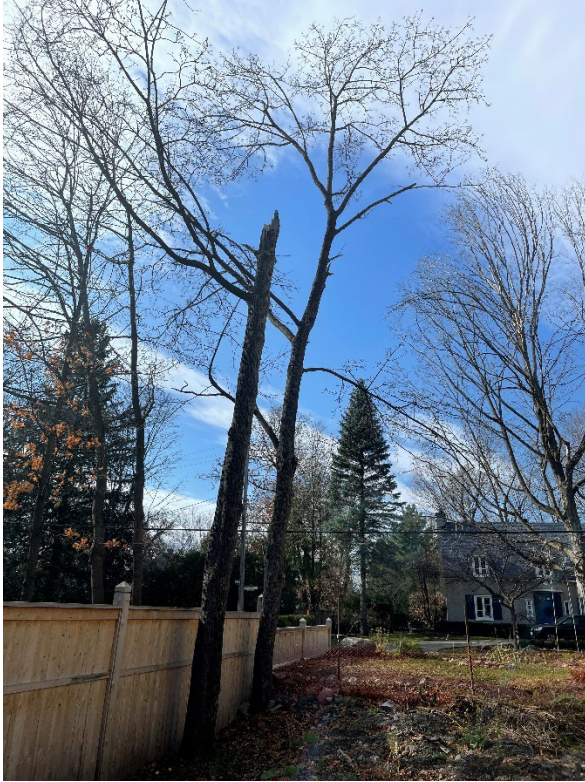
*Figure 8: Tree 20, Norway maple to be removed*

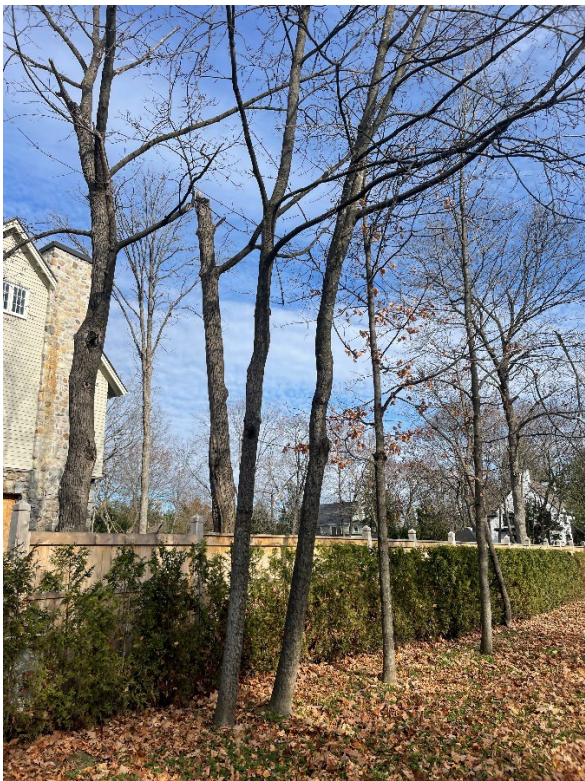
23	Norway maple ( <i>Acer plantanoides</i> )	22	City	Good	Retain	No action required; far enough from proposed construction
24	Norway maple ( <i>Acer plantanoides</i> )	15	City	Good	Retain	No action required; far enough from proposed construction
25	Norway maple ( <i>Acer plantanoides</i> )	18	City	Good	Retain	No action required; far enough from proposed construction
26	Norway maple ( <i>Acer plantanoides</i> )	14	City	Good	Retain	No action required; far enough from proposed construction

*Figure 9: Norway maples on city property (trees 22-26, to be retained)*
