ARBORIST'S REPORT: 106 PRINCE ALBERT ST

TIM-O-TREE

SUMMARY

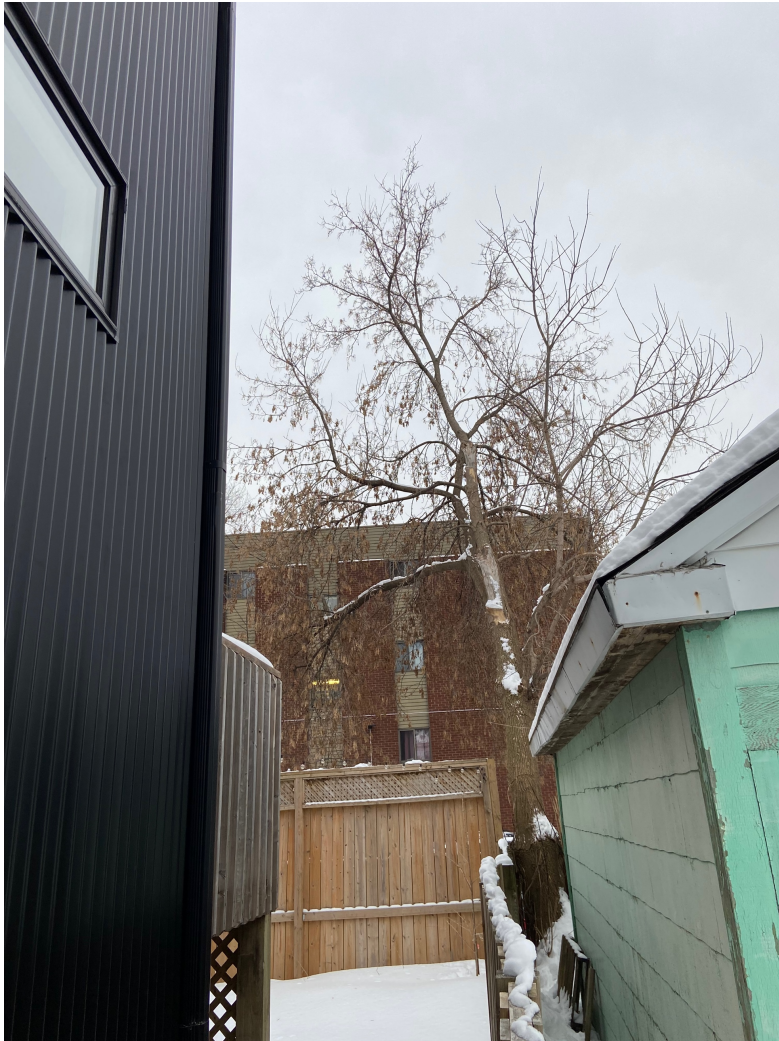
Image 1. Boxelder maple.

The boxelder maple in the back yard of 106 Prince Albert St is in poor condition due to significant storm damage and structural defects. Two large branches failed in May of 2022 during the Derecho, leaving large wounds that will likely develop a fungal infection. These

branch failures have also effectively narrowed the girth of the main stem and thereby reduced its structural stability.

The tree also has a significant northward lean over the parking lot of the adjacent apartment building. Whole-tree failure at the roots is very common for this species, especially when such a severe lean is present.

The tree does not impact construction as it needs to be removed anyway due to its condition. The owners of 106 Prince Albert st intend to remove the tree. As such, protection of the tree with fencing during construction would be pointless.

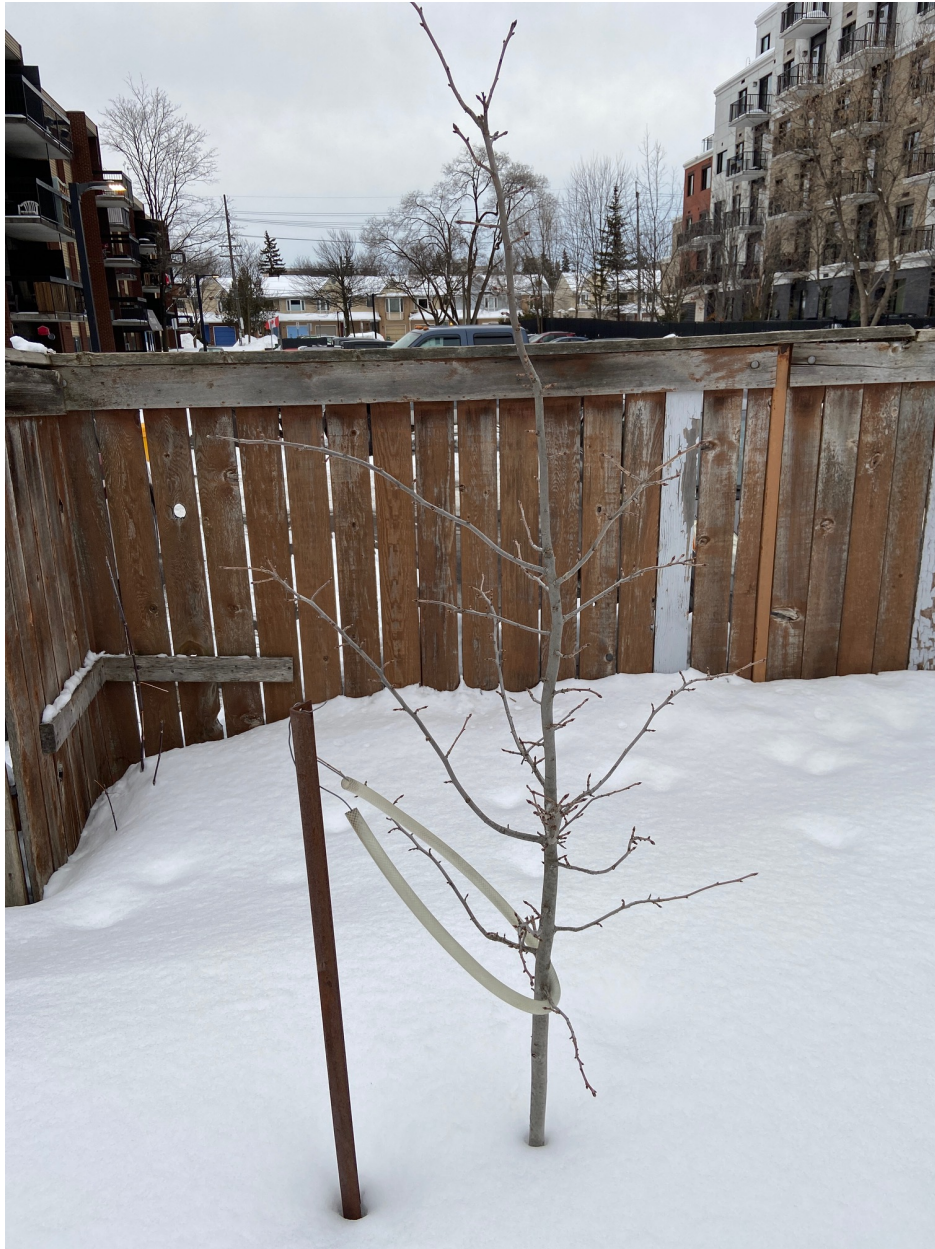
Image 2. Black Gum Tree..

All other trees on the property are under 30cm DBH and do not require protection or modifications to plans.
