December 5, 2022

Tree Information Report – 28 Oakridge Street

28-30 OAKRIDGE BOULEVARD
 NEPEAN ONTARIO
TREE INFORMATION REPORT

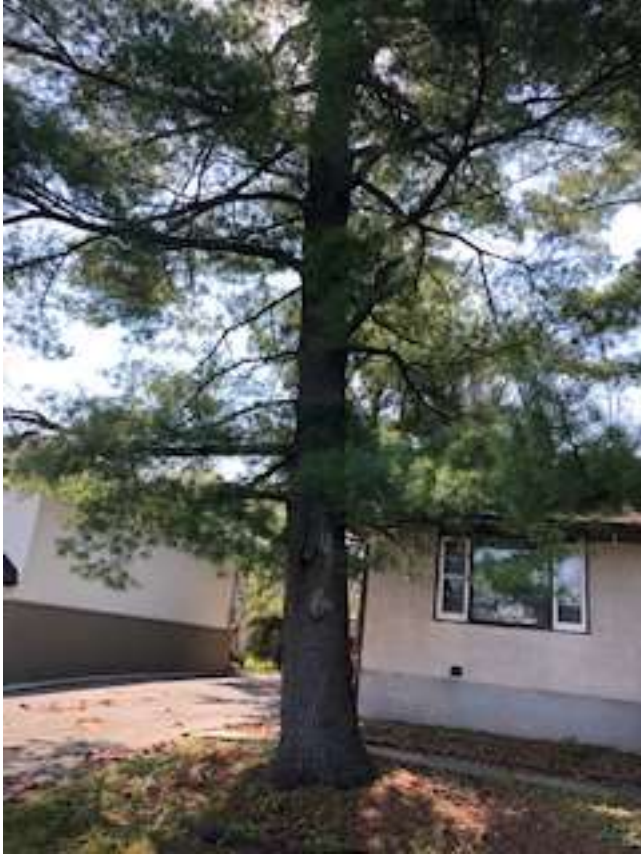
Tree #1

Tree No.	Species	D.B.H (cm)	Ownership	Condition of tree	Client's reason for removal	Arborist recommendation
1	White Pine	76	Private	Canker in main trunk has caused decay. Co dominate stems. Vigour and health are fair, structural integrity is poor.	Concerned over condition, conflict with construction.	Remove - conflict. Tree condition is a concern.
2	White Pine	54	Private	Health, vigour, and structure are good.	Conflict with construction.	Remove - conflict.
3	Red Maple	42	Municipal	Decay at base, caused by girdling root. Weak structure, co dominate stems, poor attachments. Health and vigour are fair.	Conflict with construction.	Remove - conflict. Tree condition is a concern. City permission and compensation required.
4	Red Maple	46	Municipal	Structure, health and vigour are good.	Conflict with construction.	Remove - conflict. City permission and compensation required. Adjustments to retain the have been discussed, but are not practical. CRZ will incur significant damage.

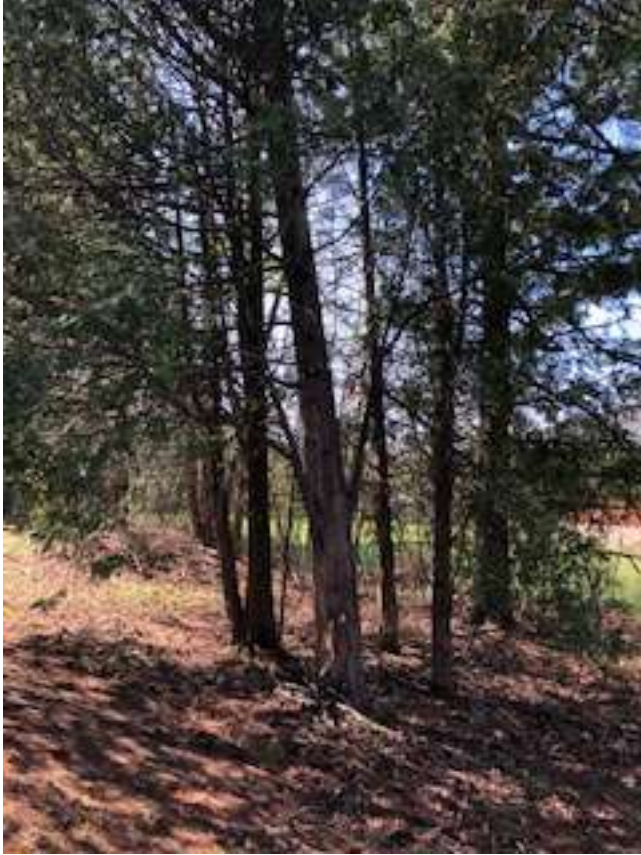
Removed – failed in May 2022 storm

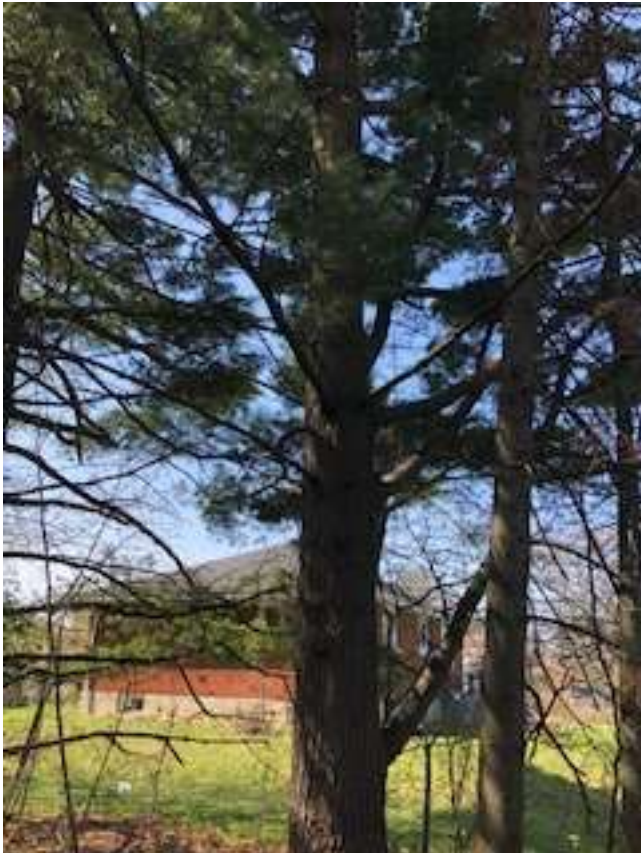
Tree #5

5	White Pine	70	Private	Dead top/decay, likely caused by canker. Decline will continue, weakening structure.	Concerned over condition, conflict with construction.	Remove - conflict. Tree present a safety risk.
6	Norway Maple	27	Private	Structure, health and vigour are good.	Conflict with construction.	Remove - conflict. Species is prone to failure, and is growing to close to purposed.
7	Norway Maple	21	Neighbour	Structure, health and vigour are good.	Retain	Retain - protect. CRZ protection fencing installed at 3ft.
8	Norway Maple	27	Private	Structure, health and vigour are good.	Conflict with construction.	Remove - conflict. Species is prone to failure, and is growing to close to purposed.
9	White Pine	52	Private	Structure is fair, health and vigour are good.	Safety.	Remove. Significant tree failures occurred on the property during the May 2022 storm, this tree presents a safety risk to purposed, and residents.

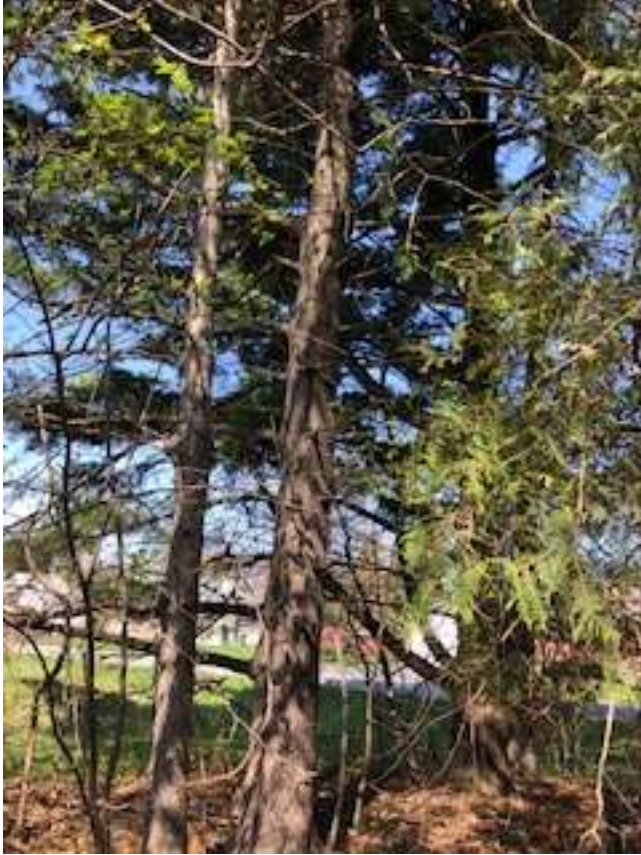
Removed – failed in May 2022 storm

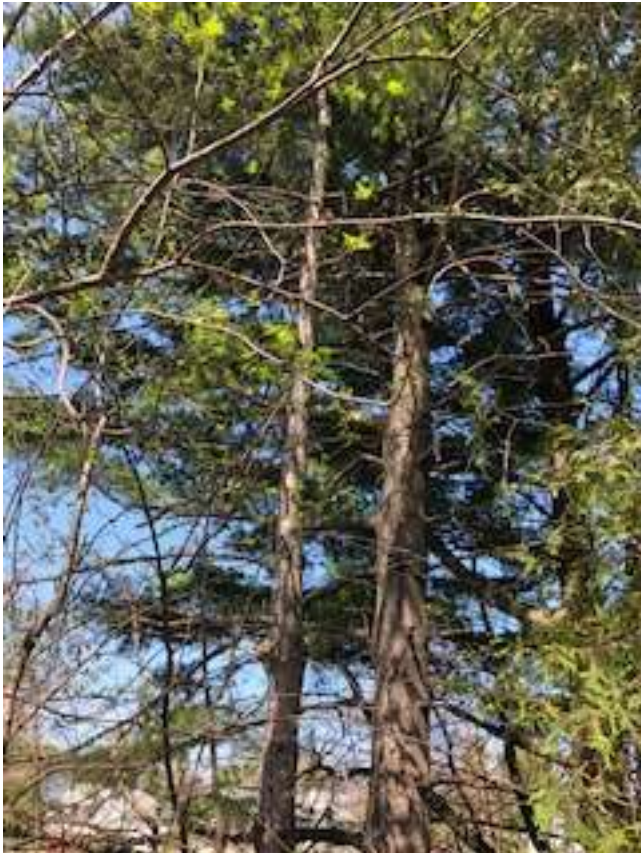
Removed – failed in May 2022 storm

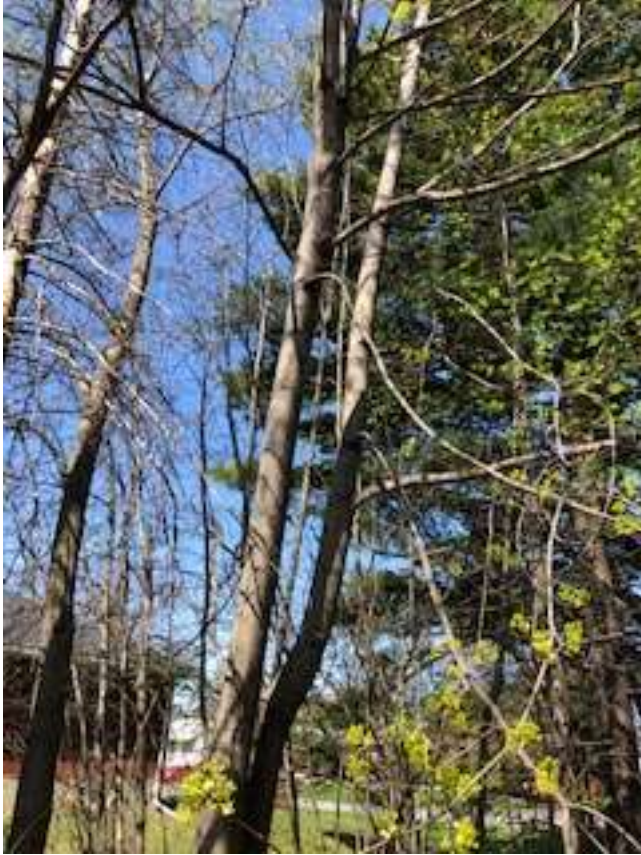
Removed – failed in May 2022 storm

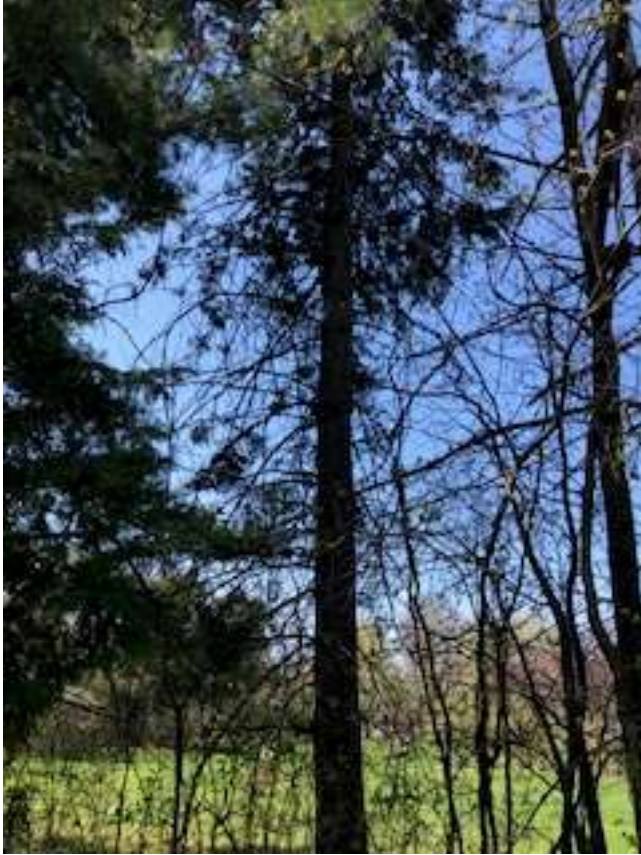
Removed – failed in May 2022 storm

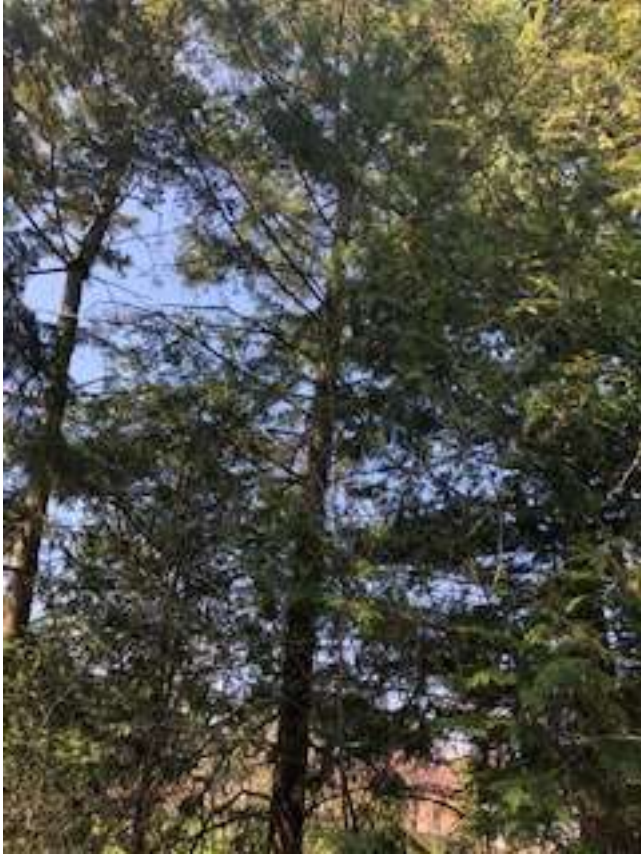
Tree #10

10	White Spruce	41	Private	Structure is fair, health and vigour are good.	Safety.	Remove. Significant tree failures occurred on the property during the May 2022 storm, this tree presents a safety risk to purposed, and residents.
11	White Spruce	39	Private	Structure is fair, health and vigour are good.	Safety.	Remove. Significant tree failures occurred on the property during the May 2022 storm, this tree presents a safety risk to purposed, and residents.
12	Norway Maple	20	Private	Structure is poor due to hydro pruning. Health and vigour are good.		Remove. Tree is not viable long term.
13	White Pine	62	Private	Structure is fair, health and vigour are good.	Safety.	Remove. Significant tree failures occurred on the property during the May 2022 storm, this tree presents a safety risk to purposed, and residents.
Tree No.	Species	D.B.H (cm)	Ownership	Condition of tree	Client's reason for removal	Arborist recommendation

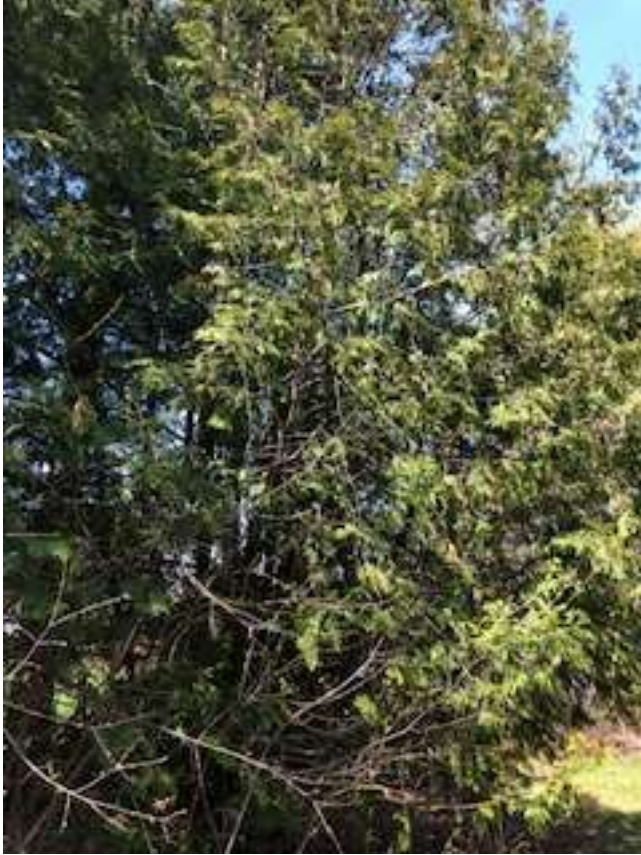
Removed – failed in May 2022 storm

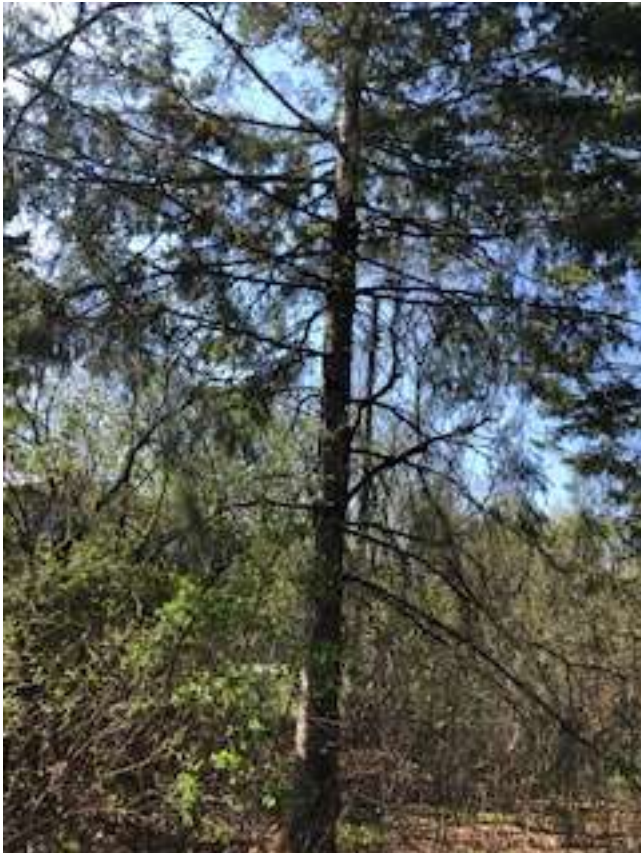
Removed – failed in May 2022 storm

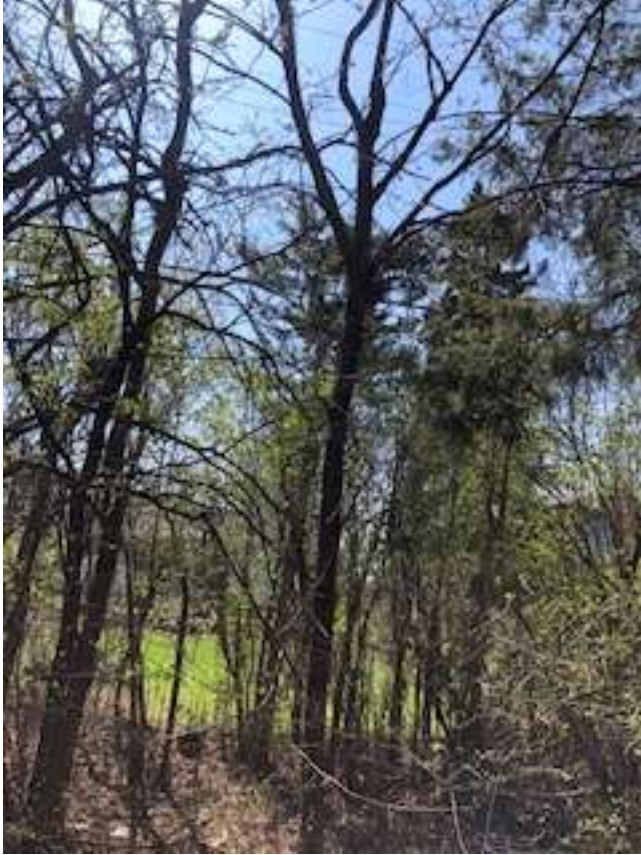
Removed – failed in May 2022 storm

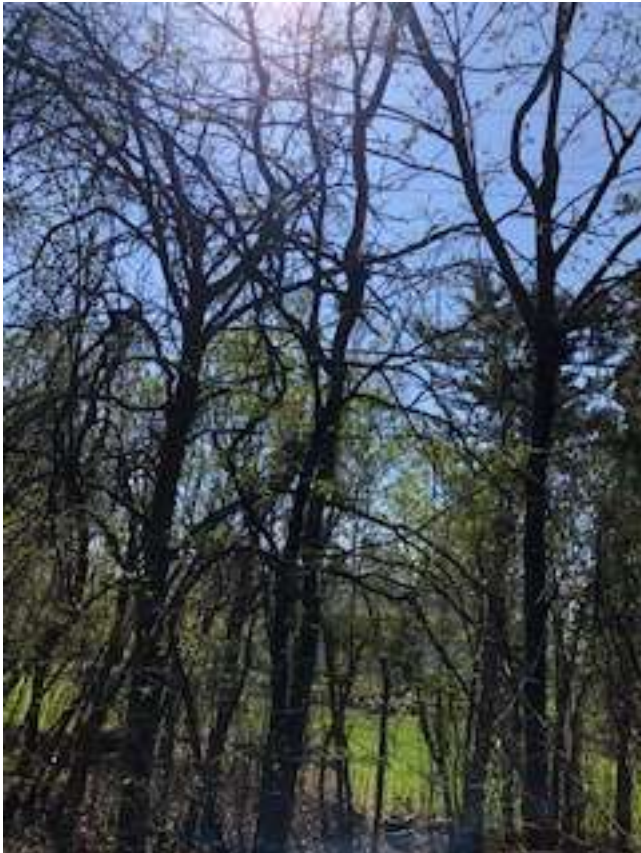
Removed – failed in May 2022 storm

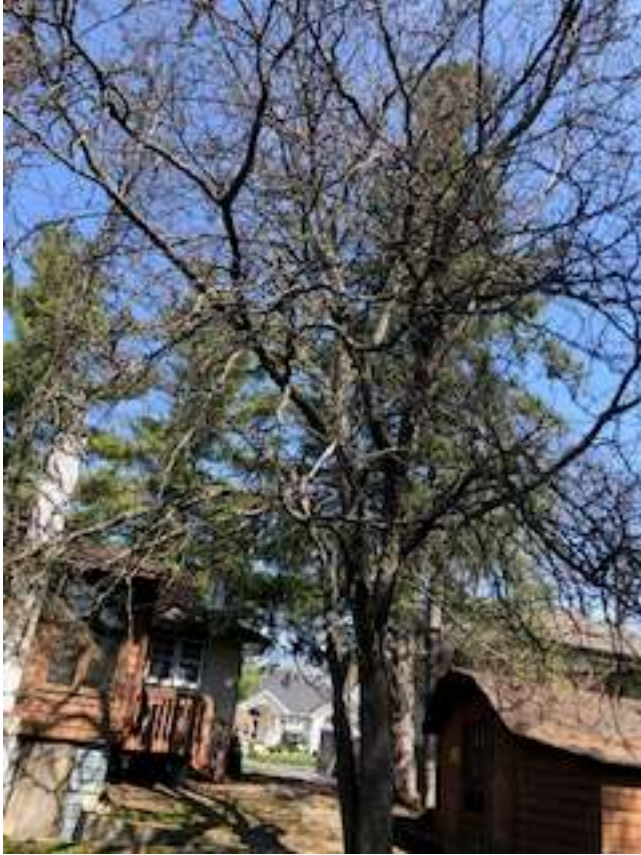
Tree #15

15	Locust	49	Private	Decay in trunk, co dominate stems, structure is poor. Health and vigour are fair. Significant deadwood present.	Conflict with construction.	Remove - conflict. Overall condition is poor.
16	White Spruce	40	Private	Borer damage present, causing decline. Health and vigour are fair.	Conflict with construction.	Remove - conflict.
17	White spruce	55	Private	Borer damage present, causing decline. Health and vigour are fair.	Conflict with construction.	Remove - conflict.
<p>*In addition to above trees there are 3 trees on the property that are dead, and will be removed.</p> <p>*Along west side sucker trees owned by neighbour to be retained, mt.ash, Norway maple, buckthorn, all under 10cm dbh. Construction fencing will protect CRZ.</p> <p>*Along south side, lilacs owned by neighbour to be retained, all under 10cm dbh. Construction fencing will protect CRZ.</p> <p>The following are measures to be implemented prior and during the construction process.</p> <ul style="list-style-type: none"> -Critical root zone of retained trees must be protected as outlined above. Snow or metal fencing must be erected around the CRZ and signage should be installed to identify tree is being protected. -Pruning must be performed prior to construction to ensure tree limbs will not be in conflict with equipment and construction. Permission must be obtained to prune Municipal or neighbors trees. (performed by Certified Arborist). -No material or equipment is permitted within any CRZ. -No signs, notices or posters may be attached to the tree. -No grade changes within any CRZ. -Ensure exhaust fumes from equipment are not directed towards tree canopy's.
