Tree Information Report

Submitted as part of Committee of Adjustment Application to the City of Ottawa

Address: 11 Warrington

Date of Report: December 15, 2022

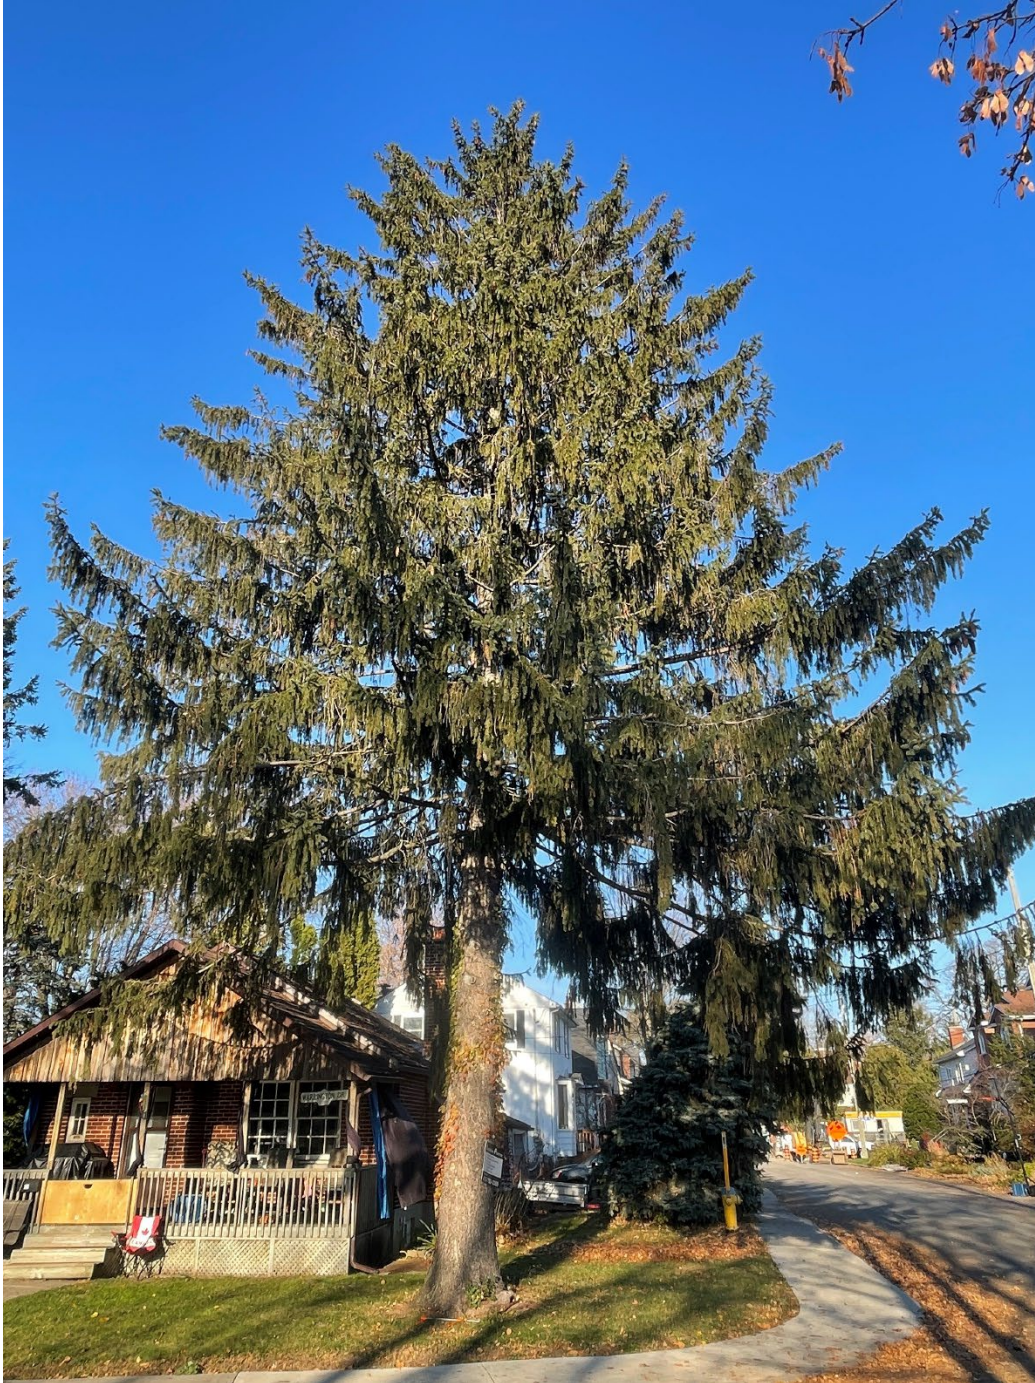
Figure 1: Tree 1, Norway spruce to be retained

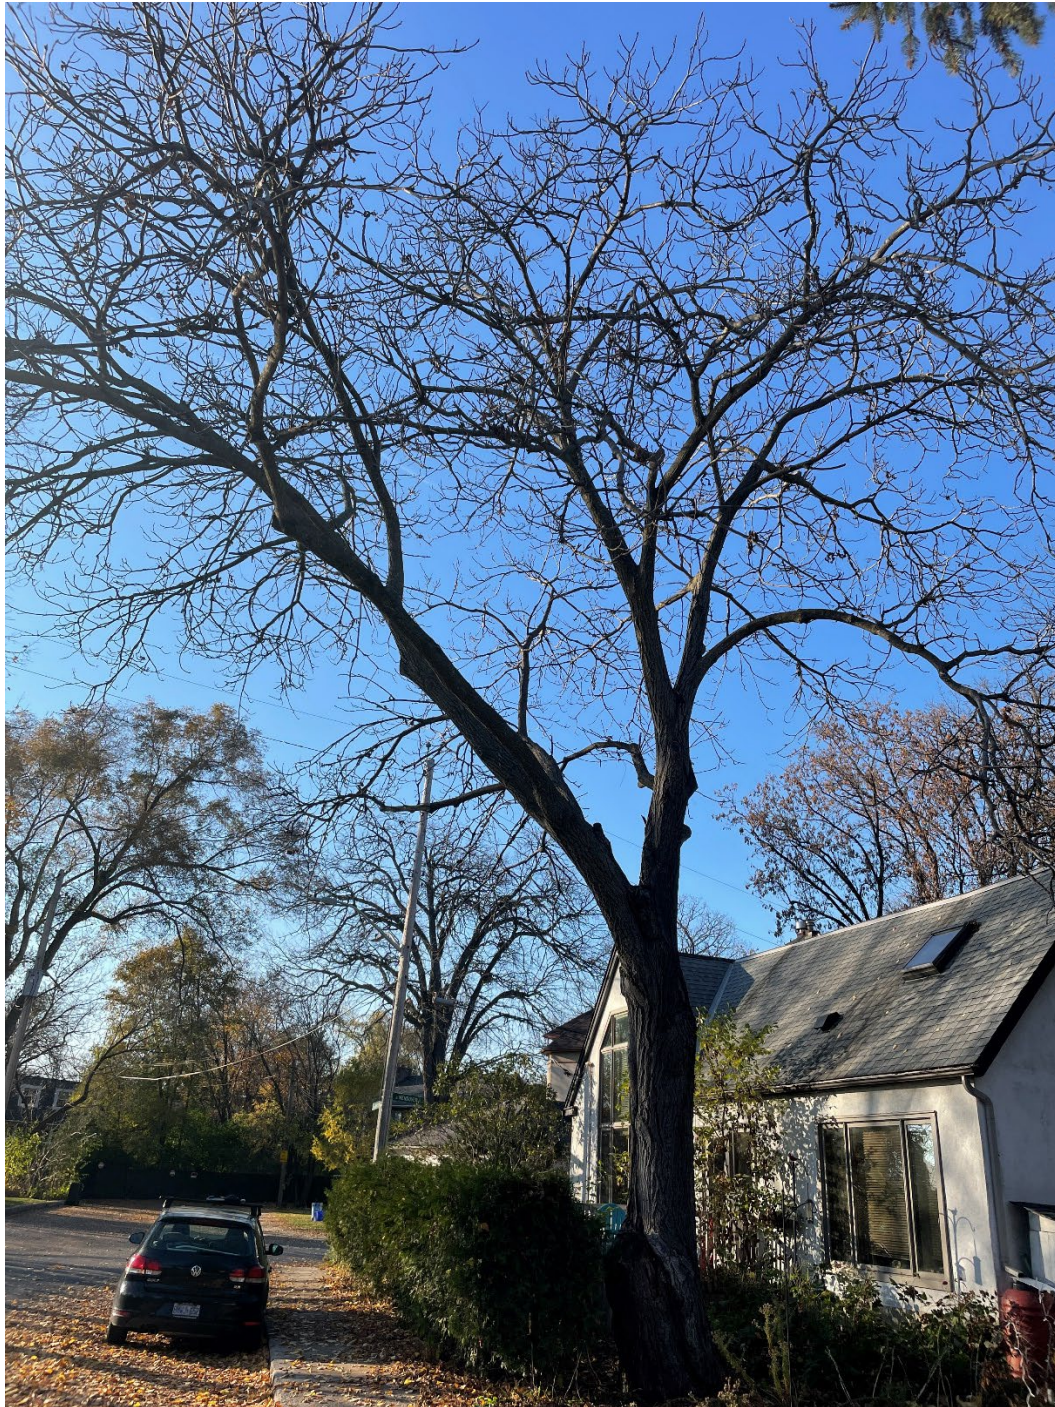
Tree number 2 on adjacent property at 35 Wendover is a butternut, a species of tree classified as endangered under the Endangered Species Act (ESA 2007). Hobin Architecture hired Rose Fleguel, Designated Butternut Health Assessor (#002), to assess the tree to determine whether it is a true butternut and fits the parameters of a protected tree under the Act. The assessment was completed on November 29, 2022, and Ms. Fleguel determined that since the tree was planted and not naturally occurring, it is considered “cultivated” and, therefore, not protected by the Act.

Figure 2: Tree 2, butternut tree on adjacent property at 35 Wendover

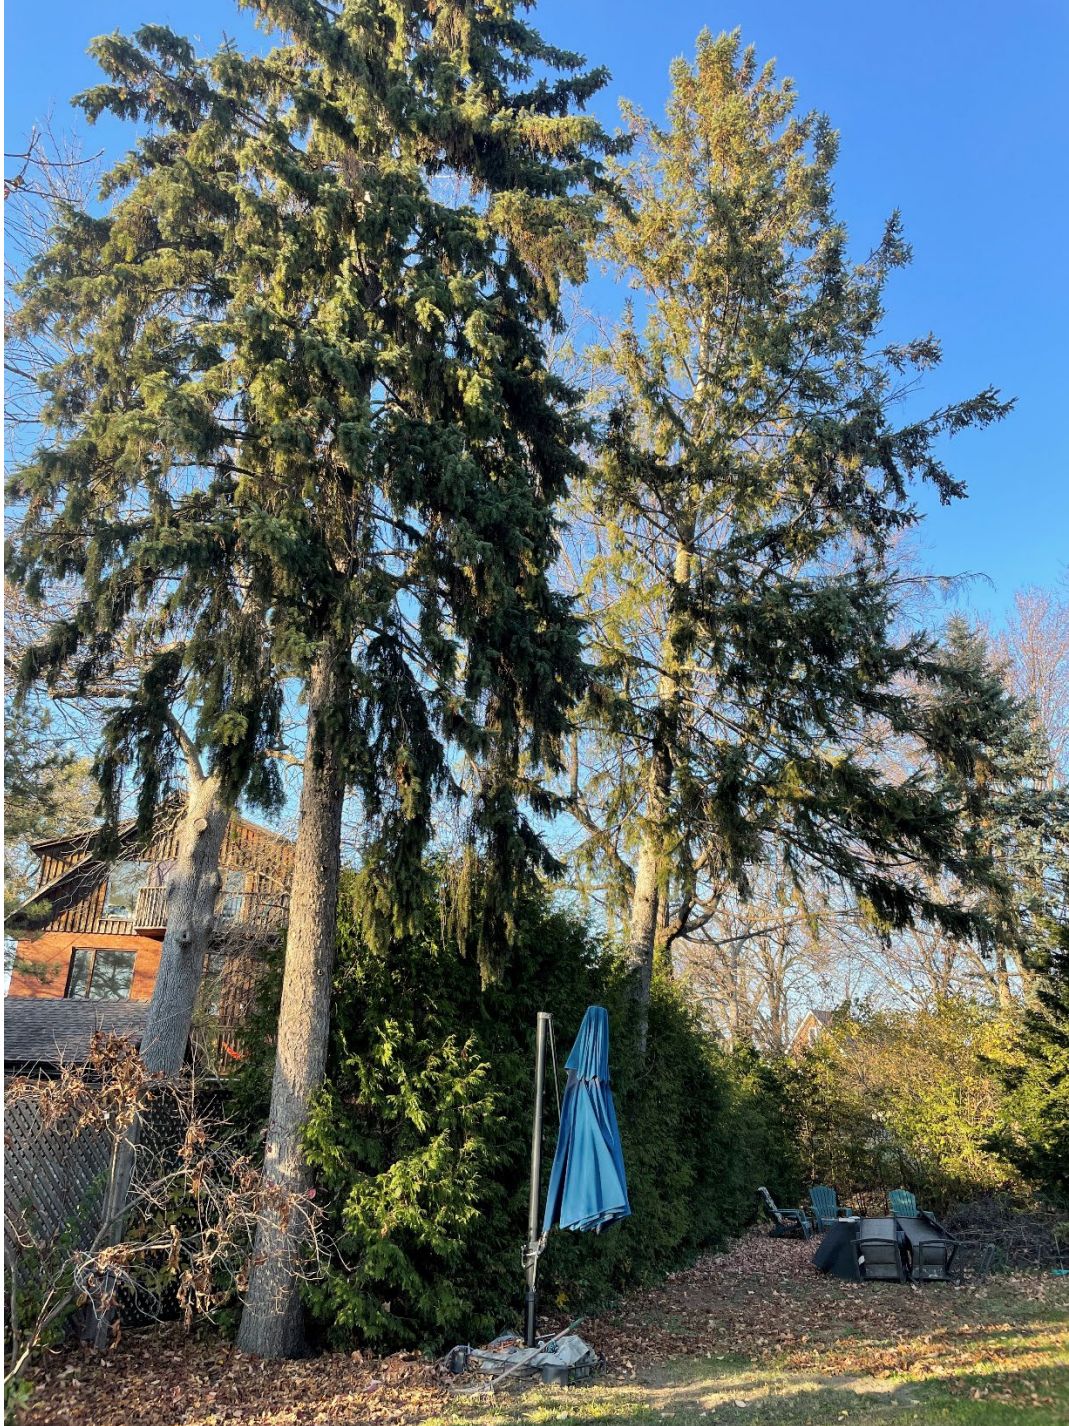
Figure 3: Trees 3 (front), white spruce to be retained, and tree 4 (behind), white spruce to be removed

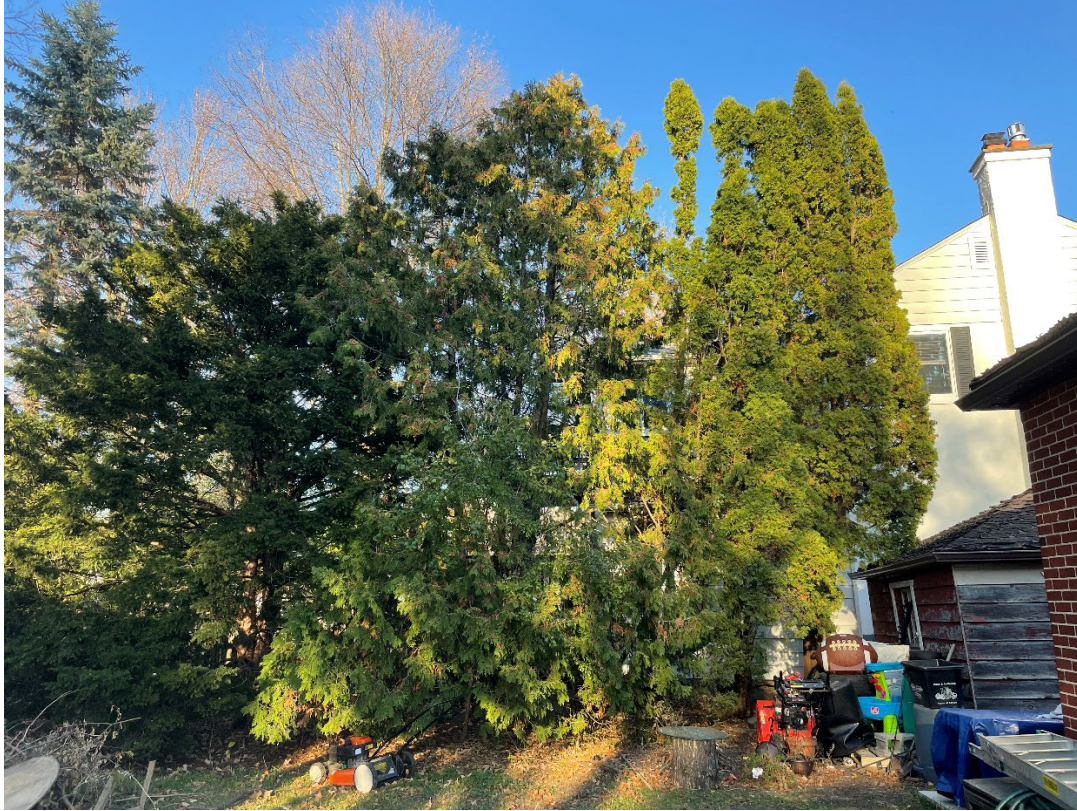
Figure 4: row of cedars at rear of property to be removed, trees 6-8 (from right to left)

7	Eastern white cedar (<i>Thuja occidentalis</i>)	31 cm	Remove; in conflict with proposed driveway, Tree Permit required for removal
8	Juniper (<i>Juniper virginiana</i>)	24, 24 cm	Remove; in conflict with proposed driveway, NO Tree Permit required for removal (under 30 cm)
9	Colorado blue spruce (<i>Picea pungens</i>)	30 cm	Remove based on heavy lean; roots will be severed and damaged, when combined with the heavy lean, any activity in the root system may cause instability, Tree Permit required for removal

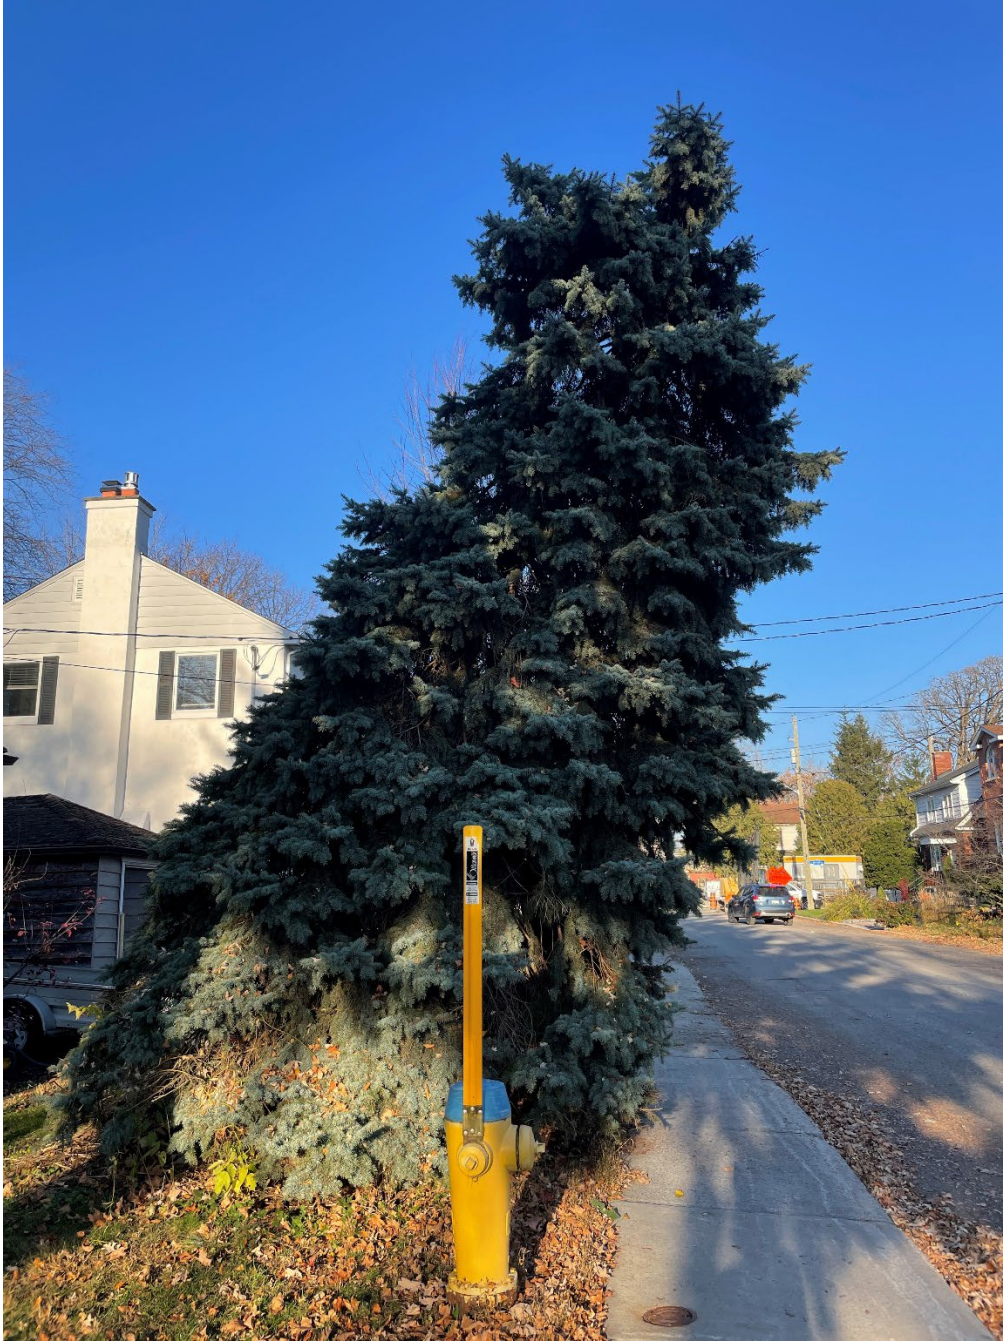
Figure 5: Tree 9, Colorado blue spruce to be removed
