URBAN FORESTRY & FOREST MANAGEMENT CONSULTING

April 20, 2021

**RE: TREE CONDITION ASSESSMENT – MAJOR’S HILL PARK / CHATEAU LAURIER**

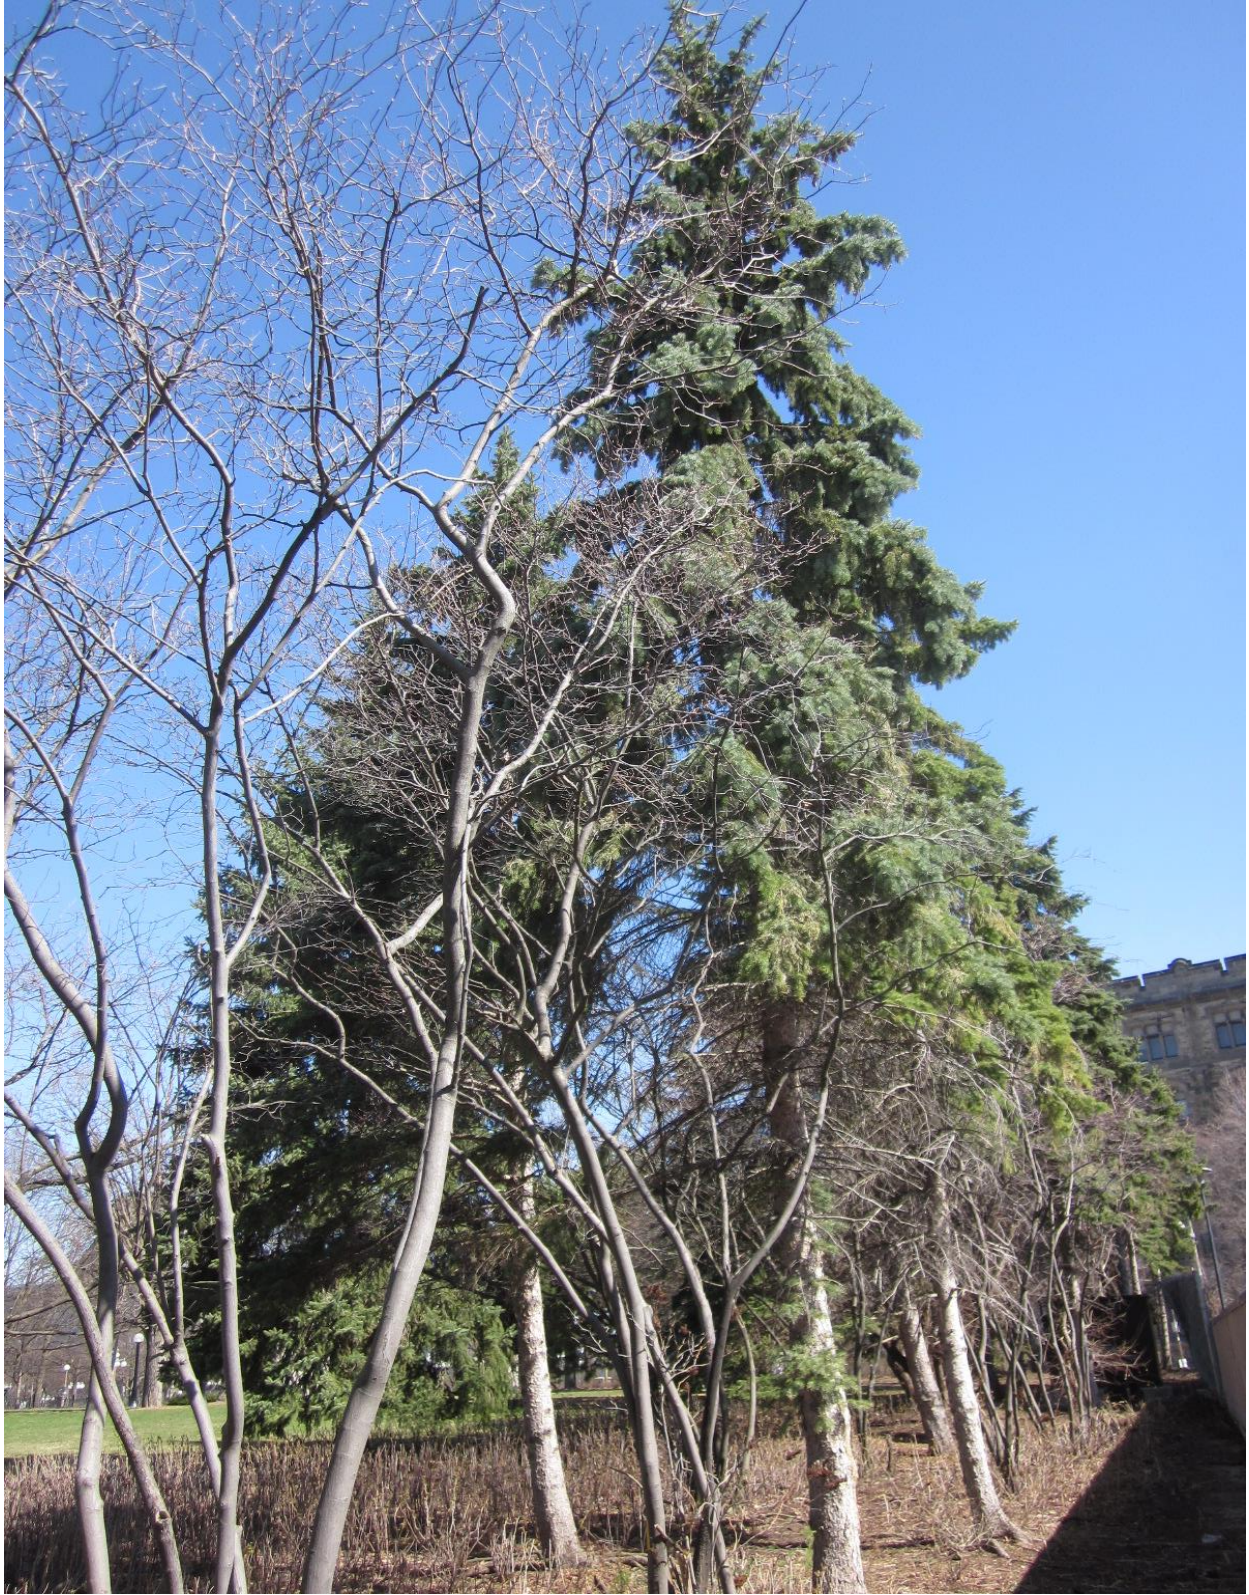
Picture 1. Colorado spruce trees within Major's Hill Park adjacent to 1 Rideau Street (serviceberries in foreground)

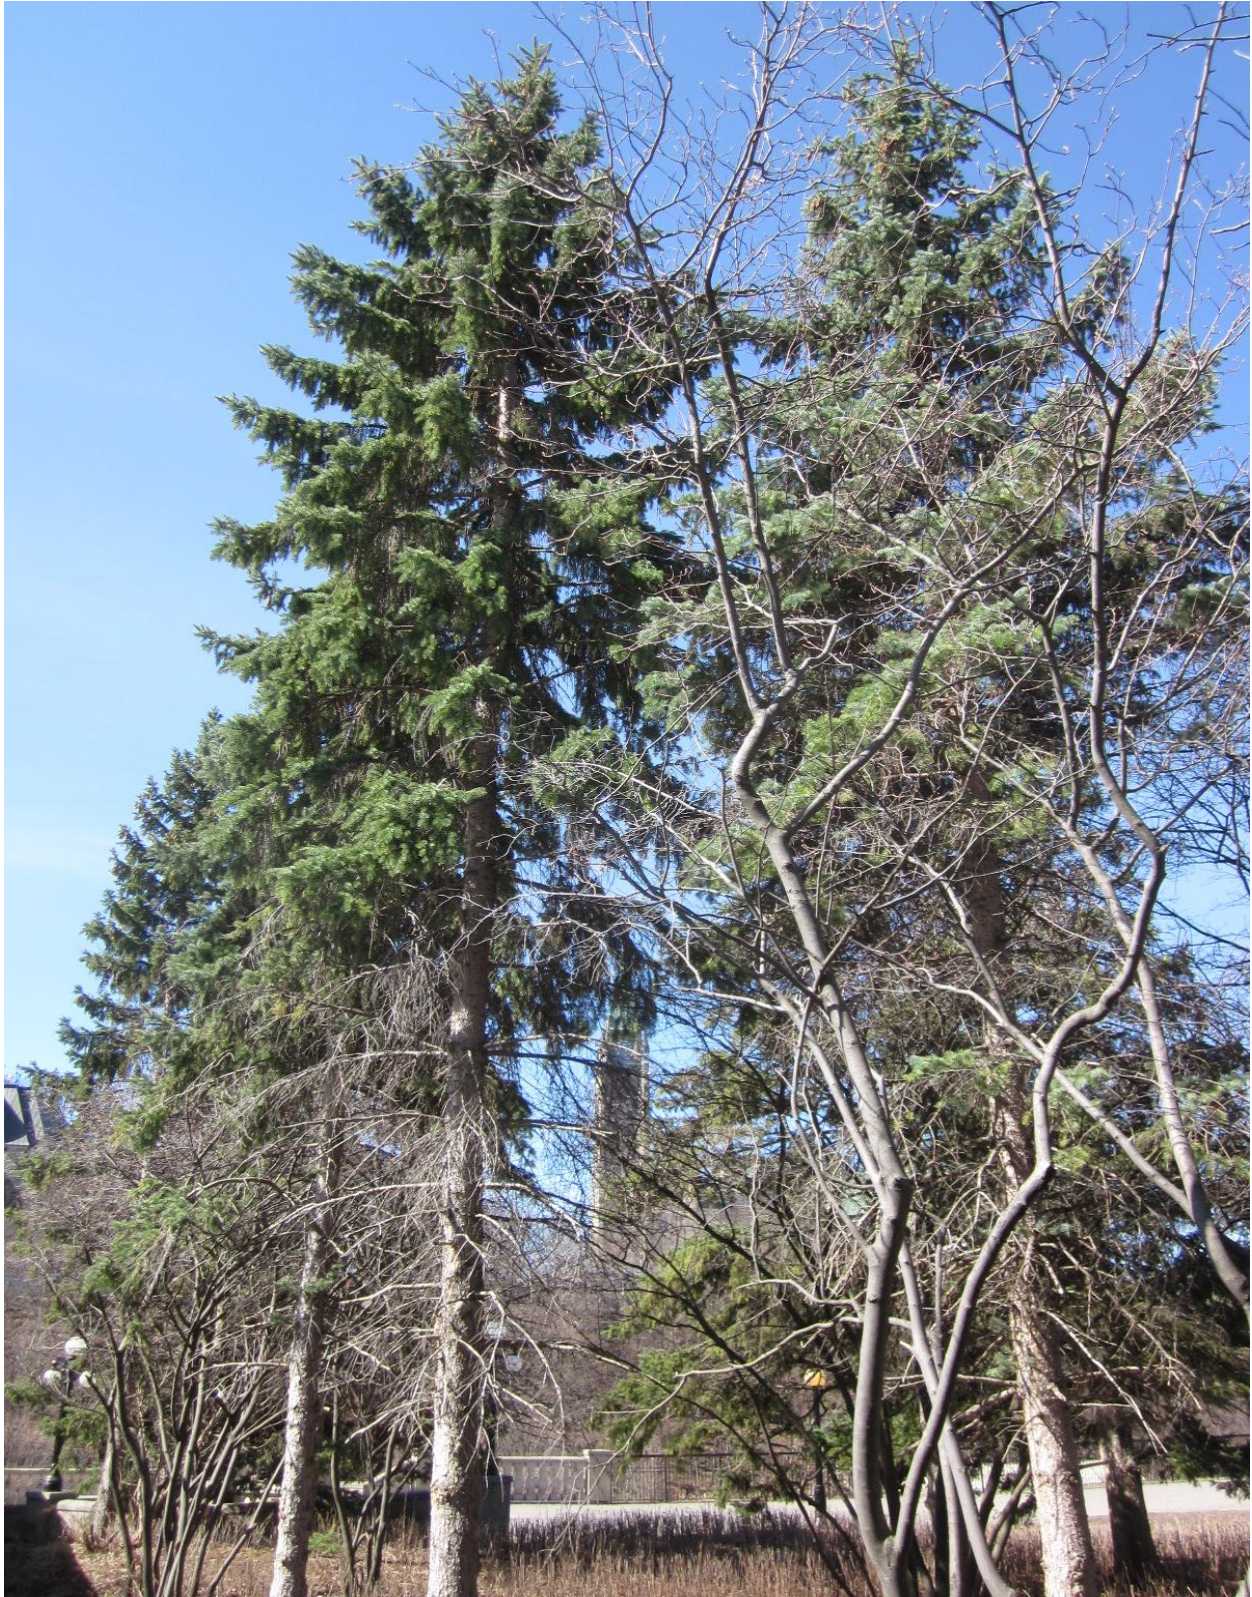
Picture 2. Colorado spruce trees within Major's Hill Park adjacent to 1 Rideau Street

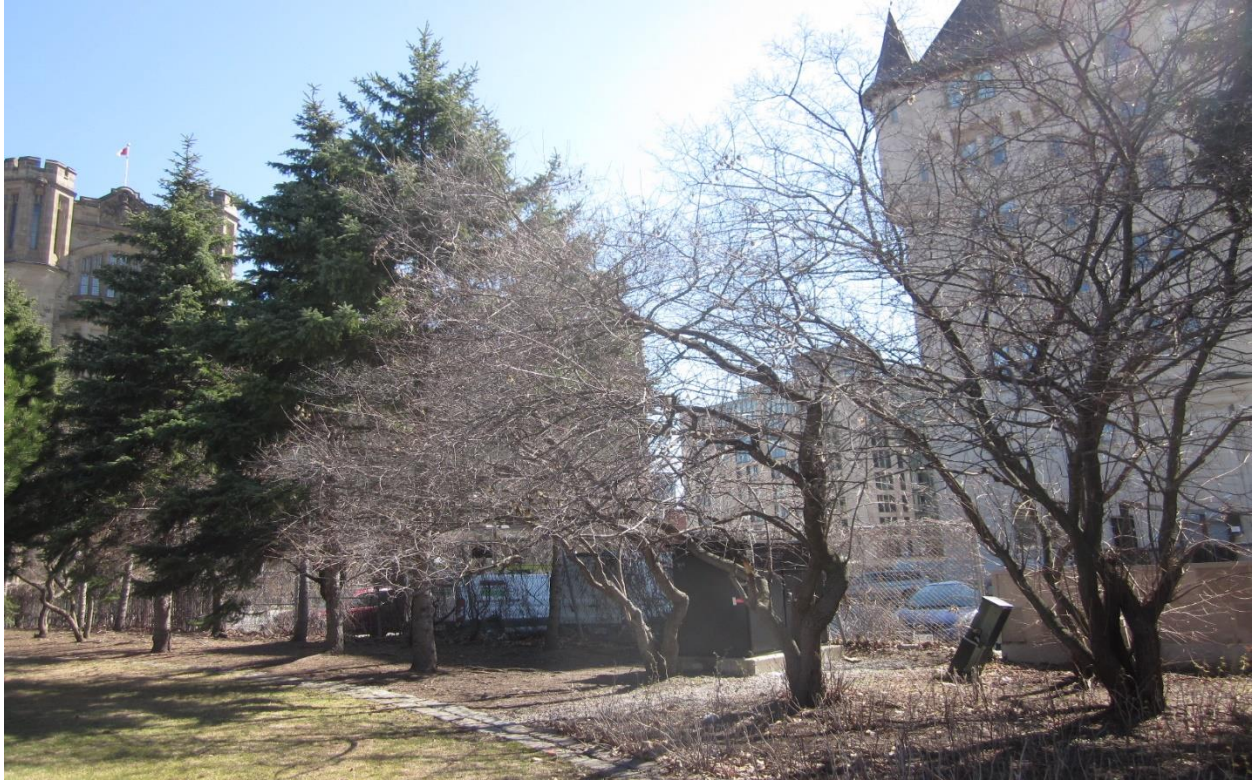
Picture 3. Colorado spruce and amur maple trees within Major's Hill Park adjacent to 1 Rideau Street

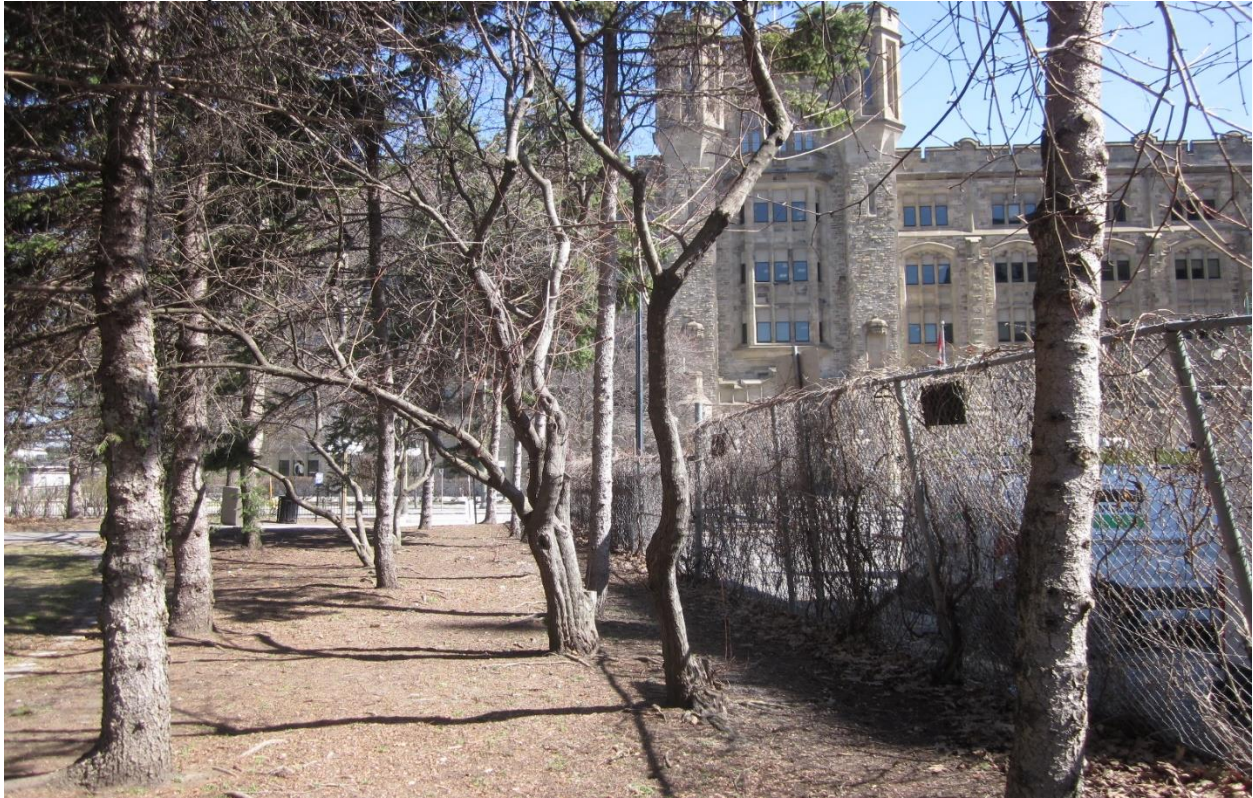
Picture 4. Colorado spruce and amur maple trees within Major's Hill Park adjacent to 1 Rideau Street

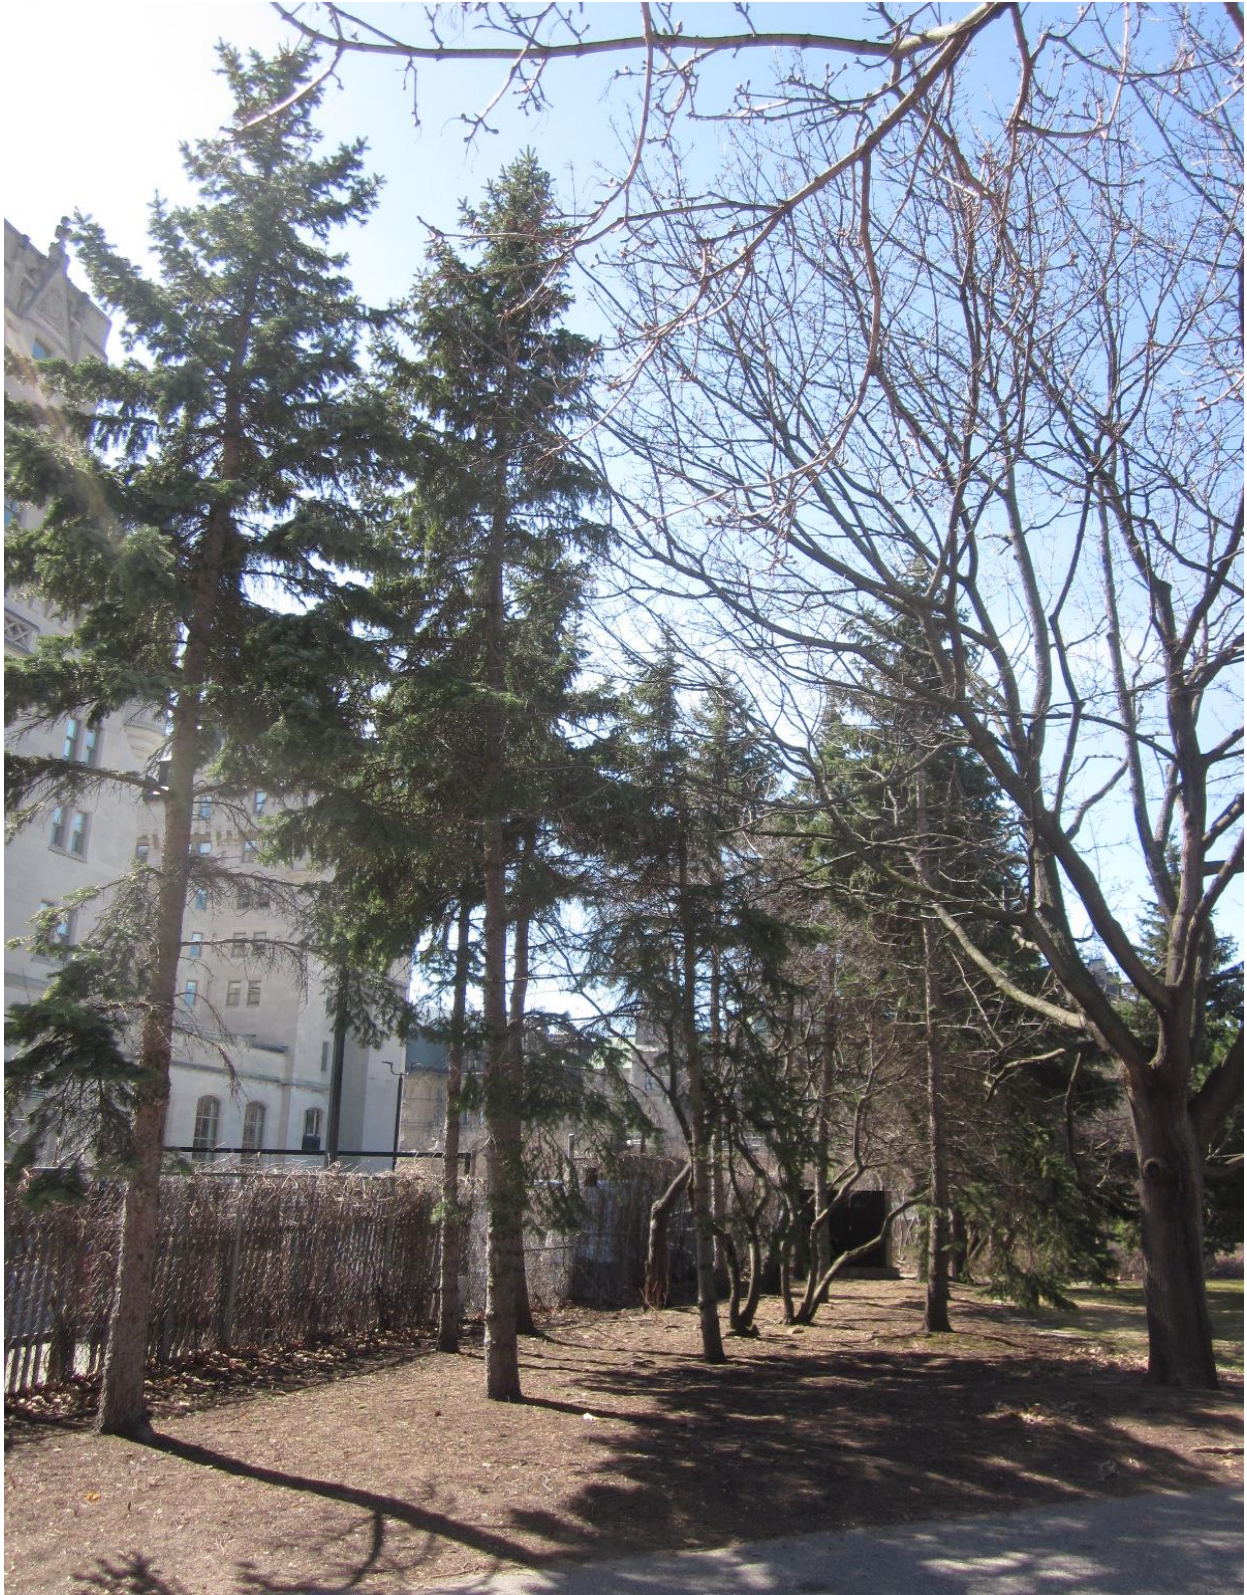
Picture 5. Colorado spruce trees within Major's Hill Park adjacent to 1 Rideau Street (shaded by mature Norway maple on right)
