Tree Information Report 2.0

Submitted as part of Building Permit Application for the City of Ottawa

Address: 56 Starwood

Date: January 27, 2023

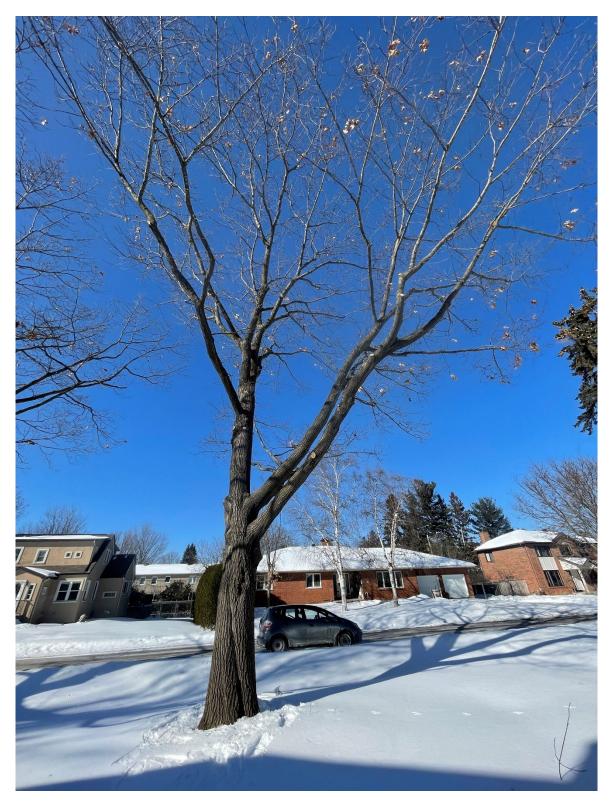
Tree ¹	Species	Diameter at breast height (cm)	Ownership 2,3	Condition	Action	Recommendations
1	Red oak (Quercus rubra)	77 cm	City	Fair; trunk has recent split -1.5 m on both sides, stems and depressions throughout trunk	Retain	Retain and protect; recommend that city forestry staff assess tree for bolting trunk, assess for basal decay after snow melt
2	White spruce (Picea glauca)	41 cm	City	Fair; crooked top, branch dieback 15%, little growth over last 5 years (diameter same measurement as	Retain	Retain and protect; city forestry inspector should consider removal and replacement given fair health combined with potential for construction damage

Figure 1: Tree 1, city-owned red oak to be retained

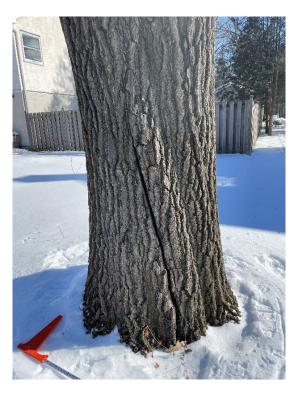
Figure 2: Tree 1, recent split in based of red oak

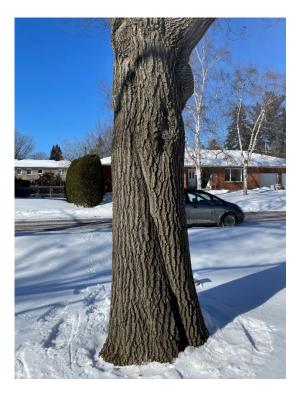
Figure 3: Split on rear side of red oak (tree 1)

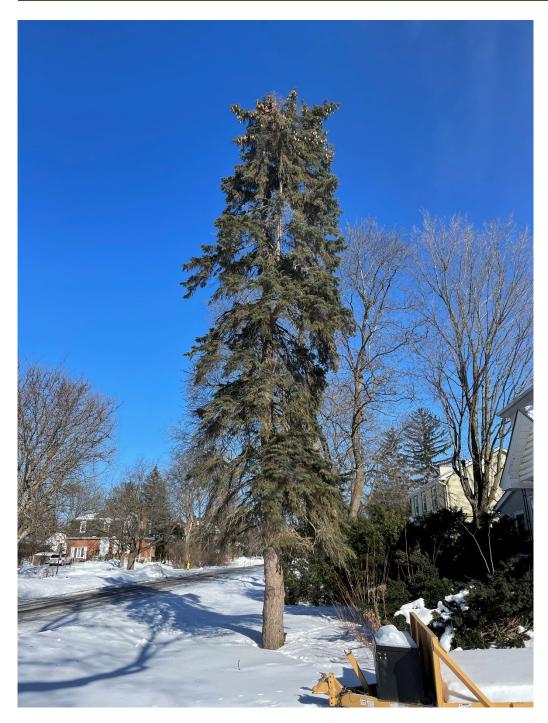
Figure 4: Tree 2, city-owned white spruce

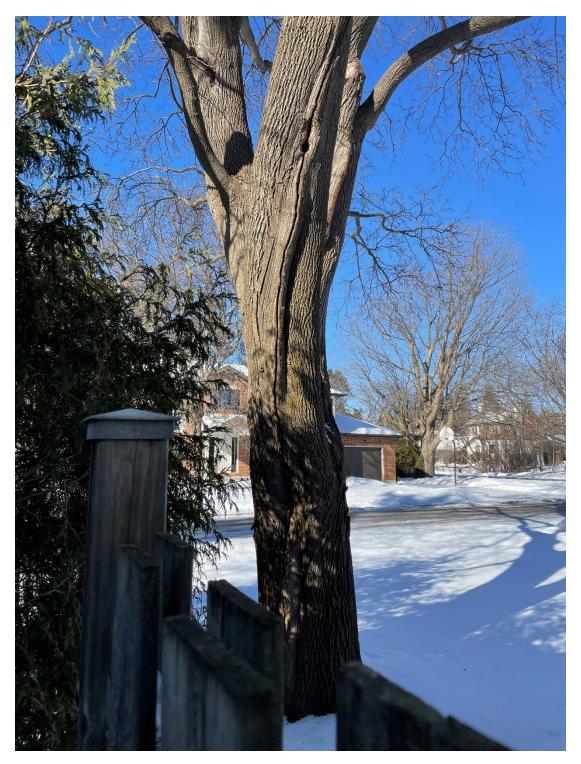
outdated tree inventory)		
3	Norway maple (Acer platanoides)	70 cm (estimate)	Adjacent property at 52 Starwood	Poor	Retain	Retain and protect with fencing as per City of Ottawa Tree Protection Specifications (March 2021); roots to be pruned to a clean cut by hand to reduce tearing and any exposed roots to be kept covered with organic material
44	Sugar maple (Acer saccharum)	45 cm (estimate)	Adjacent property at 52 Starwood	Good/fair; (trunk blocked by fence)	Retain	Retain; excavation to be reduced in corner of building; roots to be pruned to a clean cut by hand to reduce tearing and any exposed roots to be kept covered with organic material
5	Norway maple (Acer platanoides)	30 cm (estimate)	Jointly owned with adjacent property at 52 Starwood	Good; leaning over subject property	Remove	Remove as excavation will extend to base of tree; Tree Permit from city required for removal and permission from adjacent property owner

Figure 5: Tree 3, Norway maple on adjacent property

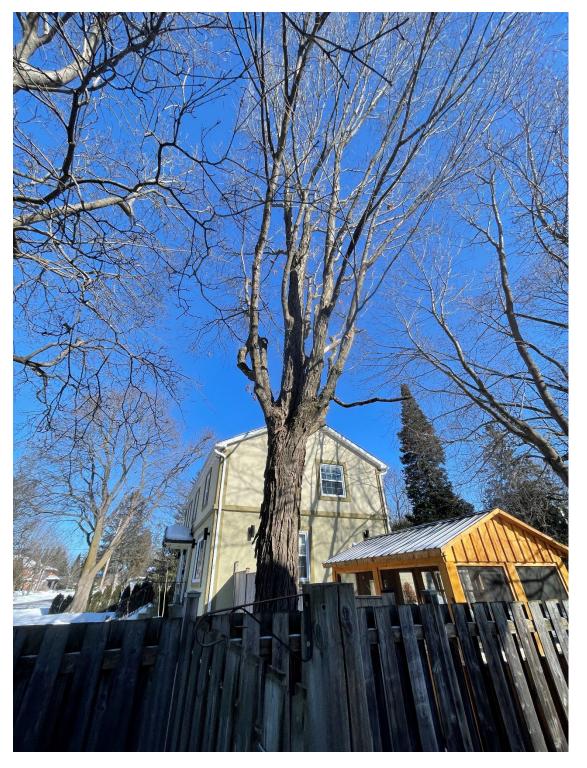
Figure 6: Tree 4, sugar maple on adjacent property

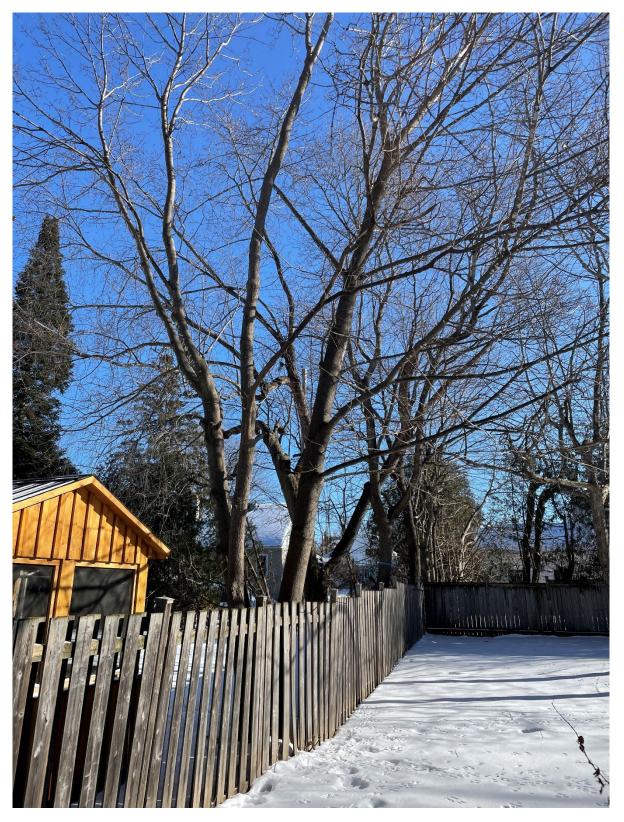
6	Norway maple (Acer platanoides)	45 cm (estimate)	Adjacent property at 52 Starwood	N/A	Retain	Retain and protect with fencing as per City of Ottawa Tree Protection Specifications (March 2021)
7	Ironwood (Ostrya virginiana)	24 cm (to be confirmed)	Private – 56 Starwood	N/A	Remove	No permit required as tree is under 30 cm
8	Ironwood (Ostrya virginiana)	30 cm (to be confirmed)	Private – 56 Starwood	N/A	Remove	Remove as within footprint of new building, Tree Permit required
9	Baswood (Tilia americana)	44 cm	Private – 56 Starwood	Good	Remove	Remove as within footprint of new building, Tree Permit required

Figure 7: Tree 5 and 6, Norway maples on adjacent property

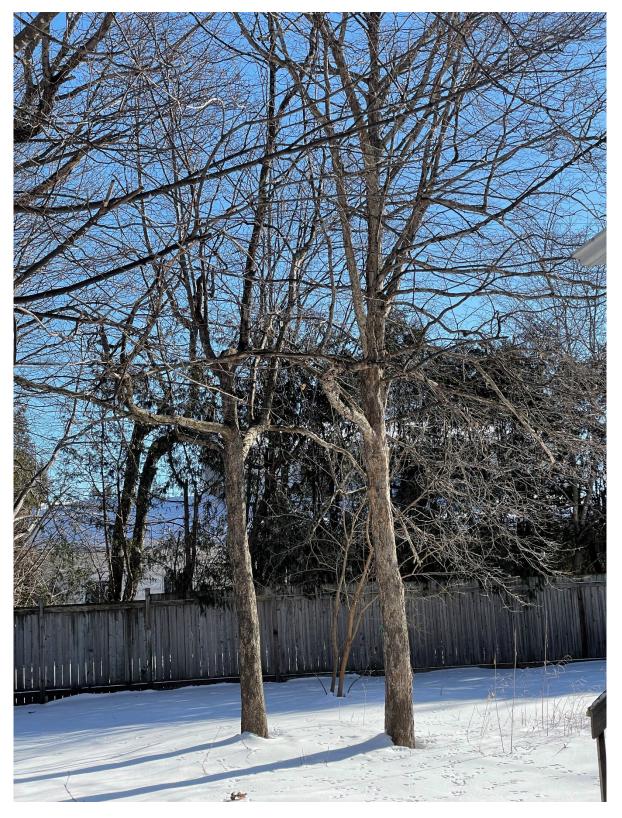
Figure 8: Trees 7 and 8, ironwood in the rear yard to be removed

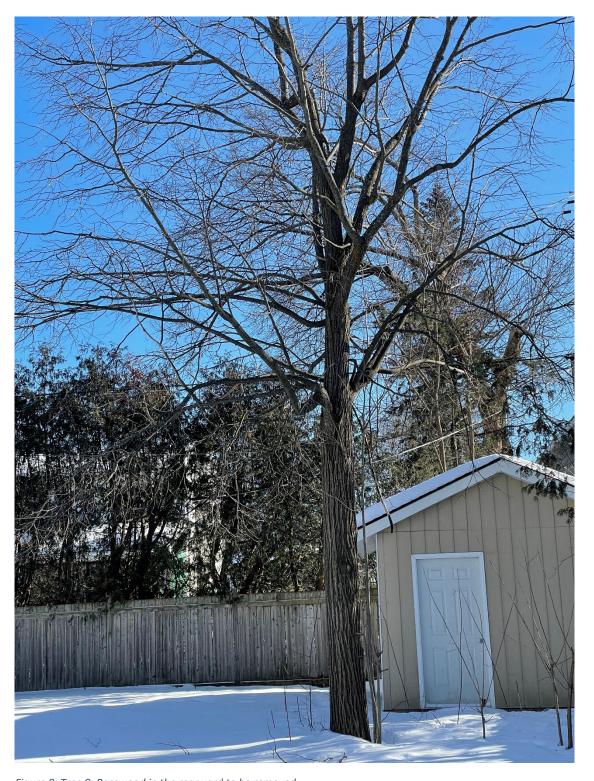
Figure 9: Tree 9, Basswood in the rear yard to be removed
