## Tree Information Report

Submitted as part of Committee of Adjustment Application to the City of Ottawa

**Address:** 481 Wentworth Avenue  
**Date of Report:** March 3, 2023  
**Date of Site Visit:** March 1, 2023  
**Prepared by:** Astrid Nielsen, RPF, ISA Certified Arborist®  
131 Smirle Ave, Ottawa, K1Y 0S4  
[Astrid.nielsen@dendronforestry.ca](mailto:Astrid.nielsen@dendronforestry.ca)

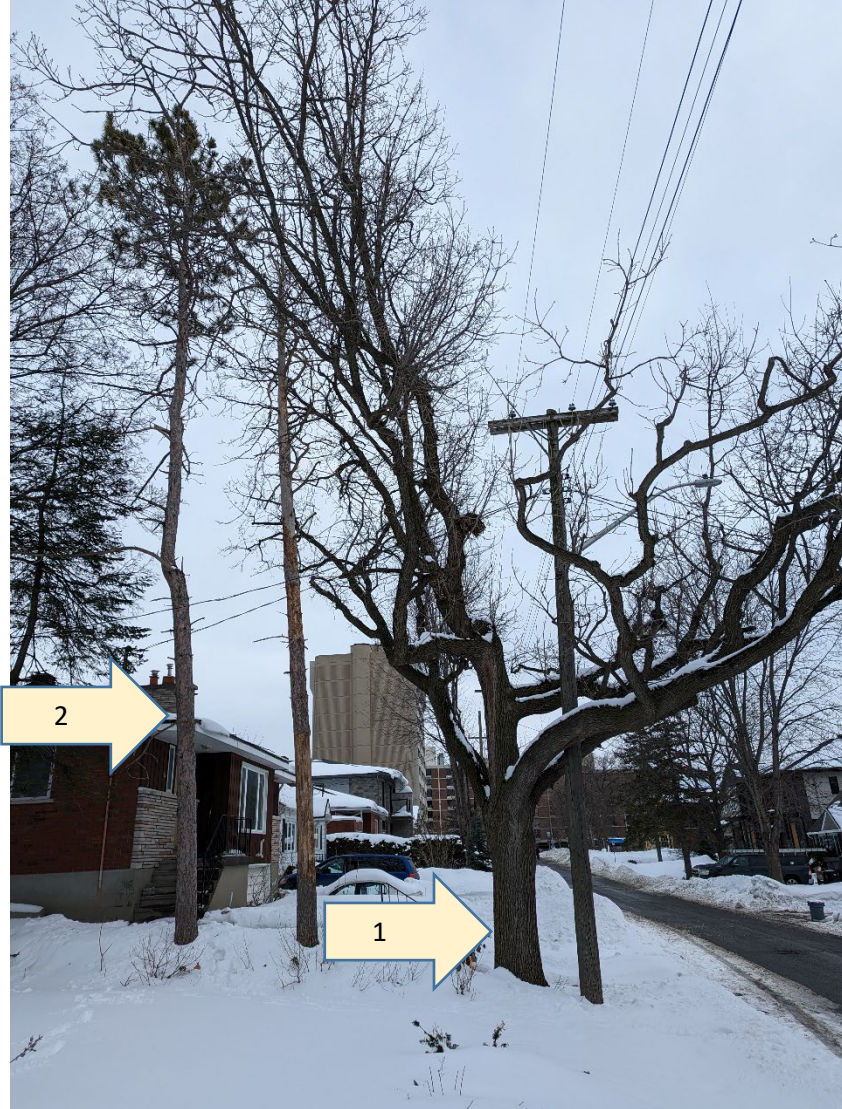
Tree <sup>1</sup>	Species	Diameter at breast height (cm)	Ownership <sup>2,3</sup>	Condition	Action	Recommendations
1	White oak ( <i>Quercus alba</i> )	67	City	Good/Fair: many epicormic shoots; pruned around hydro	Retain	Retain and protect as per City of Ottawa Tree Protection Specifications (March 2021)
2	Red pine ( <i>Pinus resinosa</i> )	32	Boundary – 485 Wentworth	Fair: some dieback in canopy; insect holes in stem, high crown	Retain	Retain: certified arborist to explore root structure and tree stability before and after excavation and determine suitability for retention
3	Norway maple ( <i>Acer platanoides</i> )	51	Boundary – 485 Wentworth	Poor: large canker severely reducing stem width and structural integrity; split in stem to base; lean towards subject property.	Remove	Remove prior to demolition due to poor health and safety concerns. <b>Tree permit and approval from adjacent property owner required</b>

*Figure 1 - Tree 1: City oak to be retained & Tree 2: boundary red pine*

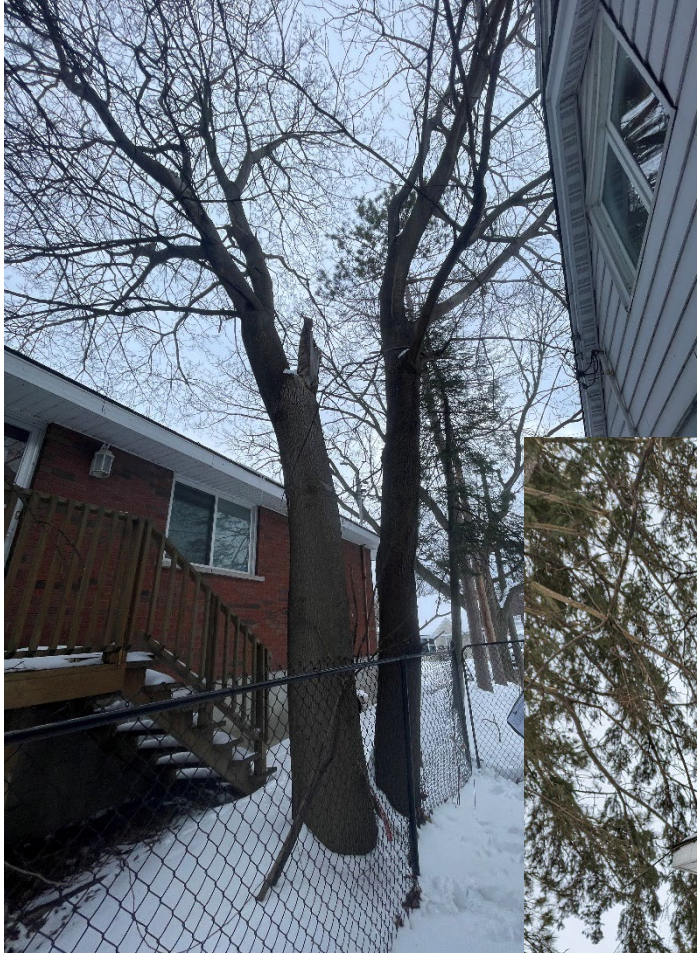
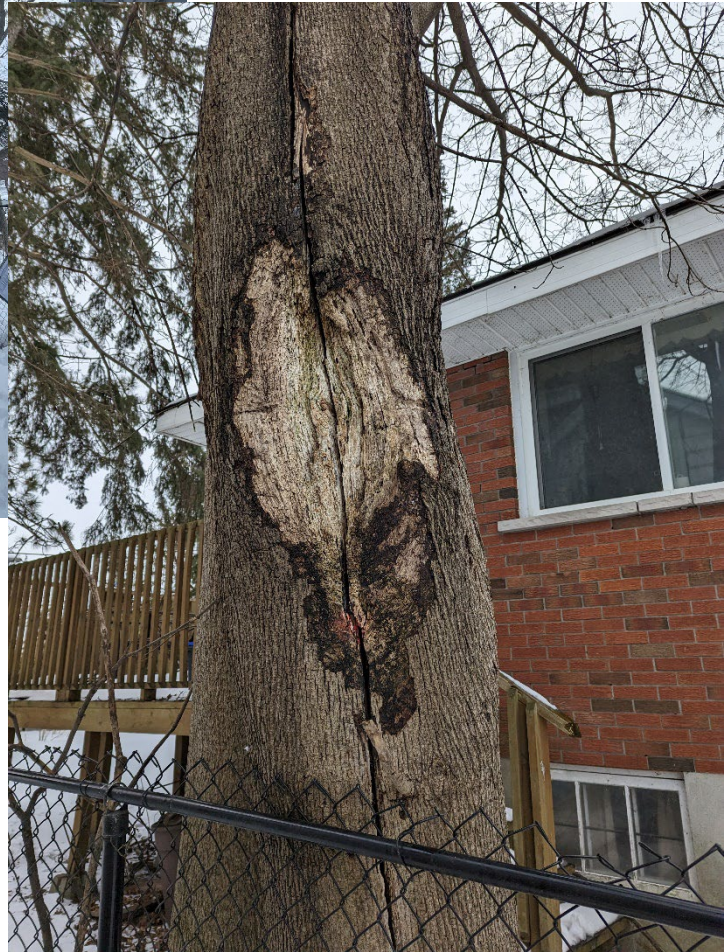
4	Norway maple ( <i>Acer platanoides</i> )	51	Adjacent – 485 Wentworth	Fair: large split in stem; stub of large broken branch	Retain	Retain: explore root structure with air spade – certified arborist to assess suitability for retention

**Tree 3** is a large Norway maple that leans over the subject property. It is badly infected with a canker, and it has a large vertical crack extending the length of the trunk. The structural integrity of the tree is compromised such that, for safety reasons, removal is recommended prior to any site works.

*Figure 2 (above) - Trees 3 and 4: adjacent Norway maples. (Right) - large canker and crack on Tree 3*

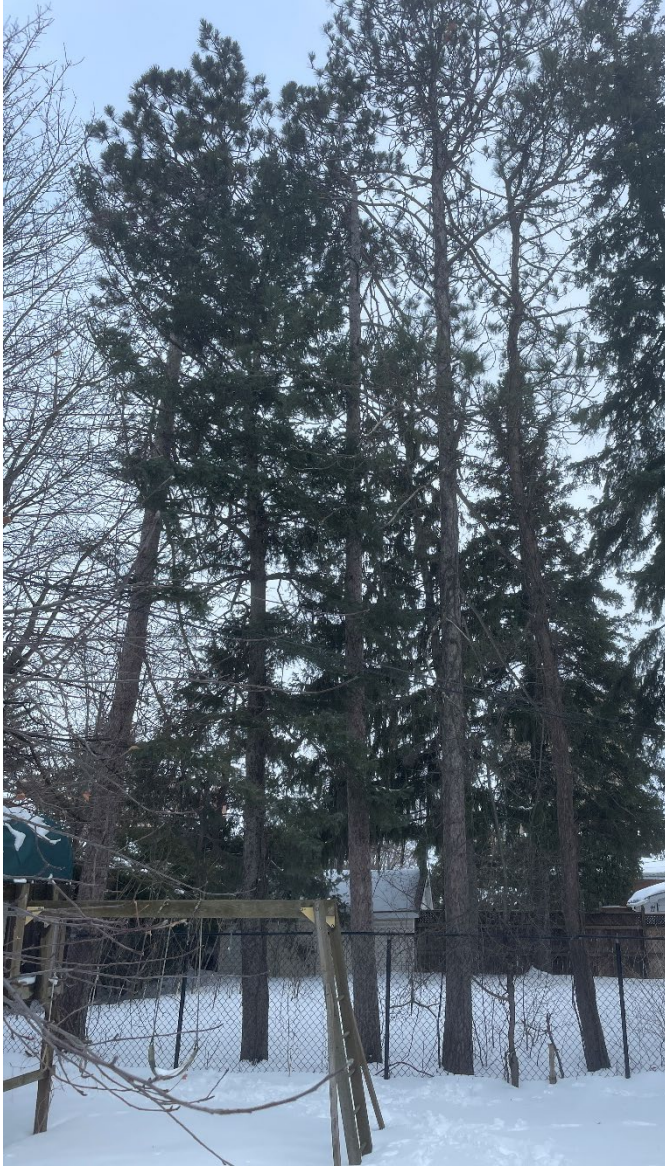
9	White spruce ( <i>Picea glauca</i> )	30 (estimate)	Adjacent – 485 Wentworth	Fair: lean; crowded	Retain	Retain and protect as per City of Ottawa Tree Protection Specifications (March 2021)
10	Red pine ( <i>Pinus resinosa</i> )	33	Adjacent – 485 Wentworth	Good/Fair	Retain	Retain and protect as per City of Ottawa Tree Protection Specifications (March 2021)
11	Norway maple ( <i>Acer platanoides</i> )	Multi-stem: 33, 34, 20	Boundary – 485 Wentworth	Fair: canker on small stem; lean towards subject property; growing around fence at base	Retain	Retain and protect as per City of Ottawa Tree Protection Specifications (March 2021)
12	Apple ( <i>Malus spp.</i> )	26 (not protected under by- law)	Private	Fair: poor form; debarking on main branch	Retain	Retain and protect as per City of Ottawa Tree Protection Specifications (March 2021)
13	Apple ( <i>Malus spp.</i> )	17 (not protected under by- law)	Private	Good	Retain	Retain and protect as per City of Ottawa Tree Protection Specifications (March 2021)

*Figure 4 (from Left to Right) - Trees 10, 9, 8, and 7*

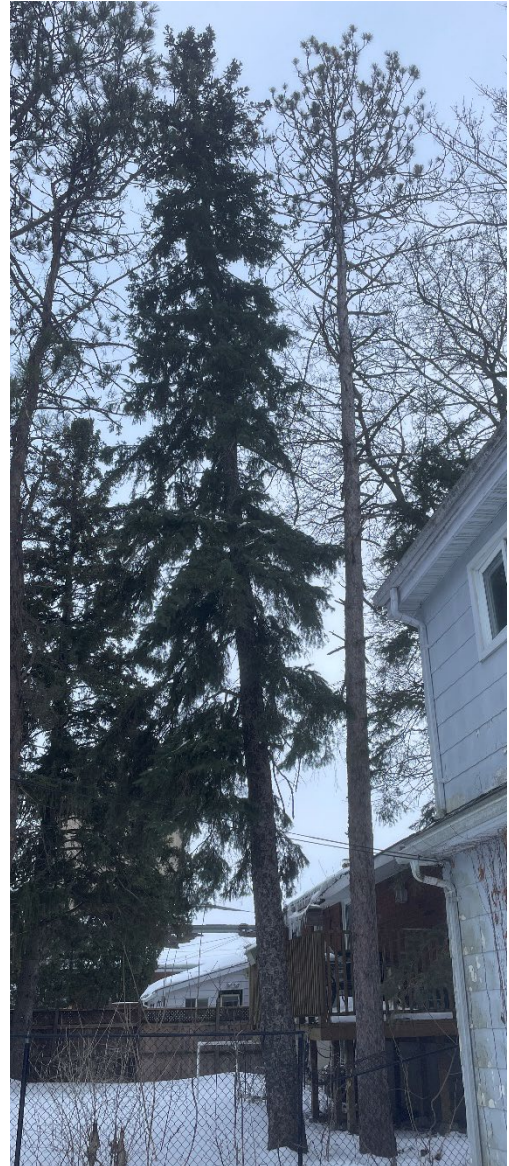
and make final determination on inspection after excavation
5	Red pine ( <i>Pinus resinosa</i> )	31	Adjacent – 485 Wentworth	Poor: extremely thin crown	Retain	Retain: explore root structure with air spade – certified arborist to assess suitability for retention and make final determination on inspection after excavation
6	White spruce ( <i>Picea glauca</i> )	37	Adjacent – 485 Wentworth	Fair: significant lean away from subject property	Retain	Retain: explore root structure with air spade – certified arborist to assess suitability for retention and make final determination on inspection after excavation
7	Red pine ( <i>Pinus resinosa</i> )	30	Adjacent – 485 Wentworth	Fair/Poor: very thin crown	Retain	Retain: explore root structure with air spade – certified arborist to assess suitability for retention and make final determination on inspection after excavation
8	Red pine ( <i>Pinus resinosa</i> )	30 (estimate)	Adjacent – 485 Wentworth	Fair: thin crown	Retain	Retain and protect as per City of Ottawa Tree Protection Specifications (March 2021)

Excavation is planned to come very close to the trunks of **Trees 2, 4, 5, 6 and 7**: a minimum distance of 1.5 - 3x the DBH is best practice (ISA BMPs on Root Management, 2017), and excavation is near or past this line for most of these trees.. However, all these trees are situated at a slightly higher grade (approx. 35cm according to the survey), and it is unclear what roots may have developed on the side of the subject property. Removal may be avoided by exploring the root development using an air spade: if few or no stabilizing roots are found, the trees may have enough support to be retained. A certified arborist should confirm stability both before and after excavation and make a final determination regarding retainability. The possibility of removal should be discussed with the adjacent property owner at 485 Wentworth prior to any root exploration.

*Figure 3 (from Left to Right) - Trees 6 and 5*

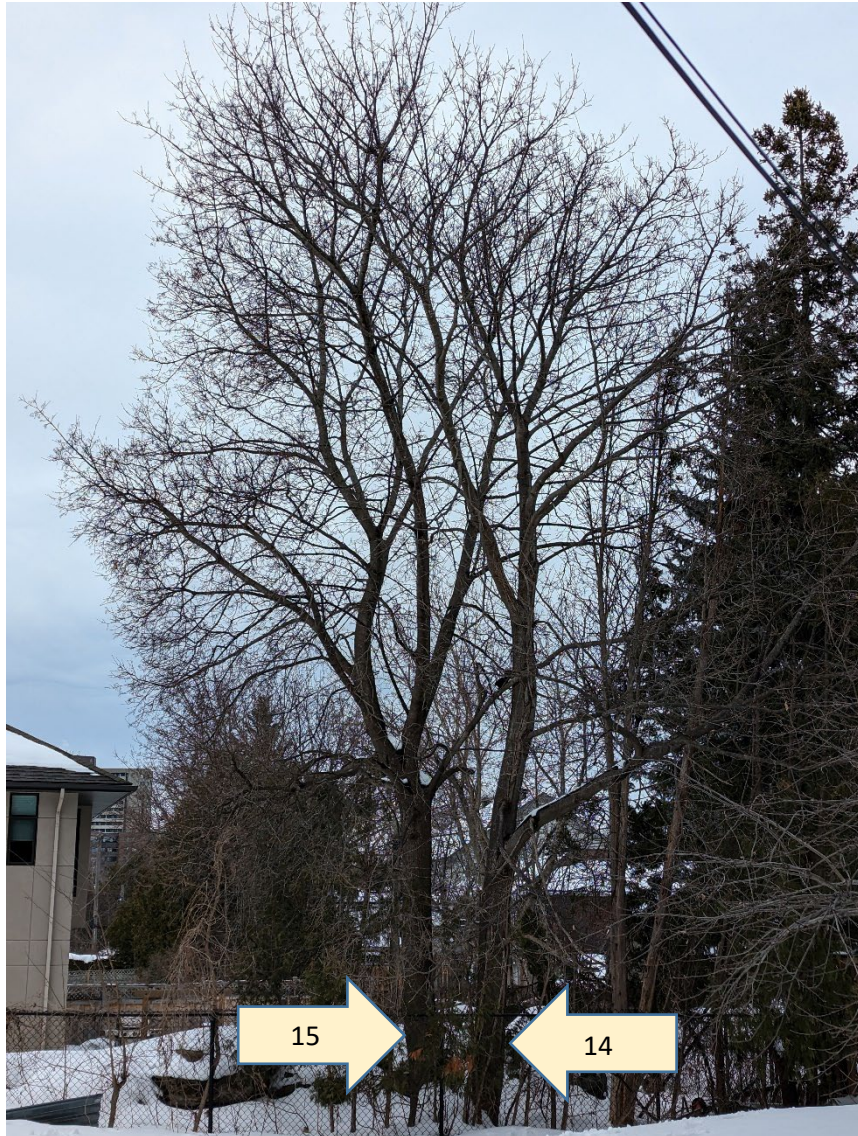
14	Norway maple ( <i>Acer platanoides</i> )	36	Adjacent – 475 Wentworth	Fair/Poor: large scar running length of bole; some deadwood in crown	Retain	Retain and protect as per City of Ottawa Tree Protection Specifications (March 2021)
15	Norway maple ( <i>Acer platanoides</i> )	40 (estimate)	Adjacent – 475 Wentworth	Fair/Good	Retain	Retain and protect as per City of Ottawa Tree Protection Specifications (March 2021)

*Figure 5 - Trees 14 and 15 - adjacent Norway maples to be retained*

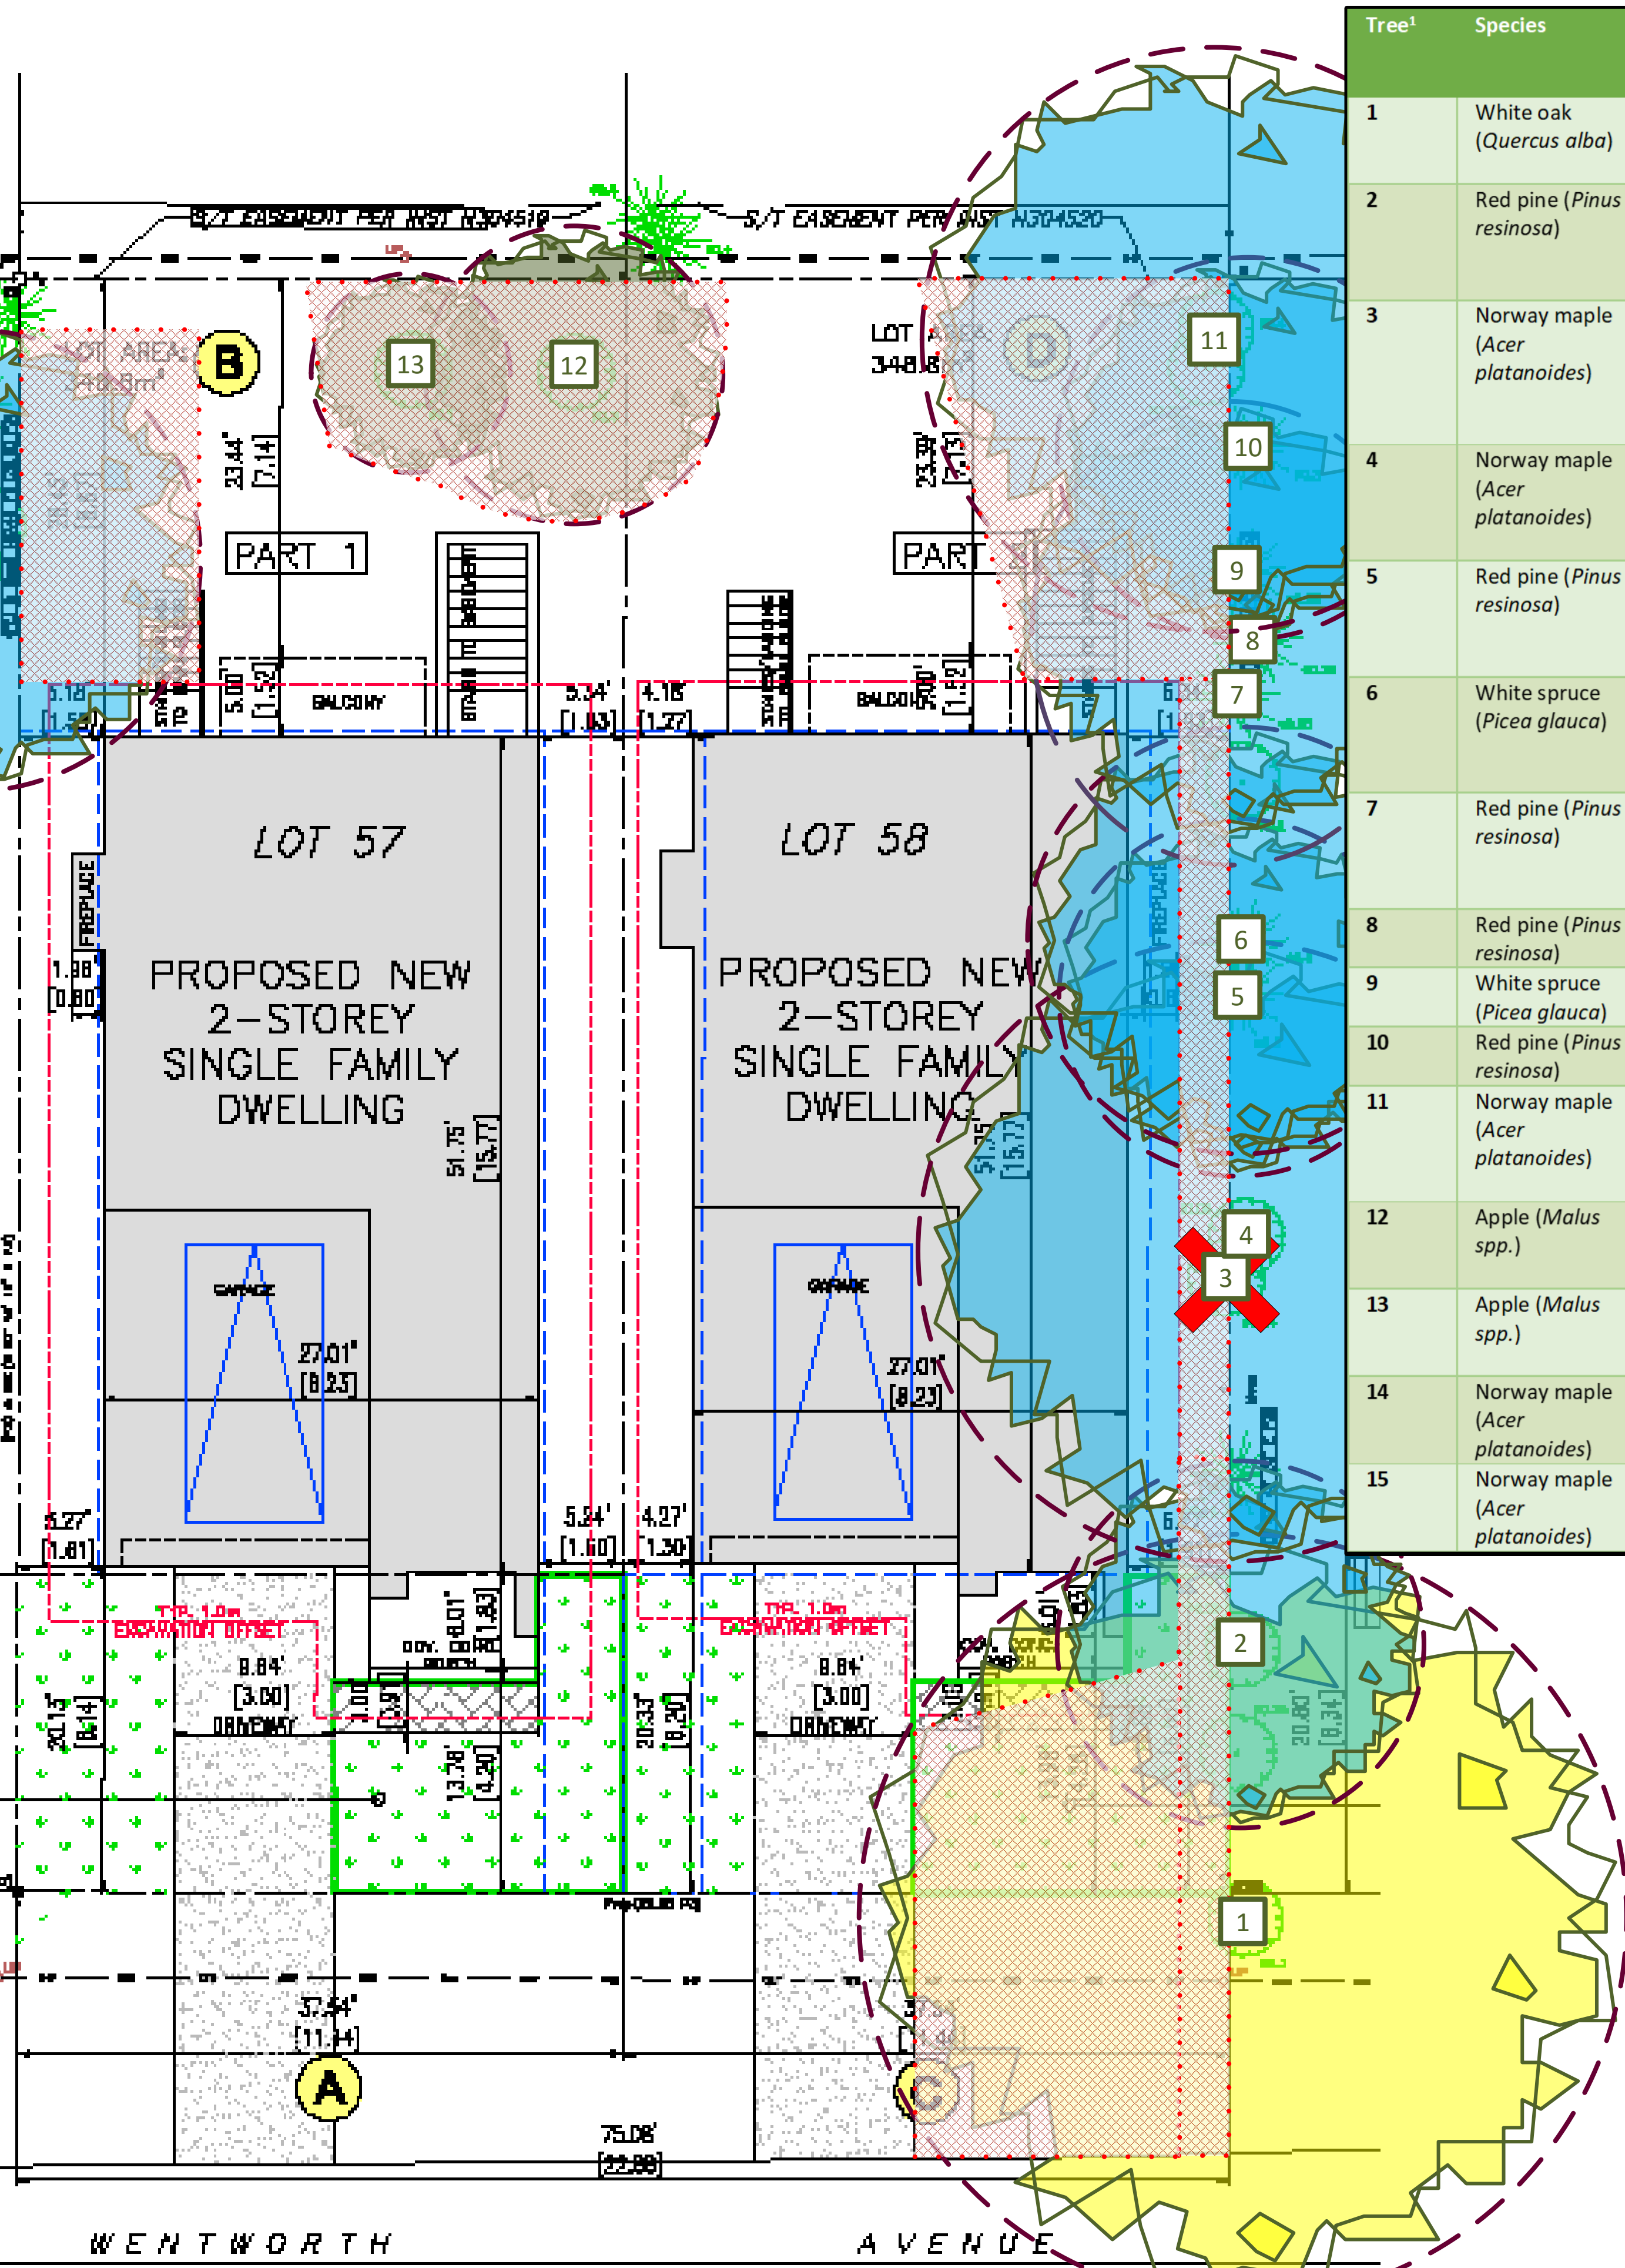
**PROPOSED SITE PLAN**  
1:150

Tree <sup>1</sup>	Species	Diameter at breast height (cm)	Ownership <sup>2,3</sup>	Condition	Recommendations
1	White oak ( <i>Quercus alba</i> )	67	City	Good/Fair: many epicormic shoots; pruned around hydro	Retain and protect as per City of Ottawa Tree Protection Specifications (March 2021)
2	Red pine ( <i>Pinus resinosa</i> )	32	Boundary – 485 Wentworth	Fair: some dieback in canopy; insect holes in stem, high crown	Retain: certified arborist to explore root structure and tree stability before and after excavation and determine suitability for retention
3	Norway maple ( <i>Acer platanoides</i> )	51	Boundary – 485 Wentworth	Poor: large canker severely reducing stem width and structural integrity; split in stem to base; lean towards subject property.	Remove prior to demolition due to poor health and safety concerns. <b>Tree permit and approval from adjacent property owner required</b>
4	Norway maple ( <i>Acer platanoides</i> )	51	Adjacent – 485 Wentworth	Fair: large split in stem; stub of large broken branch	Retain: explore root structure with air spade – certified arborist to assess suitability for retention and make final determination on inspection after excavation

5	Red pine ( <i>Pinus resinosa</i> )	31	Adjacent – 485 Wentworth	Poor: extremely thin crown	Retain: explore root structure with air spade – certified arborist to assess suitability for retention and make final determination on inspection after excavation
6	White spruce ( <i>Picea glauca</i> )	37	Adjacent – 485 Wentworth	Fair: significant lean away from subject property	Retain: explore root structure with air spade – certified arborist to assess suitability for retention and make final determination on inspection after excavation
7	Red pine ( <i>Pinus resinosa</i> )	30	Adjacent – 485 Wentworth	Fair/Poor: very thin crown	Retain: explore root structure with air spade – certified arborist to assess suitability for retention and make final determination on inspection after excavation
8	Red pine ( <i>Pinus resinosa</i> )	30 (estimate)	Adjacent – 485 Wentworth	Fair: thin crown	Retain and protect as per City of Ottawa Tree Protection Specifications (March 2021)

9	White spruce ( <i>Picea glauca</i> )	30 (estimate)	Adjacent – 485 Wentworth	Fair: lean; crowded	Retain and protect as per City of Ottawa Tree Protection Specifications (March 2021)
10	Red pine ( <i>Pinus resinosa</i> )	33	Adjacent – 485 Wentworth	Good/Fair	Retain and protect as per City of Ottawa Tree Protection Specifications (March 2021)
11	Norway maple ( <i>Acer platanoides</i> )	Multi-stem: 33, 34, 20	Boundary – 485 Wentworth	Fair: canker on small stem; lean towards subject property; growing around fence at base	Retain and protect as per City of Ottawa Tree Protection Specifications (March 2021)
12	Apple ( <i>Malus spp.</i> )	26 (not protected under by-law)	Private	Fair: poor form; debarking on main branch	Retain and protect as per City of Ottawa Tree Protection Specifications (March 2021)
13	Apple ( <i>Malus spp.</i> )	17 (not protected under by-law)	Private	Good	Retain and protect as per City of Ottawa Tree Protection Specifications (March 2021)

14	Norway maple ( <i>Acer platanoides</i> )	36	Adjacent – 475 Wentworth	Fair/Poor: large scar running length of bole; some deadwood in crown	Retain and protect as per City of Ottawa Tree Protection Specifications (March 2021)
15	Norway maple ( <i>Acer platanoides</i> )	40 (estimate)	Adjacent – 475 Wentworth	Fair/Good	Retain and protect as per City of Ottawa Tree Protection Specifications (March 2021)

Prior to any site works, protective fencing should be installed around the TPA as indicated in Map and maintained until all construction on site has been completed as per the **City of Ottawa Tree Protection Specifications (March 2021)**. Within the fenced area, the following tree protection guidelines should be applied:

The tree protection fencing must be 1.2 m in height and constructed of a rigid or framed material (e.g. modulus-steel, plywood hoarding, or snow fence on a 2"x4" wood frame) with posts 2.4 m apart such that the fence location cannot be altered. All supports must be placed outside of the CRZ and installation must minimize damage to existing roots.
