Tree Information Report

Prepared by Colleen Eames, Arborist.
Arborist Consulting Ottawa
arboristconsultingottawa@gmail.com
613-884-3394

Tree Owner	Ashwin Jain
Tree Owner's address and contact	Ashwin.jain@owlpark.ca
Address of Tree(S)	6817 Notre Dame St, Orleans
Date of Inspection:	July 22, 2021
Reason for application	Infill development
Boundary trees or trees on neighbouring properties.	Yes, see below
Regulations	None, no butternut present.

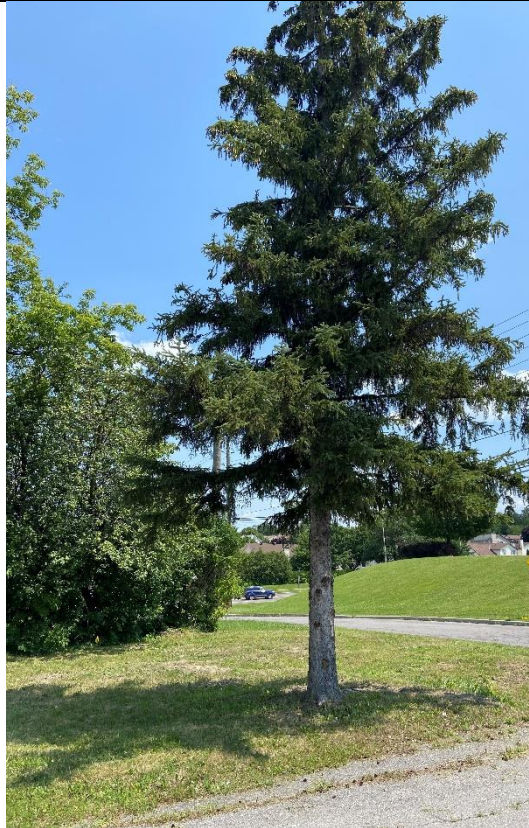
Tree #1 Spruce, 31 cm in front yard.
Remove – within excavation.

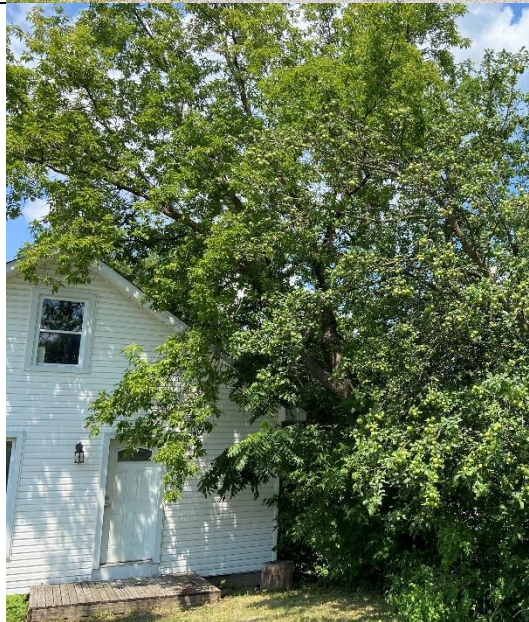
Trees #2 and #3, Apple and
Manitoba Maple in front. Remove –
within excavation.

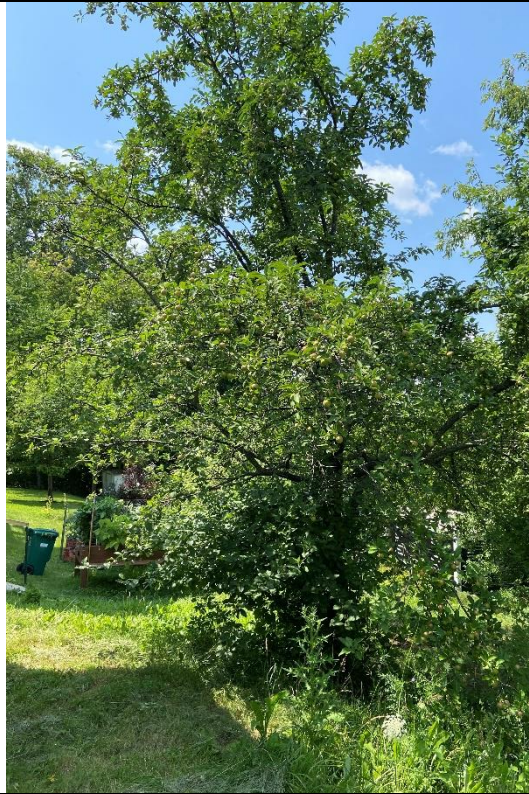
Tree #4, apple in back 24cm. Protect and retain.

- A temporary fence 1.2m high should be erected along the Critical Root Zone (CRZ) or the line of construction of the retained apple tree.. No vehicles, machinery or construction materials should be allowed within the fence. A site plan showing positions of the fence is attached, Note: the positions are approximate, and measurements should be used when placing actual fence.

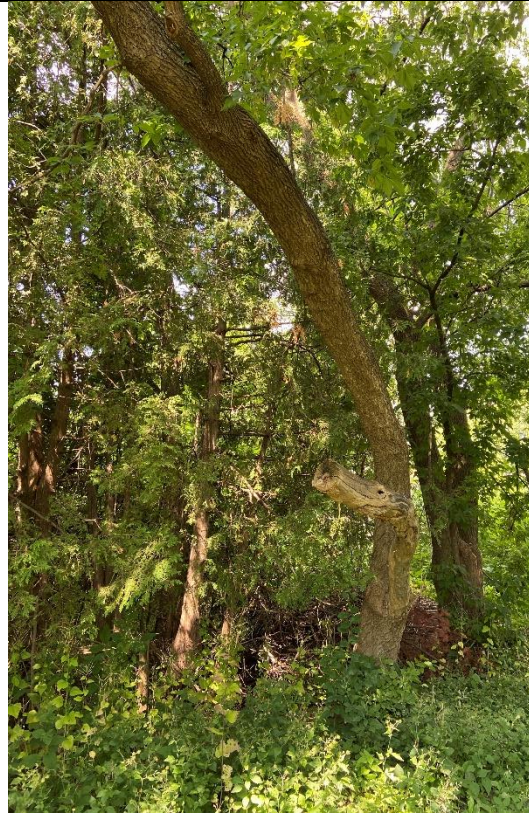
- Two spruce on neighbouring property, not affected by proposed construction.
- The property has a large number of Manitoba maples. Trees 5 and 7 are on the property border and ownership was not clear. Both trees have some structural issues including rot and structural cracks. Due to the invasive nature and poor structure of these trees, they should be removed and replaced with native species. A Tree Replacement plan is described below and illustrated on the attached site plan.
- The apple tree in the back yard is in excellent condition and should be retained if possible. A tree protection plan is outlined below in order to mitigate damage to this tree during construction and is illustrated on the attached site plan as described in the Tree Protection Plan.

Tree #5 and #7, Manitoba maples in back, #5 is heavily leaning into yard and #7 has a structural crack along the trunk to the ground. Recommended removal of both.

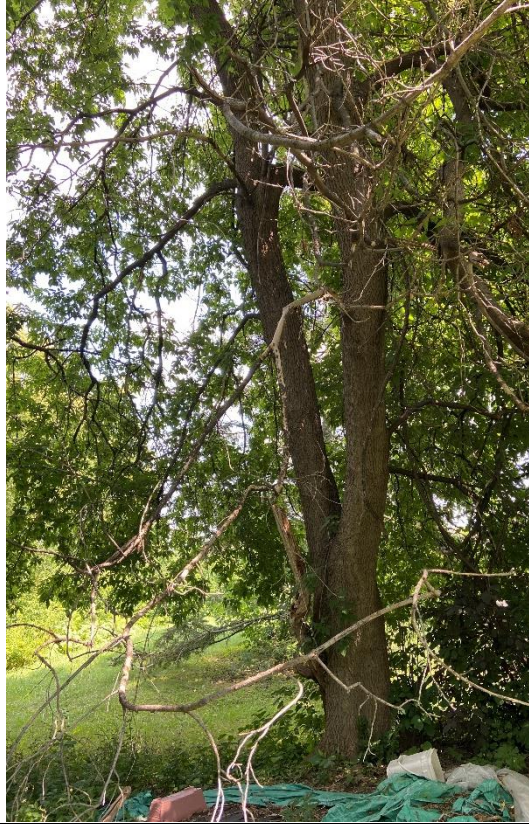
Tree #6, Manitoba maple behind existing shed in back, 67cm. Has rot at joining of two main stems and dead branches. Removal recommended.
