Tree Information Report

On May 9th 2023 at 18:00, our Certified Arborist, Caroline Goulet, completed a site and tree evaluation of 1 tree located in the backyard of 182 Keyworth Avenue, in Ottawa. The goal of the assessment is to determine if the landscaping project planned for 182 Keyworth Avenue would cause any harm to the tree in question.

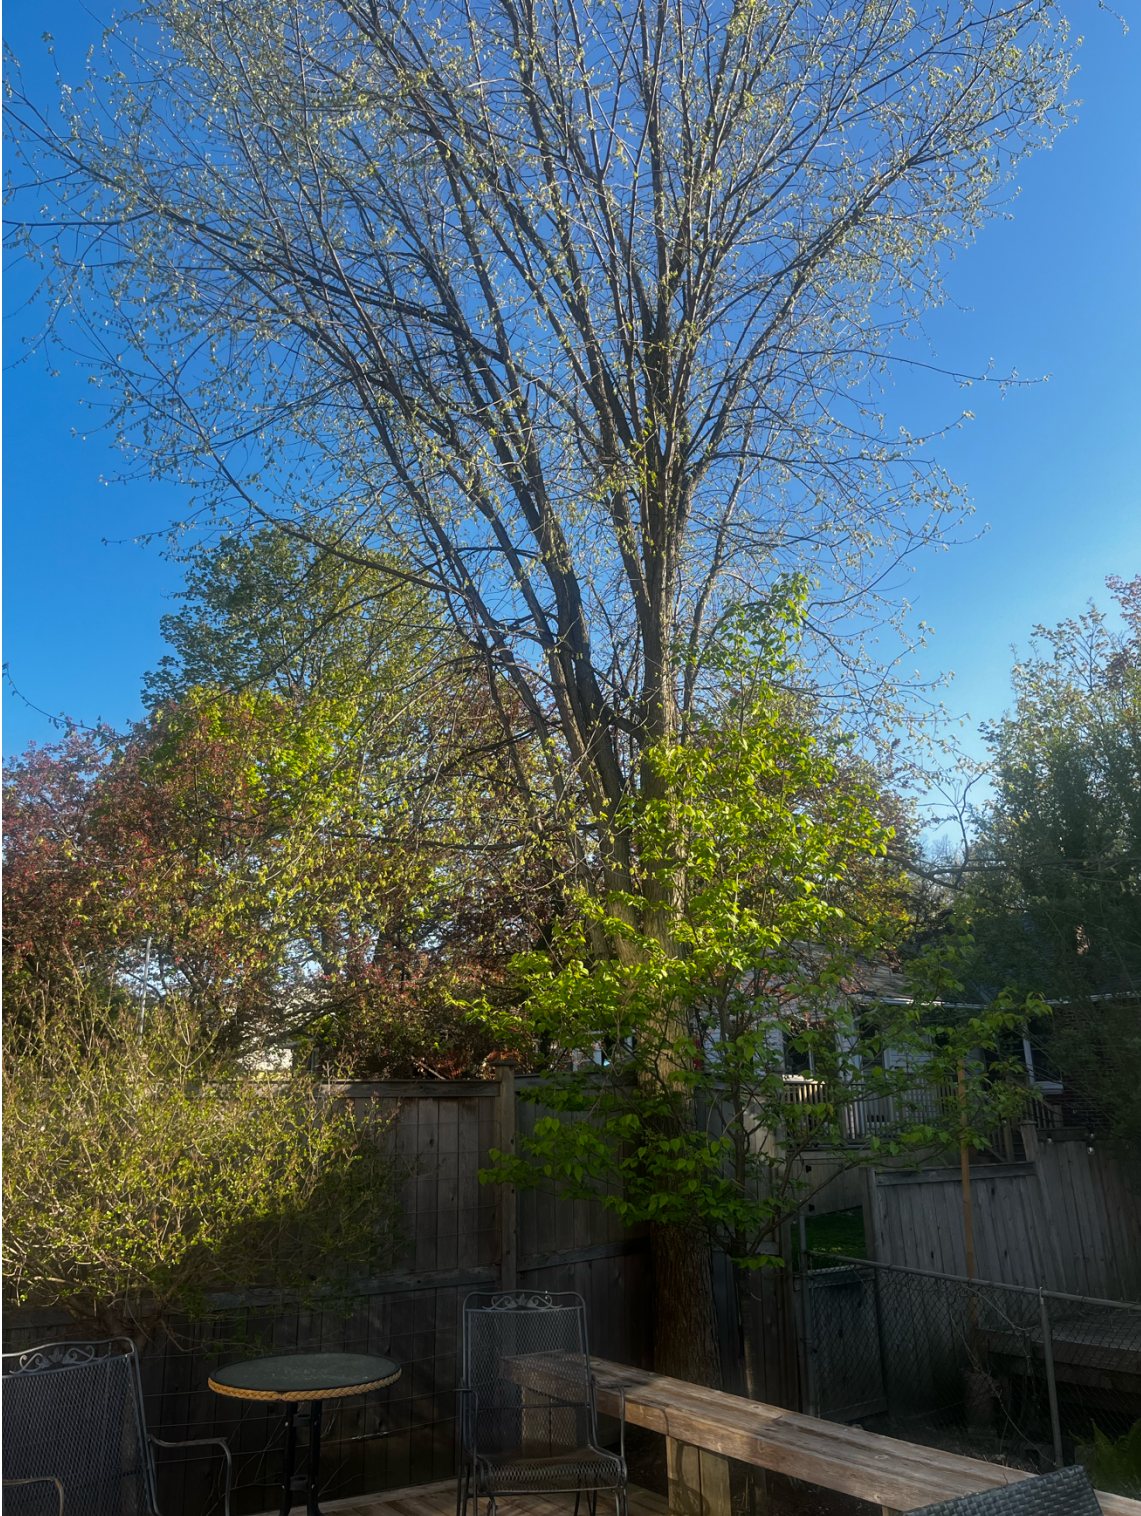
Picture 1: Overall tree

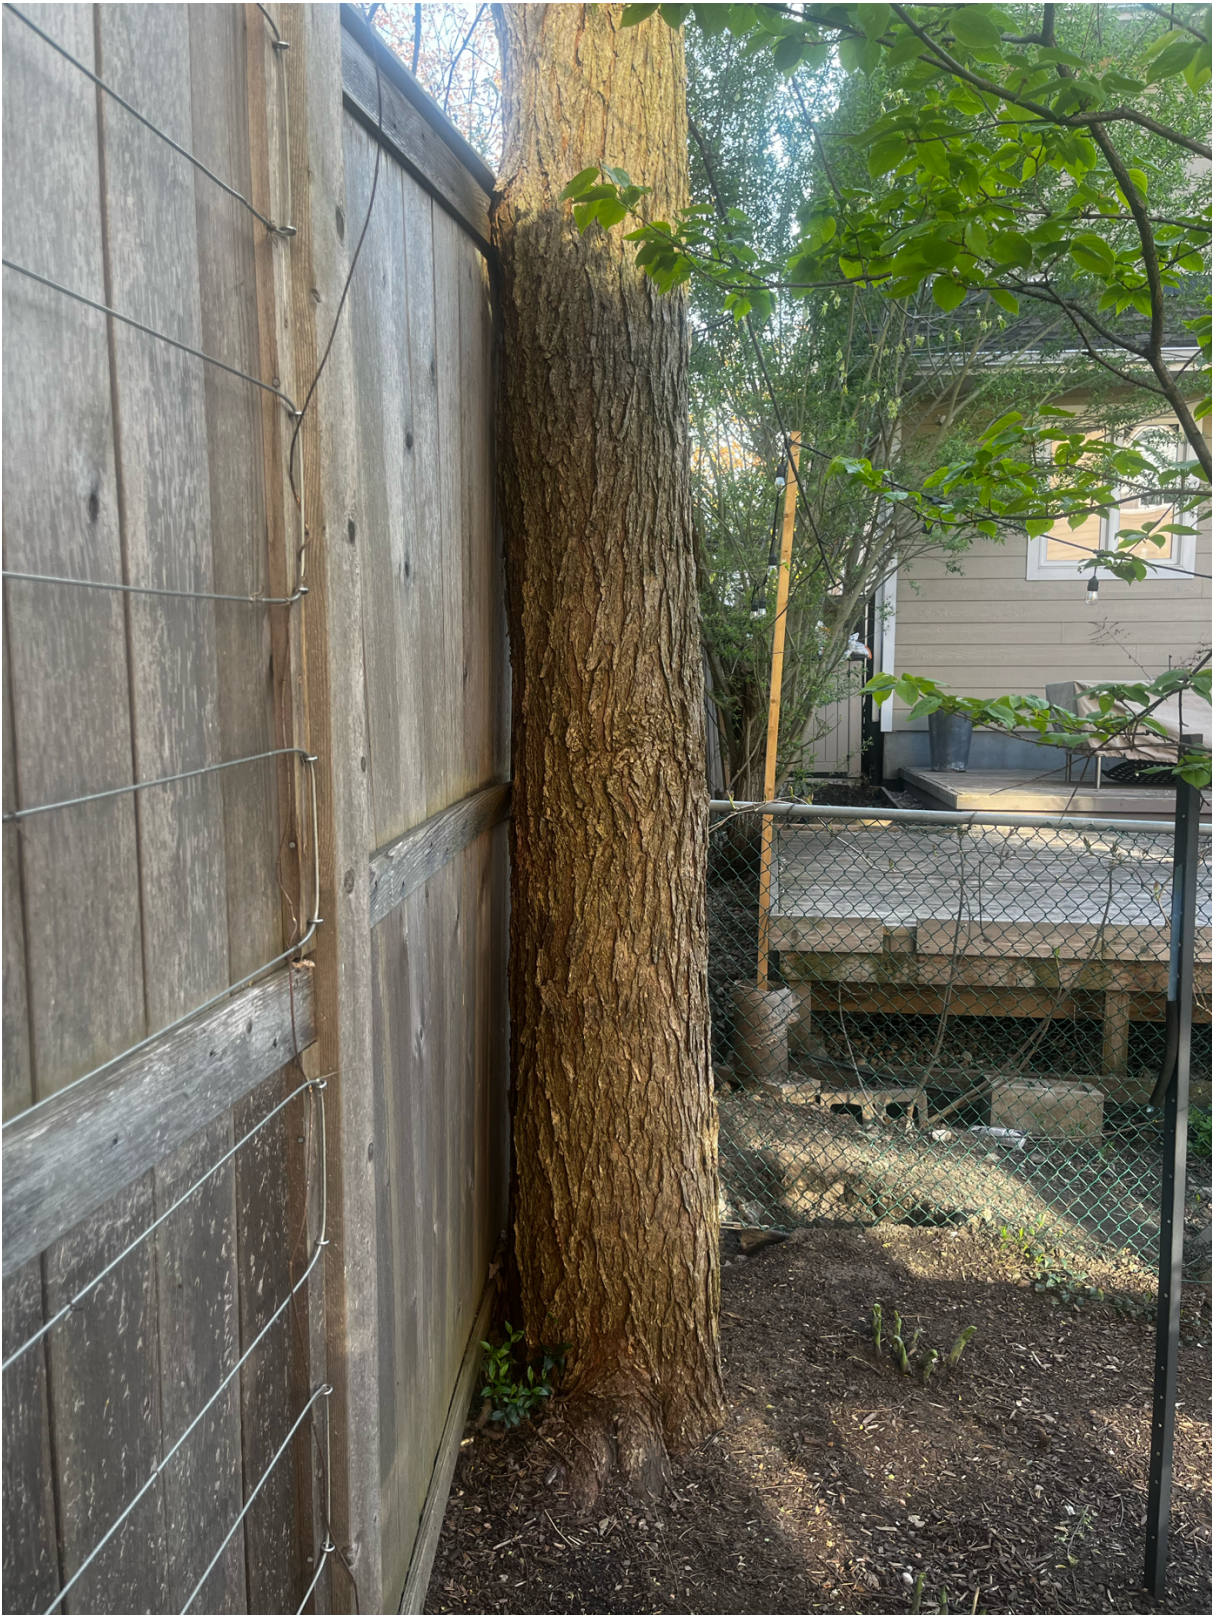
- Structural integrity: no recent limb failure, no signs of structural weaknesses, no noticeable stress cracks, no noticeable weak unions or included bark unions.
- Deadwood: very low (leaves not fully flushed)
- Vigour: excellent
- Insect infestation: no sign of beetles or any other insect
- Pathological concerns: no signs of Dutch Elm Disease or any other infection
- Sign of decay: no signs of decay or fruiting bodies
- Lean: none (straight)
- Signs that the tree is causing damages to any structures: none
- Signs that structures are causing damages to the tree: south fence between 182 Keyworth Ave. and southern neighbour; minor damage to the trunk (refer to picture in Schedule B).

Picture 2: Trunk and minor defect to the tree trunk caused by the southern fence

Not related to the landscaping work planned to be completed, but it is recommended that the fence should either be lowered around the tree trunk or moved to avoid further damage to the tree. Additionally, preventive measures are recommended in order to prevent the Dutch Elm Disease infection. Arbotect 20-S is a systemic fungicide that can be applied into the vascular system to prevent the infection. The landowner or property manager can contact us for further details.

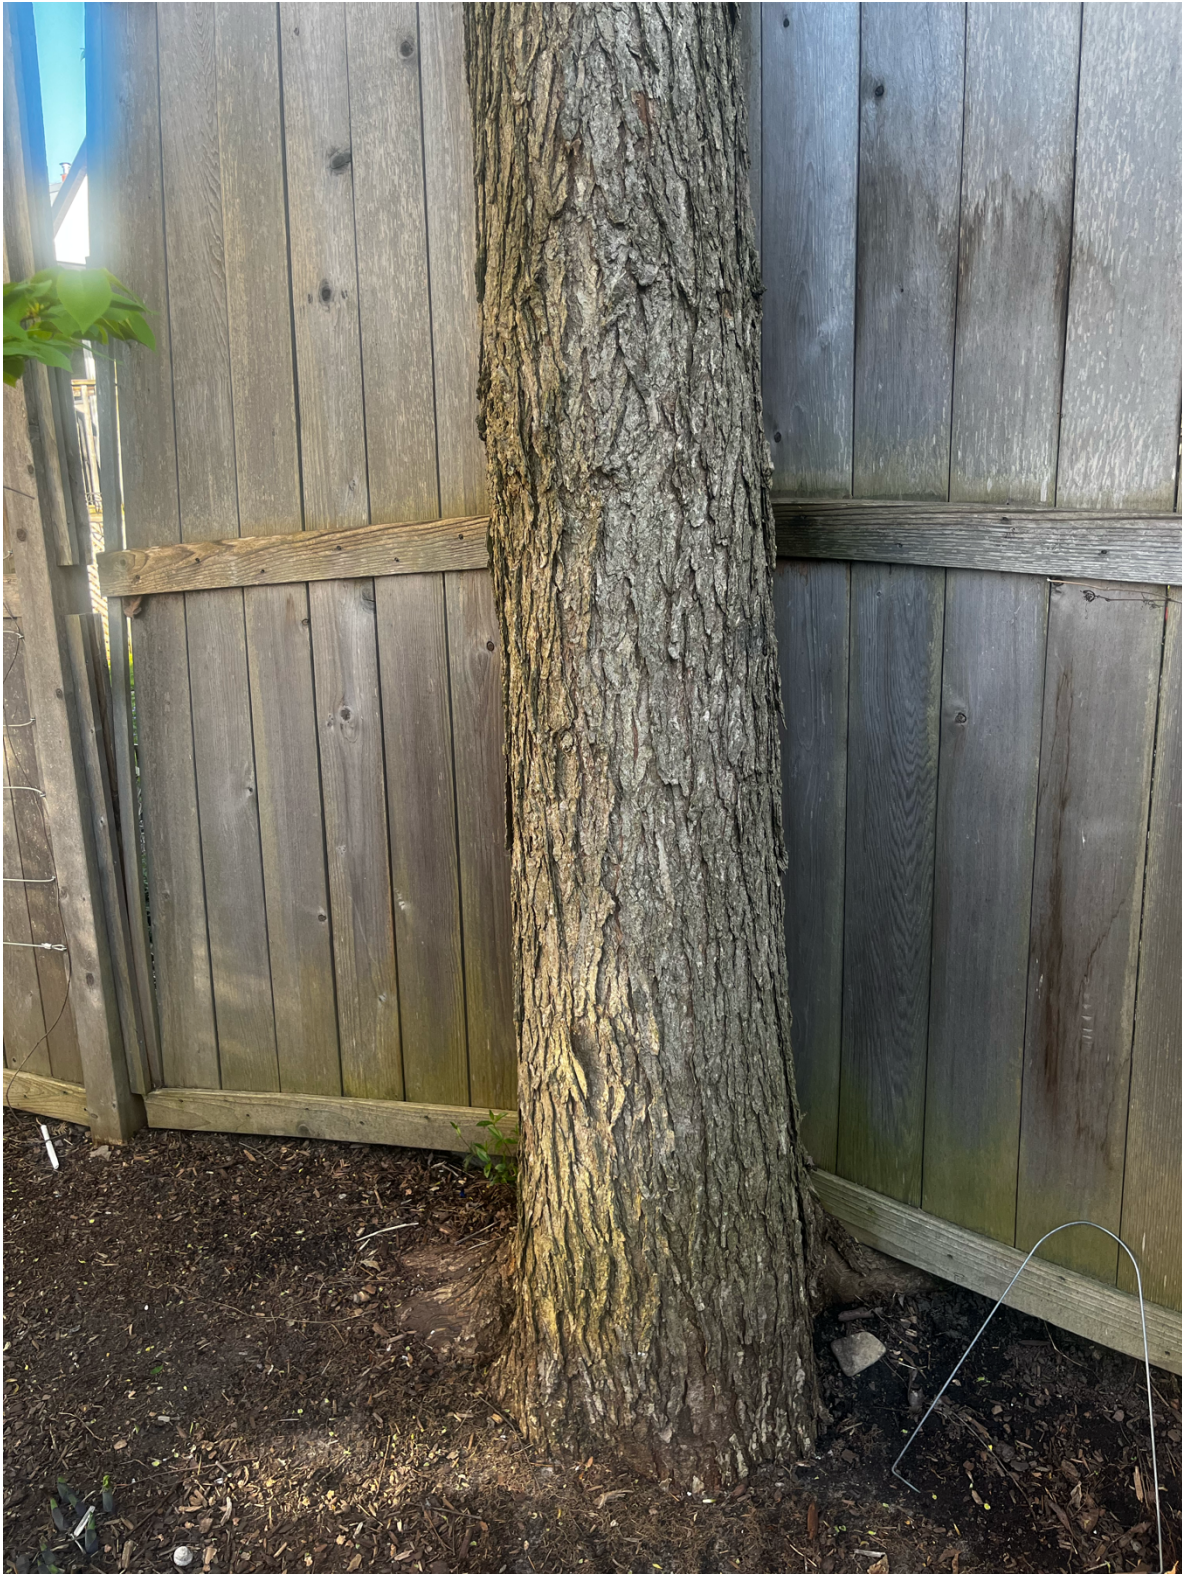
Picture 3: Trunk and base of tree

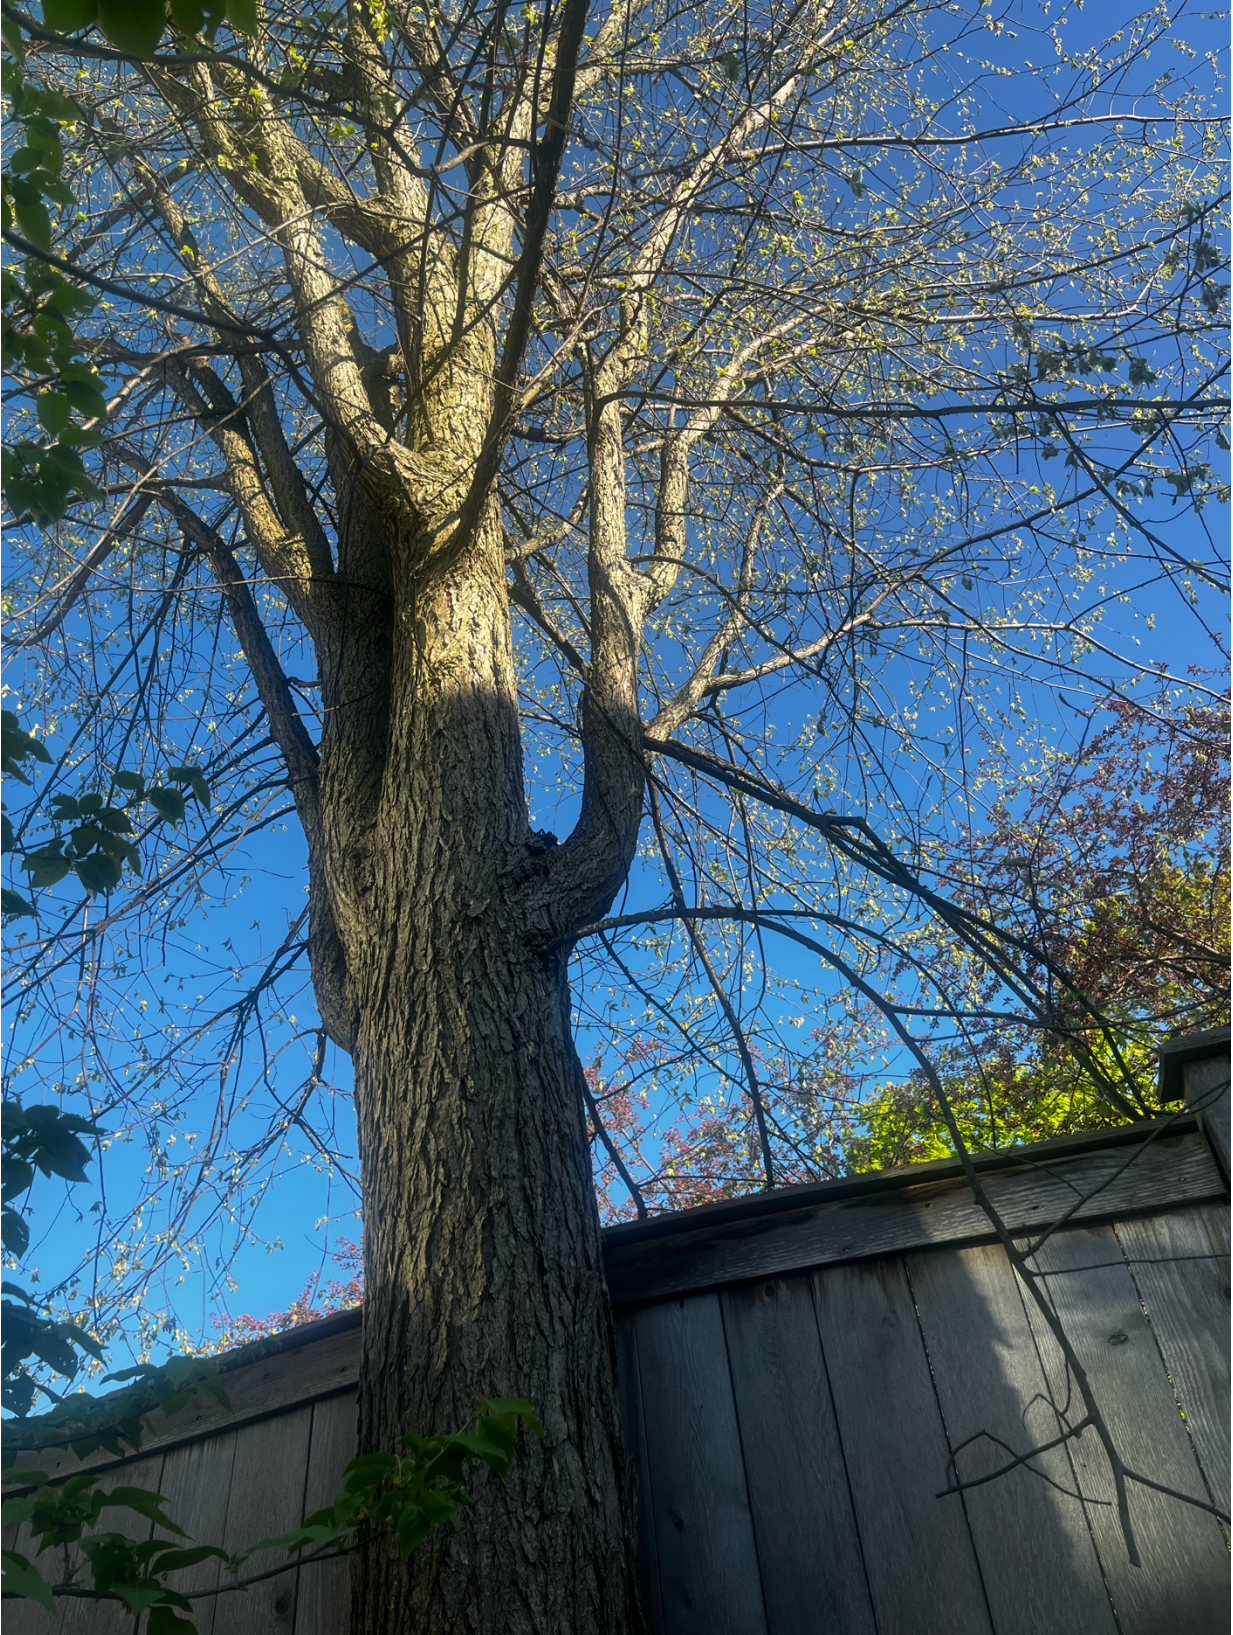
Picture 4: Branches and canopy (from under)

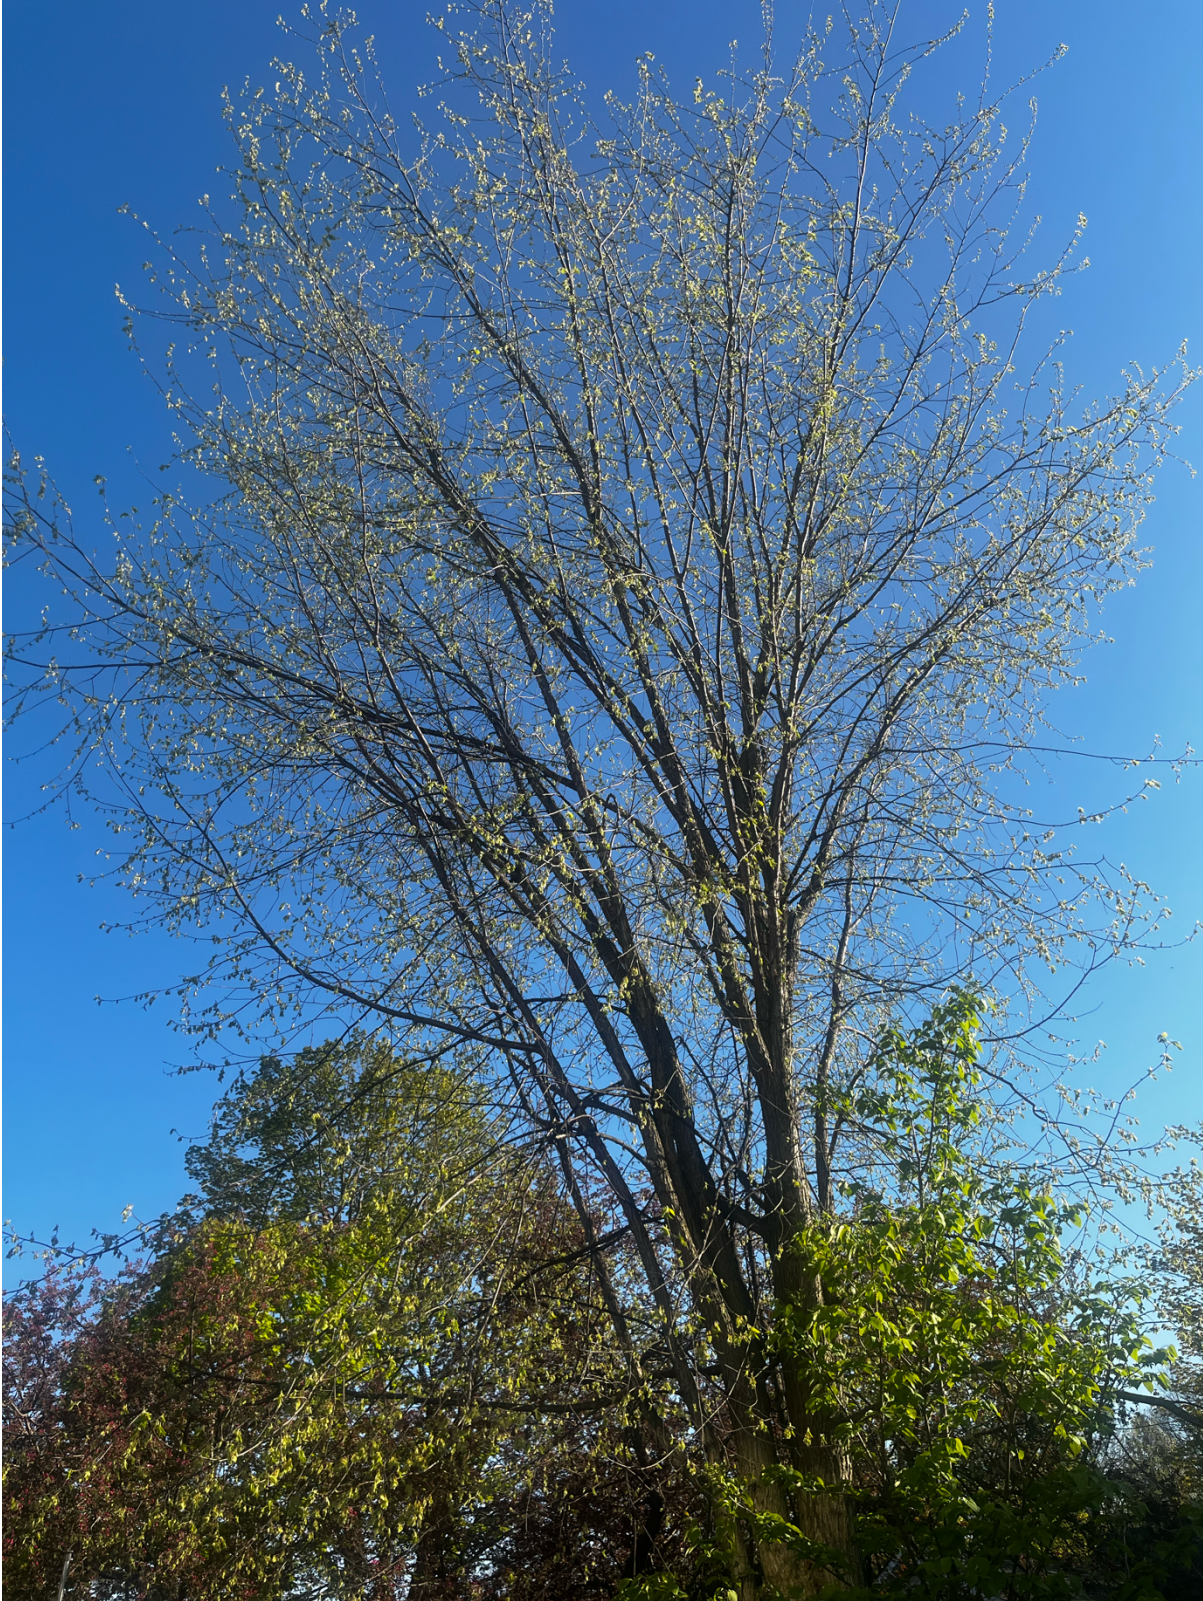
Picture 5: Branches and canopy (from side)

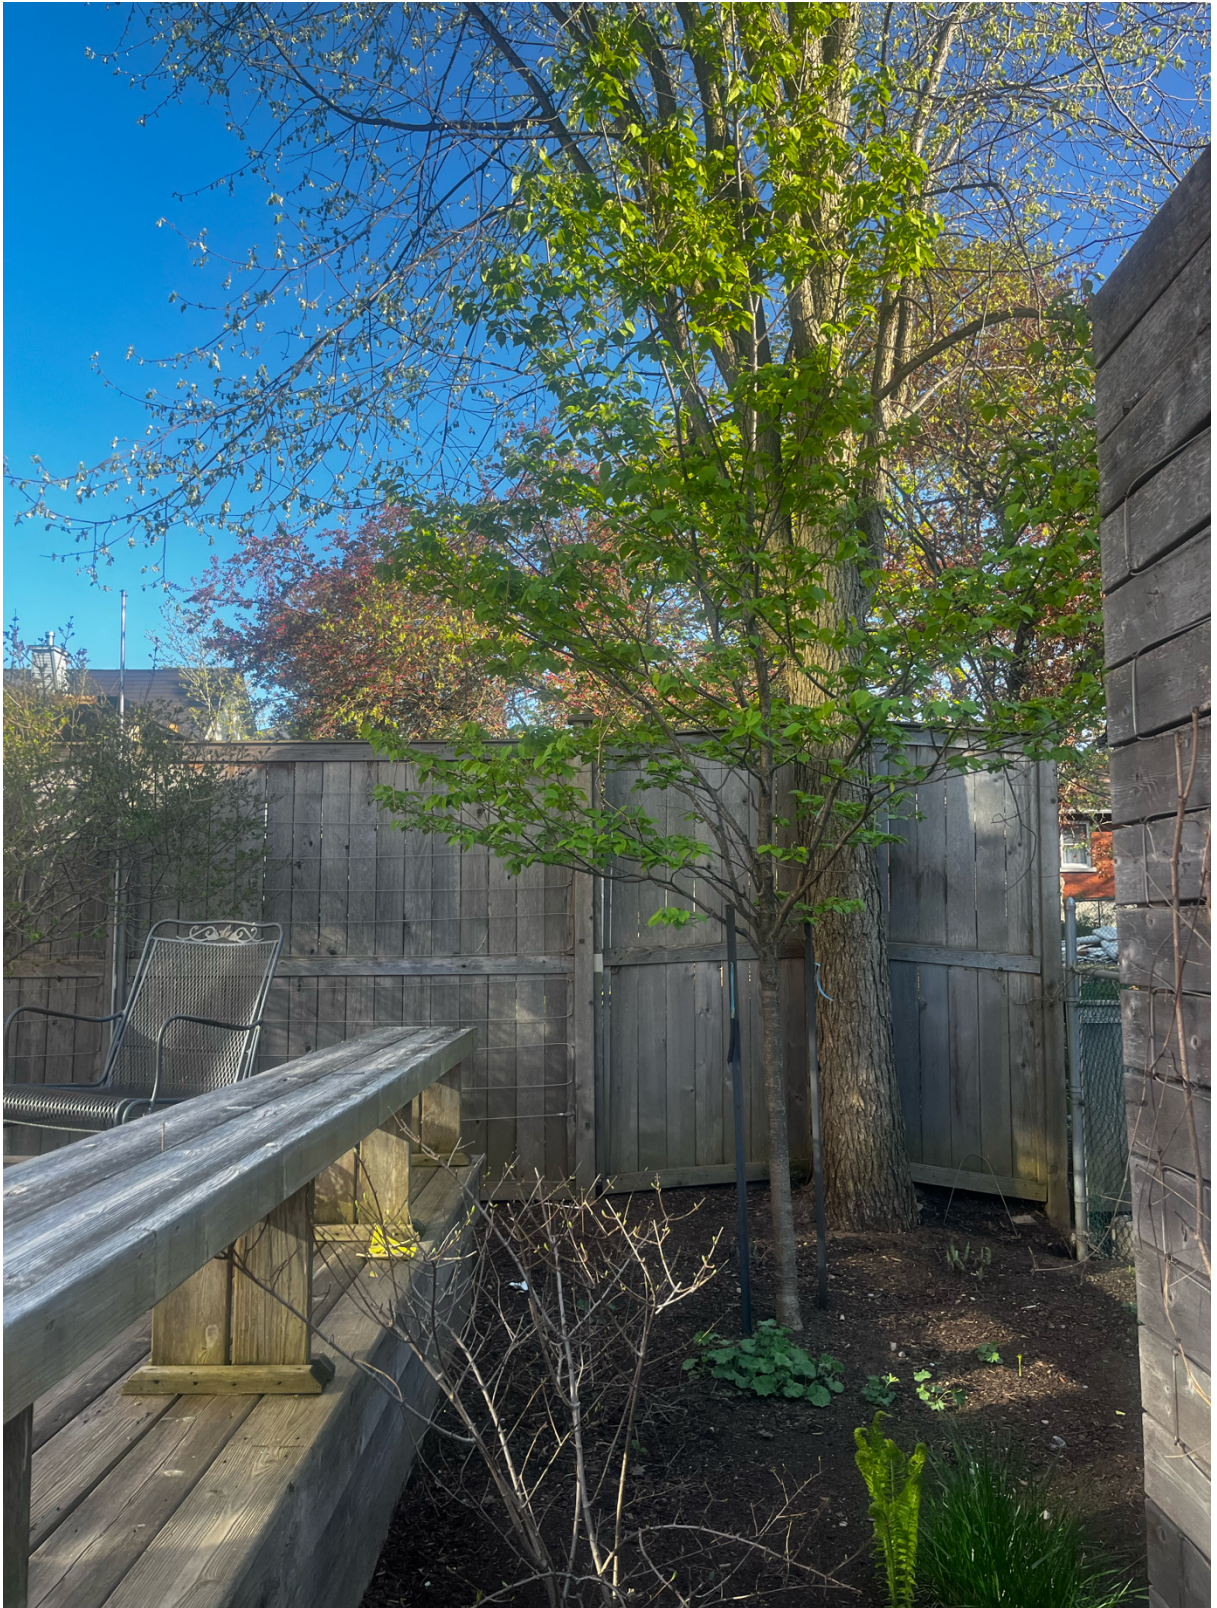
Picture 6: Tree location and deck
