TREE INFORMATION REPORT FOR 57 MURIEL STREET, OTTAWA

Prepared by Sid Thakar, OALA, Thakar Associates Design Consultants
February 22, 2023

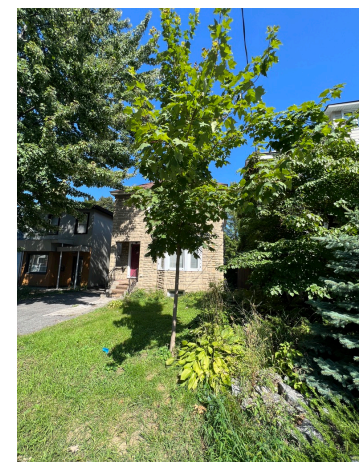
Tree #1

The only existing vegetation of significance on the subject site is a single Sugar Maple *Acer saccharum* (Tree # 1) approximately 70mm cal. in good condition located at the south-west of the property in the front yard. The rest of the property has a variety of weedy and shrubby growth, including a multi stemmed Common Lilac *Syringa vulgaris* shrub approx. 3m in height and in fair condition at the southeast corner of the site on the property line. A small Eastern Cedar *Thuja occidentalis* shrub in poor condition is also growing along the property line adjacent to the lilac bush. The CRZ of this tree is approx. 2 m in diameter.

Tree #1: The existing 50mm Sugar Maple (Tree # 1) will have to be removed as it will be in direct conflict with the proposed driveway location and related construction activities.

Compensatory planting: Due to the removal of Tree # 1, a replacement 50mm cal. Sugar Maple (*Acer saccharum*) will be planted 1.5m away from the edge of the new driveway as shown on the plan.

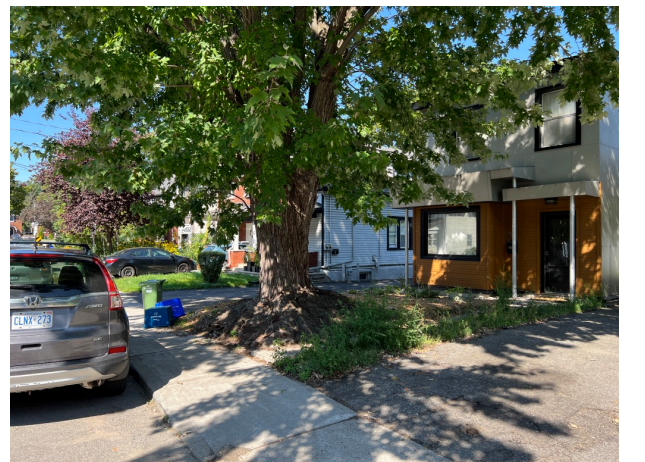
Tree #2

Tree # 2 Silver Maple: This is a 80cm DBH Silver Maple *Acer saccharinum* on 53 Muriel Street located just north of the existing driveway on the subject site and approx. 2.0 m from the property line. This massive tree is in good condition but has a pronounced root mass girdling the base of the tree that is approximately 80 cm higher than surrounding grade. The existing driveway has cut into the edge of this root mass but appears not to have affected the health or survivability of the tree. The CRZ of this tree is approx. 8m in diameter.

Tree #2: With proper protection during construction the large existing Silver Maple will not be significantly affected. Silver Maples are well adapted to urban conditions and site changes, so the long term survival of this tree should not be a concern.

The Silver Maple (Tree # 2) is a major concern for foundation damage because of its aggressive roots and its proximity to the buildings, and in any case, it is quite tolerant of disturbances around its roots. Retaining the existing driveway in its present location is not advisable as the aggressive surface roots of the Silver Maple will more than likely damage the asphalt.

Protection Measures: Excavation will be approx 6 m from this tree which will be just outside the CRZ; however a Tree Protection Fence should be installed prior to start of construction at the location indicated on the plan to ensure protection of the tree and its roots (see City of Ottawa Tree Protection Measures described on the plan)

Tree # 2: The actual site conditions at the time of excavation will determine the specific actions that will be taken to protect roots. The area around the base of Tree # 2, including the existing driveway materials and the soil surrounding the roots, will be excavated BY HAND, under the supervision of a certified arborist to identify and isolate the roots to the required depth (estimated to be approx. 30 cm). The exposed roots will be kept moist with a covering of moist burlap while root pruning and associated branch pruning is carried out to minimize conflict with existing roots and foundation of the proposed unit. This can only be estimated at this time because it is not possible to predict what actual site conditions will be. Once the root pruning is completed the whole excavated area will be backfilled with imported topsoil in 15 cm layers and lightly compacted to prevent excessive settlement and compaction around root zone. The area will be brought up to the prescribed finished grade and sodded. The affected area will be kept watered throughout the construction period to ensure optimum moisture availability for the roots and the sod.

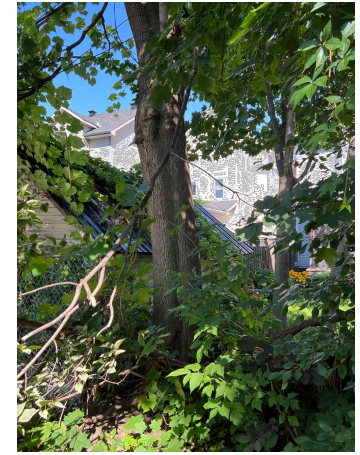
Tree #3

Tree # 3 Norway Maple: This is a 40cm DBH Norway Maple *Acer platanoides* located on 42 Gordon St to the rear of the subject site and approx. 10 cm from the property line. This tree is in good condition and has a CRZ approx. 4.0m in diameter.

The other tree at the back is a Norway Maple (Tree # 3) and it is not significantly affected by the corner of the garage encroaching into a very small section of its CRZ. The conflicts with the CRZ of the Red Maple (Tree # 4) is unavoidable because of the new driveway location, hence the protection fence will have to be located at the property line.

Tree # 3: The proposed garage is slab on grade, so there will be very minimal disturbance to the CRZ. The tree protection fencing in this case can be located about a metre from the edge of the slab to minimize any impact on the CRZ area.

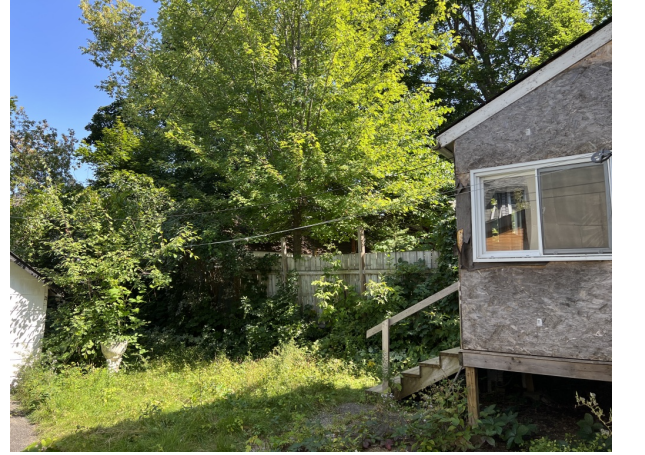
Tree #4

Tree # 4: This is a 20cm DBH Red Maple *Acer rubrum* about 1.2 m south of the subject property in the rear yard of 59 Muriel St. It has a CRZ of 2 m. This tree is in good condition, but it is far enough away from the property line that any excavation or grade changes are unlikely to have any noticeable impacts on its health or survivability.

Tree #4: The Norway Maple on the adjoining property 59 Muriel St is not expected to be affected by the proposed development as no major excavation or grade change except the driveway is proposed in the vicinity of these trees. Tree protection measures including standard snow fencing at the property line should be adequate; however additional measures to protect exposed roots, if required, as per attached City of Ottawa Tree Protection Measures described on the plan.
