# **Tree Information Report**

## Submitted as part of Committee of Adjustment Application to the City of Ottawa

Address: 672 Denbury Avenue

**Date of Report:** May 4, 2023

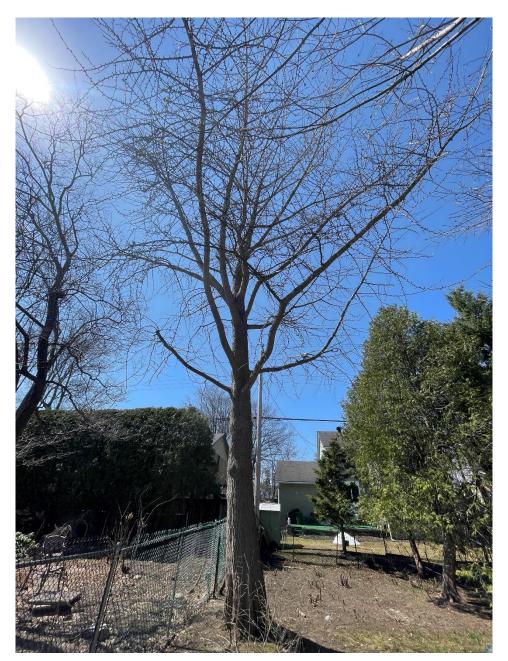
Figure 1 - Tree 5 private ginkgo to be retained.

No development has been proposed for this site at this time. When development is proposed, grading may make tree retention difficult: the areas south and east of the indicated retaining wall (see Tree Information Map) are approximately 1m below the grade of the existing building. Raising the grade within a tree's Critical Root Zone (CRZ) by more than 10cm can cause the tree stress. Due to its size and relative uniqueness, **Tree 5** is of high value for retention, and, if possible, future development should limit grade changes within its CRZ. **Tree 5** is also close to the zoned building envelope and in order to protect this tree successfully, excavation for the new home should be at least 3 m from the edge of the trunk.

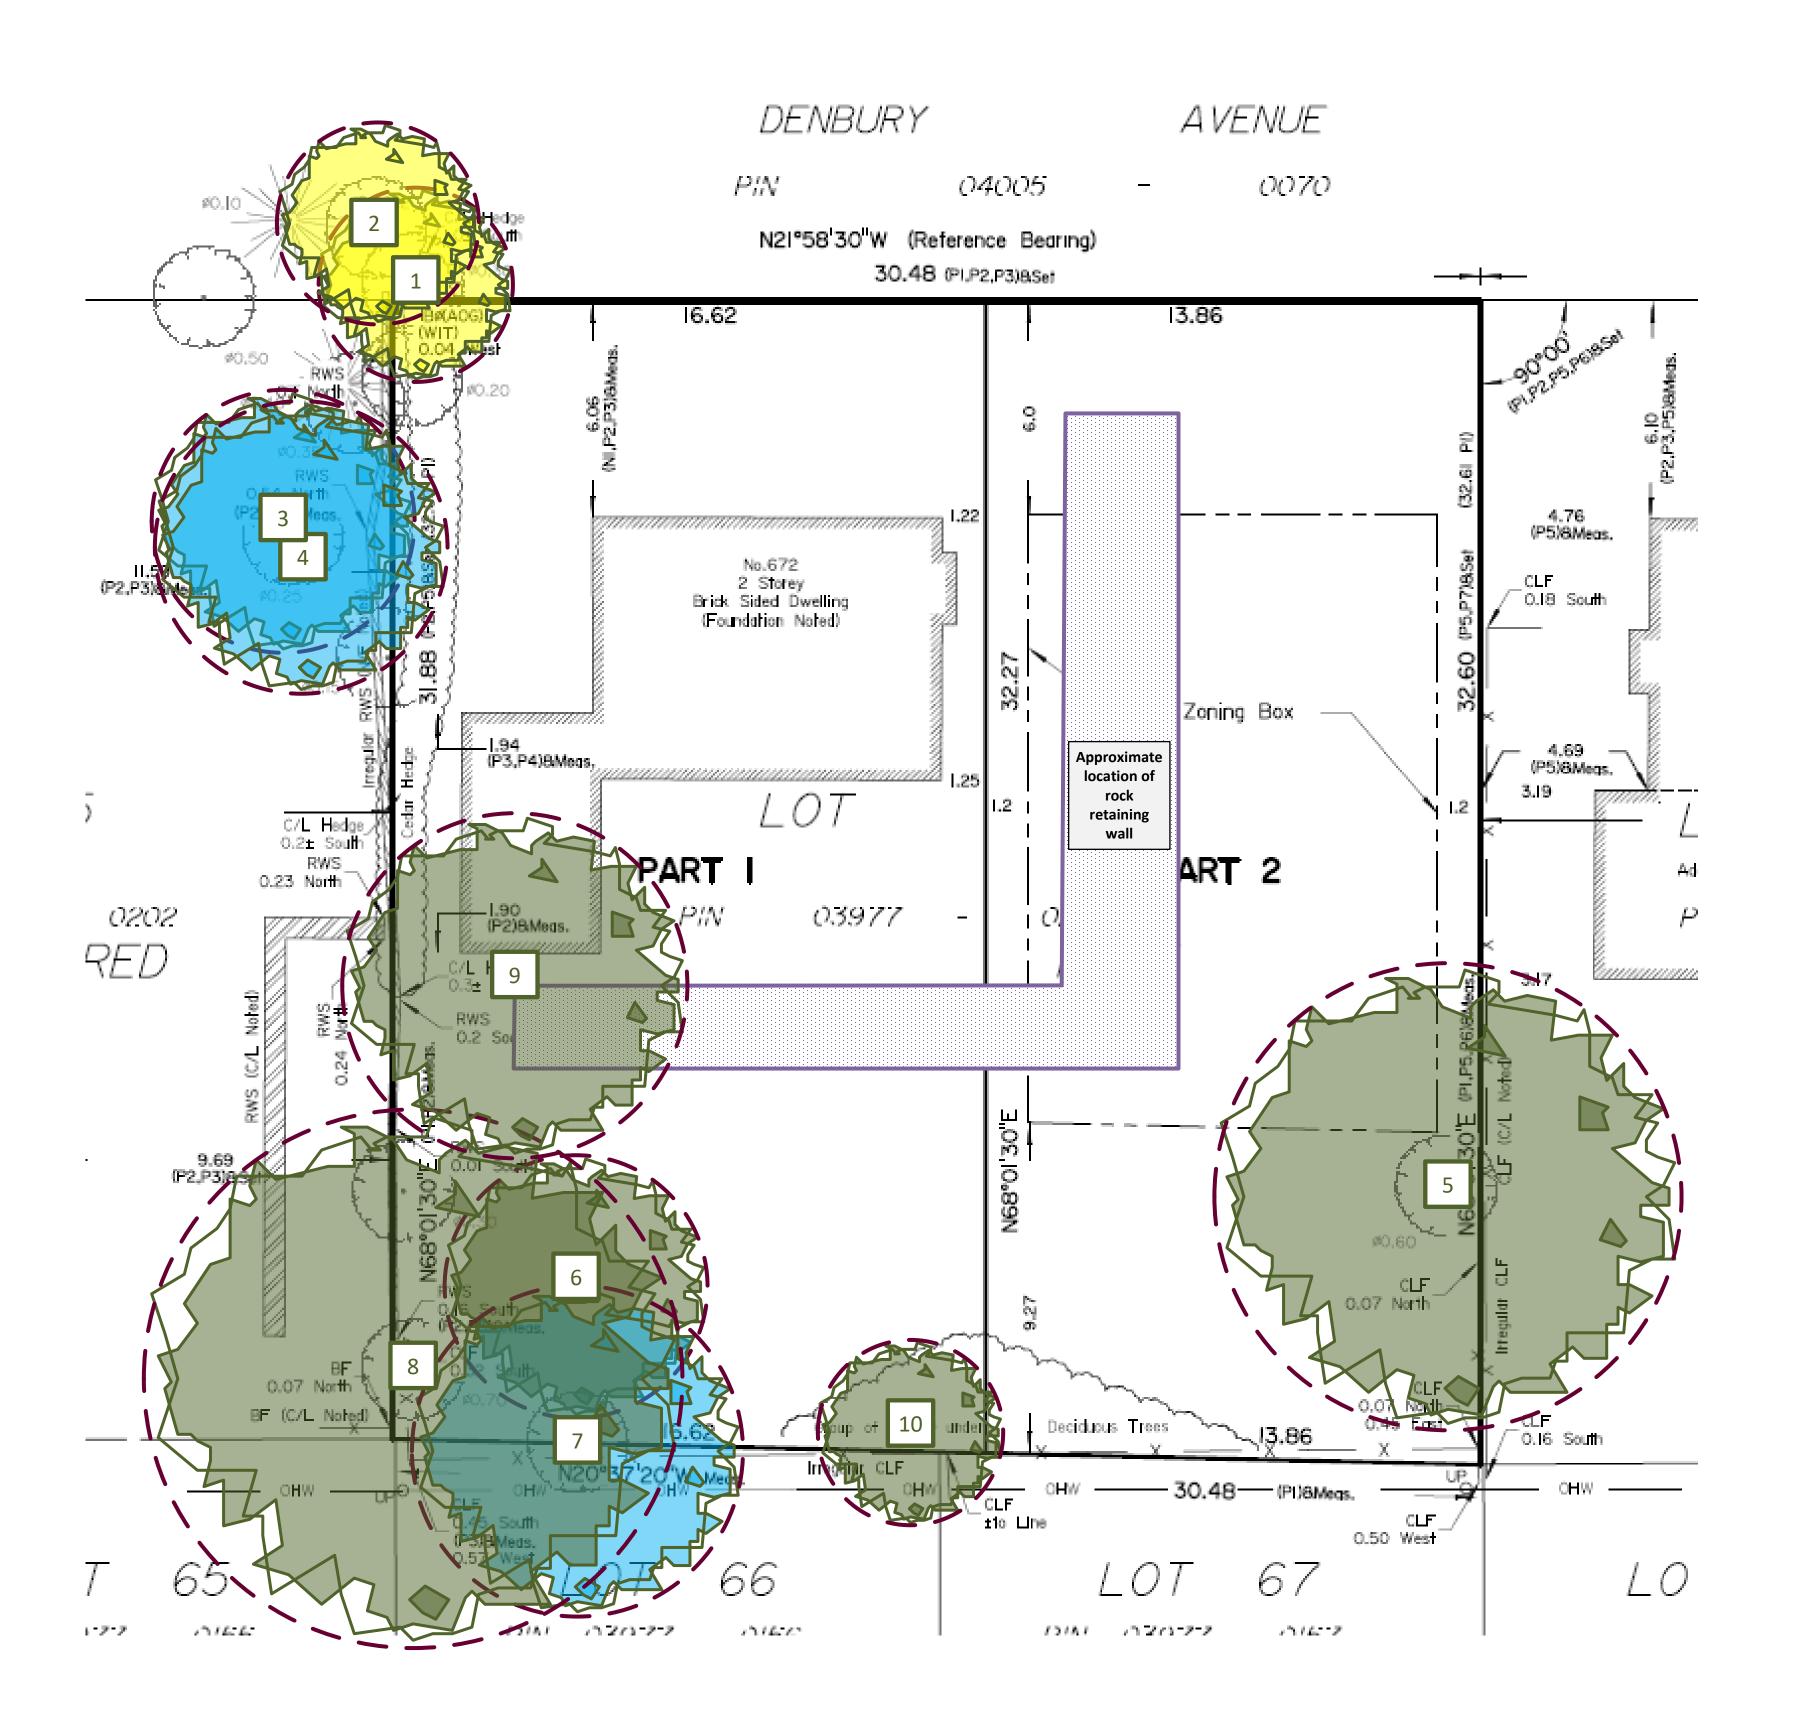
Tree Information Report – 672 Denbury Avenue Tree layer prepared by Dendron Forestry Services Version 1.0, May 4, 2023 For more information, please contact info@dendronforestry.ca

Tree <sup>1</sup>	Species	DBH (cm)	Condition	Forester recommendation
1	Sugar maple (Acer saccharum)	25	Good/Fair	No action required at this time: no development proposed for this part.
2	Sugar maple (Acer saccharum)	20, 16	Fair: asymmetric crown	No action required at this time: no development proposed for this part.
3	Basswood (Tilia americana)	34	Fair: heavy lean towards subject property	No action required at this time: no development proposed for this part.
4	Basswood (Tilia americana)	38	Good	No action required at this time: no development proposed for this part.
5	Ginkgo (Ginkgo biloba)	61	Fair: some epicormic shoots in canopy; lean at base – straightening at top; sapsucker holes	Retain and protect. Future building design to take tree into account.
64	White spruce ( <i>Picea</i> glauca)	34	Fair: lean towards existing home	No action required at this time: no development proposed for this part.

7	Manitoba maple ( <i>Acer</i> negundo)	43	Poor: sprouts at base and epicormic shoots throughout; heavily pruned under wires; poor form	No action required at this time: no development proposed for this part.
8	Manitoba maple ( <i>Acer</i> <i>negundo</i> )	70	Fair: heavy lean towards 662 Denbury	No action required at this time: no development proposed for this part.
94	Eastern white cedar (Thuja occidentalis)	40, 20	Fair/Good: woodpecker holes in bole	No action required at this time: no development proposed for this part.
<b>10</b> <sup>4</sup>	Ironwood (Ostrya virginiana)	24	Good	Not protected under bylaw 2020-340 but of high value for retention
