Tree Information Report

Submitted as part of Committee of Adjustment Application to the City of Ottawa

Address: 176 Holmwood Avenue

Date of Report: April 10, 2023

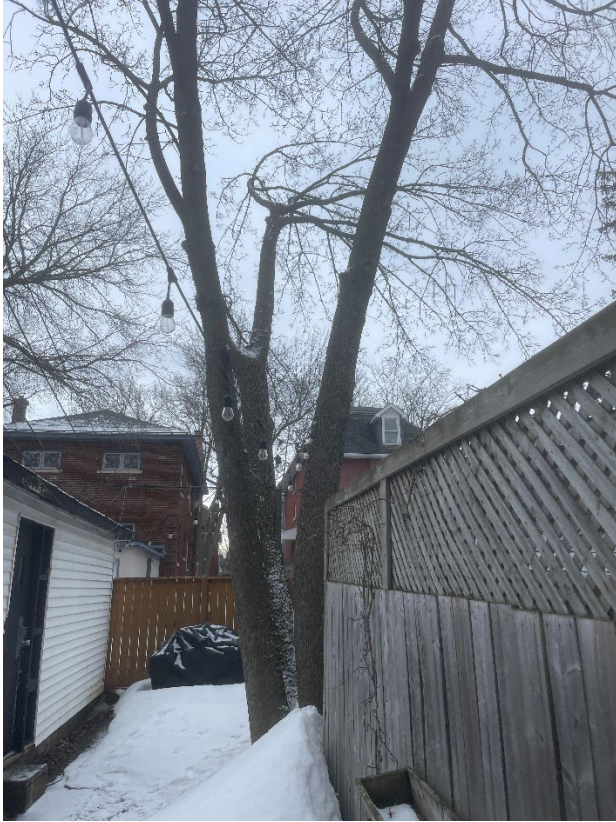
Tree ¹	Species	Diameter at breast height (cm)	Ownership ^{2,3}	Condition	Action	Recommendations
1	Norway maple (<i>Acer platanoides</i>)	Multi-stem: 36, 35, 29	Adjacent – 170 Holmwood	Good/Fair, 3 stems separate at base (deep snow limited inspection at base)	Retain	Retain: certified arborist to perform any root pruning necessary for replacing concrete

Figure 1: Norway maple on adjacent property

This project is a demolition and rebuild of a garage at the rear of the property. The only tree that may be impacted by this construction is a multi-stemmed Norway maple on the adjacent property, directly beside the garage. One of the stems of the tree is leaning over the subject property and would be considered jointly owned. Because the rebuilt garage will have almost an identical footprint to the existing one, it is assumed any tree roots that had grown underneath the floor of the garage will be minimally impacted by replacing the concrete. However, a certified arborist should be on site during removal of the old concrete slab to inspect any tree roots found and to prune them by hand if required. Any exposed roots should be kept covered and moist with an organic material.

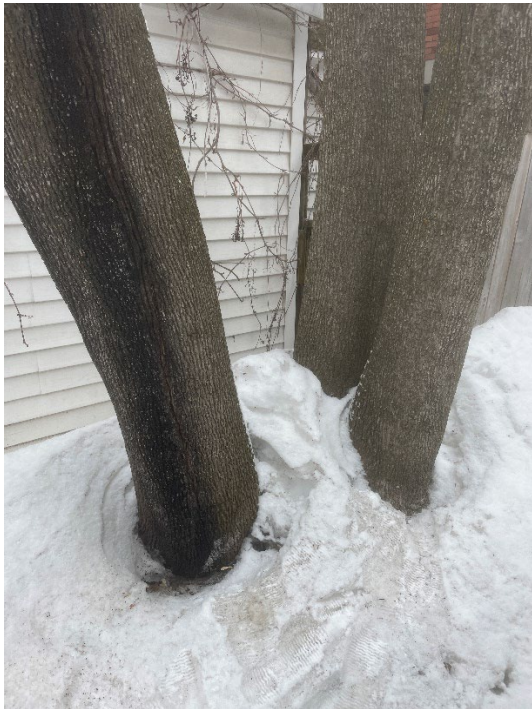
Figure 2: Base of multi-stemmed Norway maple

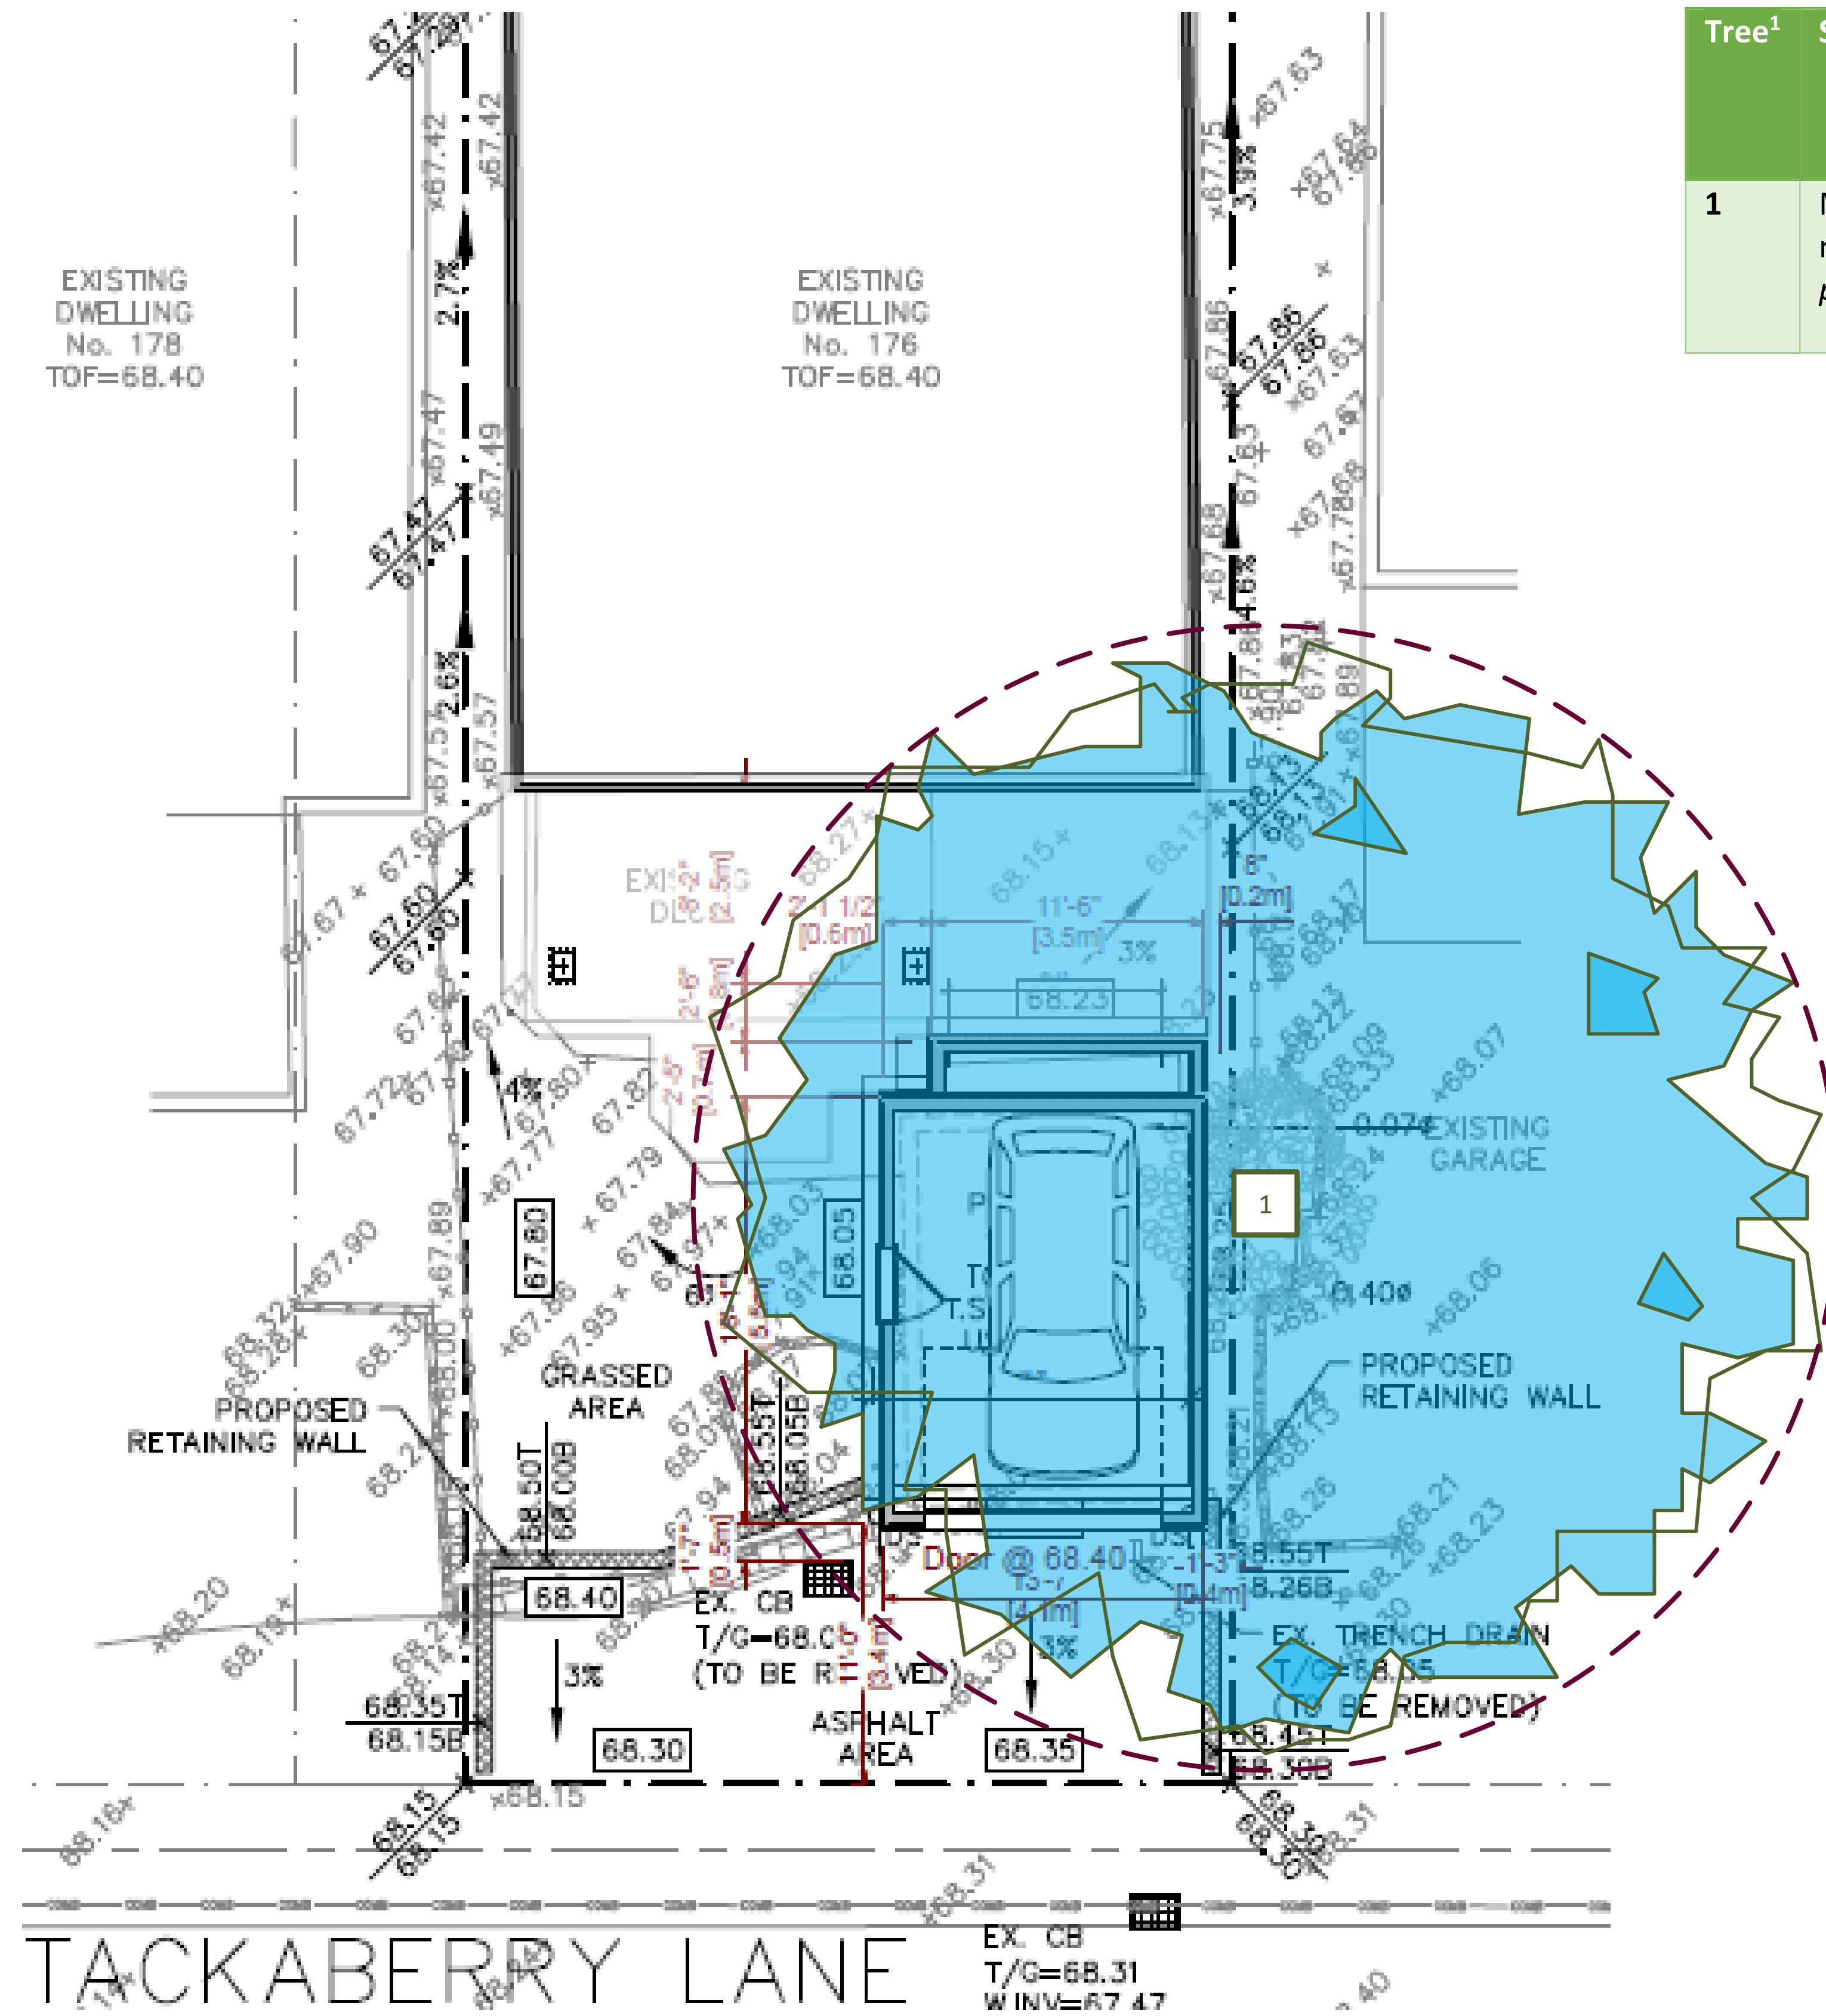
Tree ¹	Species	Diameter at breast height (cm)	Ownership ^{2,3}	Condition	Action	Recommendations
1	Norway maple (<i>Acer platanoides</i>)	Multi-stem: 36, 35, 29	Adjacent – 170 Holmwood	Good/Fair, 3 stems separate at base (deep snow limited inspection at base)	Retain	Retain: certified arborist to perform any root pruning necessary for replacing conc

Root mitigation

If any tree roots are encountered when replacing the garage, the following mitigation measures are to be applied:

- Certified arborist to conduct any root pruning required as part of garage construction
- Roots should not be left exposed and be covered with soil as quickly as possible, or temporarily with a moist, organic material such as mulch and/or burlap
- The tree should be watered during dry summer months to reduce stress it will encounter from the construction
