Tree Information Report

Address: 176 Holmwood Avenue

Date of Report: April 10, 2023

Date of Site Visit: April 3, 2023

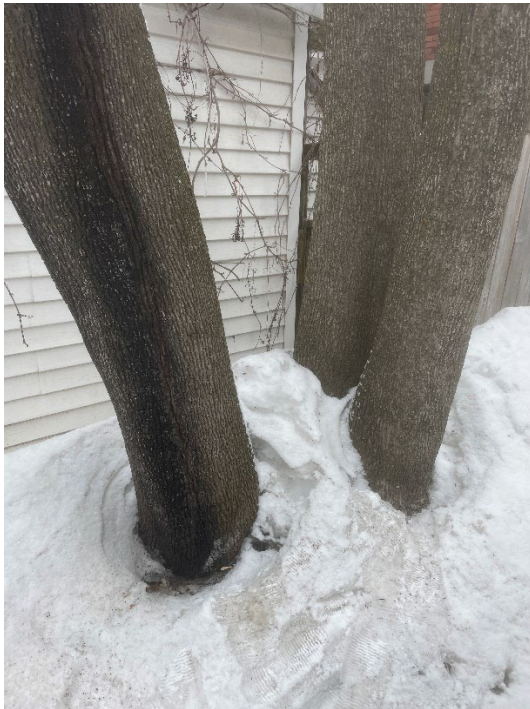
Figure 2: Base of multi-stemmed Norway maple

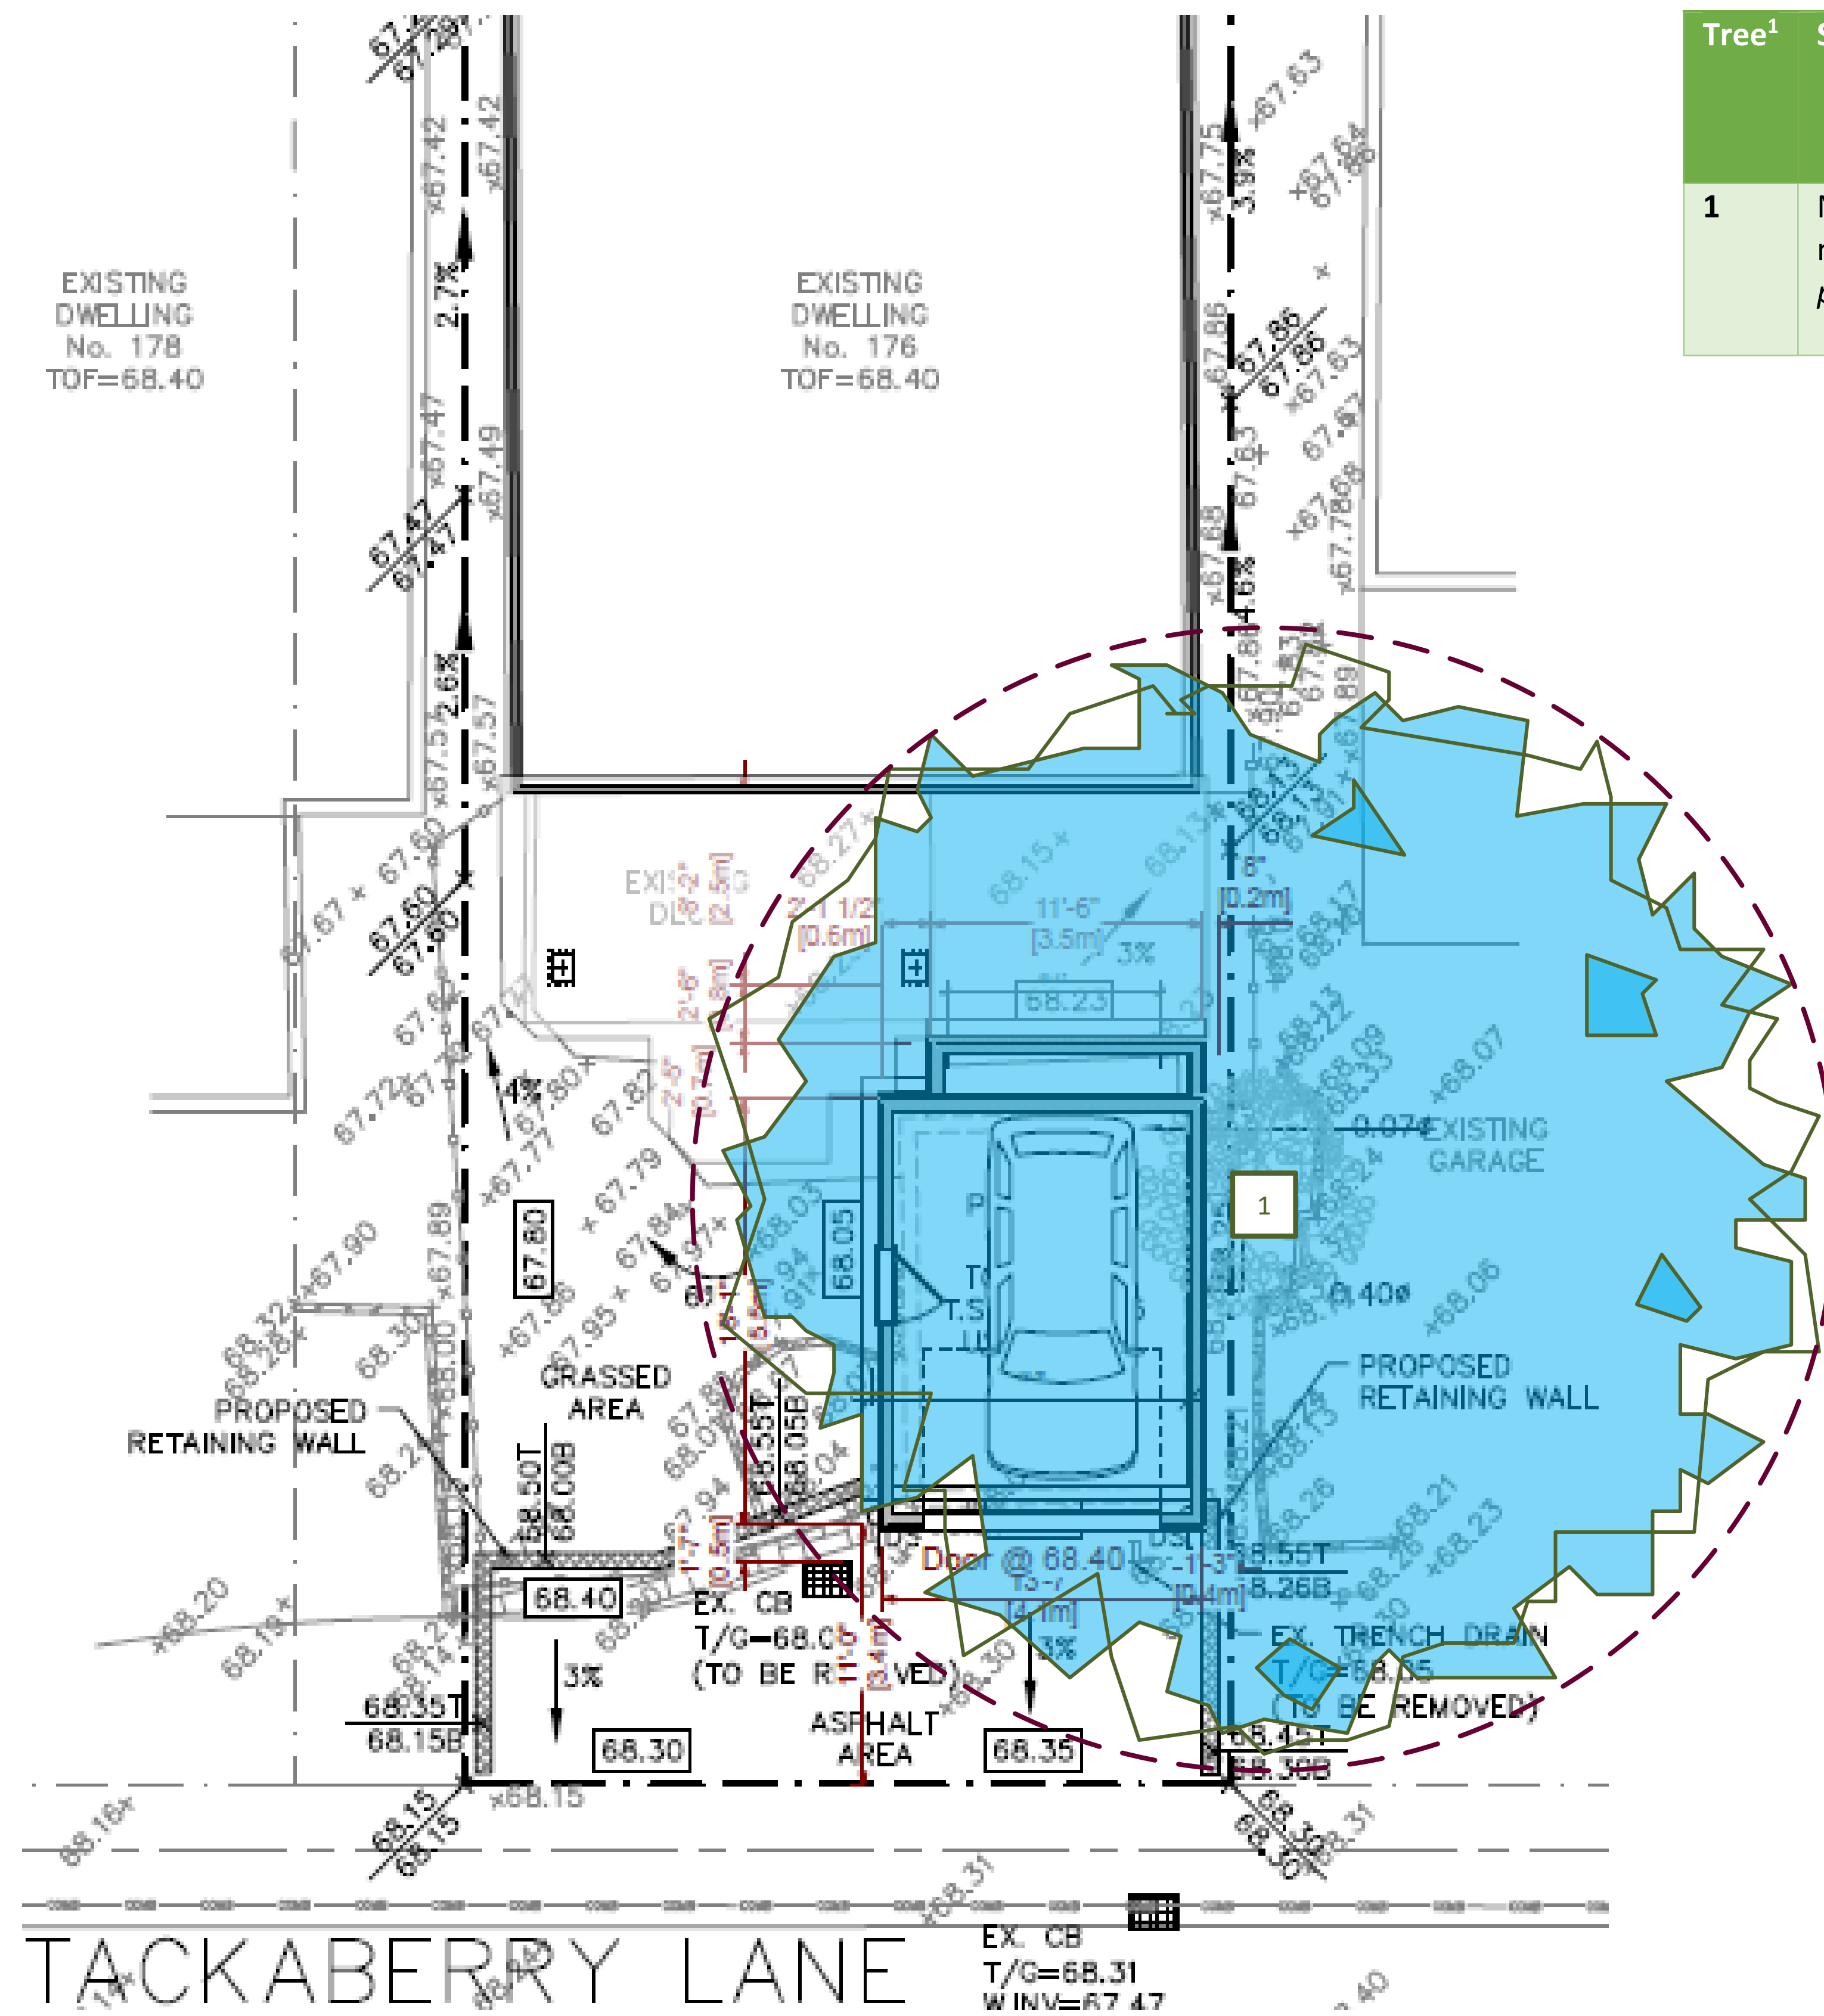
Tree Information Report – 176 Holmwood Avenue
 Tree layer prepared by Dendron Forestry Services
 Version 1.0, April 10, 2023
 For more information, please contact info@dendronforestry.ca

Tree ¹	Species	Diameter at breast height (cm)	Ownership ^{2,3}	Condition	Action	Recommendations
1	Norway maple (<i>Acer platanoides</i>)	Multi-stem: 36, 35, 29	Adjacent – 170 Holmwood	Good/Fair, 3 stems separate at base (deep snow limited inspection at base)	Retain	Retain: certified arborist to perform any root pruning necessary for replacing conc

If any tree roots are encountered when replacing the garage, the following mitigation measures are to be applied:

- Certified arborist to conduct any root pruning required as part of garage construction
- Roots should not be left exposed and be covered with soil as quickly as possible, or temporarily with a moist, organic material such as mulch and/or burlap
- The tree should be watered during dry summer months to reduce stress it will encounter from the construction
