Tree Information Report

Submitted as part of Committee of Adjustment Application to the City of Ottawa

Address: 18 Rothwell

Date of Report: December 21, 2022

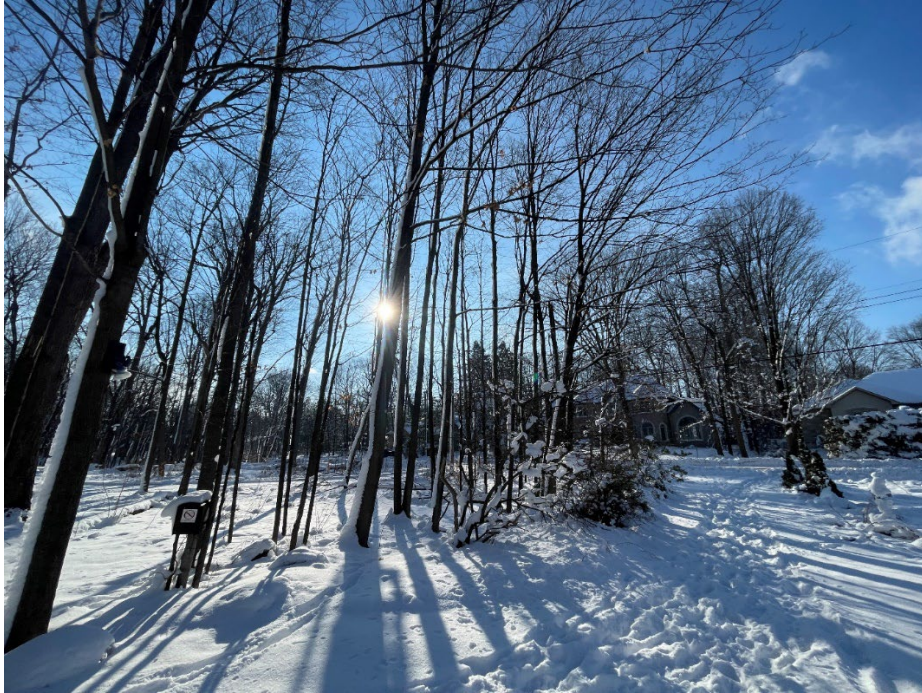
Figure 1: Trees along the eastern property line, beside the driveway

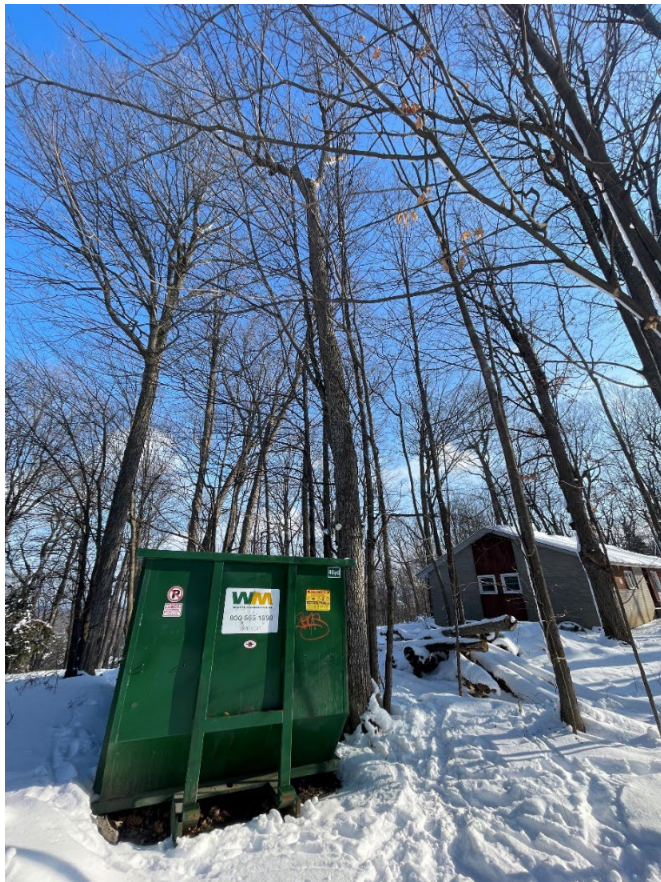
6	Sugar maple (<i>Acer saccharum</i>)	47	Private - 18 Rothwell	Good/fair; scar at base, lights attached on trunk	Remove	Remove based on conflict with new driveway; Tree Permit required

Figure 2: Tree 6 (immediately right of the bin), sugar maple to be removed

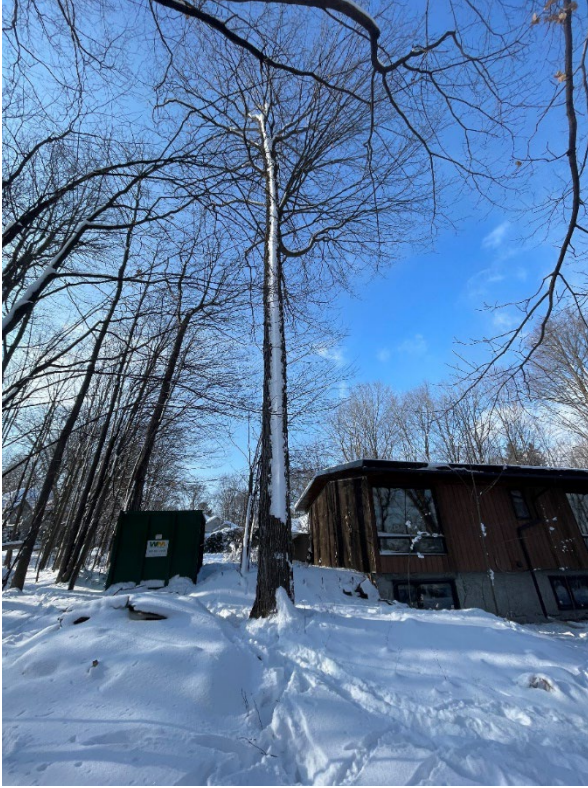
7	Sugar maple (<i>Acer saccharum</i>)	67	Private - 18 Rothwell	Good	Remove	Remove based on conflict with new driveway and excavation for new home; Tree Permit required
8	Sugar maple (<i>Acer saccharum</i>)	48	Private - 18 Rothwell	Good	Retain	Retain and protect with fencing and City of Ottawa Tree Protection Specifications (March 2021)
9	Sugar maple (<i>Acer saccharum</i>)	70	Adjacent property at 20 Rothwell	Good; slight lean towards adjacent property	Retain	Retain and protect with fencing and City of Ottawa Tree Protection Specifications (March 2021)
10	Sugar maple (<i>Acer saccharum</i>)	32	Private - 18 Rothwell	Fair/poor; significant woodpecker activity at base, 8 X 60 cm	Remove	Remove based on health; Tree Permit required
11	Sugar maple (<i>Acer saccharum</i>)	50	Adjacent property at 20 Rothwell	Good	Retain	Retain and protect with fencing and City of Ottawa Tree Protection Specifications (March 2021)

Figure 3: Tree 7, sugar maple to be removed

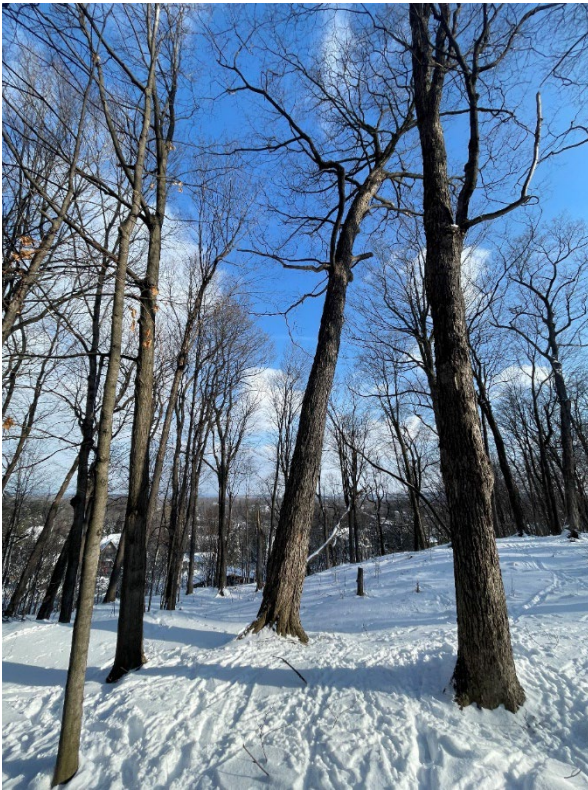
Figure 4: Trees 8-10 (right to left), tree 10 to be removed due to health

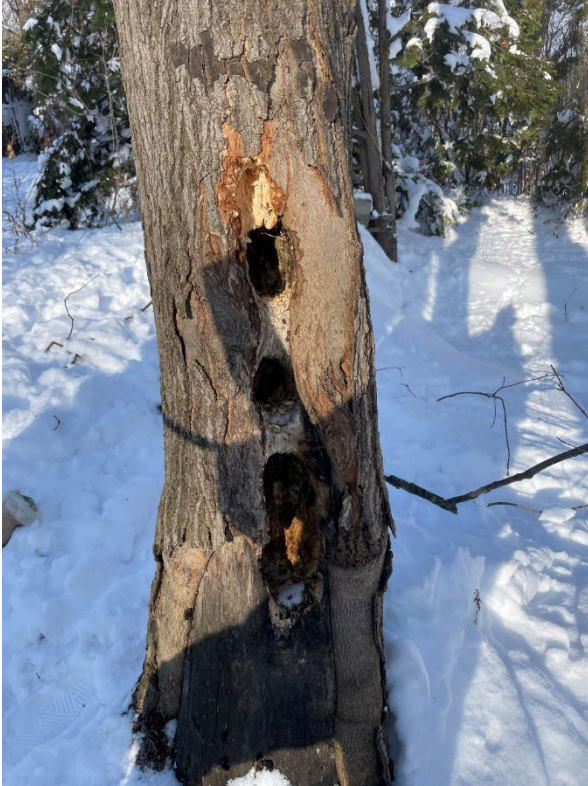
Figure 5: Base of tree 10, woodpecker holes at base

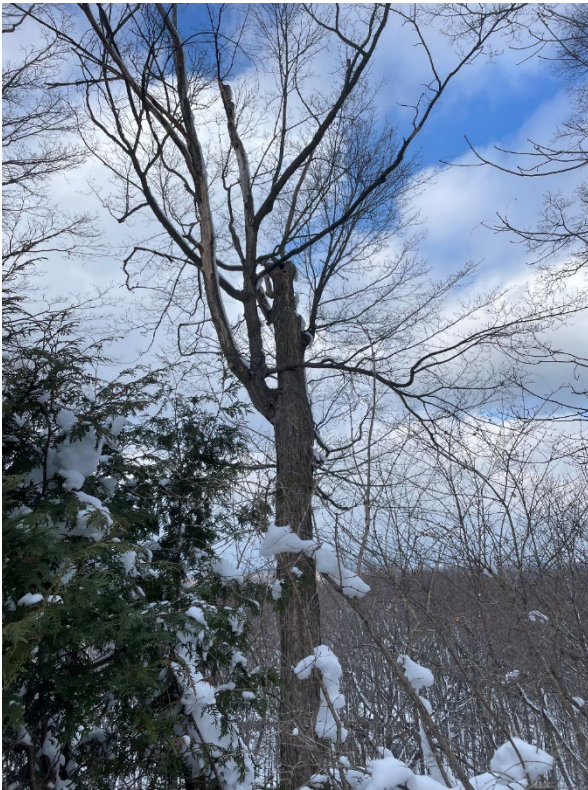
Figure 6: Photo showing top of tree 26 with dieback and decay

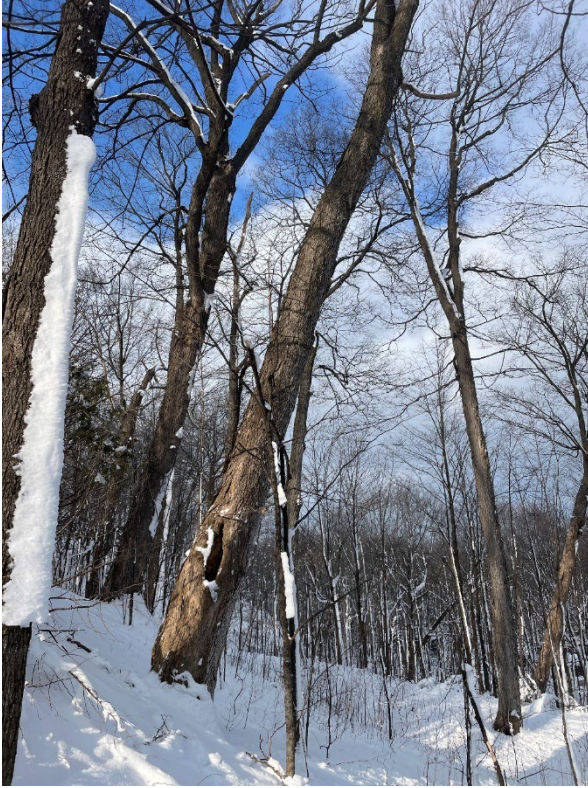
27	Sugar maple (<i>Acer saccharum</i>)	62	Private - 18 Rothwell	Good	Retain	Retain and protect with fencing and City of Ottawa Tree Protection Specifications (March 2021)
28	Sugar maple (<i>Acer saccharum</i>)	98	Private - 18 Rothwell	Fair; heavy lean downslope, cavity at base on underside	Retain	Retain and protect with fencing and City of Ottawa Tree Protection Specifications (March 2021)
29	Sugar maple (<i>Acer saccharum</i>)	50	Adjacent property at 16 Rothwell	Good	Retain	Retain and protect with fencing and City of Ottawa Tree Protection Specifications (March 2021)
30	Sugar maple (<i>Acer saccharum</i>)	60	Adjacent property at 16 Rothwell	Good	Retain	Retain and protect with fencing and City of Ottawa Tree Protection Specifications (March 2021)
31 ⁴	Sugar maple (<i>Acer saccharum</i>)	46	Adjacent property at 16 Rothwell	Fair/poor; dead top, maple borer signs	Retain	Retain and protect with fencing and City of Ottawa Tree Protection Specifications (March 2021)

Figure 7: Trees 27 (rear) and 28 (front), note heavy lean downslope of tree 28. Both trees to be retained.

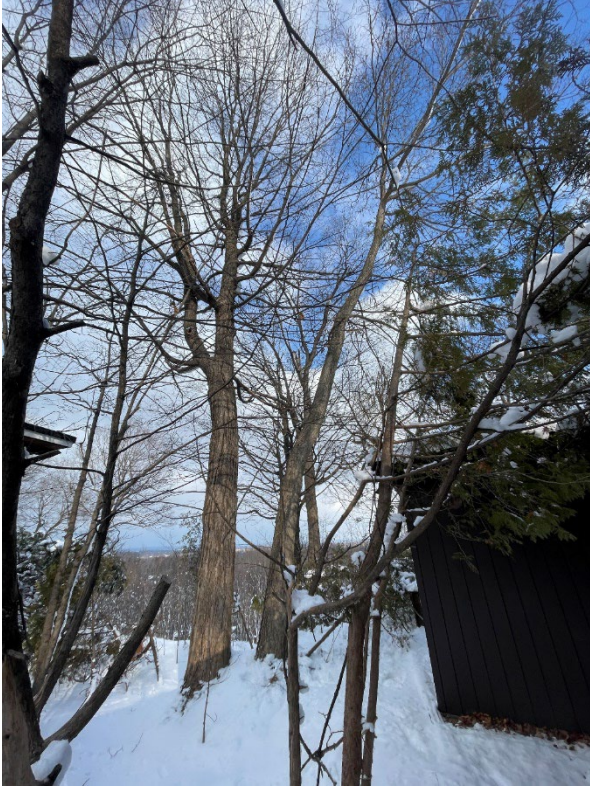
32	Hackberry (<i>Celtis occidentalis</i>)	43	Adjacent property at 16 Rothwell	Good; lean over existing home on subject property	Retain	Retain and protect with fencing and City of Ottawa Tree Protection Specifications (March 2021)
33	Sugar maple (<i>Acer saccharum</i>)	65	Adjacent property at 16 Rothwell	Good; deadwood and decay in large branch in crown	Retain	Retain and protect with fencing and City of Ottawa Tree Protection Specifications (March 2021)
34	Sugar maple (<i>Acer saccharum</i>)	29.6	Adjacent property at 16 Rothwell	Good	Retain	Retain and protect with fencing and City of Ottawa Tree Protection Specifications (March 2021)

Figure 8: Trees 32 (sugar maple, left) and 33 (hackberry, right) on adjacent property

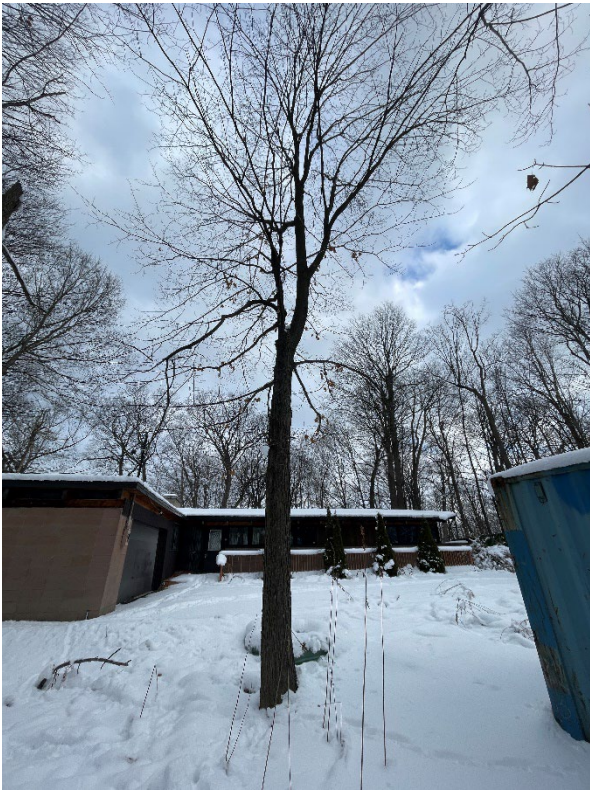
Figure 9: Tree 38, sugar maple tree to be removed
