Tree Information Report for 845 Dundee Avenue, Ottawa

The owner is applying for a permit to demolish the existing structure and build a semi-detached (R2G) residential building.

**Inspection dates:** 2023-02-27 and 2023-06-30

The objective of this report is to identify all protected trees on this and adjacent properties whose Critical Root Zones (CRZ's) fall within the area of construction and to provide strategies for tree preservation during development and construction.

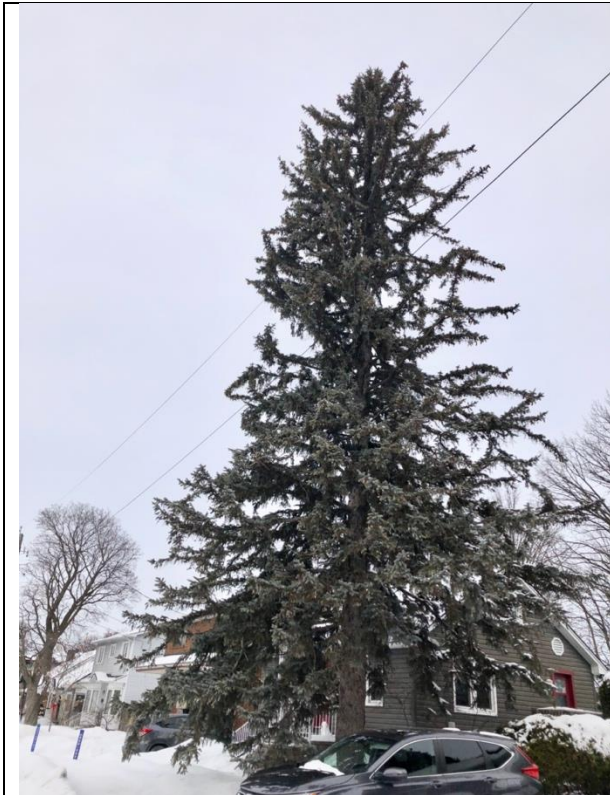
Photo 1  
Tree #1 Colorado Spruce

This is a mature Colorado spruce. See photos 1 and 2, p. 3

It has a single trunk.

Stem has no lean and tapers gradually.

Foliage density, size and colour are all good.

There is some die-back of smaller branches.

There are no co-dominant stems or included bark.

Crown has been raised to 3 M.

Roots may be restricted by existing paved driveway at 845 Dundee Ave.

There is currently encroachment into the CRZ from existing driveway at 845 Dundee. Excavation for the new driveway is outside the CRZ. A very small percentage (~5%) of the limit of excavation will disturb the CRZ. The tree will be able to tolerate this small amount of root loss.<sup>1</sup>

Provide protective fencing around the CRZ as indicated in Drawing #1 p 8 and the pink dotted line in Drawing #2 p 9. Follow all the Steps to Conserve Trees p 6.

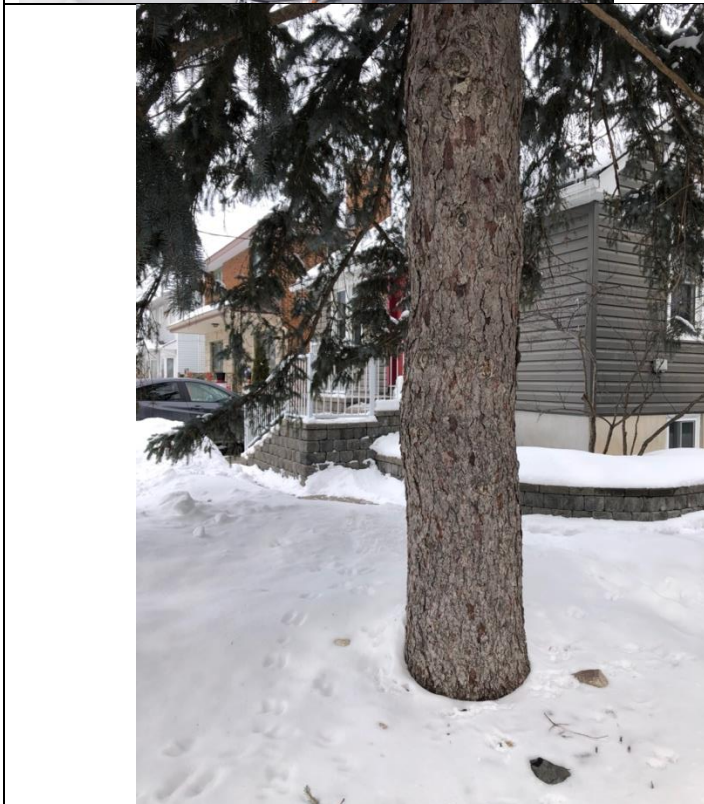
Photo 2  
#1 Healthy Trunk

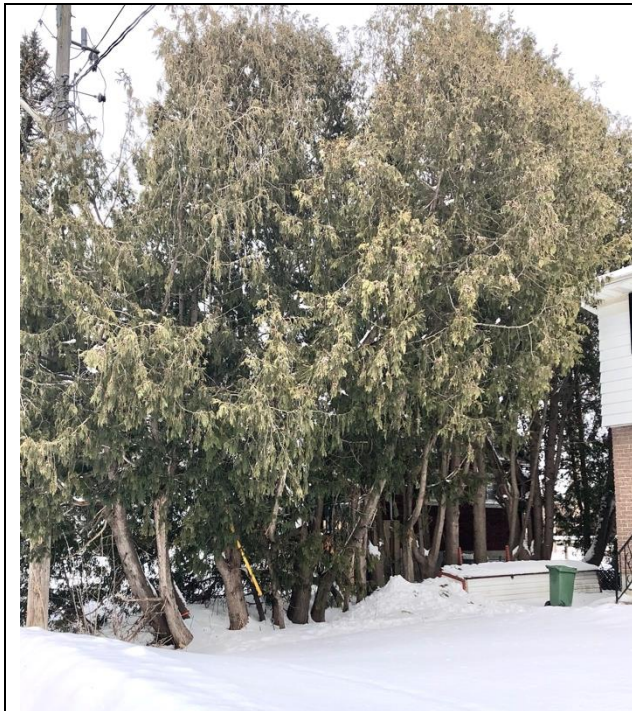
There is a row of cedars at 851 Dundee close to the boundary with 845. A few are growing in the ROW. See Photos 3 to 5 below.

The hedgerow is mature with the cedars varying in diameter from 10 cm to 46.5 cm.

The hedge has already been raised about 3 M along the south side and 3 M along a section on the north side next to the house at 845 Dundee. More cedars would have to be raised the same amount on the north side to allow access to any proposed entrances.

Photo 3  
South facing side (851 Dundee)  
of Cedars

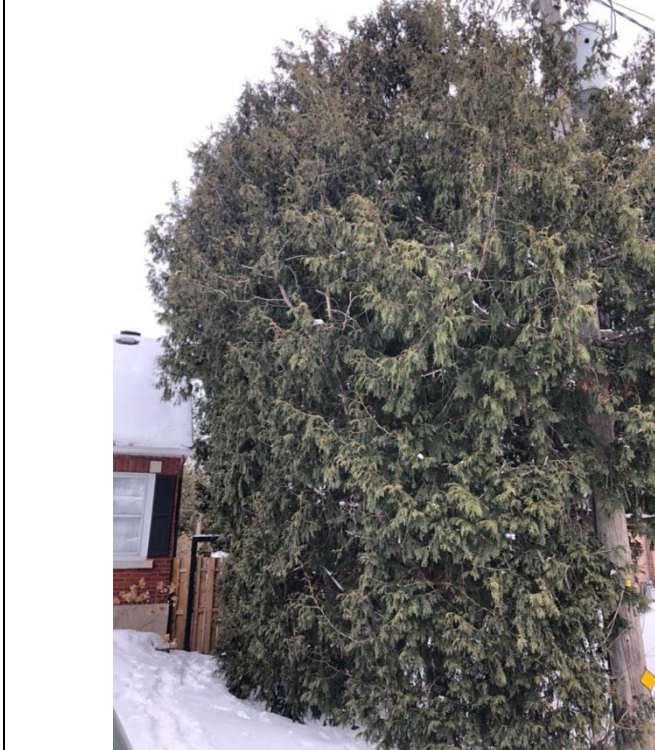
Photo 4  
Cedars (845 Dundee) North  
facing side

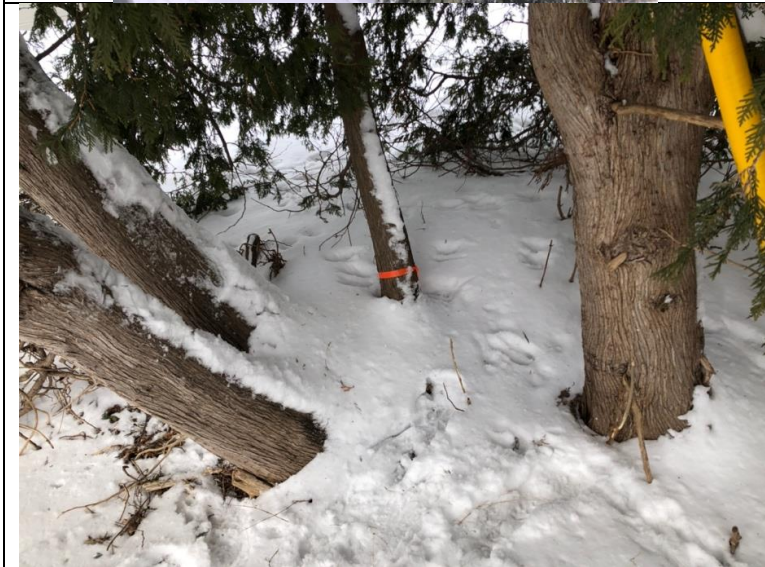
Photo 5 (left)  
Some cedars in the ROW

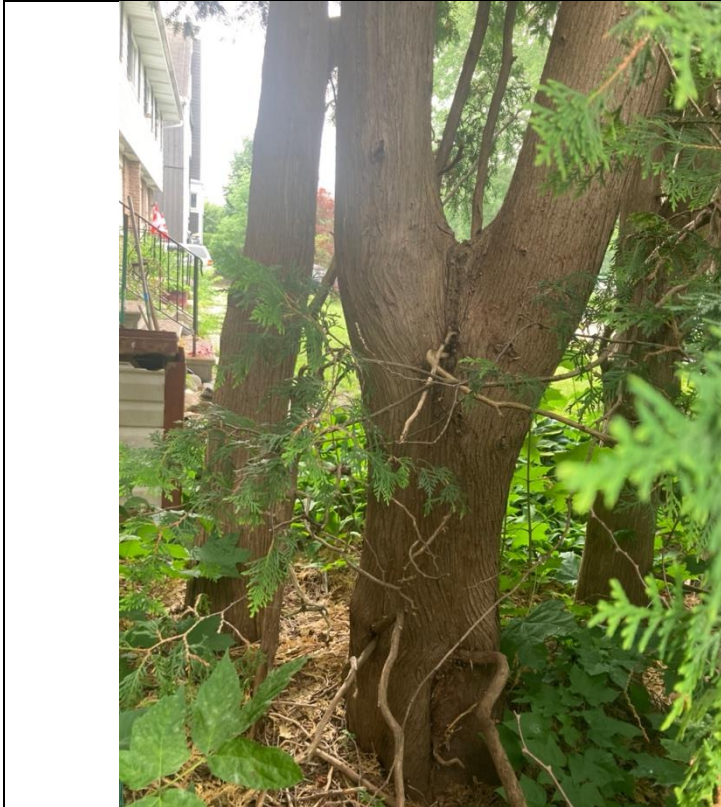
Photo 6  
Tree #2

The CRZ's for these cedars extends up to the existing foundation on the side of 845 Dundee. Excavation will remove less than 20 % of the actual area of the existing roots for these two trees. As cedars show very good tolerance of root loss and infill soils, these two trees should not be adversely affected by the construction as long as all Steps to Conserve trees are followed.

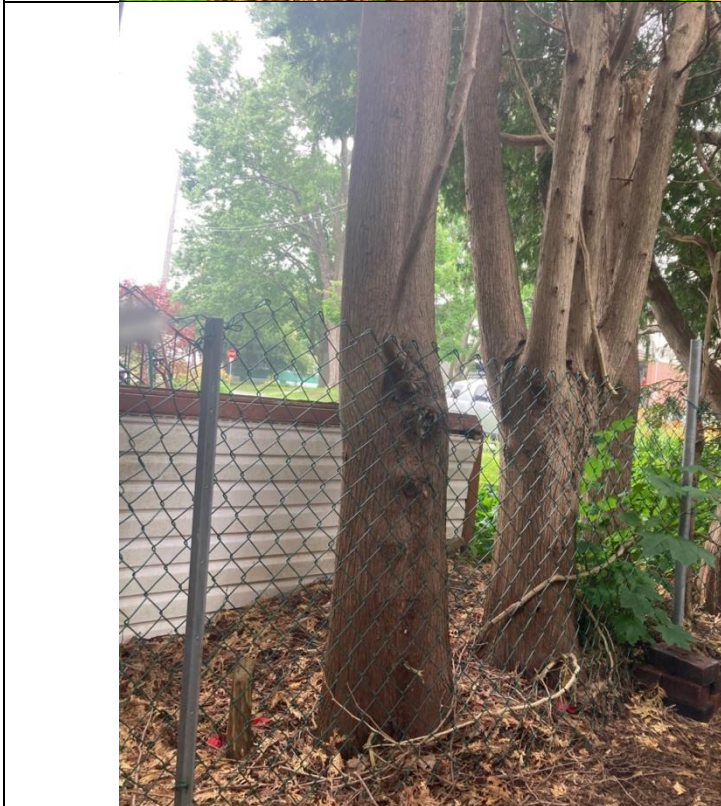
Photo 7  
Tree #3 on the right side of  
photo

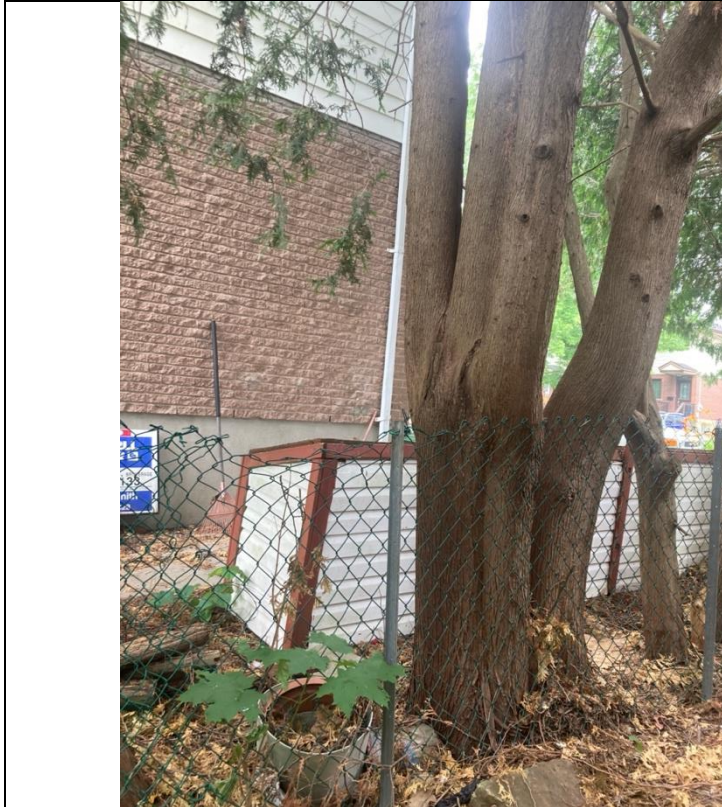
Photo 8  
Tree #4 in the center

This cedar has a CRZ that has been restricted by the foundation at 845 Dundee. The limit of excavation will be narrowed along the section within their illustrated CRZ's to preserve the amount of undisturbed soil extending from the base of this tree. This will leave a distance of 1.68 cm.

This tree could lose approximately 35% of the root zone as defined by the term CRZ in the definitions. But at least 15% of this area is limited by the presence of the existing foundation meaning that the tree will only lose about 20% of the actual root mass.

In order to mitigate damage to their roots in the area of the zone between the limit of excavation and the cedar trees, a mechanical shovel is not to be used along the cut line. Excavation will be carried out by hand with a sharp spade or by using hydro pressure with special attention to No. 6 and no. 7 below of **Steps to Conserve Trees**. The orange dotted line in Diagram #2 shows the distance that is to be hand excavated. It is anticipated that by following these steps Cedars #4 and #5 will be able to tolerate the work.

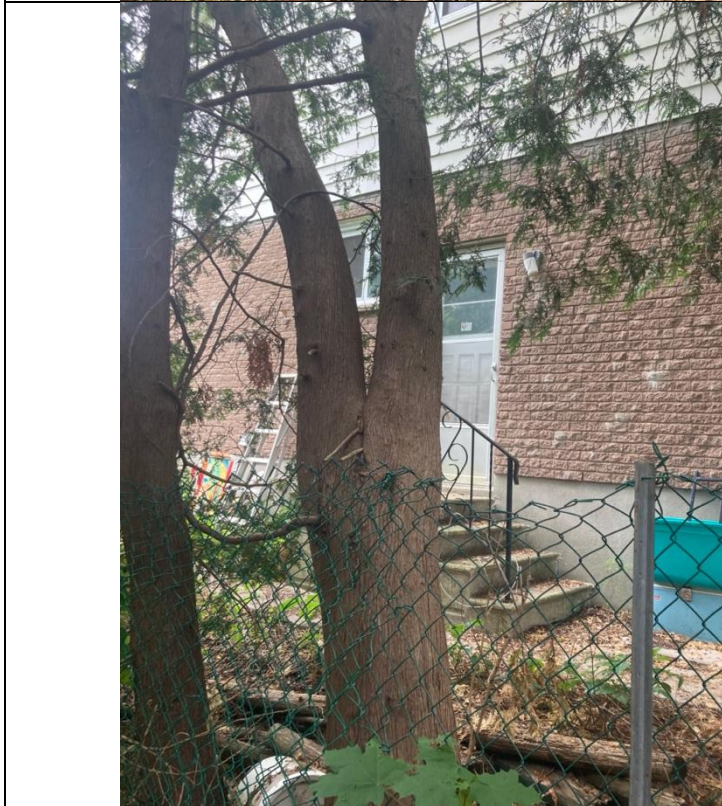
Photo 9  
Tree #5

This cedar also has a CRZ that has been restricted by the house foundation. The limit of excavation is planned to be narrowed near the trunk of this tree. The cut line has been narrowed a further distance of 2 M to accommodate the CRZ radius of 4 M from the tree trunk. This will ensure that the tree will lose only about 35% of the standard CRZ and considering part of this is restricted by the foundation it should actually amount to less than 30%.
