SOMERSET HOUSE REHABILITATION

352 Somerset Street West, Ottawa, Ontario, K2P 0J9

2023 DESIGN INTENT REPORT

Project No. 0653
Revision No. 00
June 23, 2023

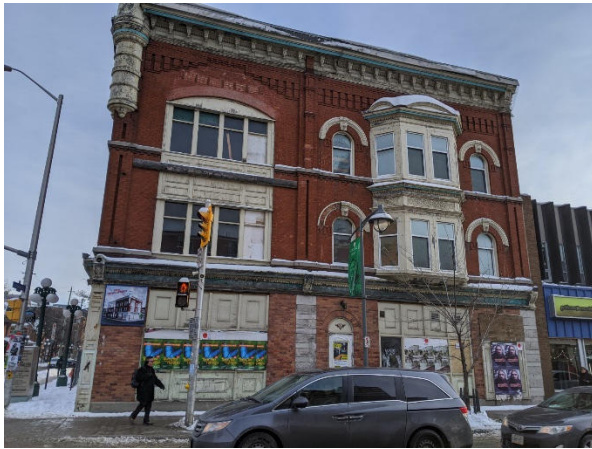
Figure A1 – West Exterior Wall

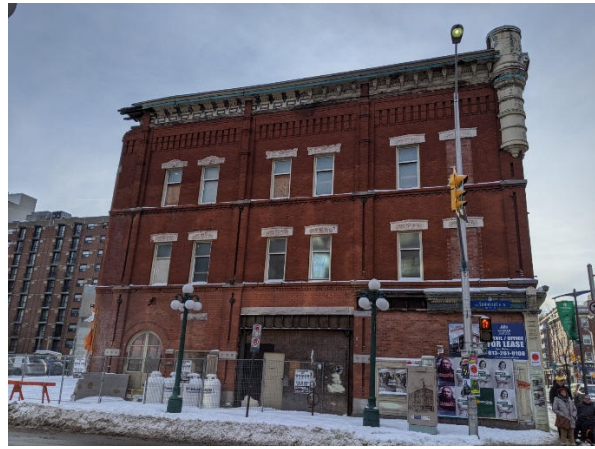
Figure A2 – North Exterior Wall

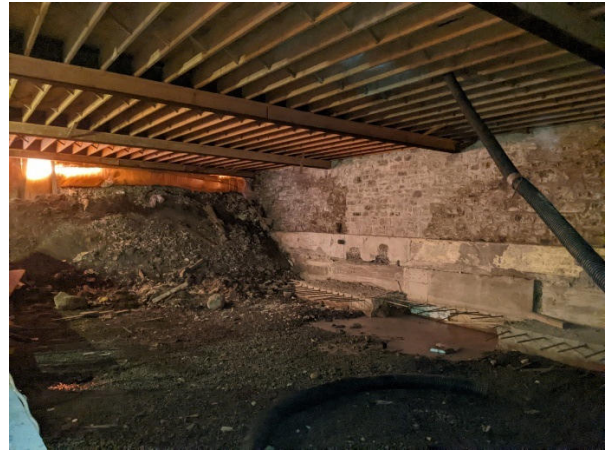
Figure A6 – Basement South Foundation

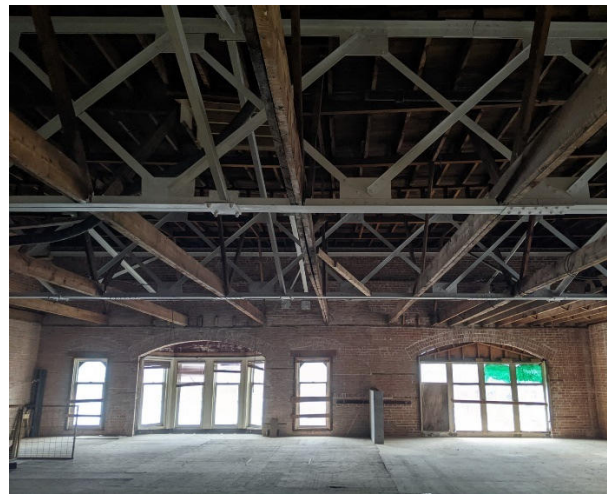
Figure A8 – Third Floor Facing West
