## SOMERSET HOUSE REHABILITATION

### 2023 DESIGN INTENT REPORT

Project No. 0653  
Revision No. 00  
June 23, 2023

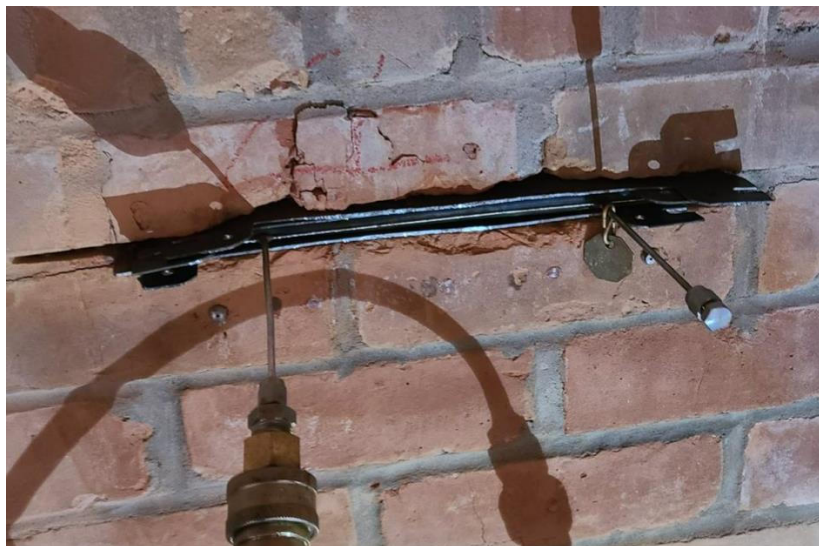
Deformations of the masonry behaved as expected for the initial loading conditions. Brick units however began failing under load at low values, early into the tests. On release of the load, most joints within the test area cracked.

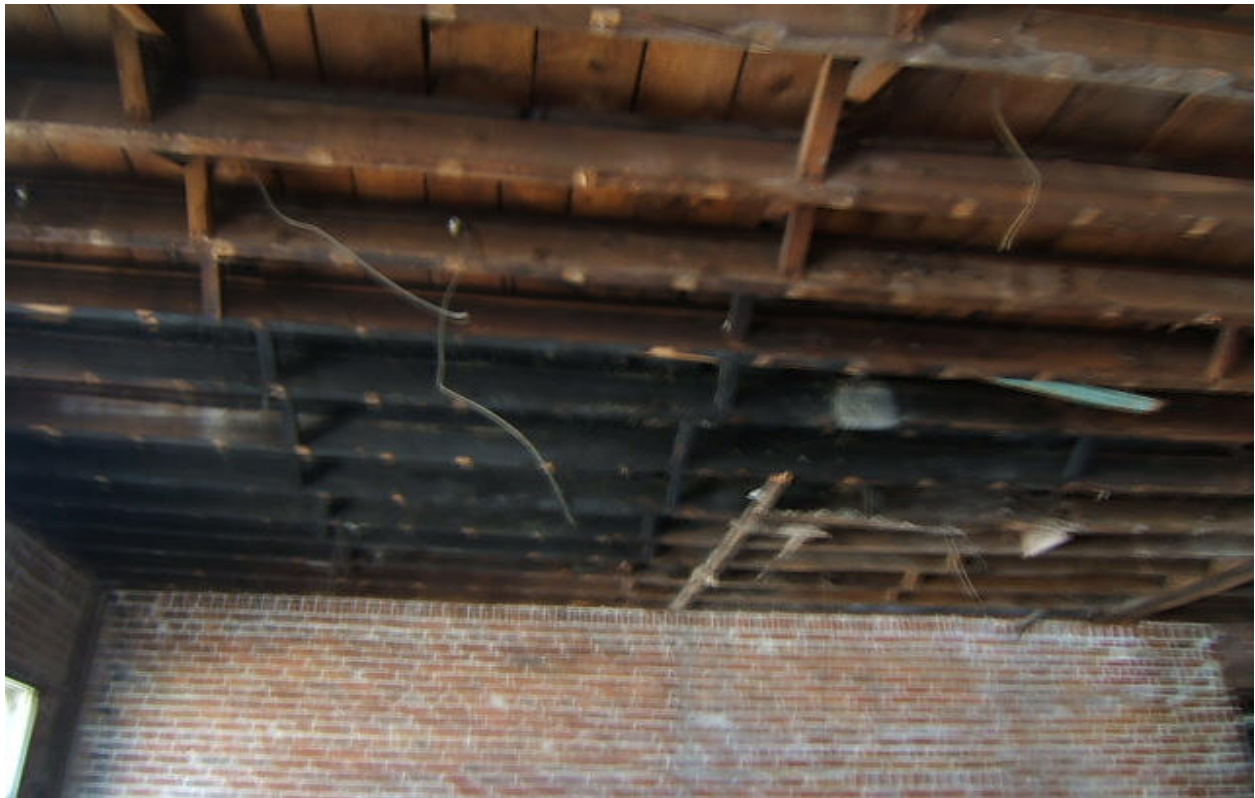
**Figure 4: Previously Existing Condition Flooring System and Fire Damage**

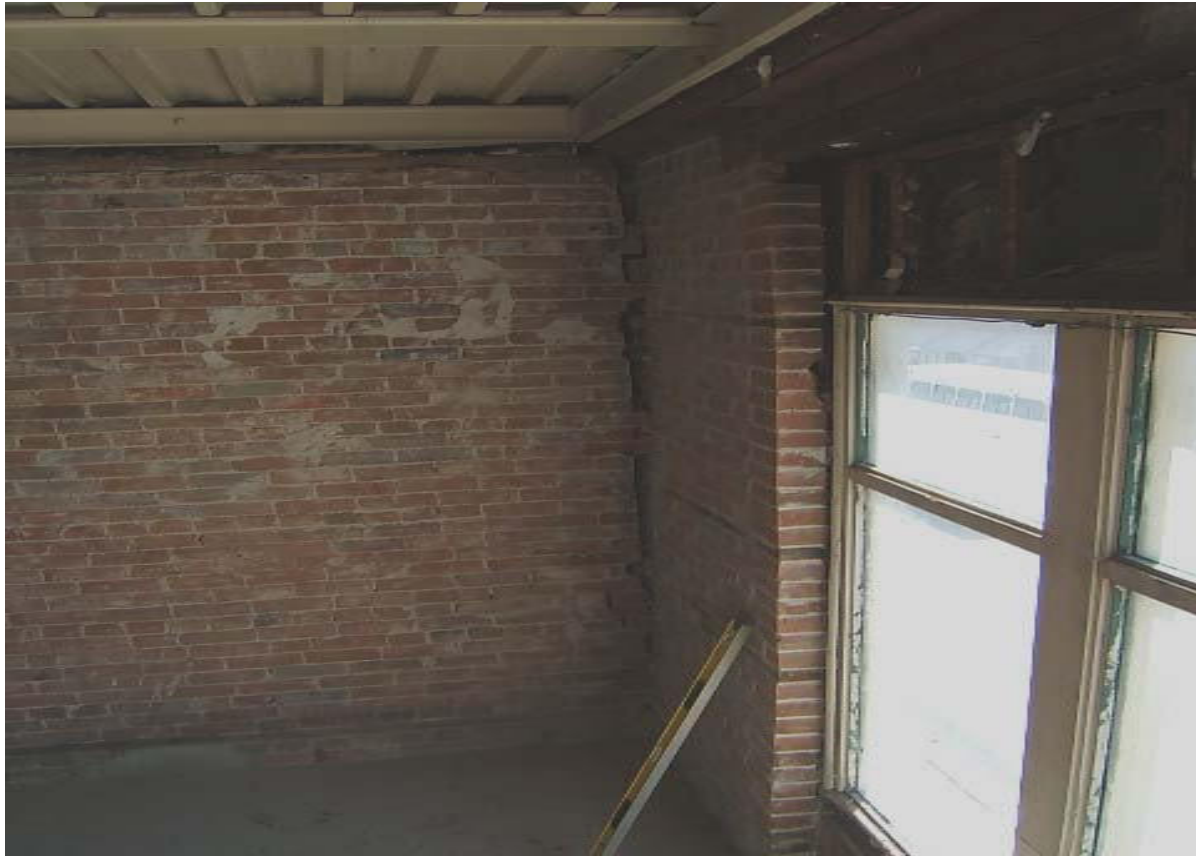
**Figure 8: Previously Existing Condition Outlining Movement of West Wall**
