Project No. 2020-134

November 17, 2020

**Re: 1 Maple Lane and 1112 Lisgar Road – Ottawa, ON
Field Inspection Report**

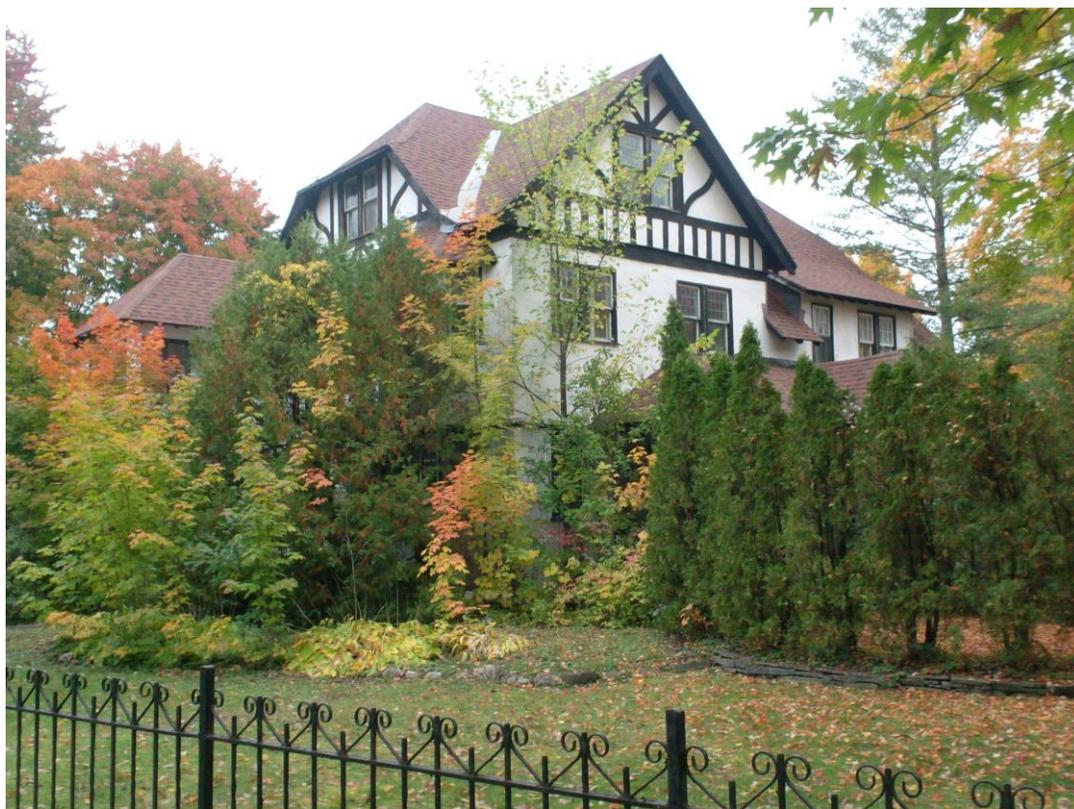
Photo 1

As requested by Roca Homes, REMISZ Consulting Engineers personnel Robert Papiez performed a site inspection of the residential building located at 1 Maple Lane and 1112 Lisgar Road in Ottawa (photo 1), on October 20, 2020. We were accompanied by house owner and representative from Paterson Group who did their own environmental check.

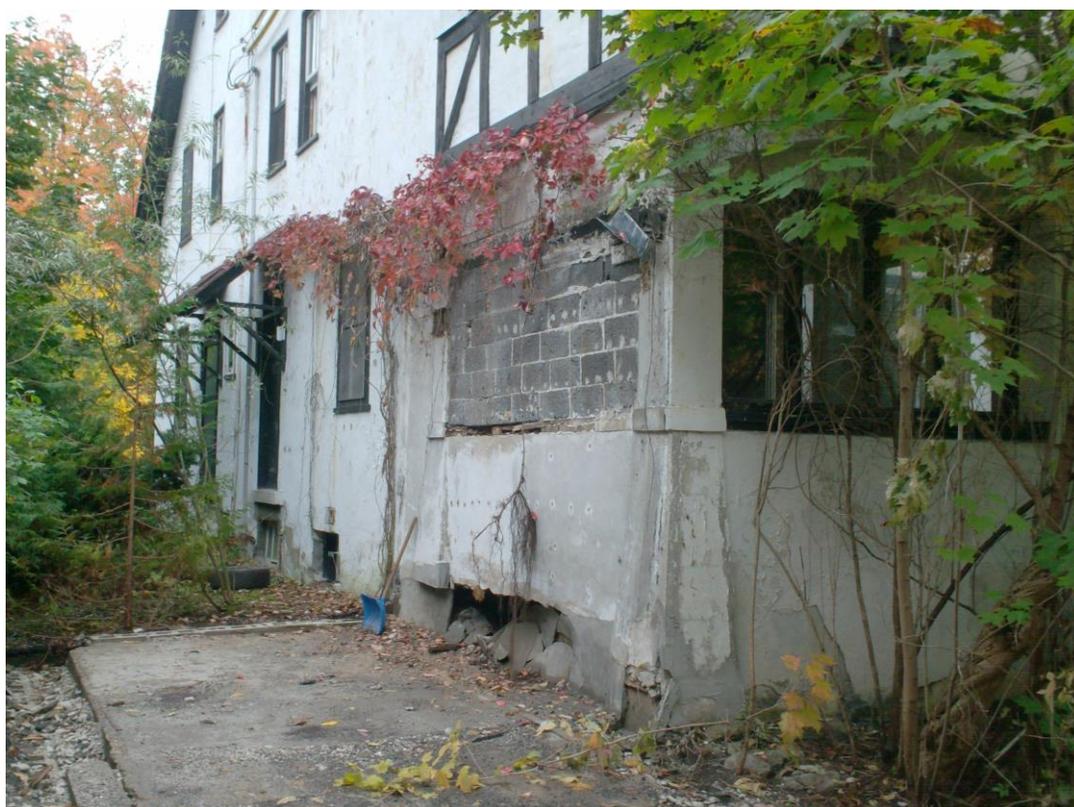
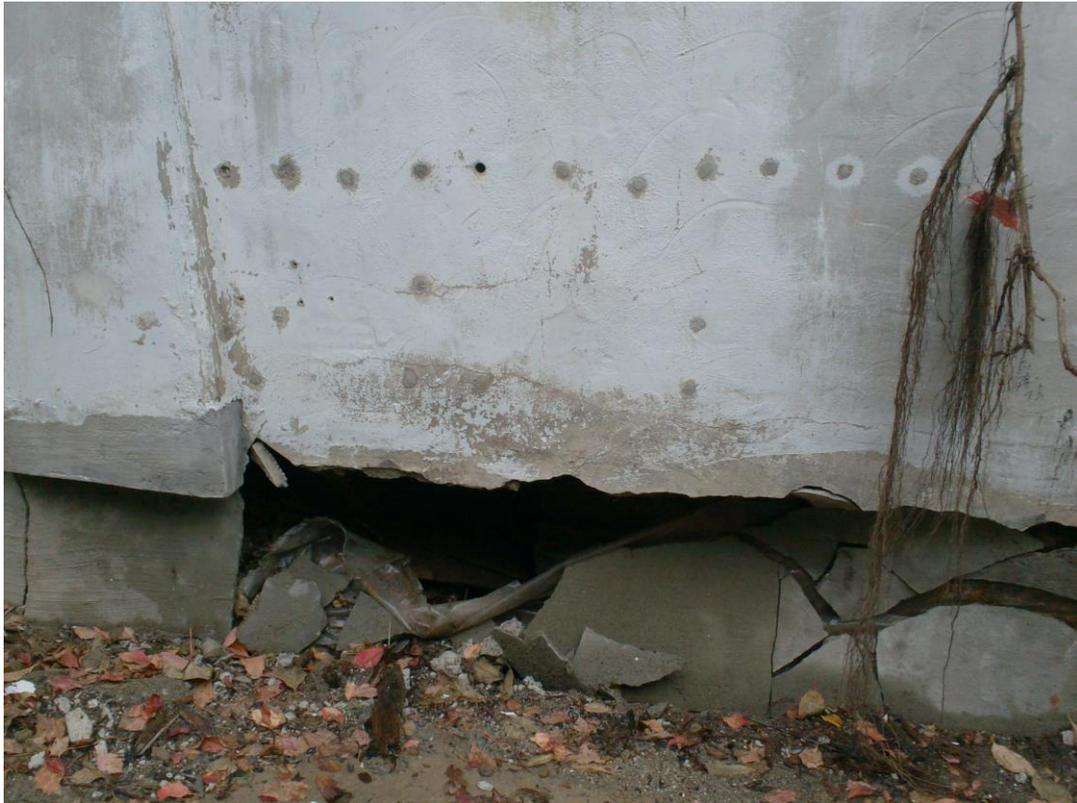
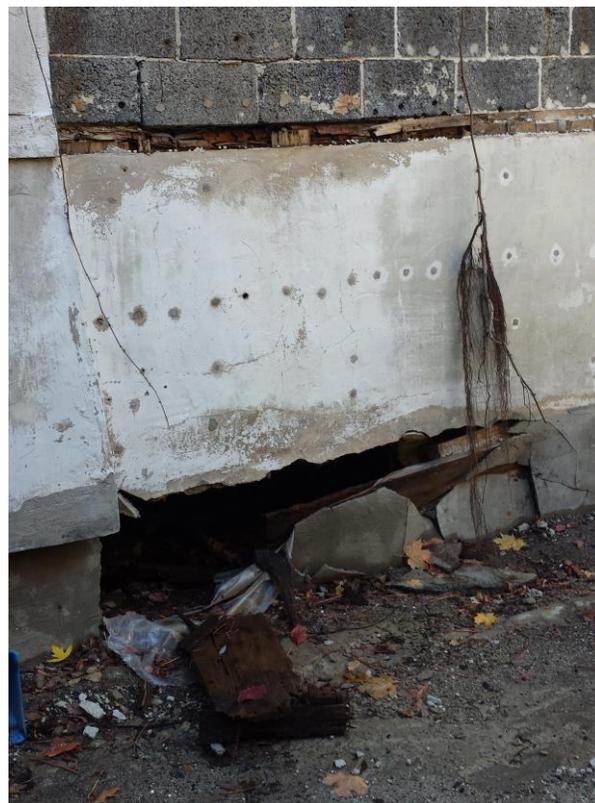
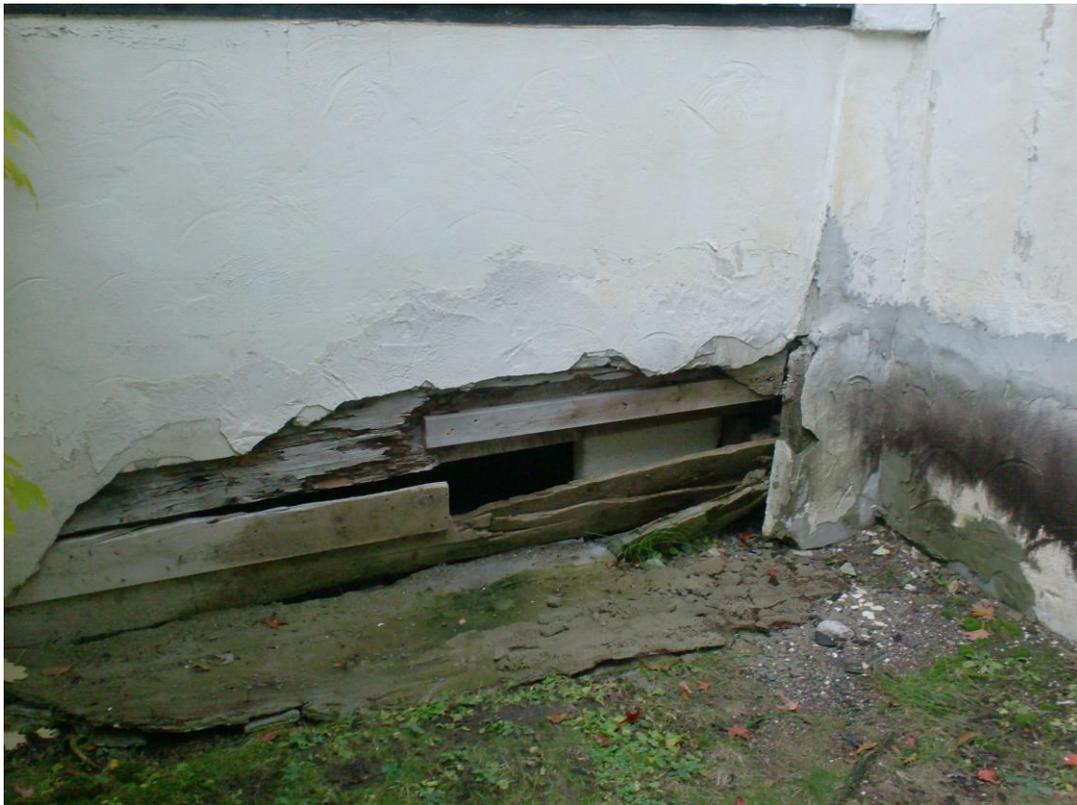
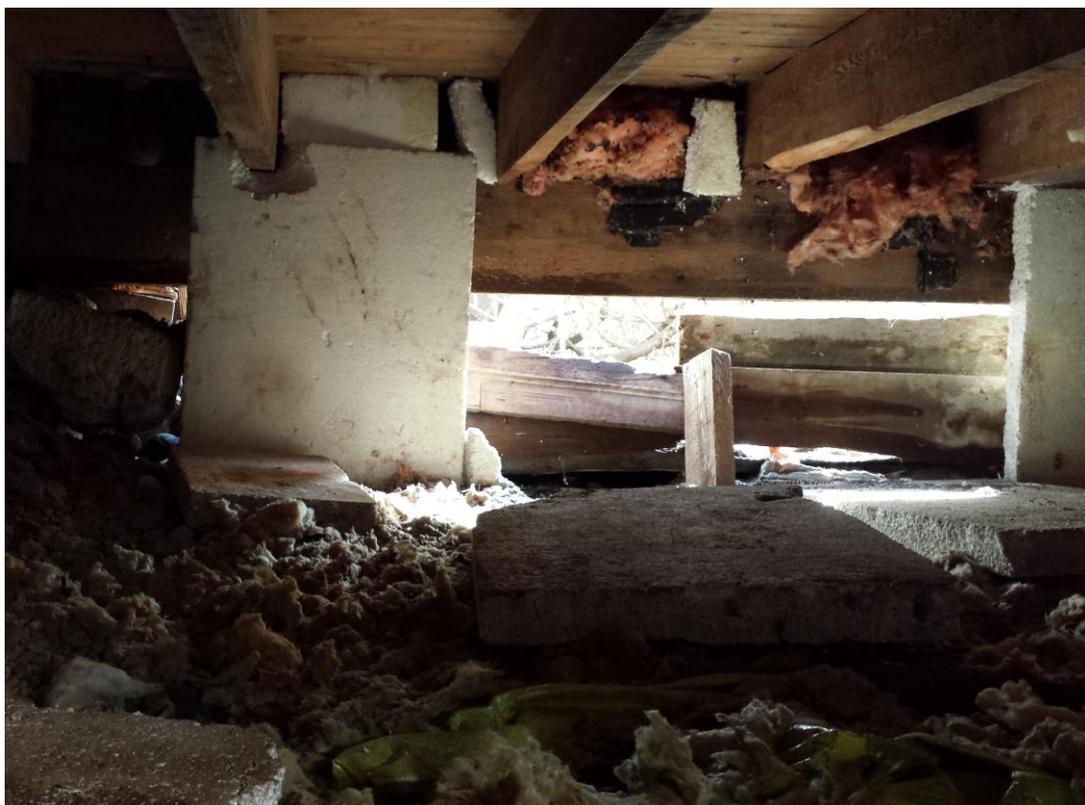
The façade of the building is deteriorating in many areas. The foundation walls collapsed in some places creating holes in exterior walls (photos 2-6). Roof shingles are in a poor condition. (photo 7). We were not able to check the wood framing but the home owner informed us that he replaced some shingles 3 years ago, and wood was found very rotten. We could see outside exposed members, and they are rotten confirming the owner information.

Partial demolition and repairs/renovations are not feasible, there are no salvageable elements remain due to mould accumulation. We recommend full demolition of the existing building. All demolished items must be removed from the site and disposed accordingly. Special care should be taken by the contractor to ensure all works are performed safely within the property lines to not affect adjacent properties.

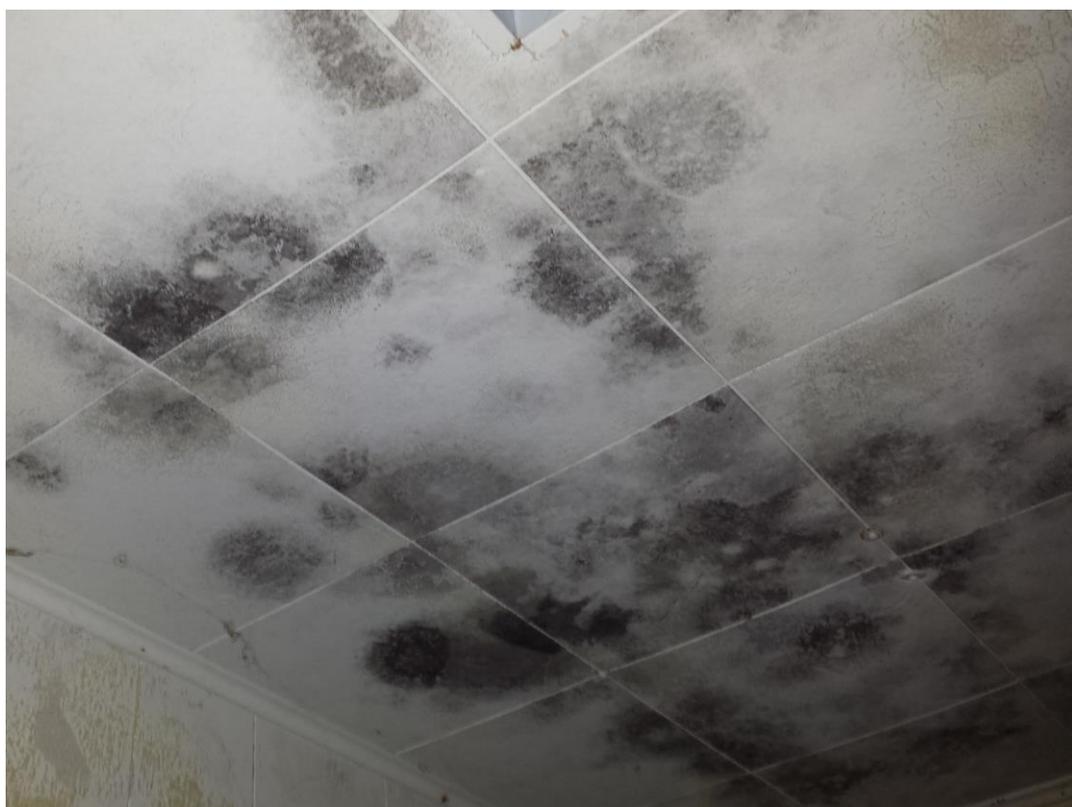
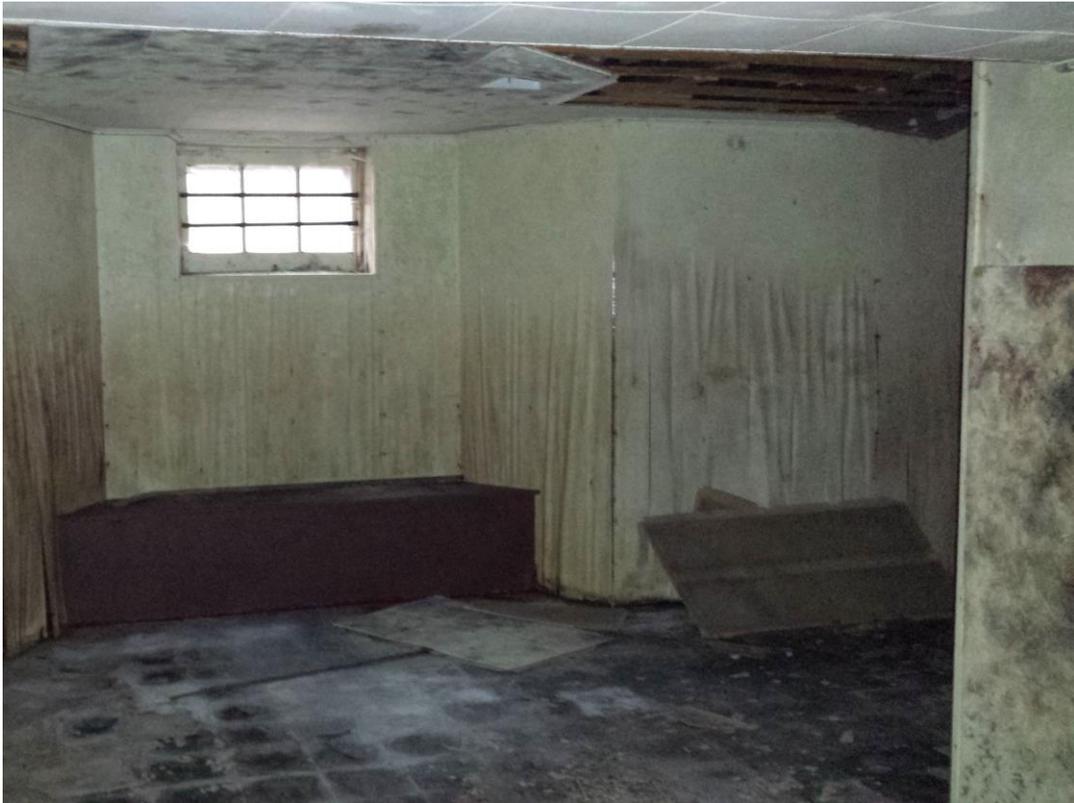
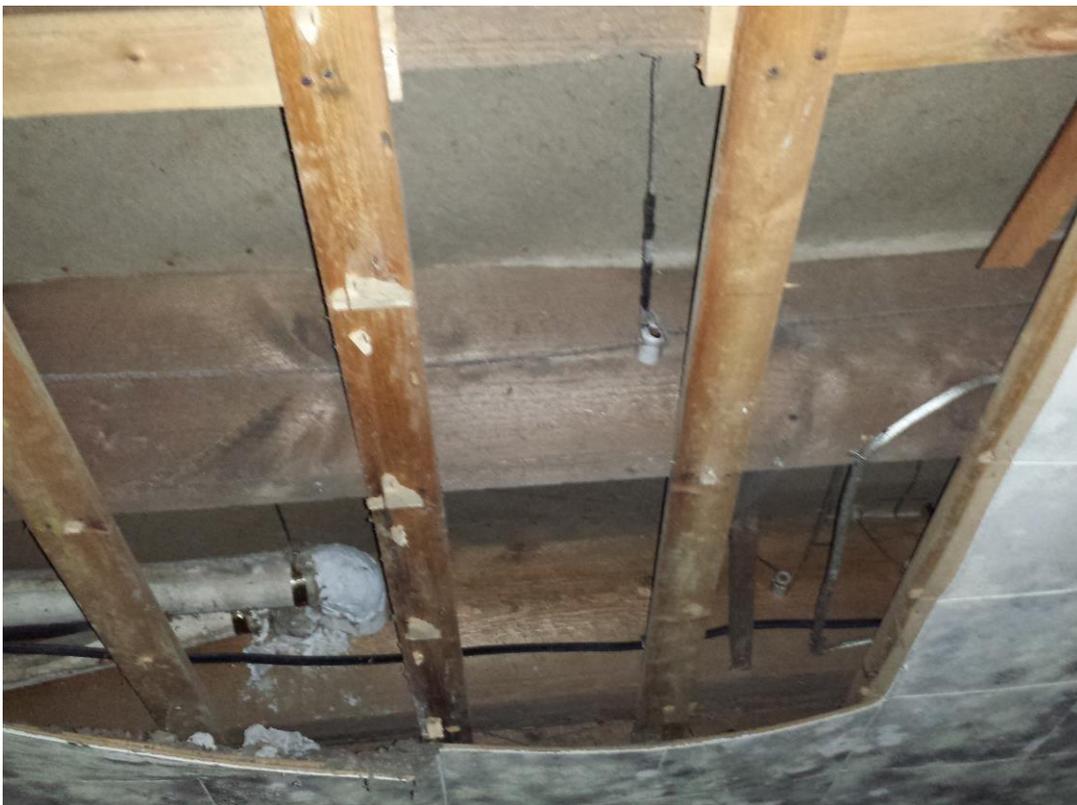
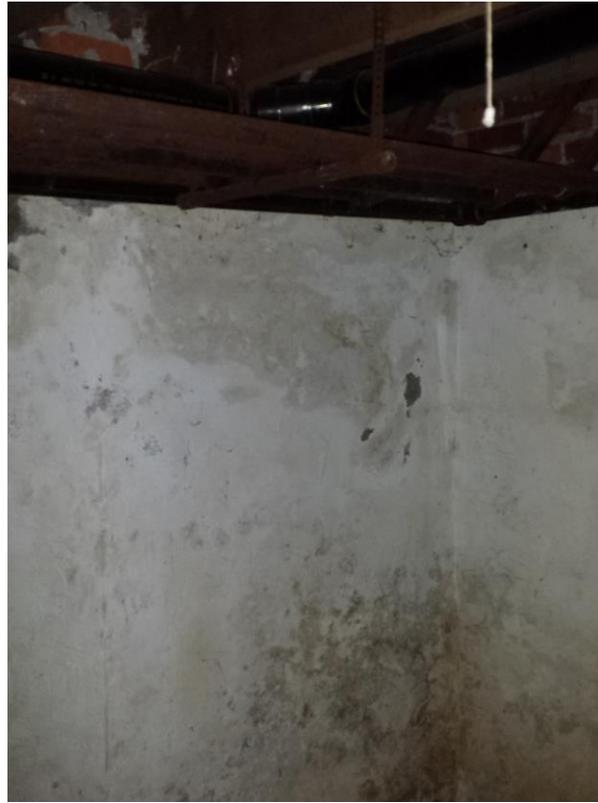
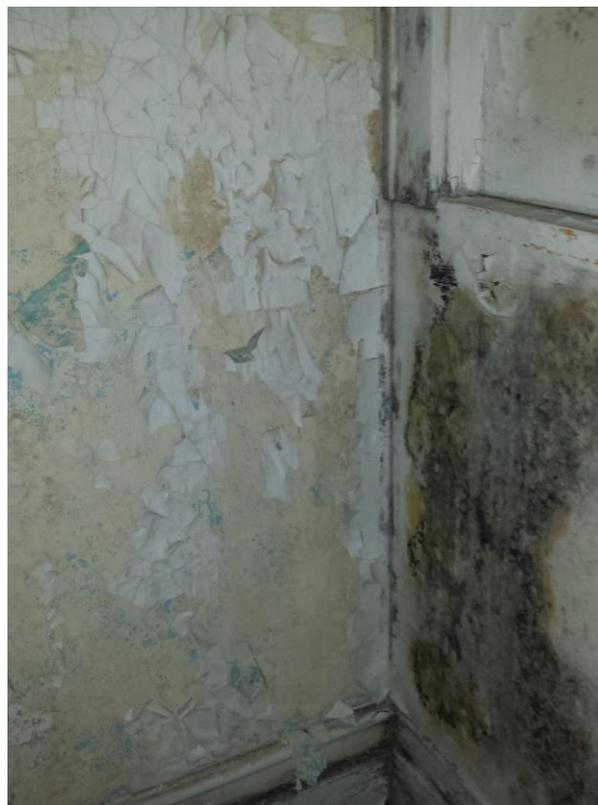
Ground floor and the second floor of both units are in poor condition. There is extensive mould and rot throughout the building (photos 8 - 12). Due to moisture and the freeze-thaw cycle there is continuing damage to all timber structural elements at all different levels (photos 13-16). The ceiling collapsed in numerous spots revealing worn and moulded insulation (photos 17 - 20).

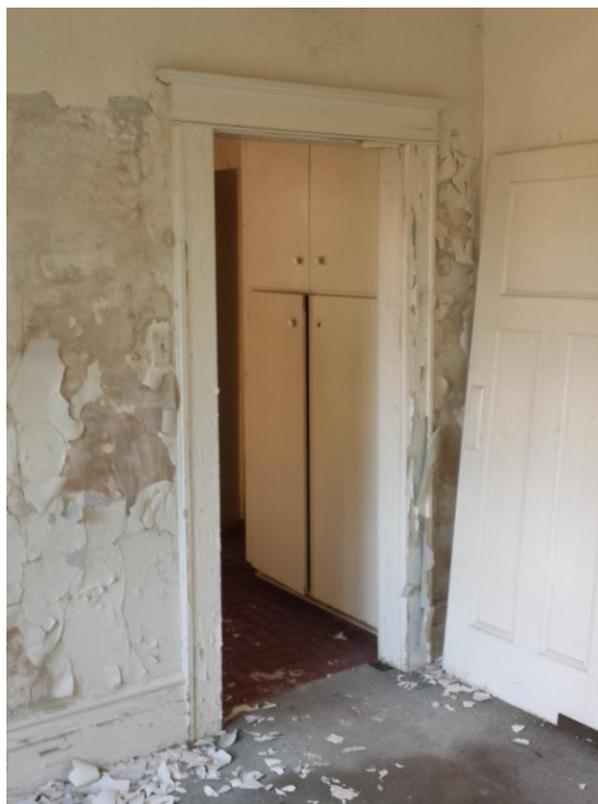
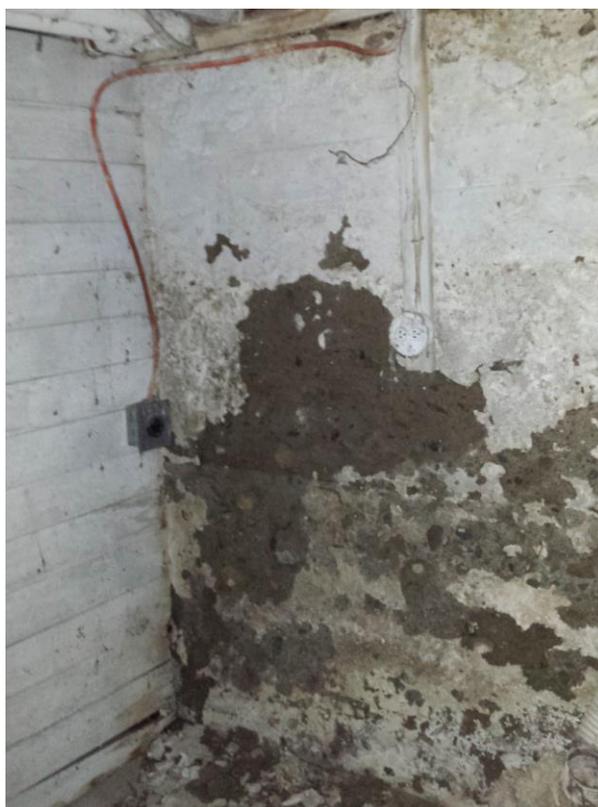
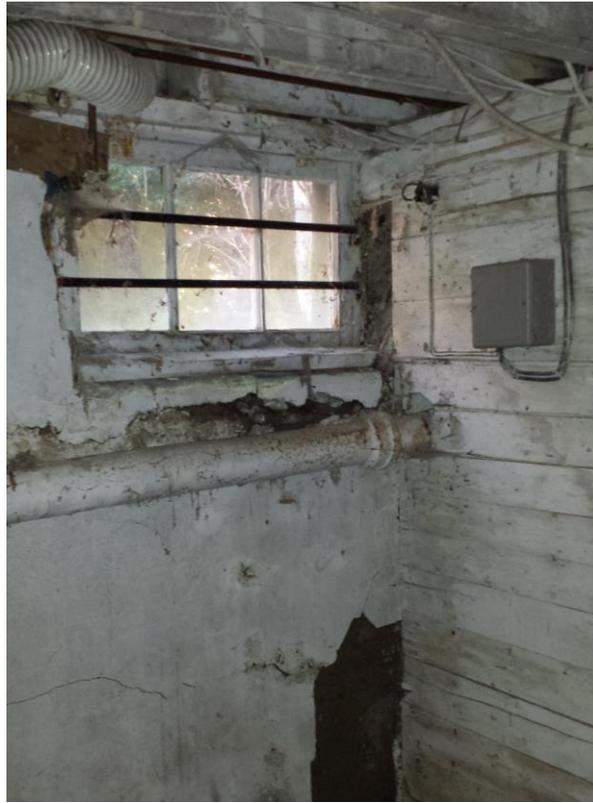
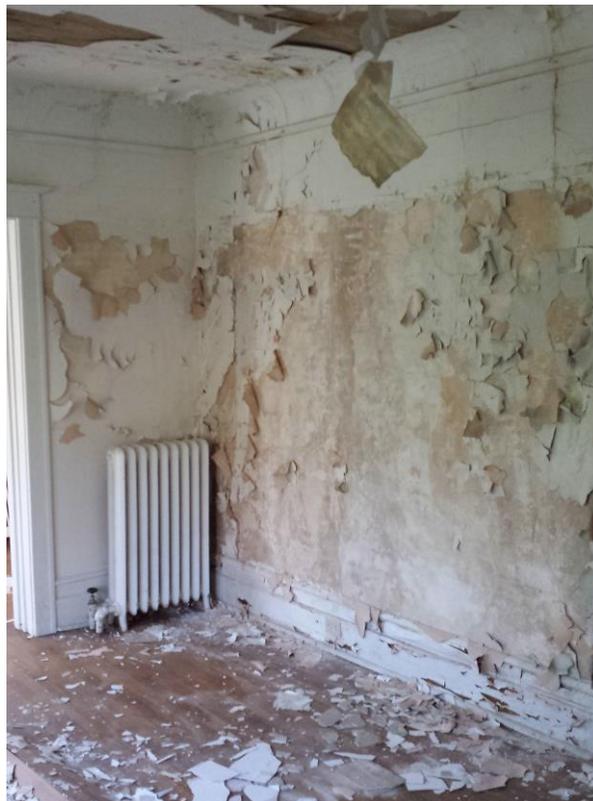
Water presence and long-term excessive moisture accelerate deterioration of all the structural members. Lack of heating in the winter season causes frost penetration in the foundations and all other components weakening the building structure.

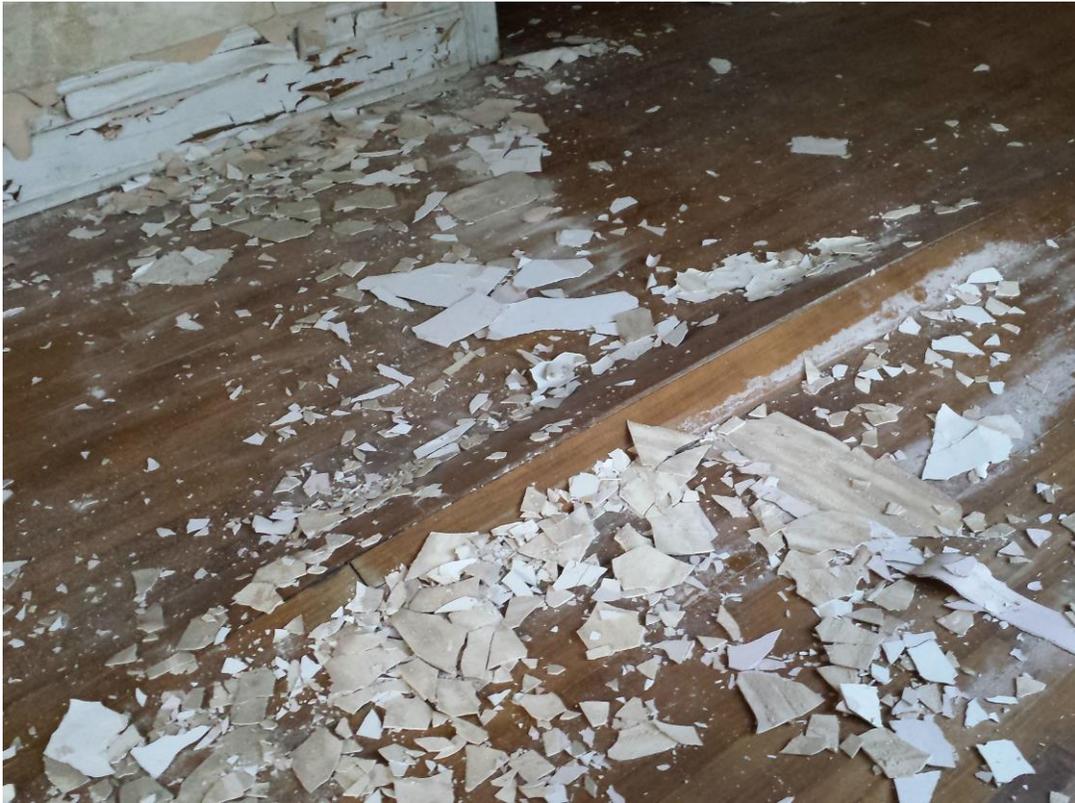
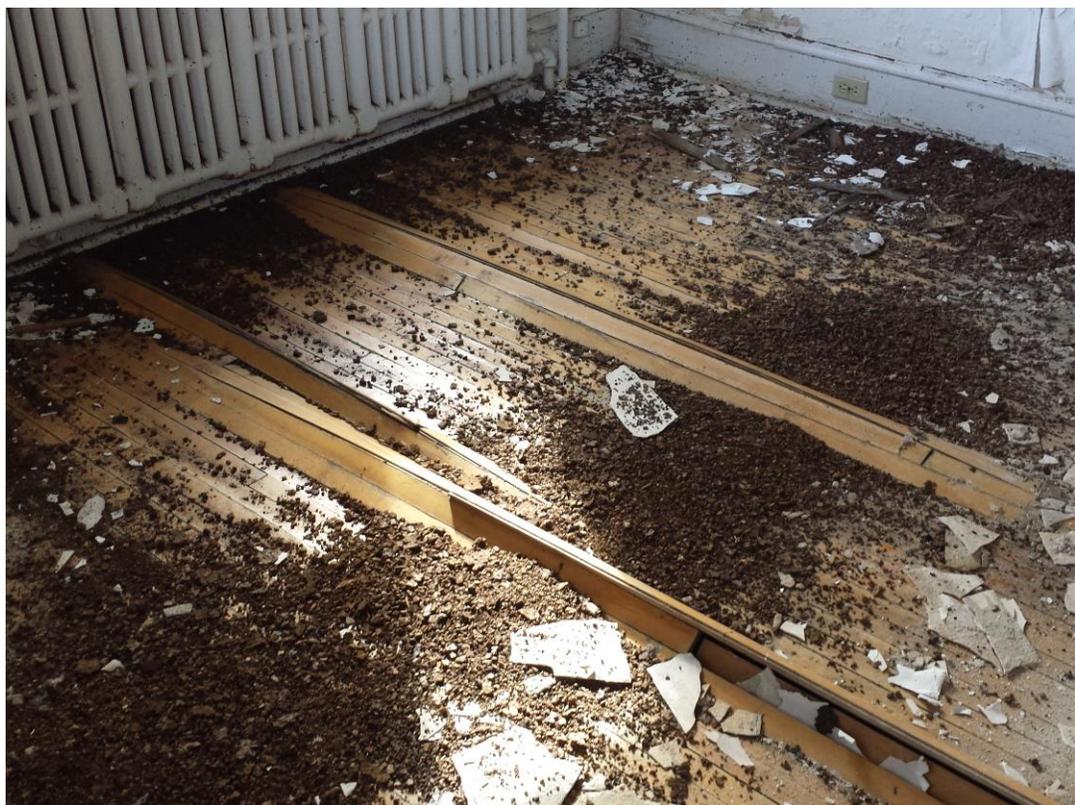
Because of lack of heat and consequently changing temperatures and humidity the wood floor started to bulge in many spots (photos 21, 22). In many areas there are significant deteriorations of structural members due to mould and temperature changes (photos 23 - 27).
