## Tree Information Report v4.0

Submitted as part of Building Permit Application to the City of Ottawa

**Address:** 49 Loch Isle  
**Date of Report:** August 17, 2023  
**Date of Site Visit:** September 9, 2022  
**Prepared by:** Astrid Nielsen, RPF, ISA Certified Arborist ®  
131 Smirle Ave, Ottawa, K1Y 0S4  
[Astrid.nielsen@dendronforestry.ca](mailto:Astrid.nielsen@dendronforestry.ca)  
**Client:** David Baron, David.Baron@cowater.com

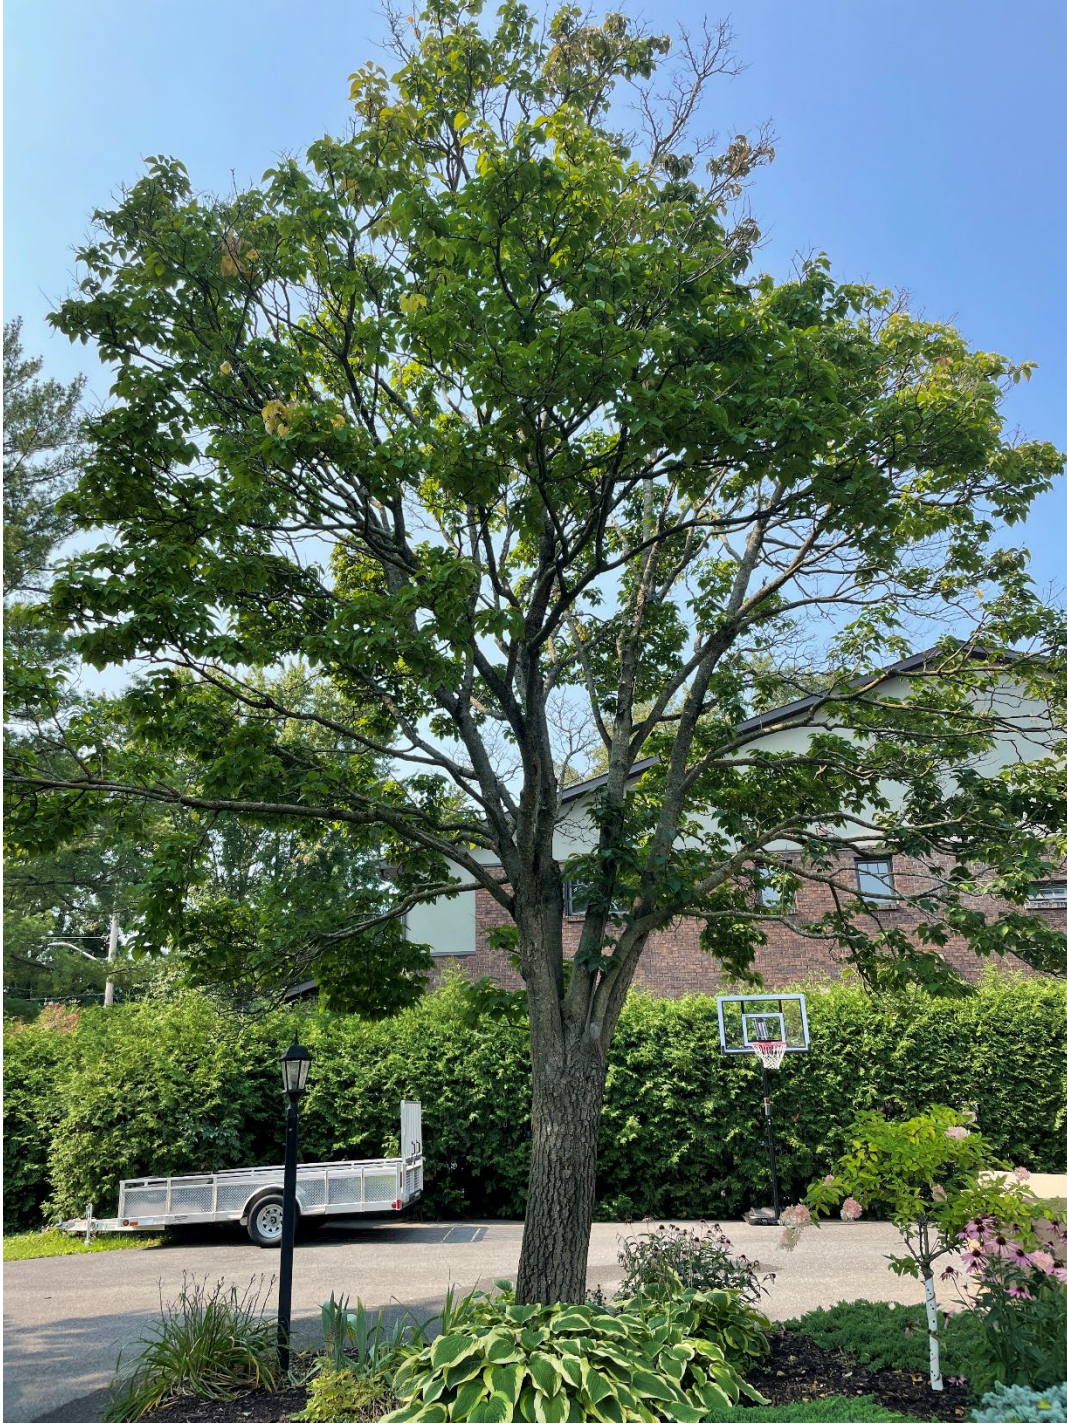
*Figure 1: Tree 2, Japanese lilac in fair/poor condition, to be retained*

*Update to v4.0:* This version simply incorporates the latest site plan provided by the client. Specific impacts to the trees have not increased or decreased from the previous version, and therefore no recommendations for removal or retention have changed. The newly proposed pathway is designed to run around the periphery of the CRZ of **Tree 2** and is expected to have minimal impact on its health.

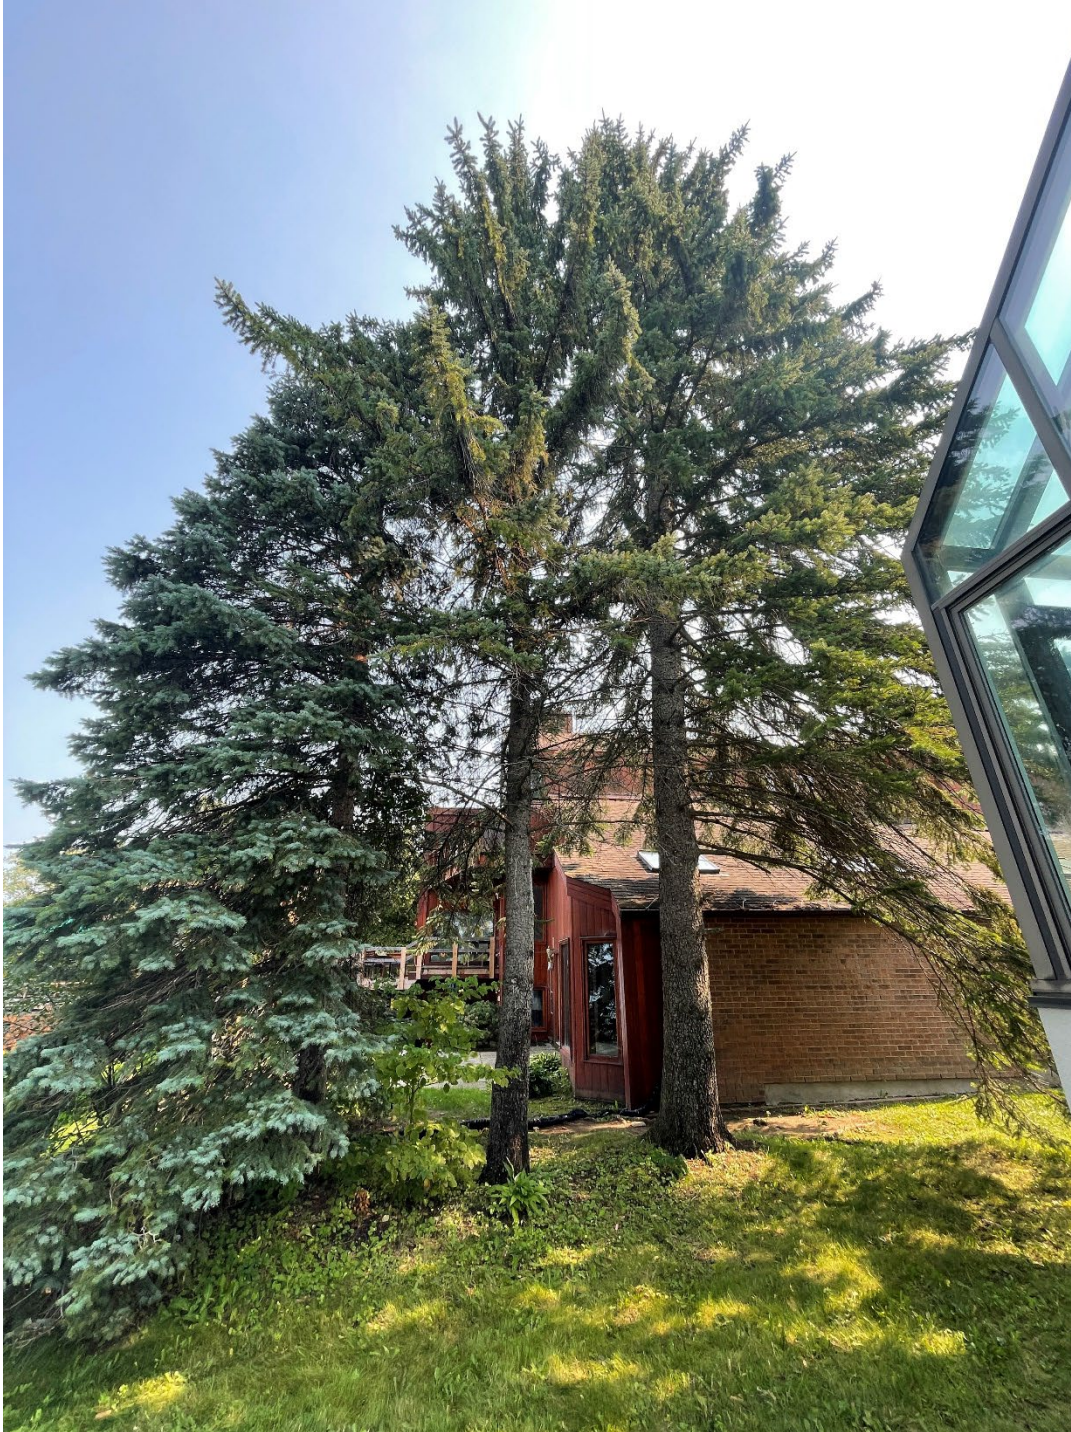
*Figure 2: Clump of white spruce, trees 3-5. Tree 5 on right, to be removed*

*Update for v3.0:* In v2.0 of this report, it was stated that the addition beside **Tree 3** would be built on helical piles. Due to engineering constraints, that has been edited in v3.0 to state it will be built on bigfoot footings on a sono tube installed by auguring to the diameter of the footing. This footing is to be a maximum diameter of 36", to be reduced to 24" if possible. Locations and numbers of footings on the map are approximate.

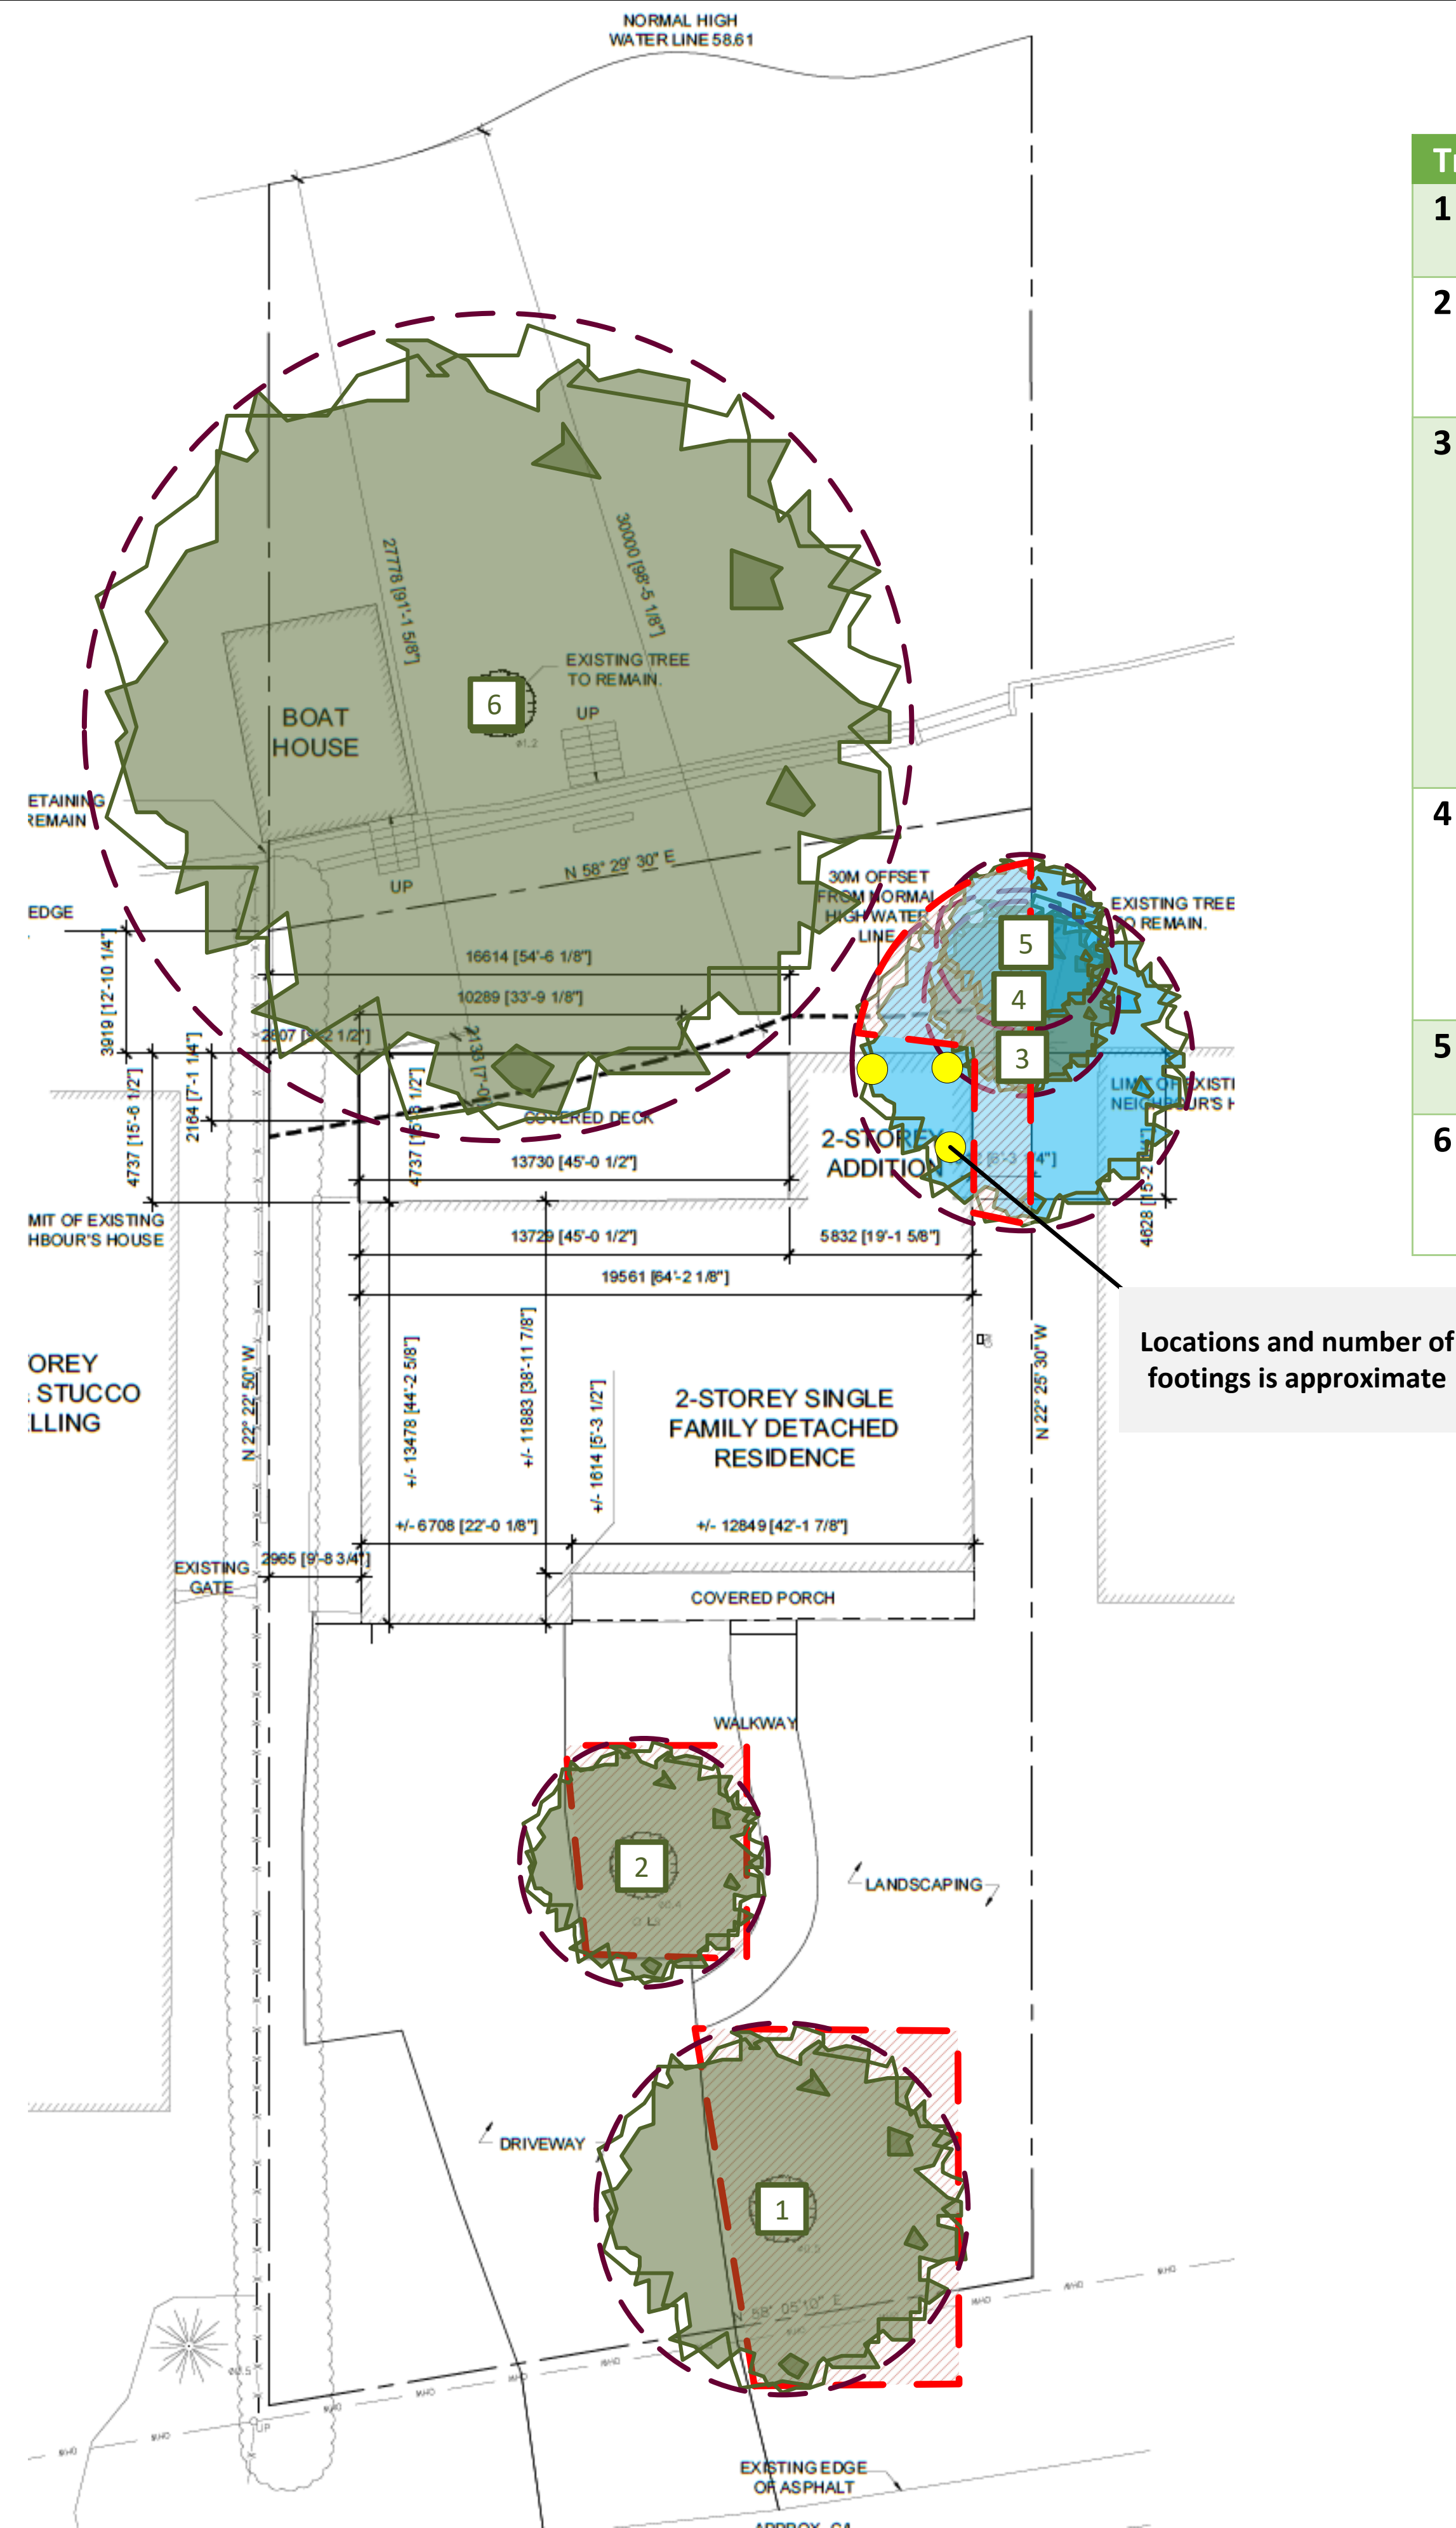
Tree <sup>1</sup>	Species	DBH (cm)	Condition	Recommendations
1	Pin oak ( <i>Quercus palustris</i> )	56 cm	Good	Protect with fencing as per City of Ottawa Tree Protection Specifications (March 2021)
2	Japanese lilac ( <i>Syringa reticula</i> )	37 cm	Fair/Poor, significant dieback throughout crown	Protect with fencing as per City of Ottawa Tree Protection Specifications (March 2021)
3	Colorado spruce ( <i>Picea pungens</i> )	51 cm	Good	Tree is approximately 1.5 from the foundation of the new addition. Foundation within CRZ to be bigfoot footing on a sono tube installed by auguring to the diameter of the footing; 36" maximum, to be reduced to 24" if possible; tree should be monitored during construction to ensure that structural roots have not been severed and tree is stable; lower branches will require pruning by certified arborist to accommodate the 2-storey addition
4	Colorado spruce ( <i>Picea pungens</i> )	29 cm	Good	Retain and protect. Excavation for the new sunroom will be close to tree, but the tree is smaller and should be able to withstand stress; Keep excavation as far from tree as possible and monitor root loss and risk of failure during excavation

5	Colorado spruce ( <i>Picea pungens</i> )	27 cm	Good	Protect with fencing as per City of Ottawa Tree Protection Specifications (March 2021)
6	Silver maple ( <i>Acer saccharinum</i> )	120 cm (estimate)	Good	No action required. Recommend pruning for wind resistance every 2-3 years

Prior to any site works, protective fencing should be installed around the TPA as indicated in Map and maintained until all construction on site has been completed as per the City of Ottawa Tree Protection Specifications (March 2021). **Failure to install and maintain fencing as indicated in this report may result in fines from the city.**
