Committee of Adjustment

City of Ottawa

ARBORIST'S REPORT: 60 LEES AVENUE

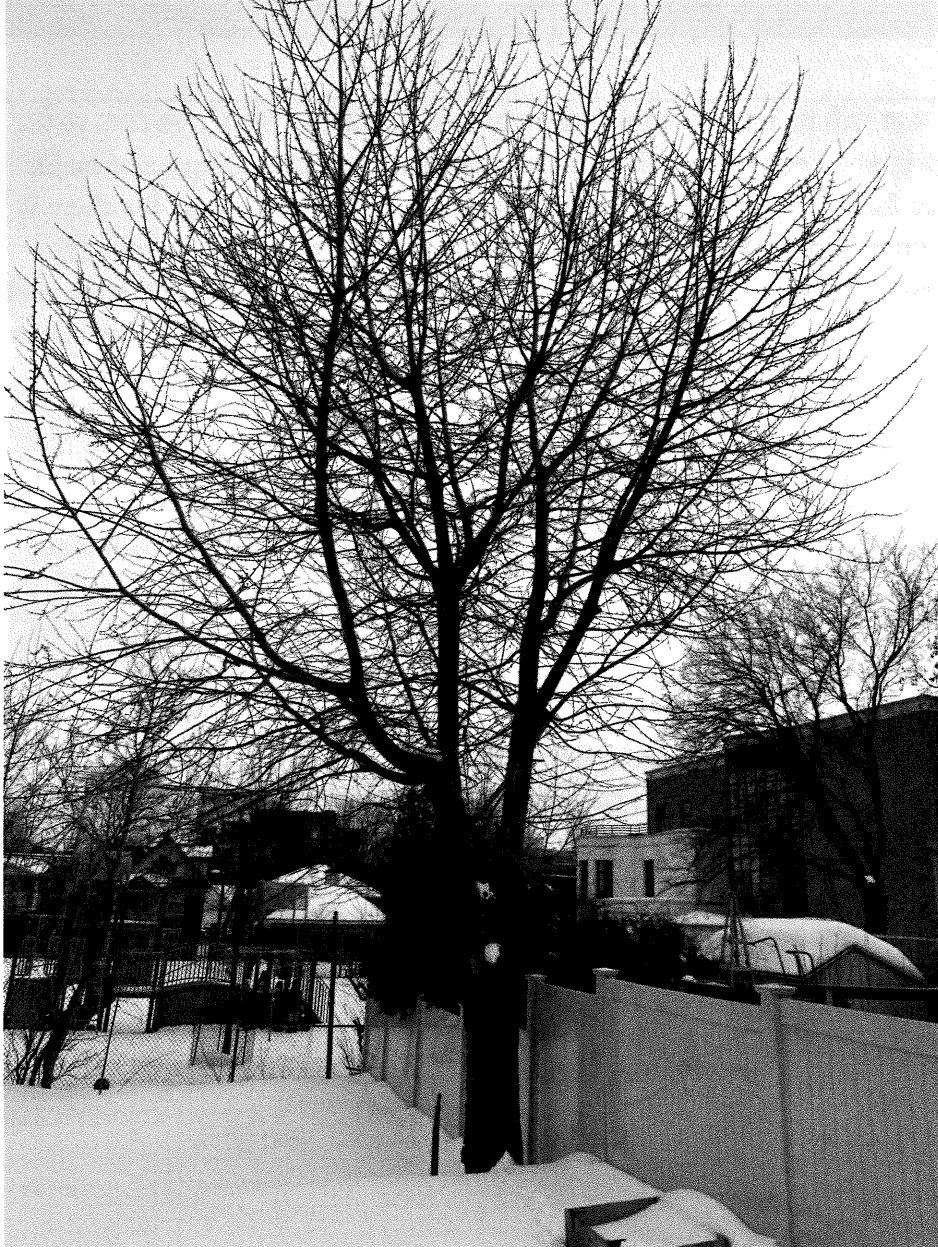
The only distinctive tree that will be impacted by construction is a mature cherry tree next to the western fence. The tree is in good condition, with a full canopy and no signs of illness or major structural defects. The tree forks into two codominant stems at about 7ft from grade, but there is no included bark, so the union appears to be structurally sound. No major hollows, cracks or signs of fungal infection were present. Due to snow cover, it was not possible to observe the root crown, but given the tree's health and vigour, it is unlikely that any girdling roots or other issues are present. Based on the DBH and species, the tree is estimated to be between 50-60 years old.

The tree conflicts with planned construction as it falls partially within the footprint of the proposed building. It is located near the southwest corner of the proposed building, which will be approximately 60cm from the property line³. On-site measurements indicate that this will place the outer edge of the building about halfway through the trunk of the tree.

Image 1. Cherry Tree – Crown and surroundings.

Retention of the tree is not viable without unreasonable modifications to proposed construction. If retained, the tree's critical root zone (CRZ) would have to be blocked off with protective fencing at a minimum of 1.5m⁴. As a result, the western edge of the proposed building would have to be pushed 2.1m to the east of where it is currently planned to be. This would result in a 40% reduction of the building's width.

Given that protecting the tree during construction is not viable, it is recommended that the tree be removed and replaced at a 2:1 ratio as per the Tree Protection Bylaw.

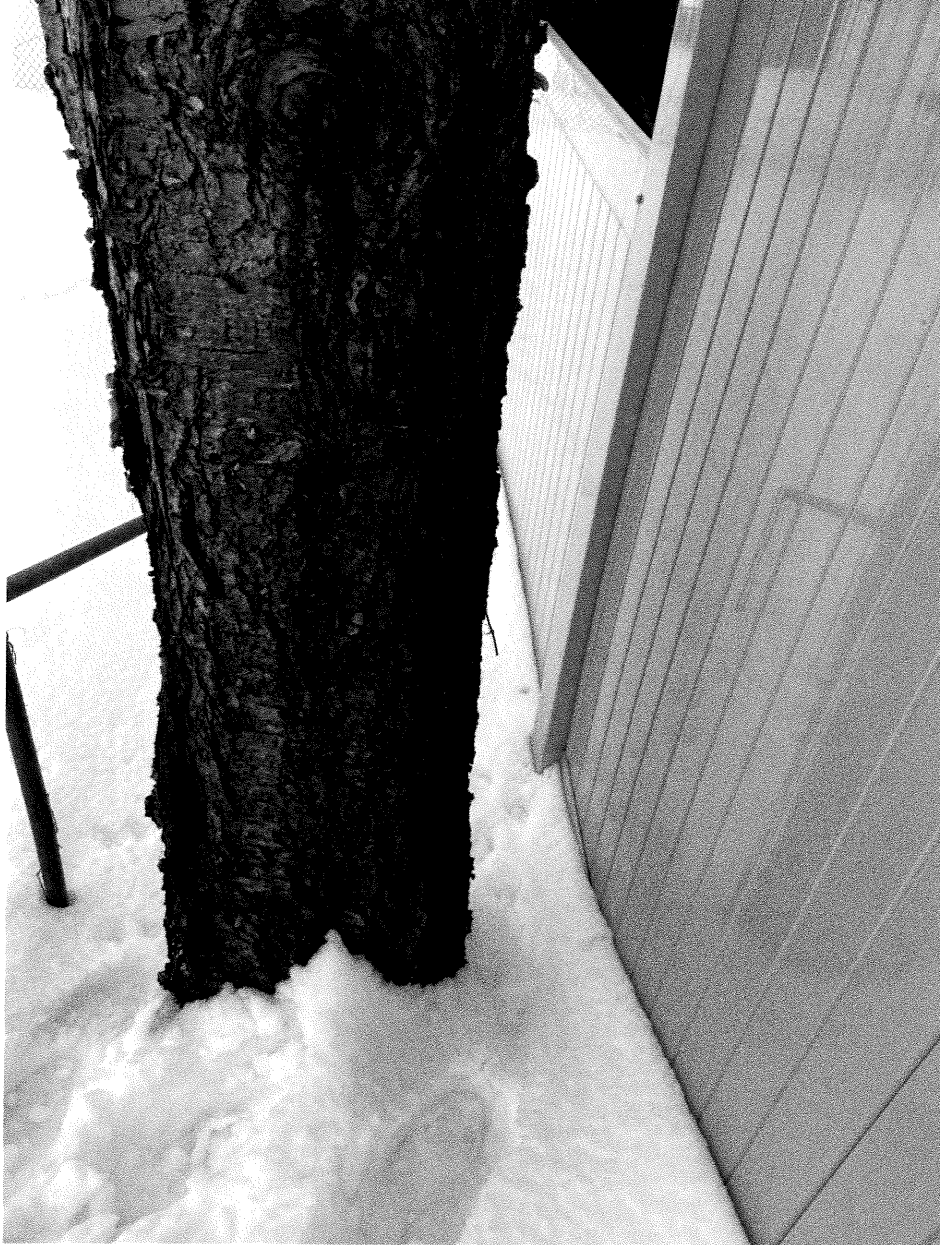
Image 2. Cherry Tree – Trunk and fence.

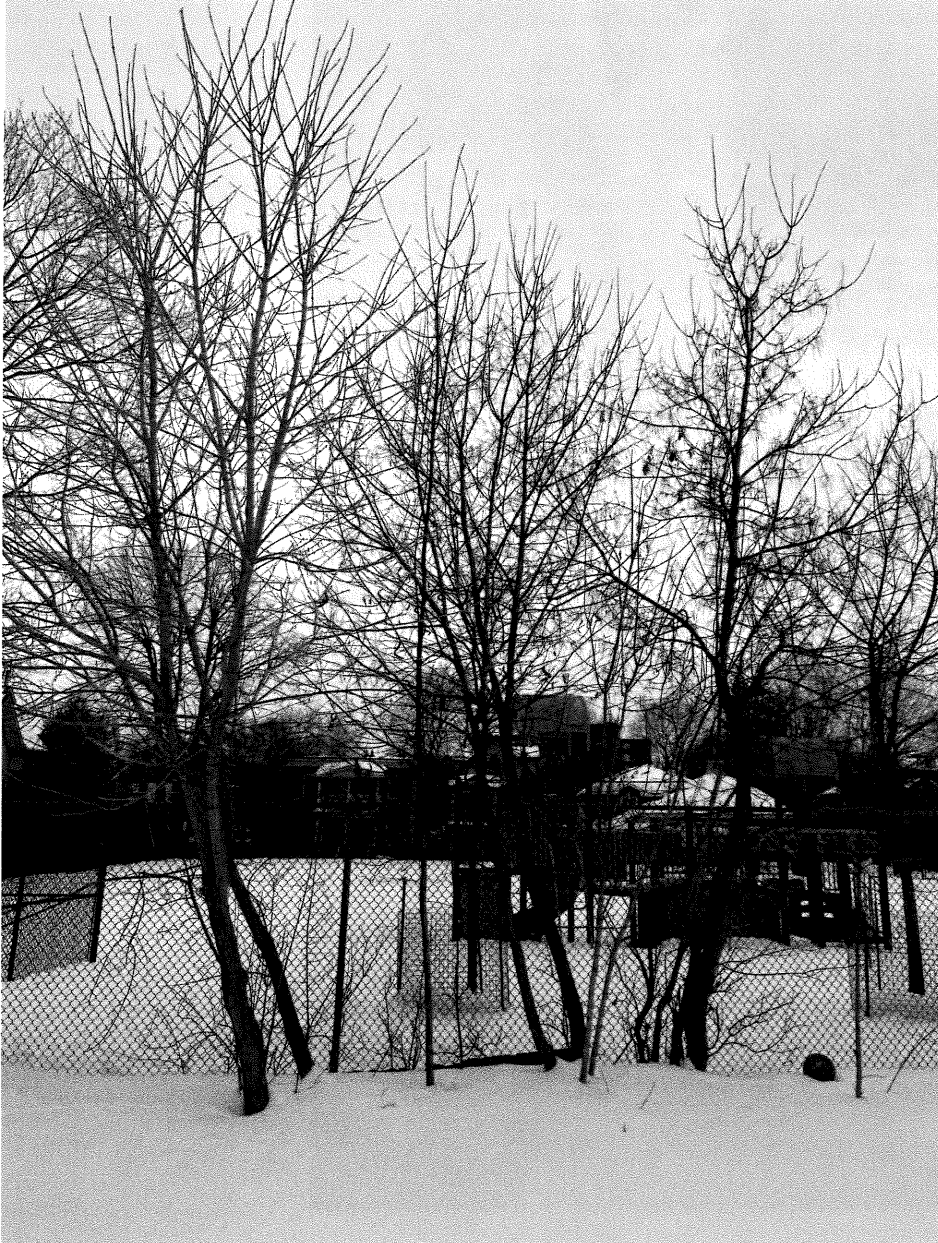
Several other trees on the property fall below 30cm DBH and therefore do not require any protections or compensation.

Image 3. Manitoba Maples and Elm Tree.

It is recommended that the Manitoba maples be removed as they are invasive and could suppress the replacement trees.

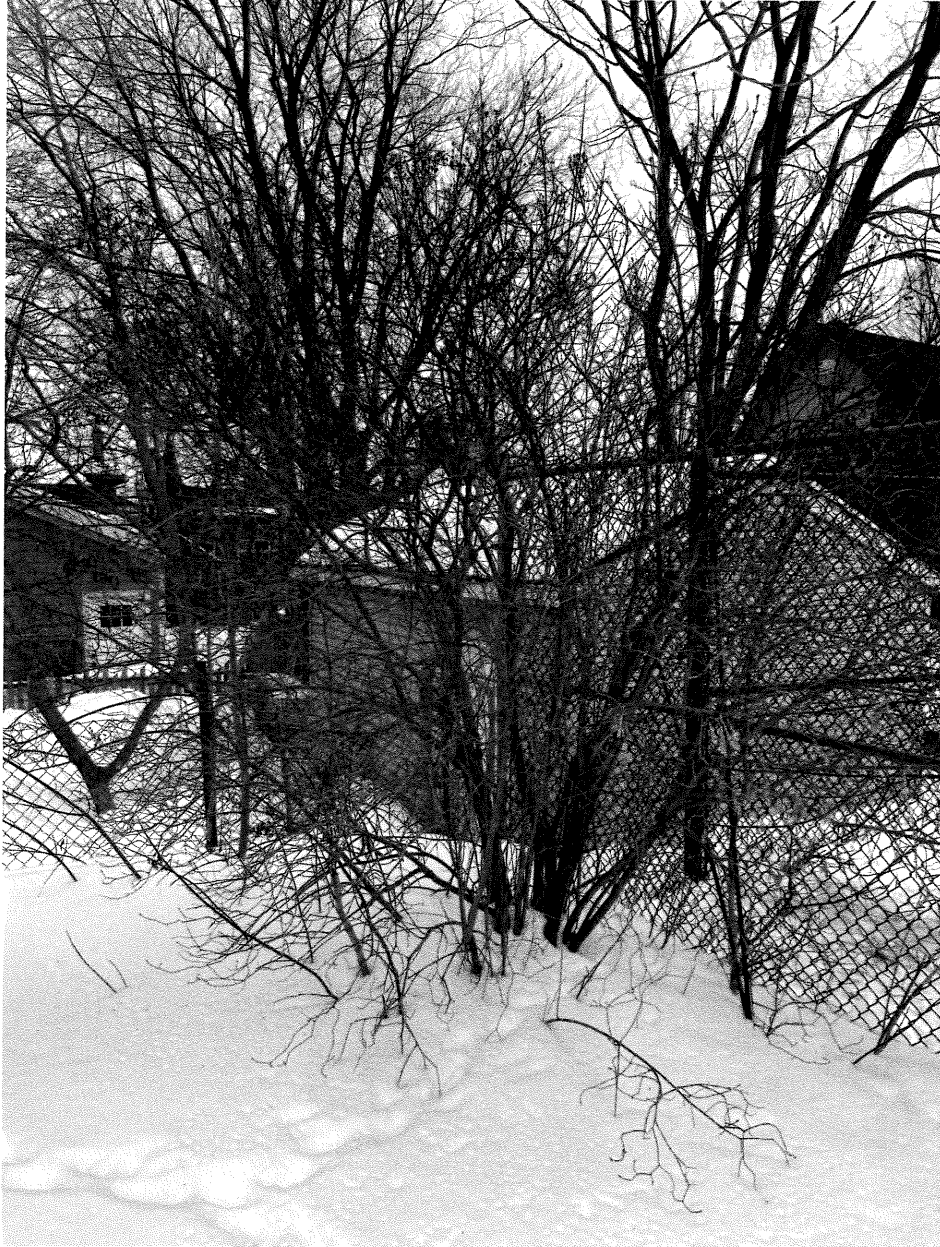
Image 4. Common Lilac.

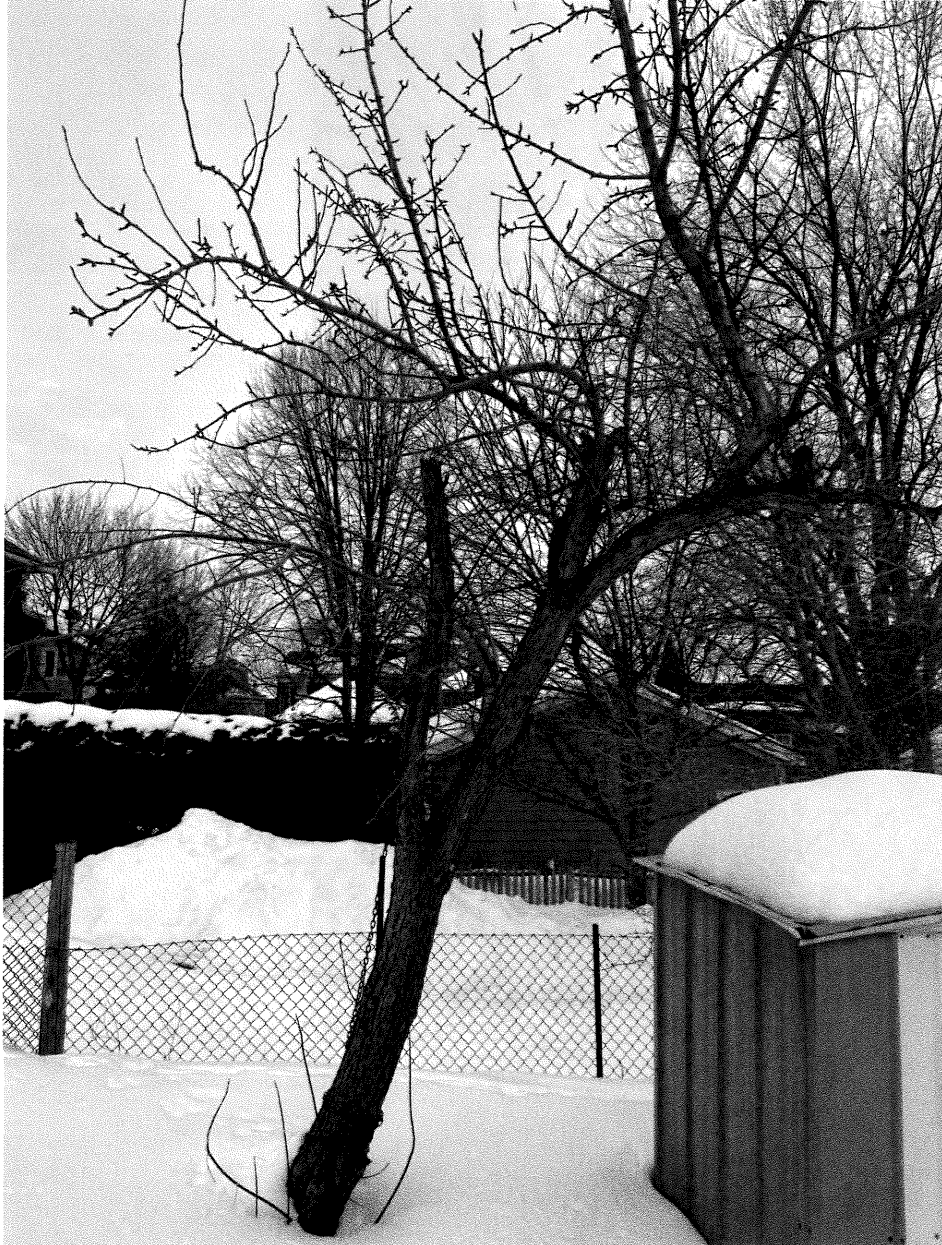
Image 5. Apple Tree.
