Property is 49 Fairmont Ave., Ottawa

Inspection date: 2023-06-12

The objective of this preliminary report is to identify all protected trees on this and adjacent properties whose Critical Root Zones (CRZ's) fall within the proposed area of construction along with their condition.

Tree Information Report for 49 Fairmont Avenue, Ottawa

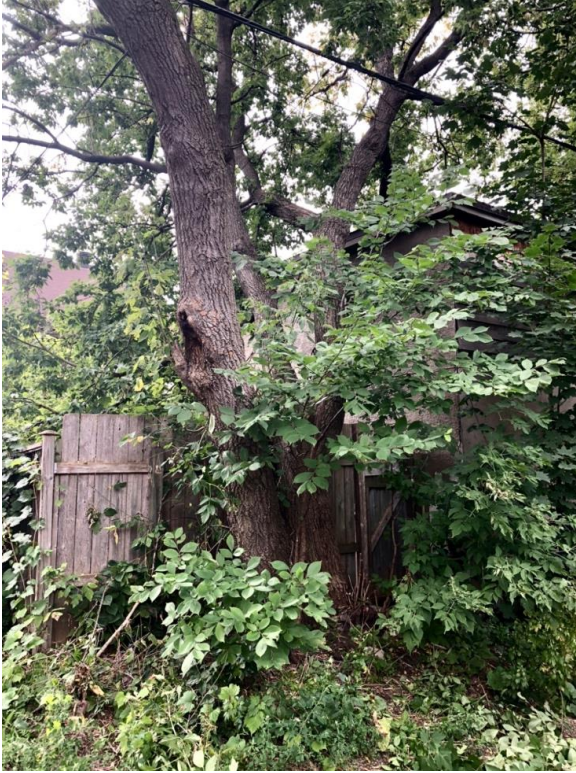
Photo 1 Tree #1 Manitoba Maple

This mature tree has a double trunk with co-dominant stems.

Owners should prune out dead wood and remove some weight from the leaning stem or remove the stem to trunk level. During construction the developer should provide protection to the CRZ where it extends into 49 Fairmont. This area (about 20% of the total CRZ) is currently a compacted gravel parking space. Photo 5, p. 6. *Acer negundo* shows good tolerance to root disturbance¹. Shallow excavation and maintaining this area as a parking spot should not adversely affect this tree.

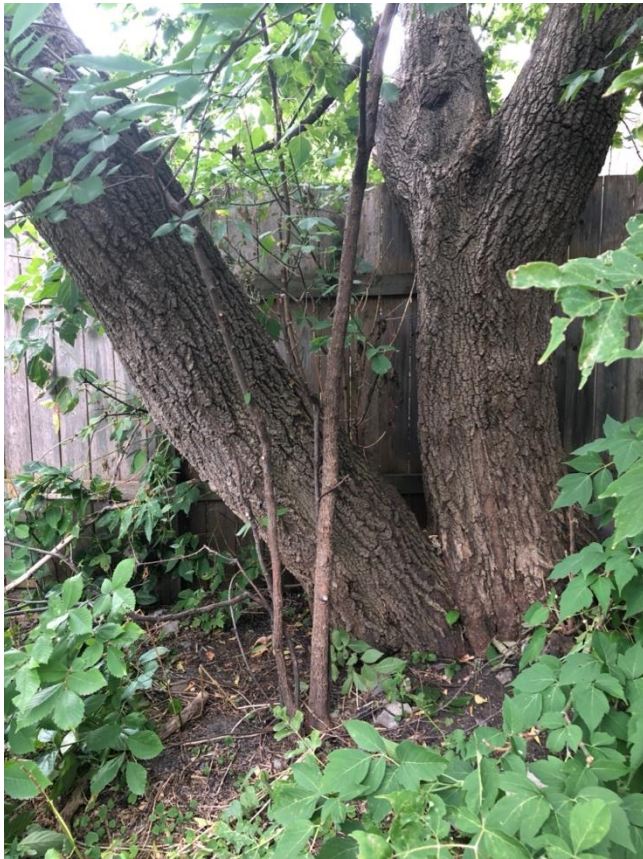
Photo 2 Tree #1 Double trunk, leaning stem

One stem is leaning at a 30° angle from the vertical and is in contact with the service cables.

The other stem has a slight lean over a structure at 45 Fairmont.

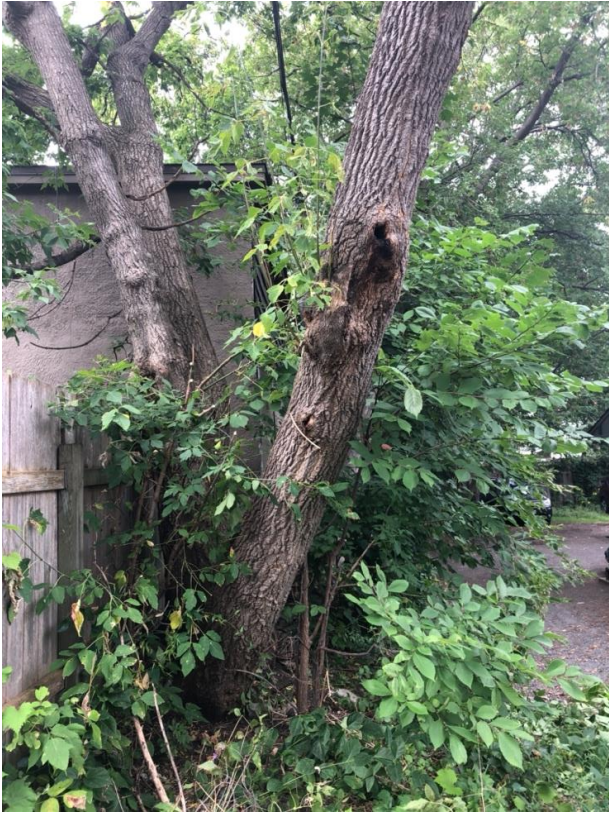
Photo 3 Tree #1

The tree has decay in leaning stem and cavities at 2 M and 2.5 M above grade. Photo 3, p. 4.

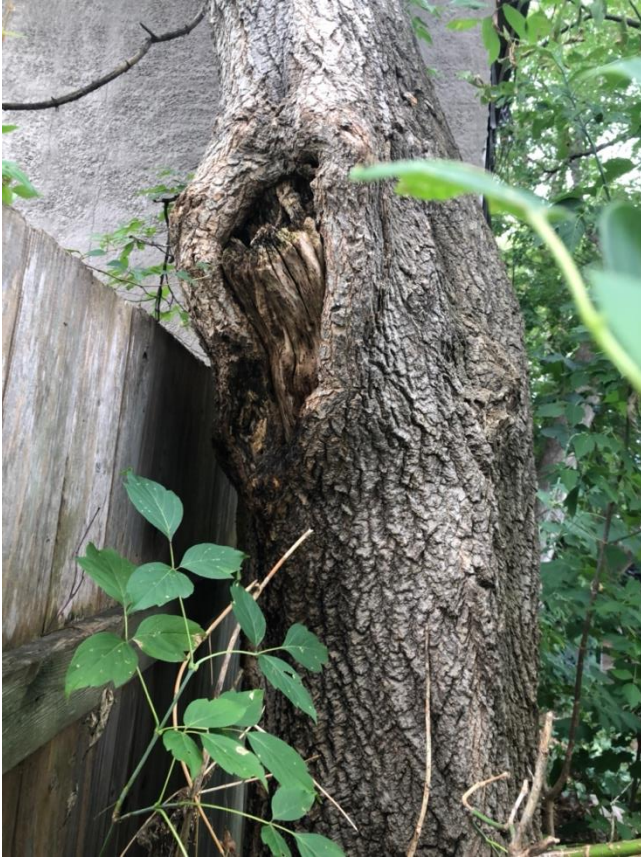
Decay in stems Photo 4 Tree #1

There is visible decay at about 1.5 M. Photo 4, p.4. as well as in root flare.

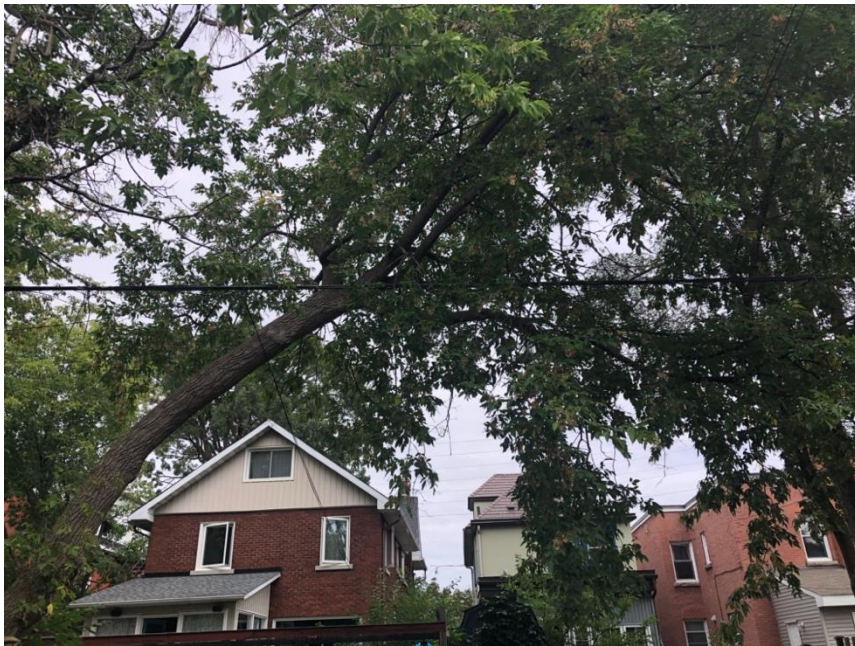
Photo 5 Tree #1 Leaning stem with excessive end weight

This stem has excessive end weight. Photo 5, p.4.

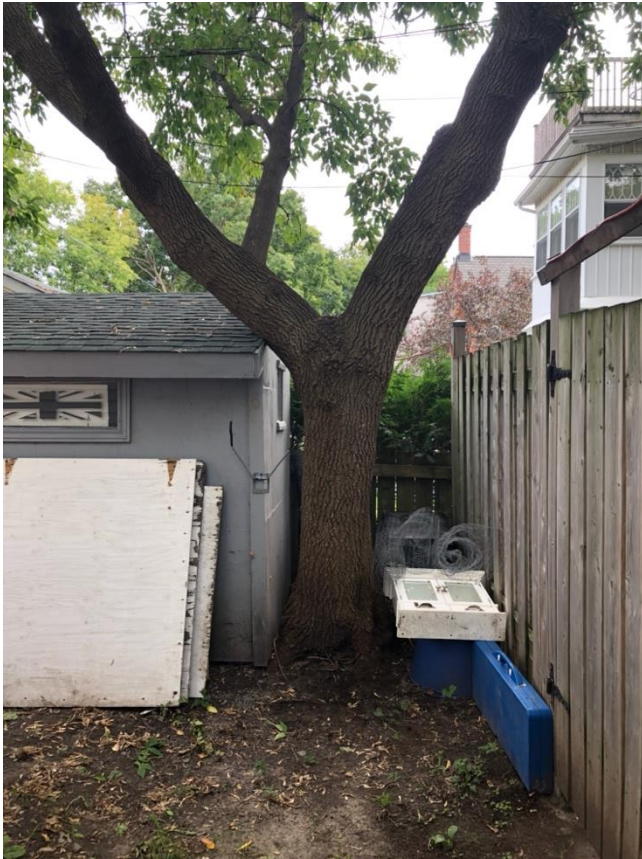
Photo 6 Tree #2 View from north side

This mature tree has a single trunk and only a slight lean.

One branch is growing around the roof of a small shed.

Dieback and deadwood comprise about 20% of the canopy.

Service cables run through the canopy.

The trunk of the tree is close to the area proposed for excavation shown in pink in Drawing #2 (Proposed Plan). Given that Manitoba maples are tolerant of some root loss¹, if the limit of excavation was reduced to 2' (60 cm) from the building footprint the tree may be retained. It would lose roots in ~30% of the CRZ. The existing parking area which is compacted soil-gravel, would require some shallow excavation. It is unlikely that there are feeder roots in this area because of the compaction. However, there may be some under the small shed and some of this area would part of the shallow excavation for future parking.

By reducing the area of excavation for the foundation and the sunken garden to 60 cm from the forms rather than the standard 1.2 M, just in the area of the CRZ would reduce the impacted by the construction. Hand shovelling or soil washing near the tree as shown in Drawing #2 and shoring up of the soil within the CRZ should mitigate damage and increase the likelihood of the tree's survival. Protective fencing should be erected as outlined in Drawing #2.

Selective pruning of the branches near the second level of the proposed dwelling could be balanced with some removal of branches on the opposite side of the tree.

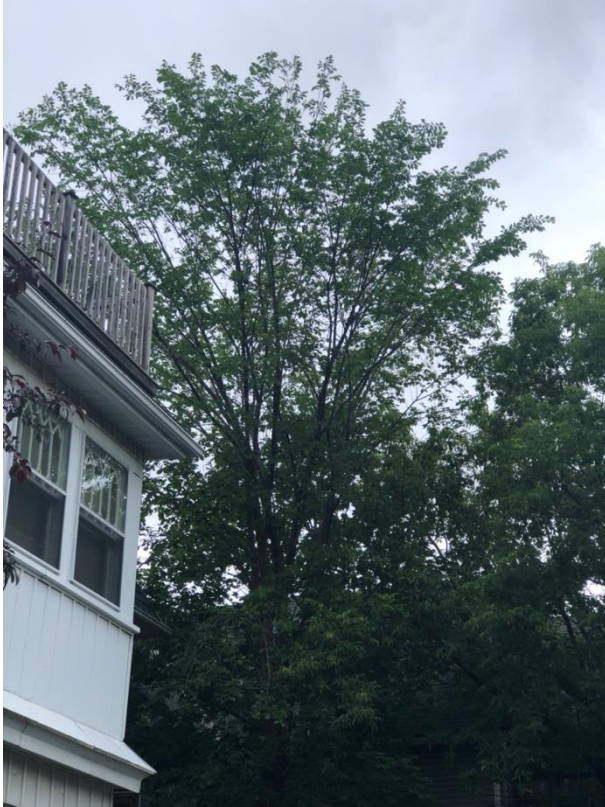
Photo 8 Tree #3 Elm

Overall condition of this tree is good.

Canopy appears healthy but leaf size is smaller than usual.

Species is highly susceptible to Dutch Elm Disease.

This tree has shallow roots. (See Photo 9). Most of them, along with the trunk, are visibly within the area proposed for excavation. This tree should be removed.

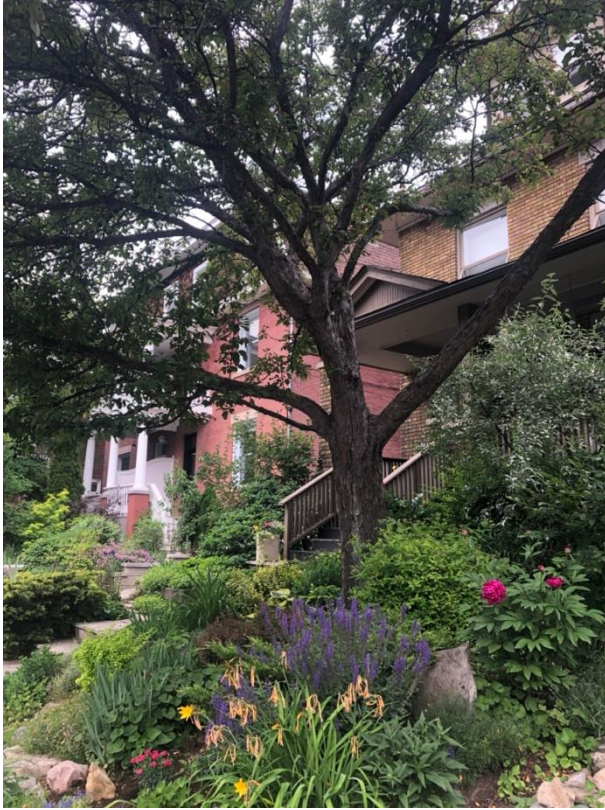
Photo 10 Flowering crab, Tree #5, 45 Fairmont

This tree is in good condition with only a little deadwood in it.
The CRZ comes close to the border with 49 Fairmont.

The perimeter fencing for the construction site will be all that is required to protect this tree and the CRZ.

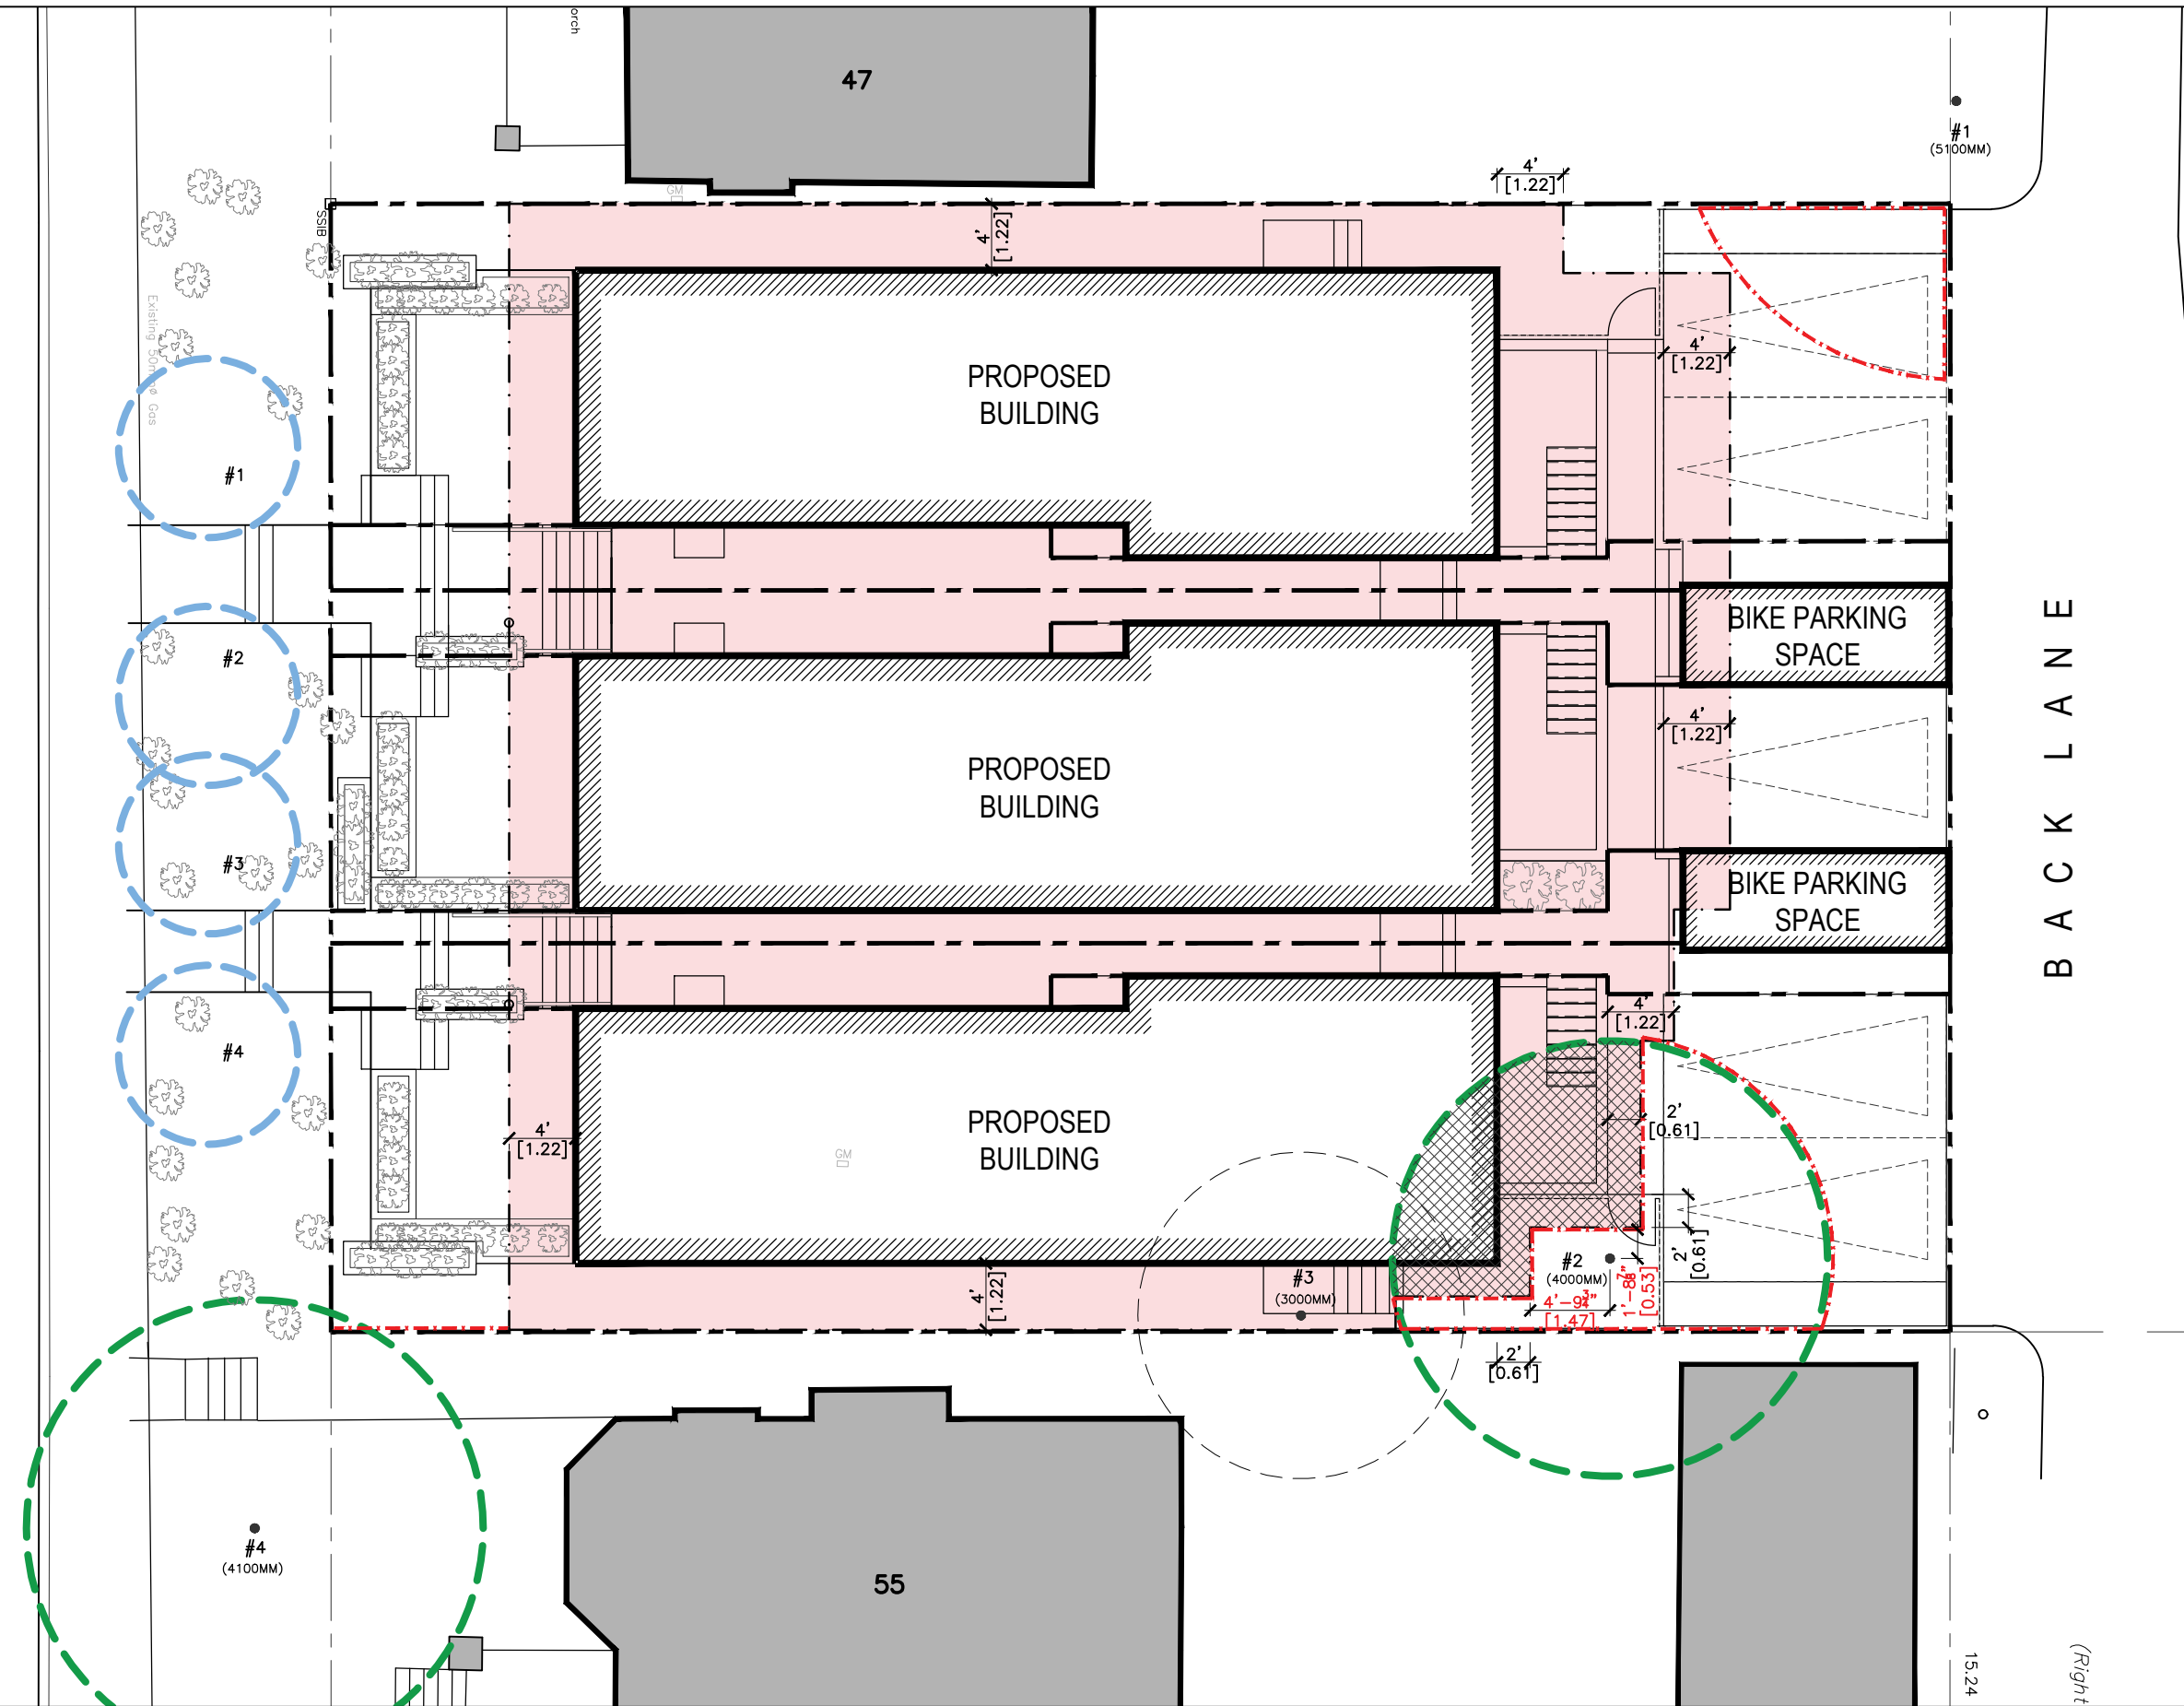
DRAWING TITLE
TREE PLAN
AREA OF EXCAVATION
AND TREE CRZ

- EXISTING TREE (*CRZ MM)
- EXISTING TREE (*CRZ MM)
- EXISTING TREE (*CRZ MM)
- * CRZ: CRITICAL ROOT ZONE
1 RADIUS OF CRZ = x10 DBH
(DIAMETER AT BREAST HEIGHT)
DEFINITION FROM TREE PROTECTION BY-LAW OF CITY OF OTTAWA
- PROTECTIVE FENCING
- PARKING FLEX SPACE
- AREA OF EXCAVATION
- AREA OF *CRZ OF TREE WITHIN THE EXCAVATION AREA
- TREE #2:** 165.6 FT² [15.4 M²]
(30.6% OF AREA OF CRZ)
