November 10, 2020
File: PG5544-LET.01

154 Colonnade Road South
Ottawa, Ontario
Canada, K2E 7J5
Tel: (613) 226-7381
Fax: (613) 226-6344

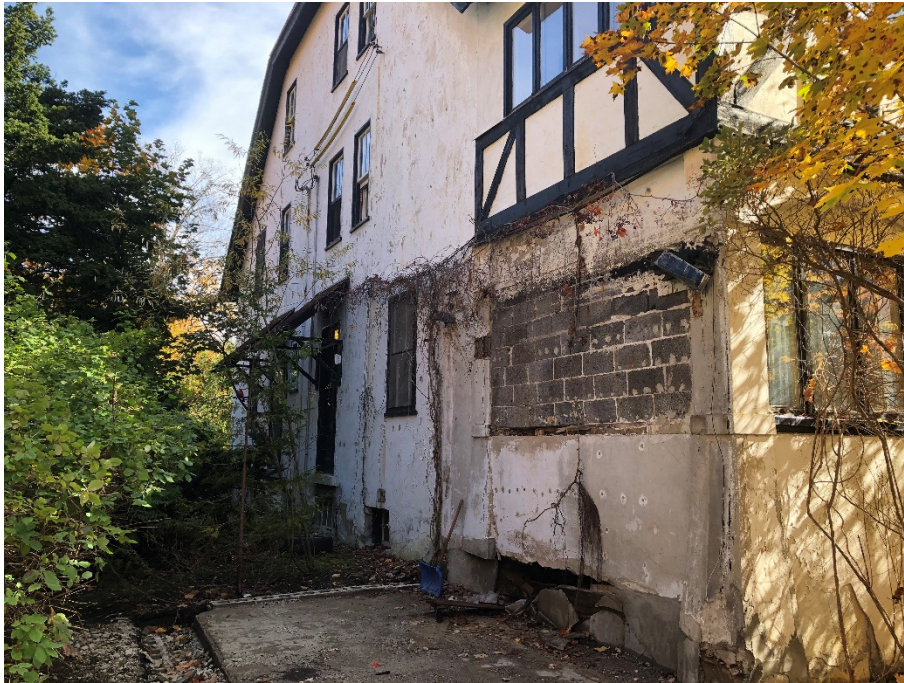
Photograph 1: Deteriorating façade on the north façade of 1112 Lisgar road.

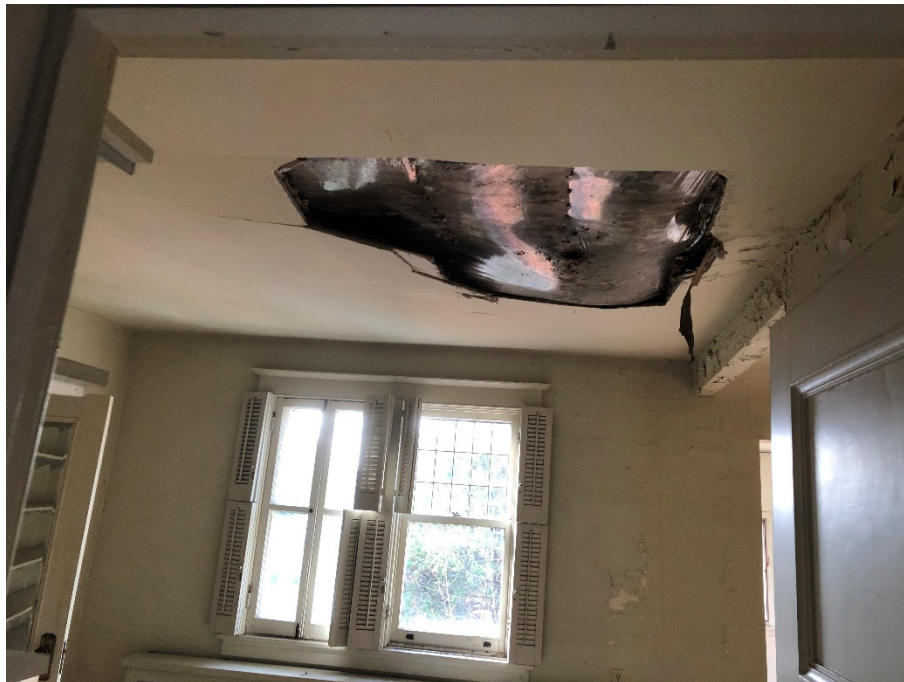
Photograph 2: Collapsed ceiling on second floor of 1112 Maple Road.

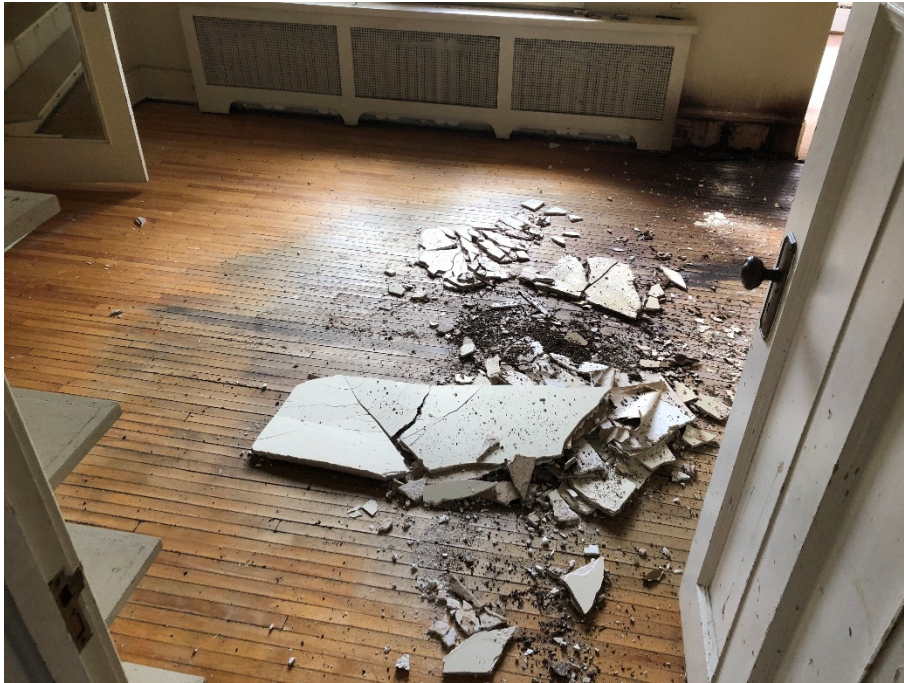
Photograph 3: Ceiling material from collapsed ceiling on second floor. Showing signs of moisture staining indicated cause of failure was from moisture intrusion.

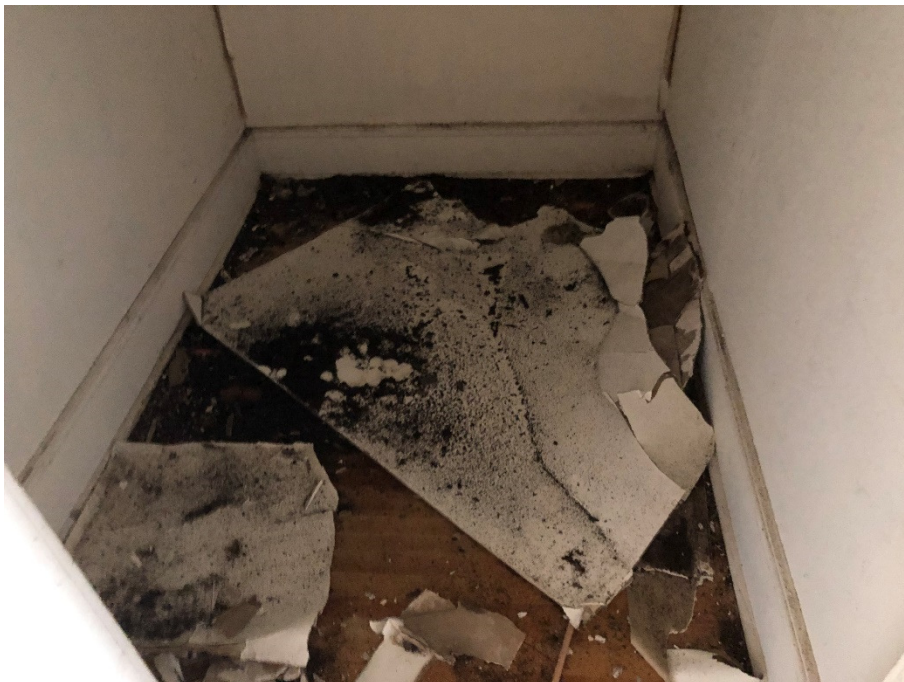
Photograph 4: Additional collapsed ceiling material within closet on third floor of 1112 Lisgar Road.

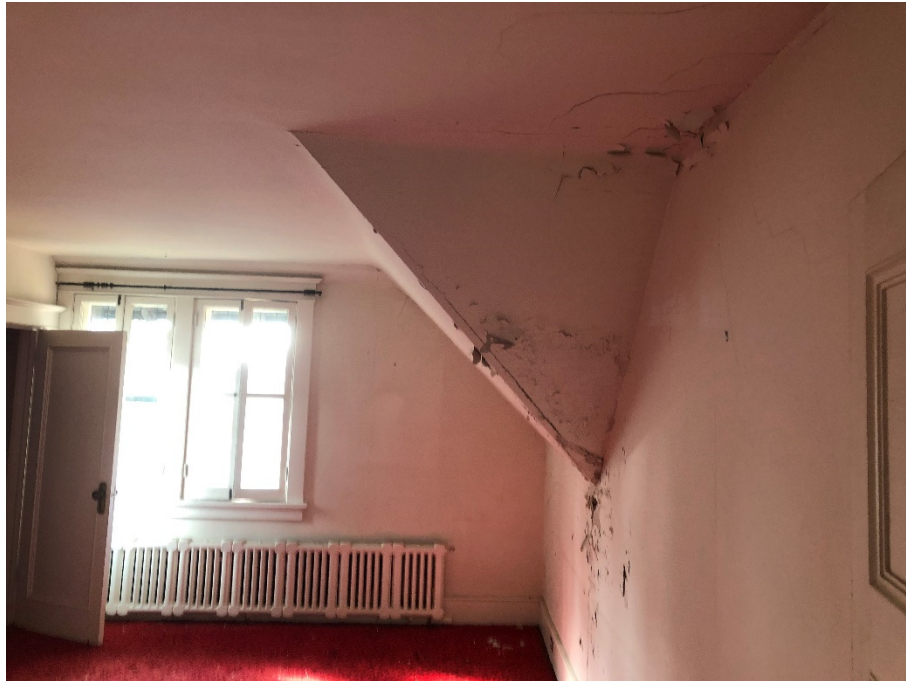
Photograph 5: Deteriorating ceiling and wall material from moisture intrusion on third floor of 1112 Lisard Road.

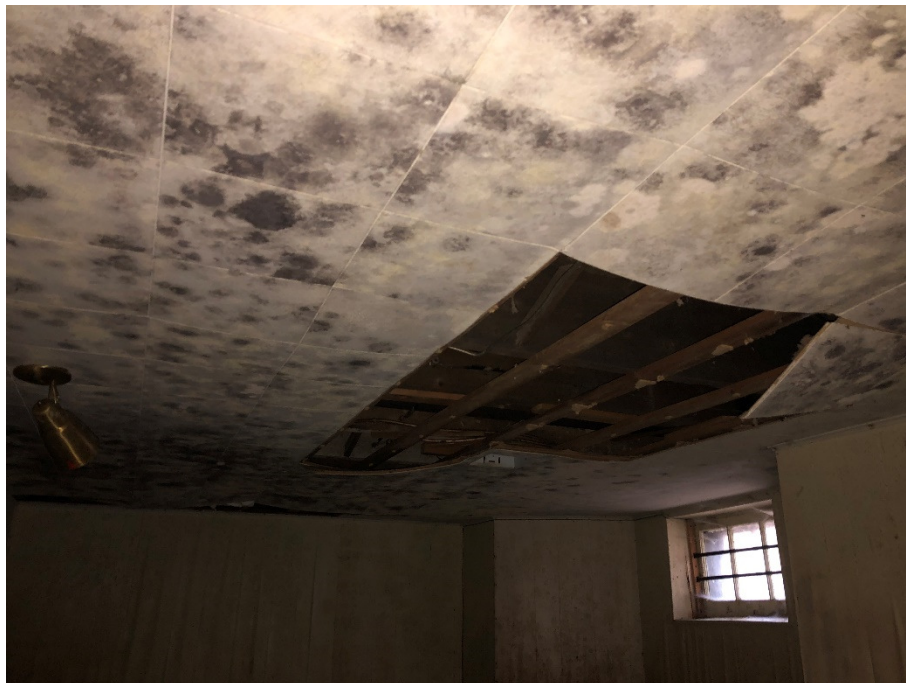
Photograph 6: Basement office of 1112 Lisgar Road showing extensive mould growth from moisture intrusion occurring on floors above.

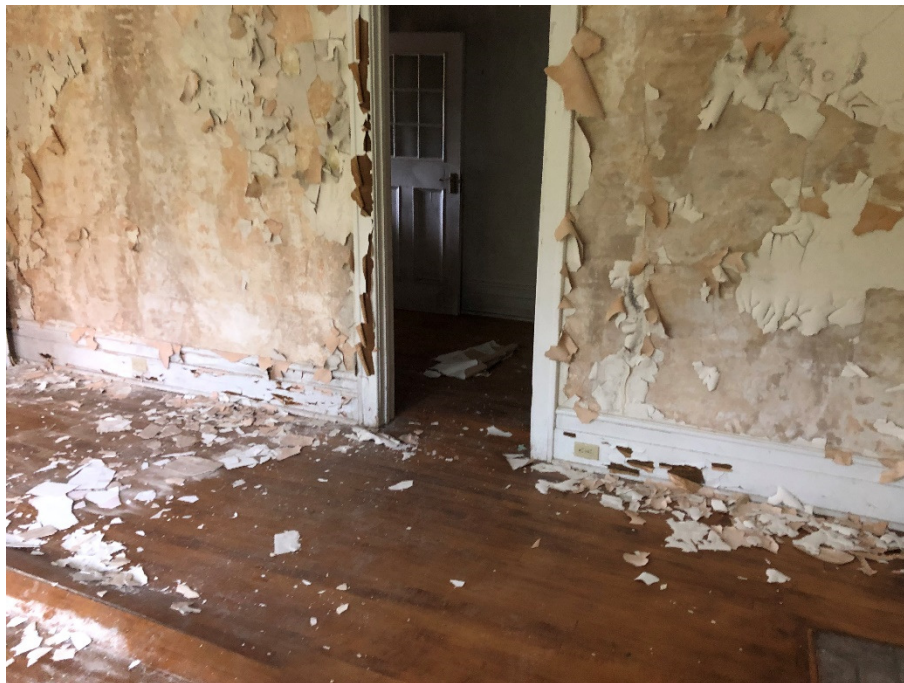
Photograph 8: Deteriorating walls on ground floor of 1 Maple Lane due to prolonged moisture intrusion.

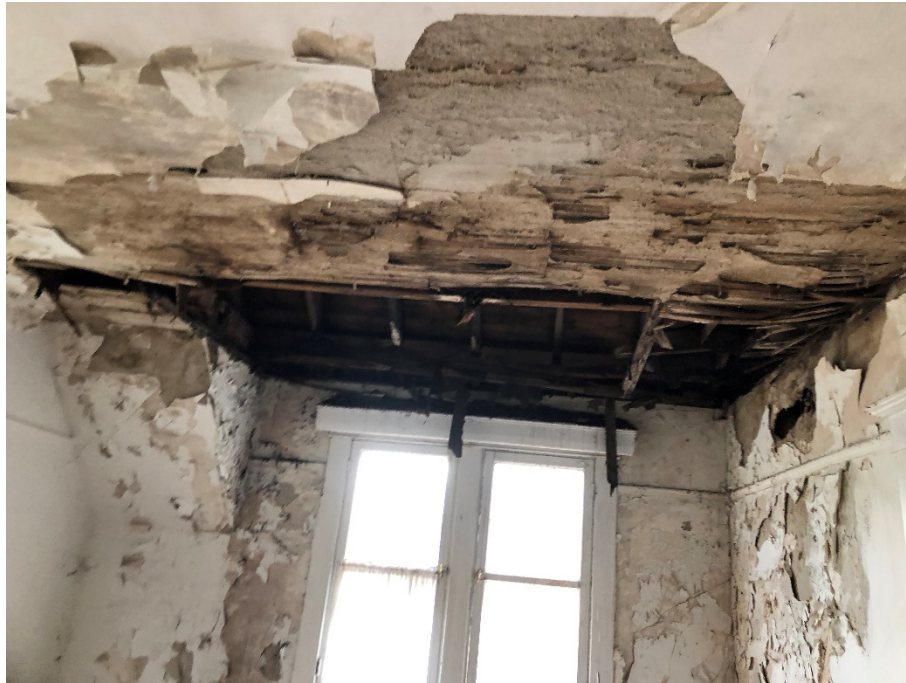
Photograph 9: Collapsed ceiling on ground floor of 1 Maple Lane due to moisture intrusion.

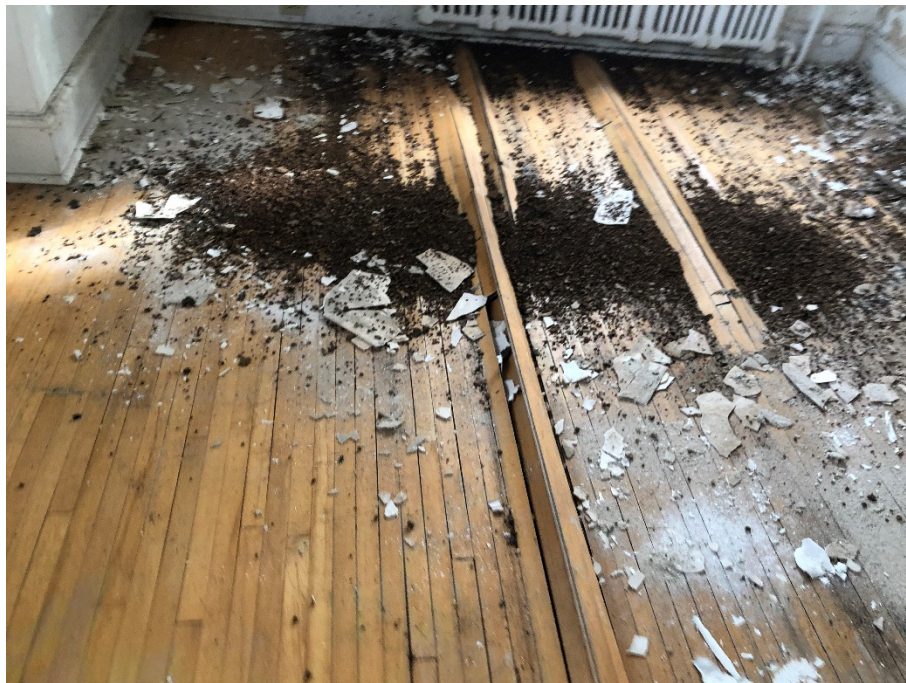
Photograph 10: Ceiling material from ground floor ceiling of 1 Maple Lane. Signs of significant water intrusion is shown from buckling hardwood flooring material.
