Planning, Infrastructure and Economic Development Dept.
City of Ottawa
110 Laurier Ave.
Ottawa, ON

March 4, 2021
Revised: August 13, 2021
Project No. 21113

**RE: 1 Maple Lane and 1112 Lisgar Rd – Structural Condition Reports
Heritage Peer Review**

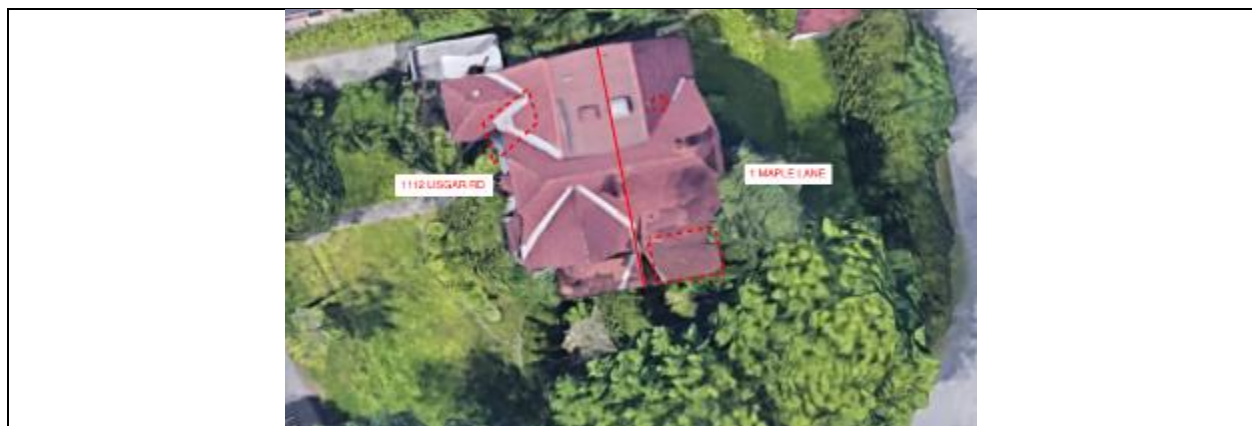
Figure 1: Roof plan with areas of deterioration outlined [JCAL 2021]

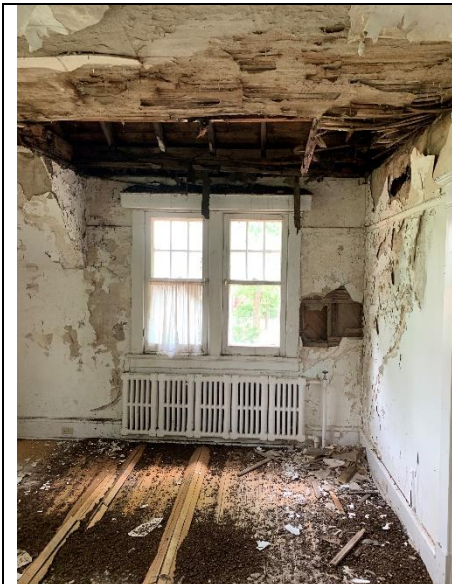
Previous renovations were carried out in this residence, however the roof has failed at the SE corner, leading to significant damage. This roof failure has resulted in decayed wood visible in the roof structure, exterior wall, third floor framing and second floor. Water damage and peeling finishes were also noted on the ceiling and exterior wall on the ground floor below this area of leaking. Mold was also noted on adjacent

walls in the second and ground stories. An opening was made in the second story wall at mid height, and the exposed wall stud was noted to be dry (see photo 1 through photo 4). On the third story where the upper portion of the sloped roof meets the third story knee wall, water damage is noted in the finishes (see photo 5).

Photo 1: South second story wall overview, damages noted to floor, wall and ceiling finishes surrounding the area of significant water damage [JCAL 2021]

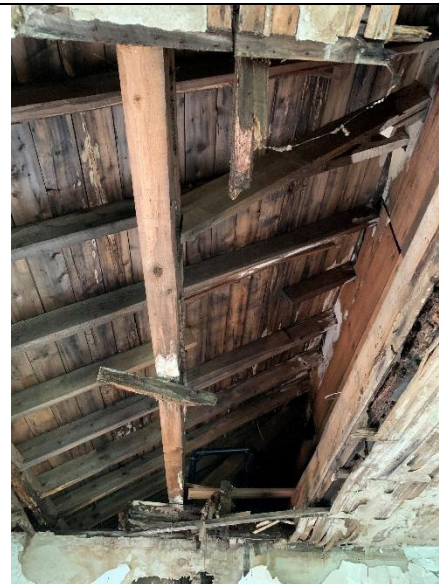
Photo 2: View into ceiling damage shown in photo 1- roof rafters decaying [JCAL 2021]

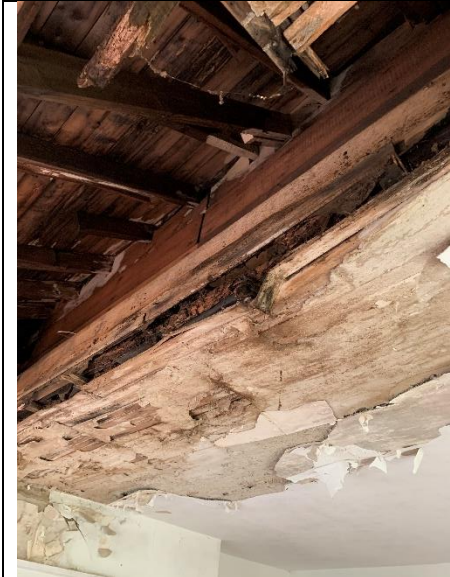
Photo 3: Closer view of damage and decay to edge of third floor framing [JCAL 2021]

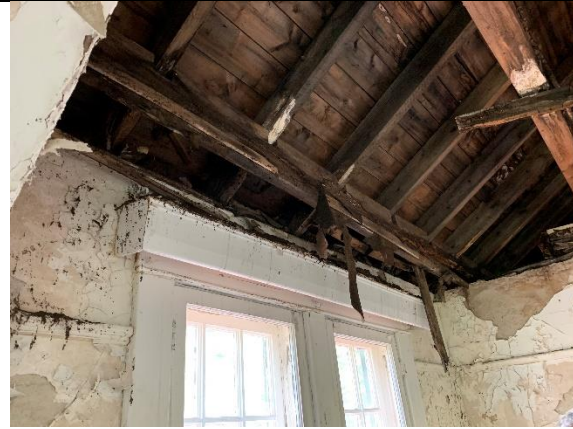
Photo 4: Closer view of damage and decay to top of exterior wall [JCAL 2021]

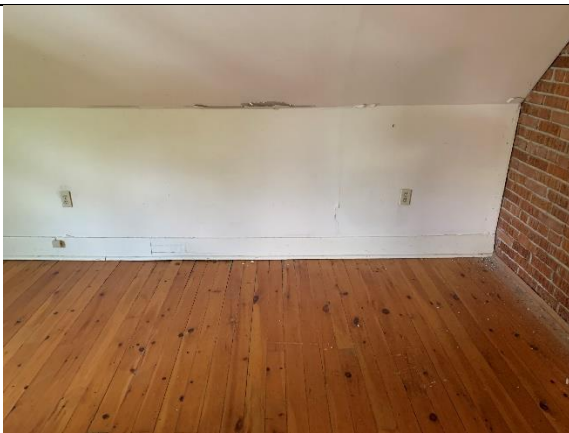
Photo 5: Third story SE corner water damage to finishes [JCAL 2021]

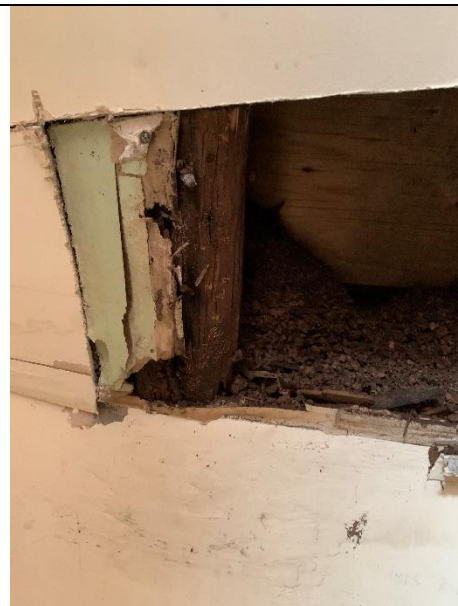
Also on the third floor, in the closet located on the east side of the unit at the top of the stairs, water damage was noted on the sloped ceiling, and an opening was made in this location. Decaying timber particles filled the cavity, and damaged roof rafters were visible (see photo 6).

Photo 6: Third story north sloped roof; damage noted within roof and on roof joists [JCAL 2021]

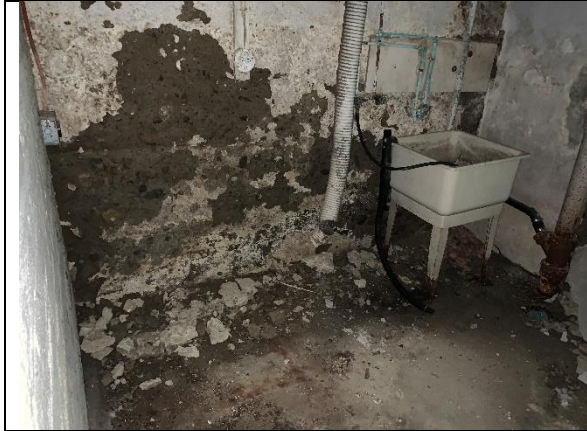
In the basement, excessive mold was noted on all ceiling and wall finishes, however the most significant structural issue noted is the condition of the concrete foundation walls. A large portion of the north and east foundations are visible for review, though they are painted, and typical on all walls the concrete foundation is spalling significantly as a result of water and salt damage. In spalling areas, concrete from the interior face was removed, and the concrete behind was noted to be soft with salt deposits which had built up within the wall. Up to several inches of concrete has spalled from the interior face in some areas. Large size smooth aggregate was noted in the concrete, as expected for the age of the building (see photos 7- 9).

Photo 7: Concrete foundation damage and salt deposits [JCAL 2021]

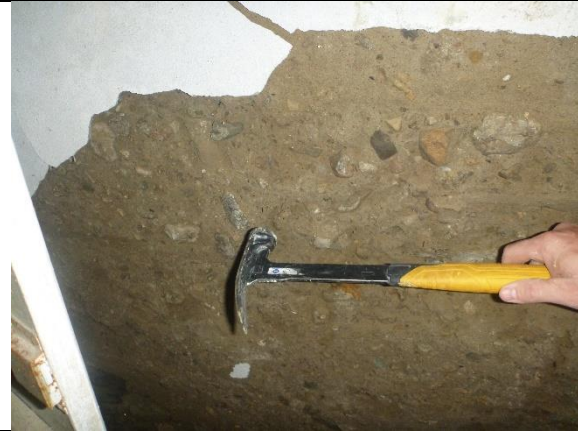
Photo 8: Soft concrete in the interior of the foundation wall [JCAL 2021]

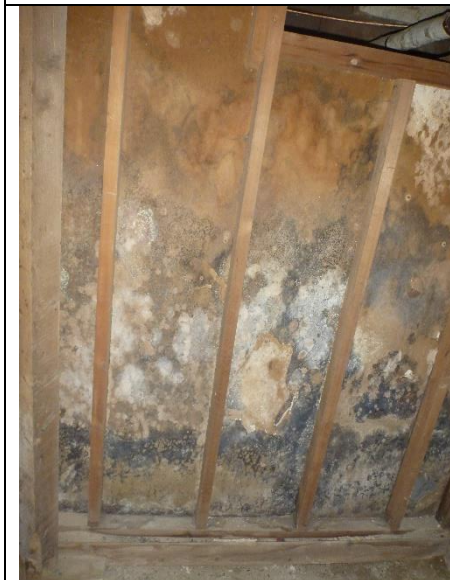
Photo 9: Interior basement wall typical condition with extensive mold. [JCAL 2021]

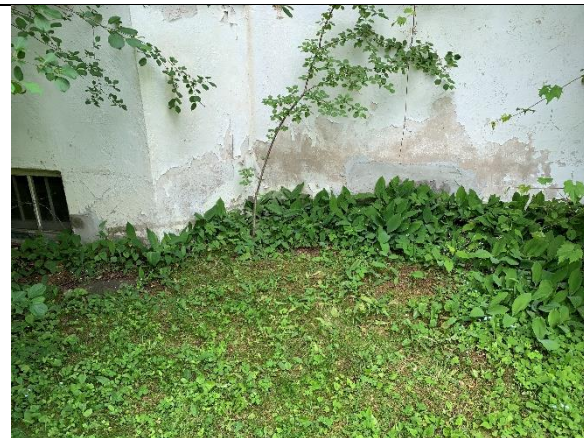
On the exterior of the building, the stucco appears to be generally in fair condition except at the base of the wall. A small opening was made which shows mesh within the stucco, and the finish coats appear to be well bonded in this area. The lower meter of the stucco is in poor condition with debonding and cracking, previous poor quality patching, and peeling paint finish.

Photo 10: General poor condition of stucco at base of wall [JCAL 2021]

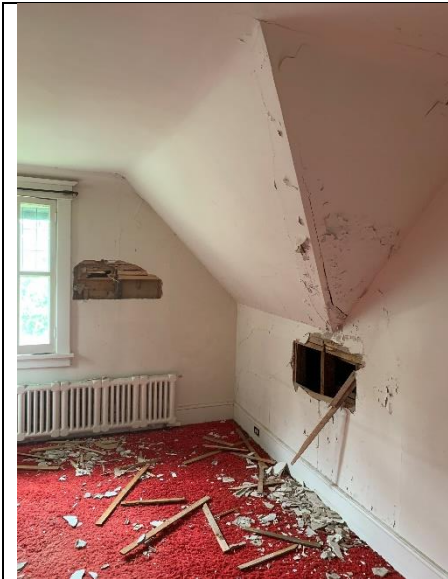
Photo 11: Opening location in west valley [JCAL 2021]

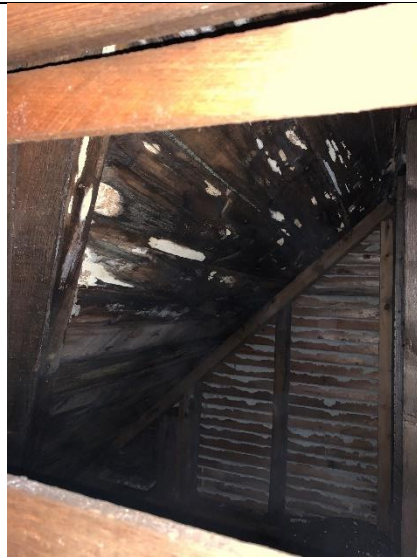
On the third floor, openings were made in the valley with the sunroom addition, where water damage was noted in the ceiling finishes. The valley rafters were visually reviewed; water damage and mold was noted on some rafters (see photo 11-13). Water damage and mold on insulation was also noted in the closet in the room on the west side of the third floor (see photo 14). Openings were also made in the wall finishes at the south end of the house on the third floor; no damage or mold was noted on the wall studs in these locations (see photo 15).

Photo 12: Roof water damage and mold within valley [JCAL 2021]

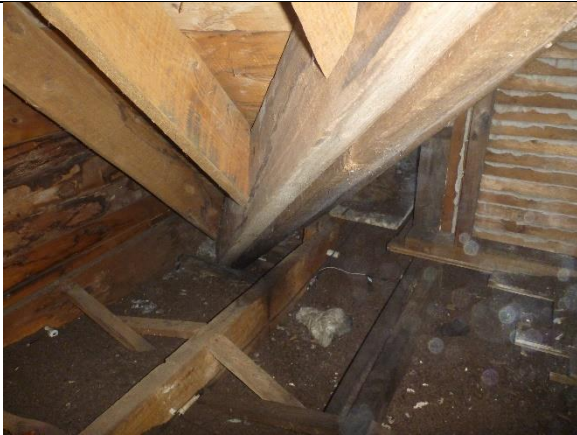
Photo 13: Water damage at base of valley [JCAL 2021]

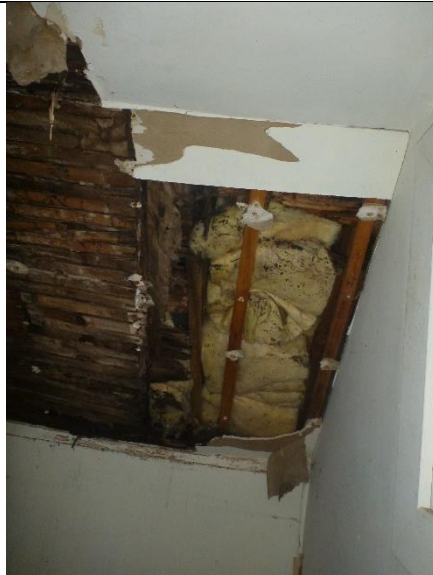
Photo 14: West room closet water damage and mold [JCAL 2021]

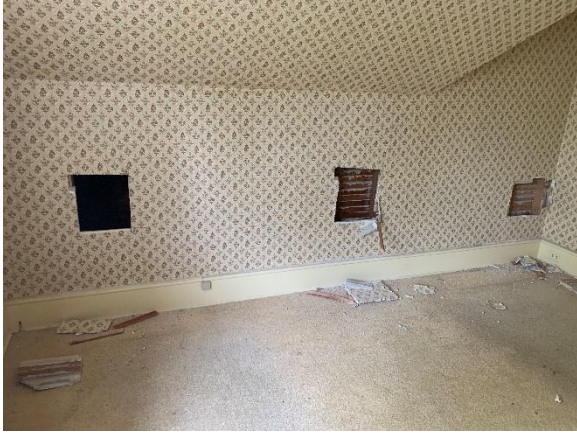
Photo 15: Openings in southern room [JCAL 2021]

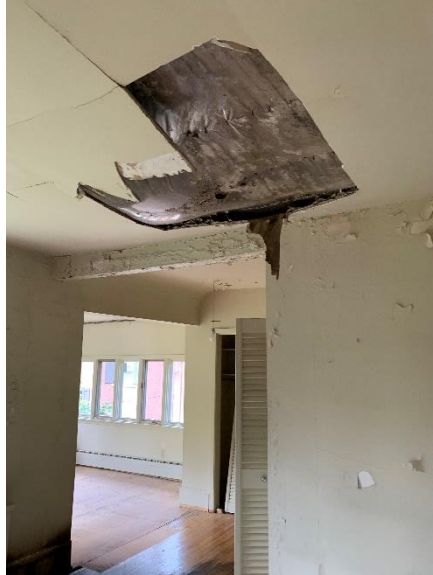
On the second and ground floor below the leaking valley, extensive water damage is noted to the wall and ceiling finishes (see photo 16-18). Openings were made on the ground floor to determine the extent of

Photo 16: Second floor damage to ceiling finishes [JCAL 2021]

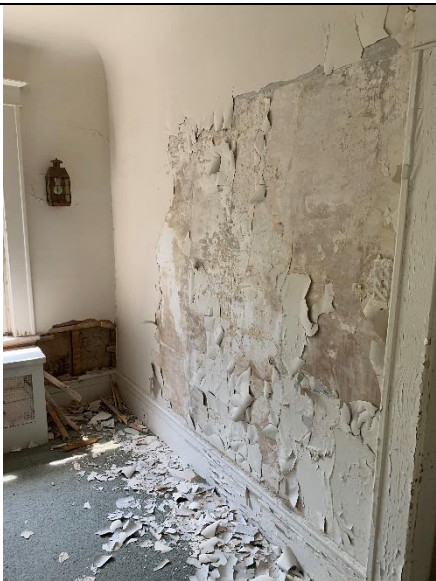
Photo 17: Ground floor west room water damage on interior wall [JCAL 2021]

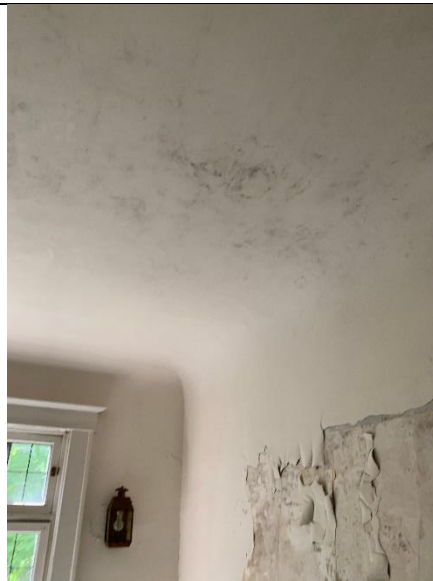
Photo 18: Ground floor west room mold on ceiling finishes [JCAL 2021]

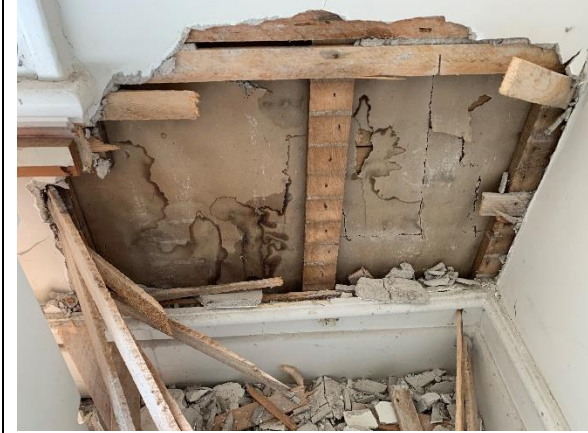
damage, and the spread of damage is much greater along the west wall at the ground floor level. In the wall opening made next to the west wall window on the ground floor, water damage and mold was noted on the wall exterior finishes and timber wall studs (see photo 19). Mold was noted on the underside of wallpaper on the ceiling on the ground floor room (see photo 20).

Photo 19: Ground floor wall opening- water damage and mold noted [JCAL 2021]

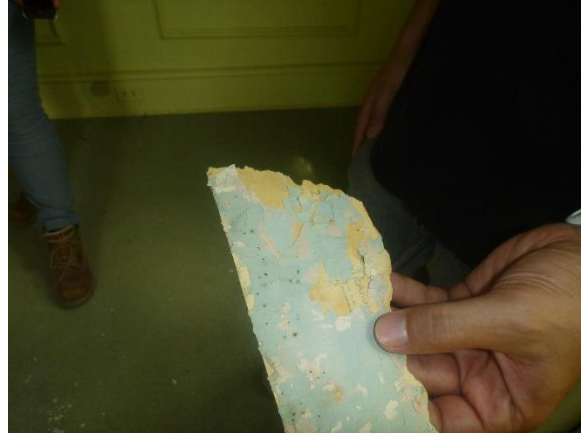
Photo 20: Mold noted on underside of ground floor ceiling wallpaper [JCAL 2021]

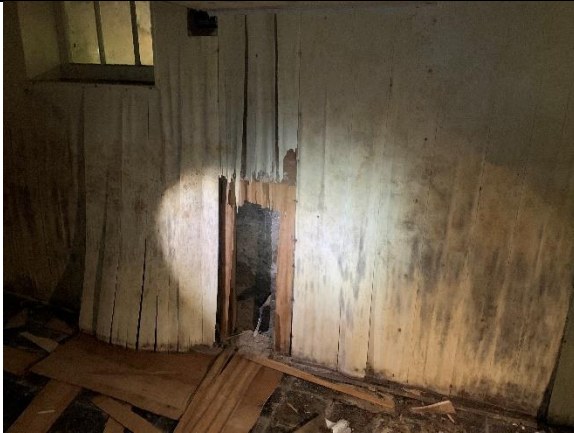
The basement conditions on the Lisgar side of the building are the same as on the Maple Lane side, as the two basement areas are interconnected. Mold was noted on all wall and ceiling finishes, and the exposed concrete wall spalling was as noted for Maple Lane (see photo 21 and photo 22). Mold was also noted on exposed ground floor joists in the area of west wall room with water damage (see photo 23). The foundation of the sunroom addition is not poured concrete, and is in very poor condition (see photo 24).

Photo 21: Typical extent of mold throughout basement [JCAL 2021]

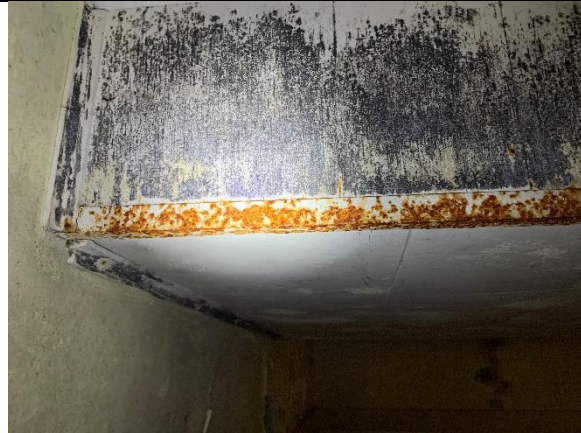
Photo 22: Typical extent of mold throughout basement [JCAL 2021]

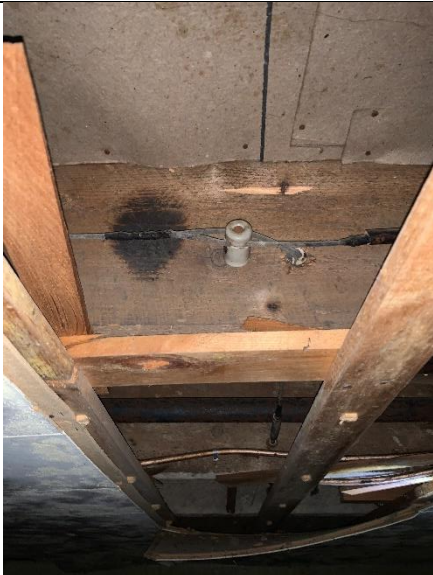
Photo 23: Mold noted on ground floor structure [JCAL 2021]

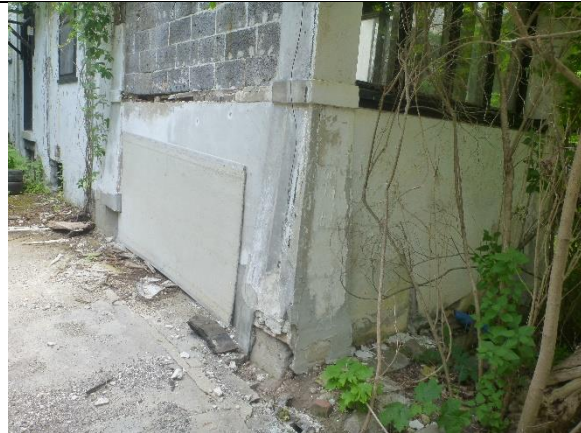
Photo 24: Foundation of sunroom addition in very poor condition. [JCAL 2021]
