SOMERSET HOUSE REHABILITATION

352 Somerset Street West, Ottawa, Ontario, K2P 0J9

2023 DESIGN INTENT REPORT

Project No. 0653
Revision No. 00
June 23, 2023

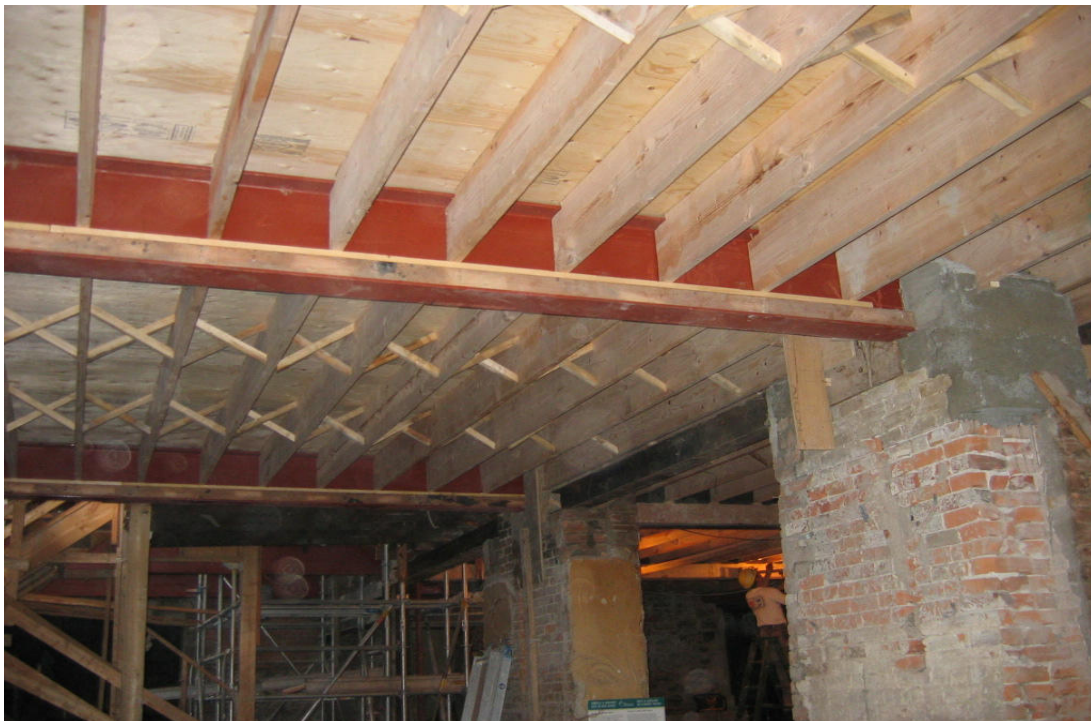
Figure 7: Previously Existing Condition Outlining Brick Piers in Basement
