Tree Information Report

Submitted as part of Committee of Adjustment Application to the City of Ottawa

Address: 44 Dunham Street

Date of Report: February 2, 2023

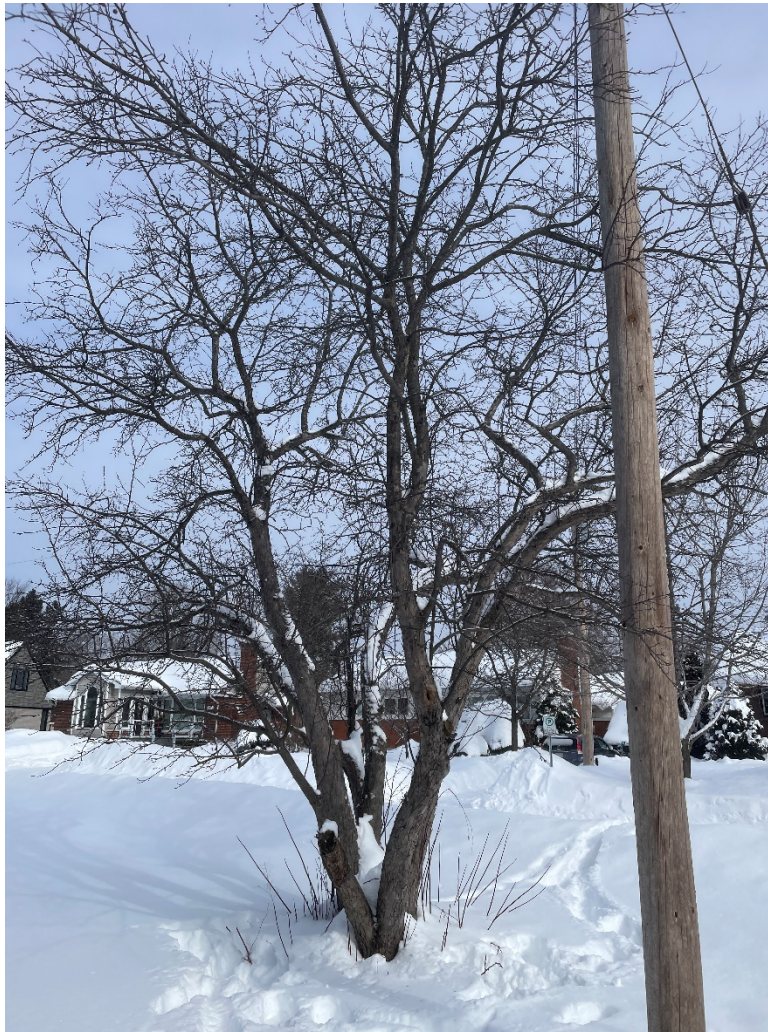
Tree ¹	Species	Diameter at breast height (cm)	Ownership ^{2,3}	Condition	Action	Recommendations
1	Crabapple (<i>Malus sp.</i>)	Multi-stem: 18, 16, 7, 21, 16, 17	City	Fair: 3 inner stems in good health, 3 outer stems poor – large wounds, bark loss	Retain	Retain: not an ideal candidate for future retention based on location and fair health
2	Manitoba maple (<i>Acer negundo</i>)	Multi-stem: 33, 24, 24	Private – subject property	Good/Fair: heavy lean on all 3 stems; epicormic shoots throughout	Retain	Retain: no damage from equipment to occur during demolition; not an ideal candidate for future retention
3	Manitoba maple (<i>Acer negundo</i>)	57	Boundary – jointly owned with 46 Dunham	Fair: trunk has multiple depressions – likely joined stems; lean toward subject property house	Retain	Retain: monitor during construction for stability; not suitable for retention for future build
4	Manitoba maple (<i>Acer negundo</i>)	30.8	Boundary – jointly owned with 46 Dunham	Fair/Poor: main leader girdled near top	Retain	No action required

Figure 1 - Tree 1: City; crabapple to be retained

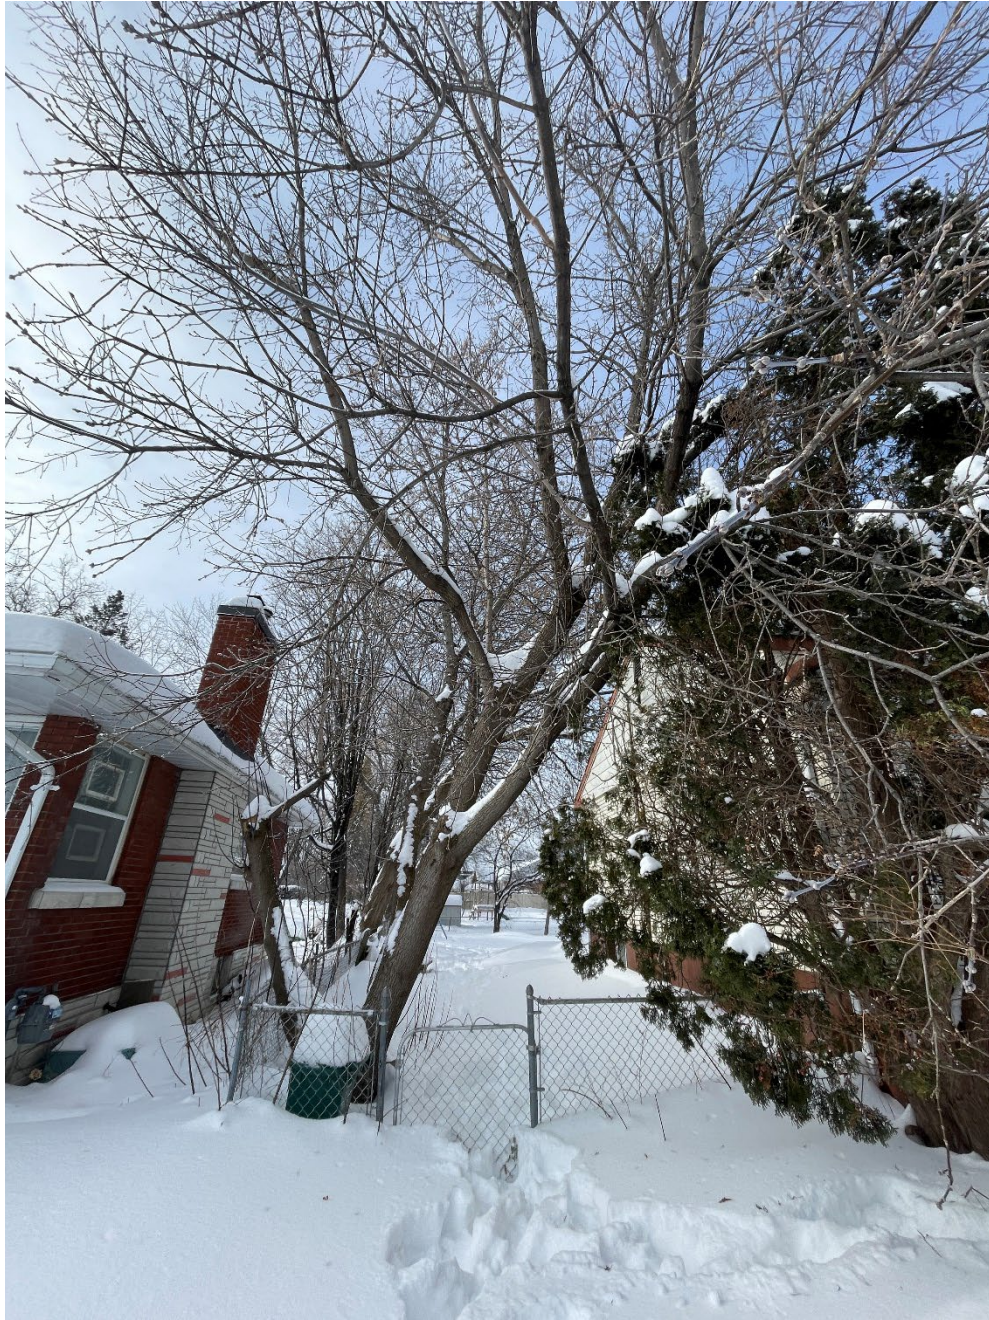
Figure 2 – Tree 2: Private; Manitoba maple to be retained

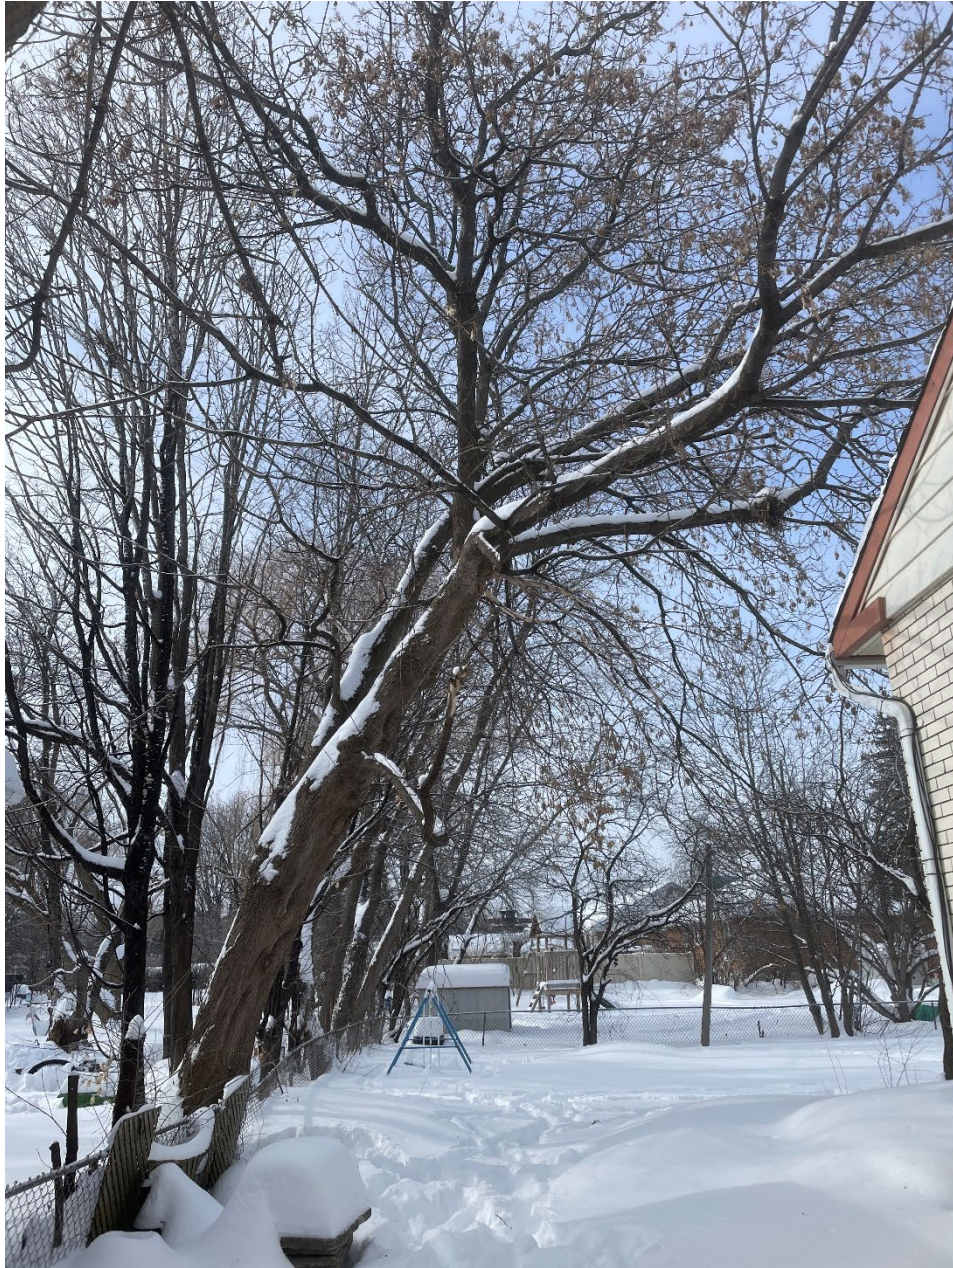
Figure 3 – Tree 3: Boundary; Manitoba maple to be retained

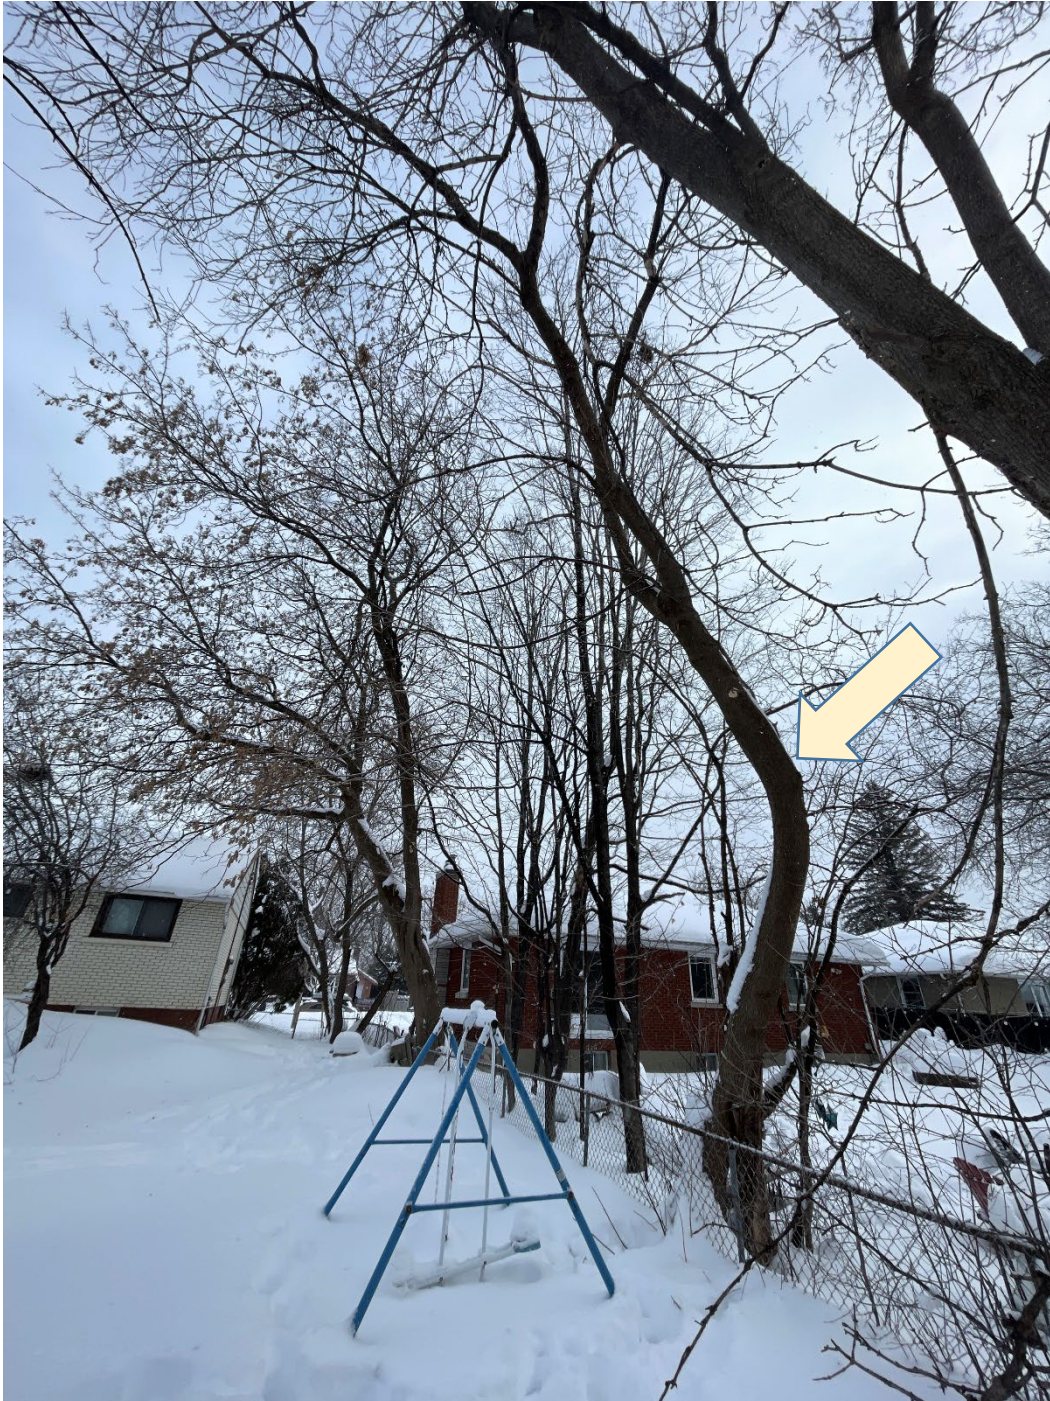
Figure 4 - Tree 4 (indicated with arrow): Boundary; to be retained

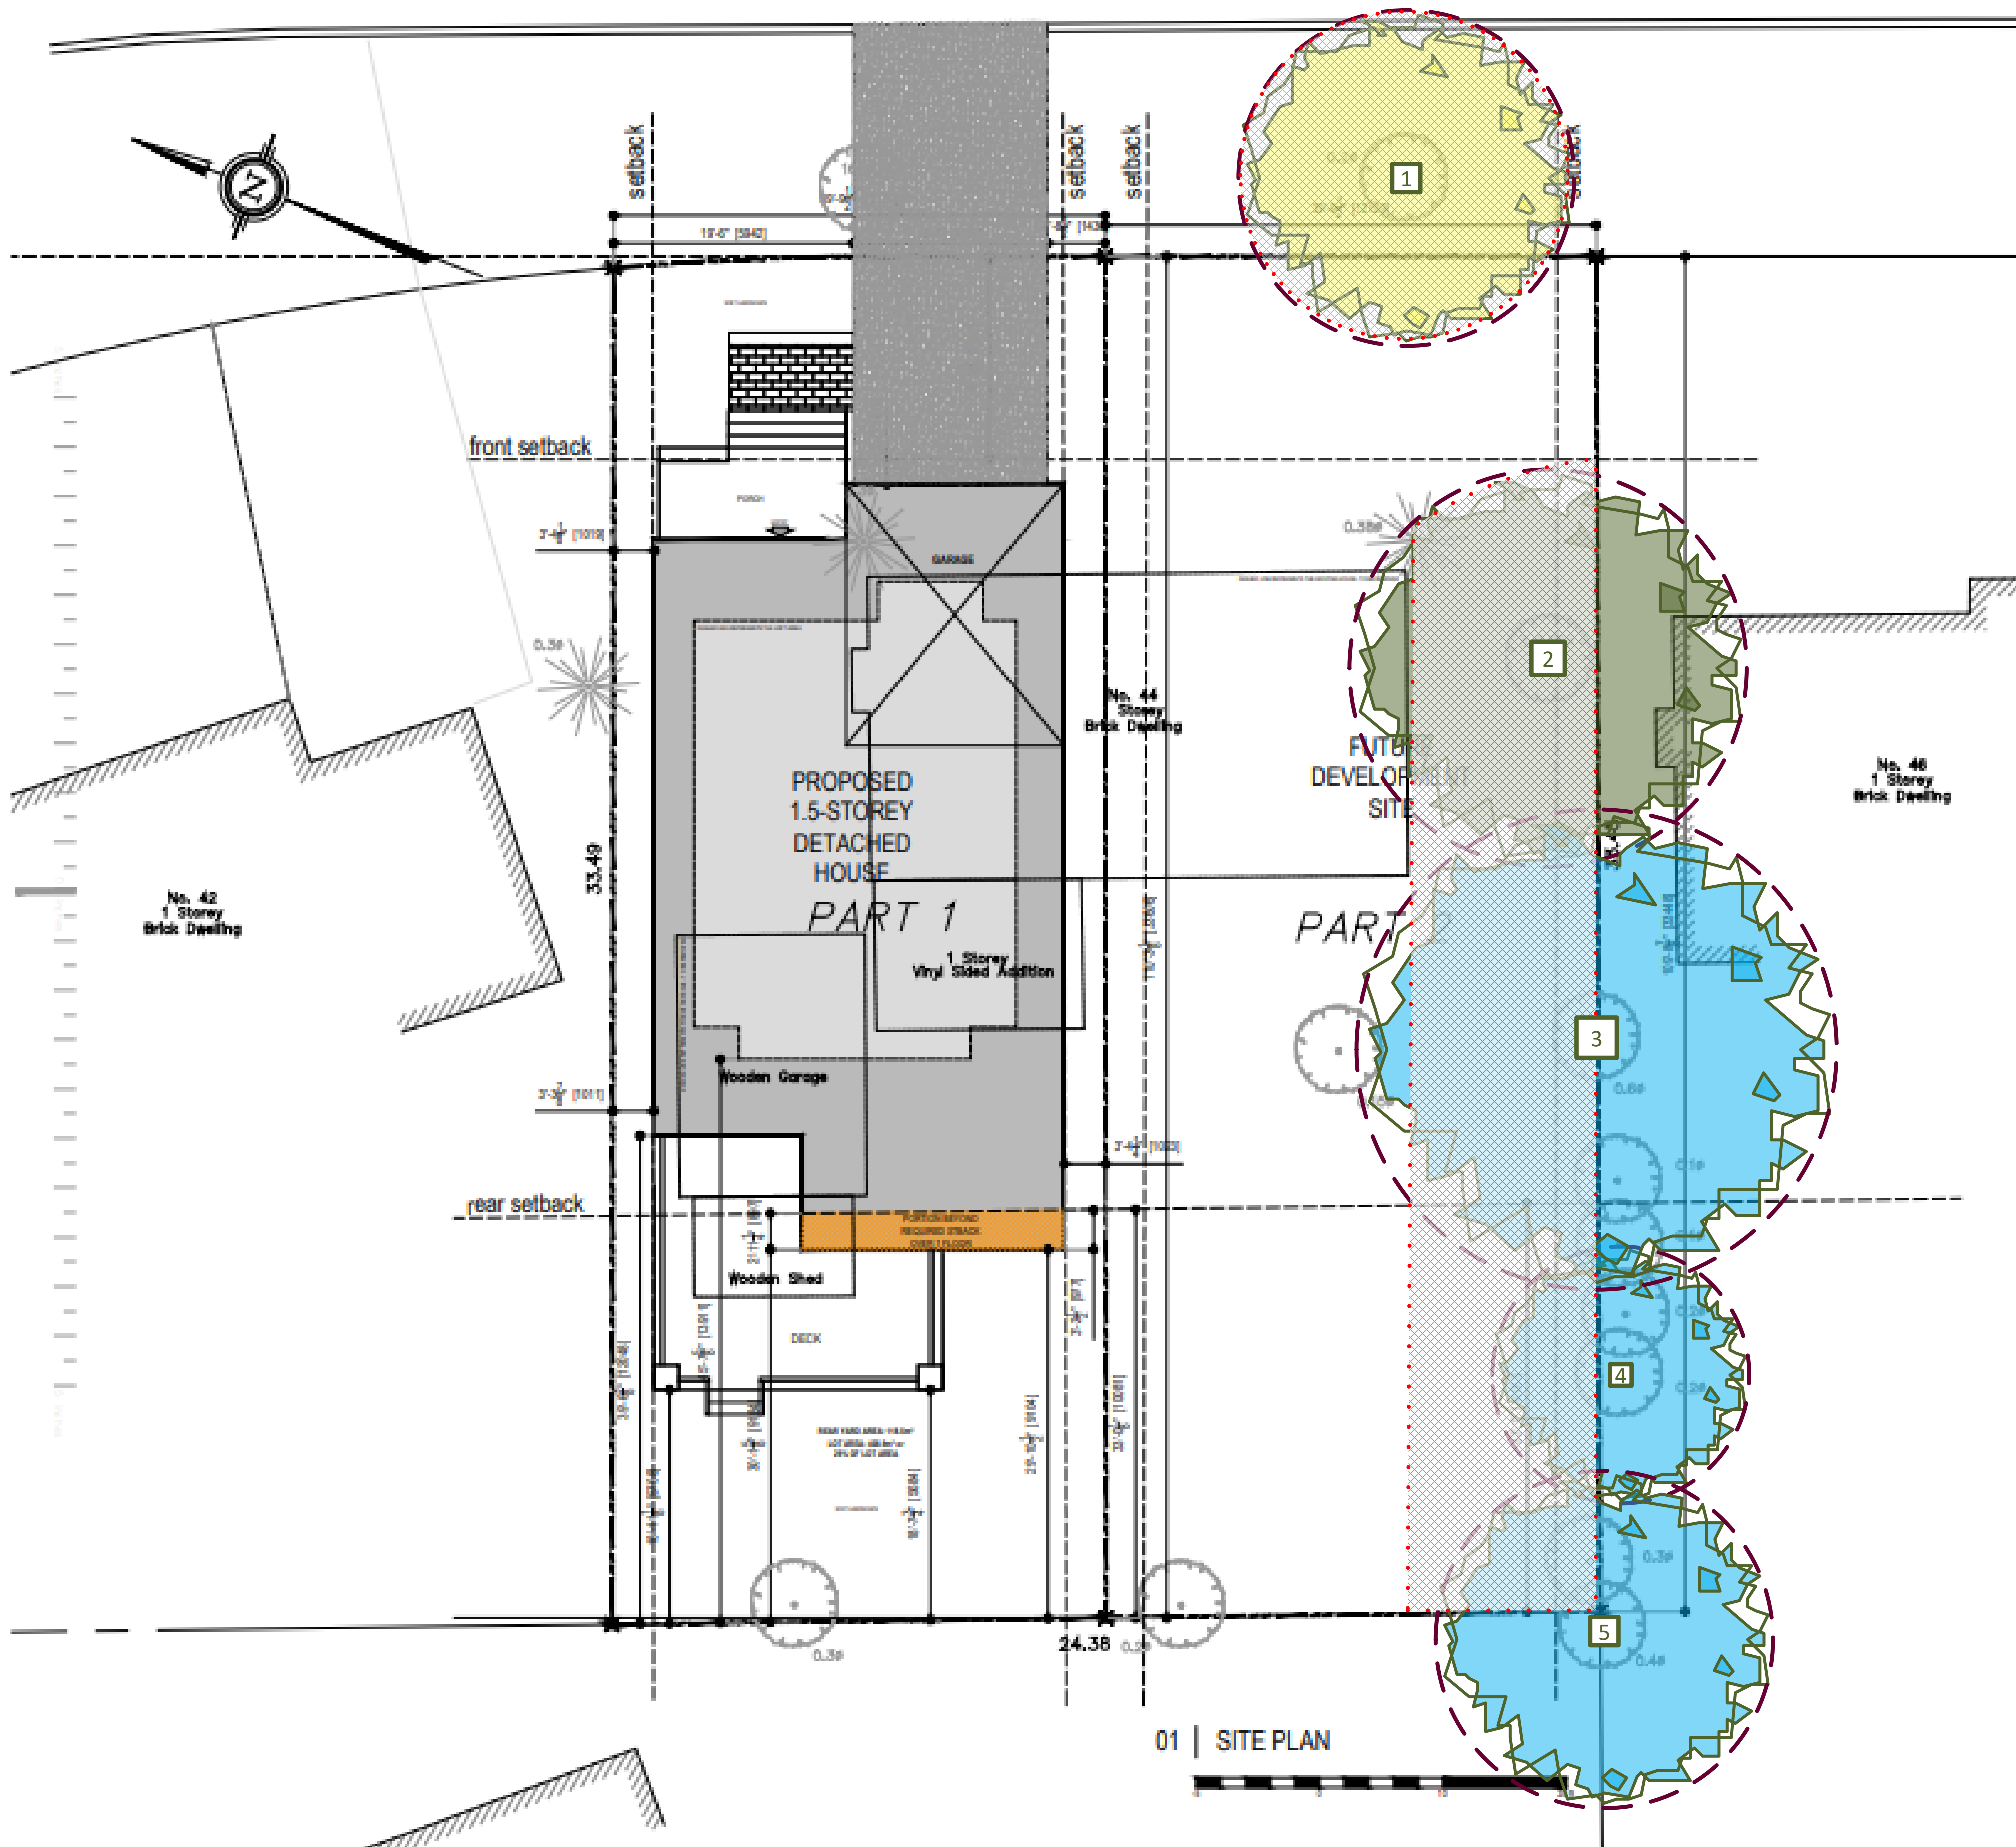
01 | SITE PLAN

Tree ¹	Species	Diameter at breast height (cm)	Action	Recommendations
1	Crabapple (<i>Malus sp.</i>)	Multi-stem: 18, 16, 7, 21, 16, 17	Retain	Retain: not an ideal candidate for future retention based on location and fair health
2	Manitoba maple (<i>Acer negundo</i>)	Multi-stem: 33, 24, 24	Retain	Retain: no damage from equipment to occur during demolition; not an ideal candidate for future retention
3	Manitoba maple (<i>Acer negundo</i>)	57	Retain	Retain: monitor during construction; not suitable for retention for future build
4	Manitoba maple (<i>Acer negundo</i>)	30.8	Retain	No action required
5	Horsechestnut (<i>Aesculus hippocastanum</i>)	40	Retain	No action required

Prior to any site works, protective fencing should be installed around the trees as indicated in Map and maintained until all construction on site has been completed as per the **City of Ottawa Tree Protection Specifications (March 2021)**. Within the fenced area, the following tree protection guidelines should be applied:

The tree protection fencing must be 1.2 m in height and constructed of a rigid or framed material (e.g. modulus – steel, plywood hoarding, or snow fence on a 2”X4” wood frame) with posts 2.4 m apart such that the fence location cannot be altered. All supports must be placed outside of the CRZ and installation must minimize damage to existing roots.

- Place a layer of 6-12 inches (15 to 30 cm) of woodchip mulch to the area
- Apply ¾ (2 cm) inch plywood, or road mats over a 4+ inch (10 cm) thick layer of the wood chip mulch
- Apply 4-6 inches (10 to 15 cm) of gravel over a taut, staked, geotextile fabric
