October 11, 2022

**Re: 359 Kent Street Façade Conservation
Structural Engineering Feasibility Review**

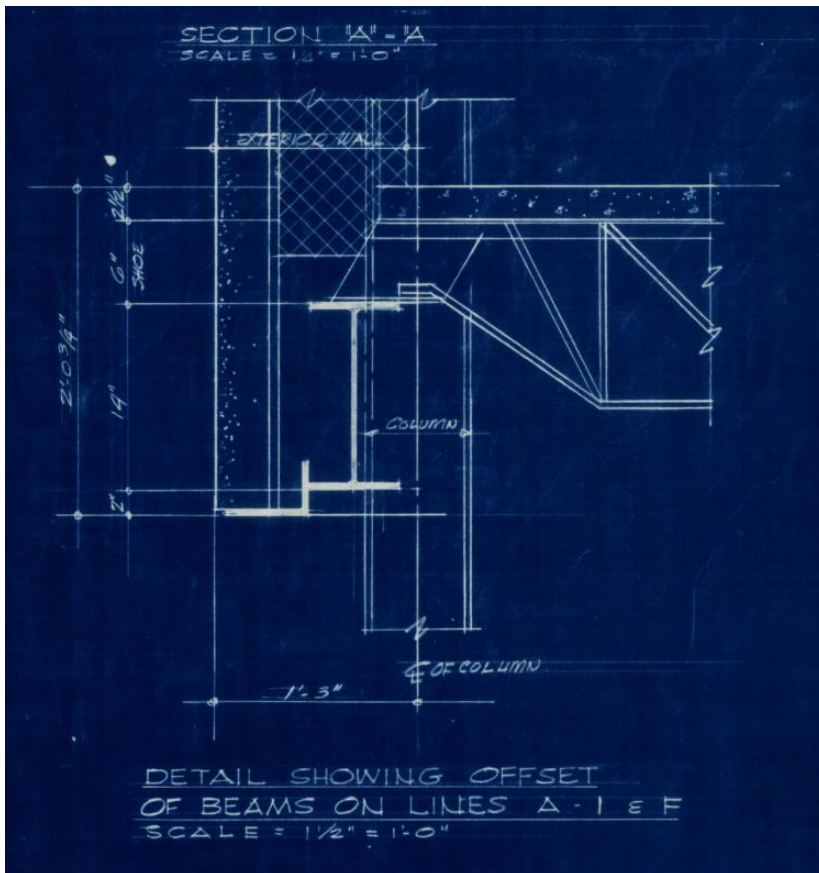
The existing floor joists bear on an offset beam on the gridlines considered for retention. The joist shoe is connected to an offset beam and the beam is cast in concrete for fire proofing purposes. The veneer and back-up masonry block wall bear on this concrete-encased at each floor and induce torsion on the beam (see Figure 4 for the typical detail). The joists brace the beam and provide resistance to the torsion created by the eccentric masonry loads. Removal of the interior joists will require compensating construction to deal with the eccentric loads and this complicates in situ retention of the facade.

Figure 4. Typical Off-Set Beam Detail at GL 1 and F.
