Tree Information Report

Prepared by Colleen Eames, Arborist. Arborist Consulting Ottawa arboristconsultingottawa@gmail.com 613-884-3394

Tree Owner	Ugandan High Commission
Address of Tree(s)	235 Mariposa Ave, Ottawa
Location of Tree(s) on property	Various around property
Species of Tree(s)	Various, see descriptions
Date of tree Inspection	April 16, 2021
Reason for Removal	N/A trees to be maintained – except where recommended below.
Reason for Inspection	Application for Minor Variance, Heritage plan in place. Renovations to be done on building and landscaping.
Restrictions	No Butternut present.

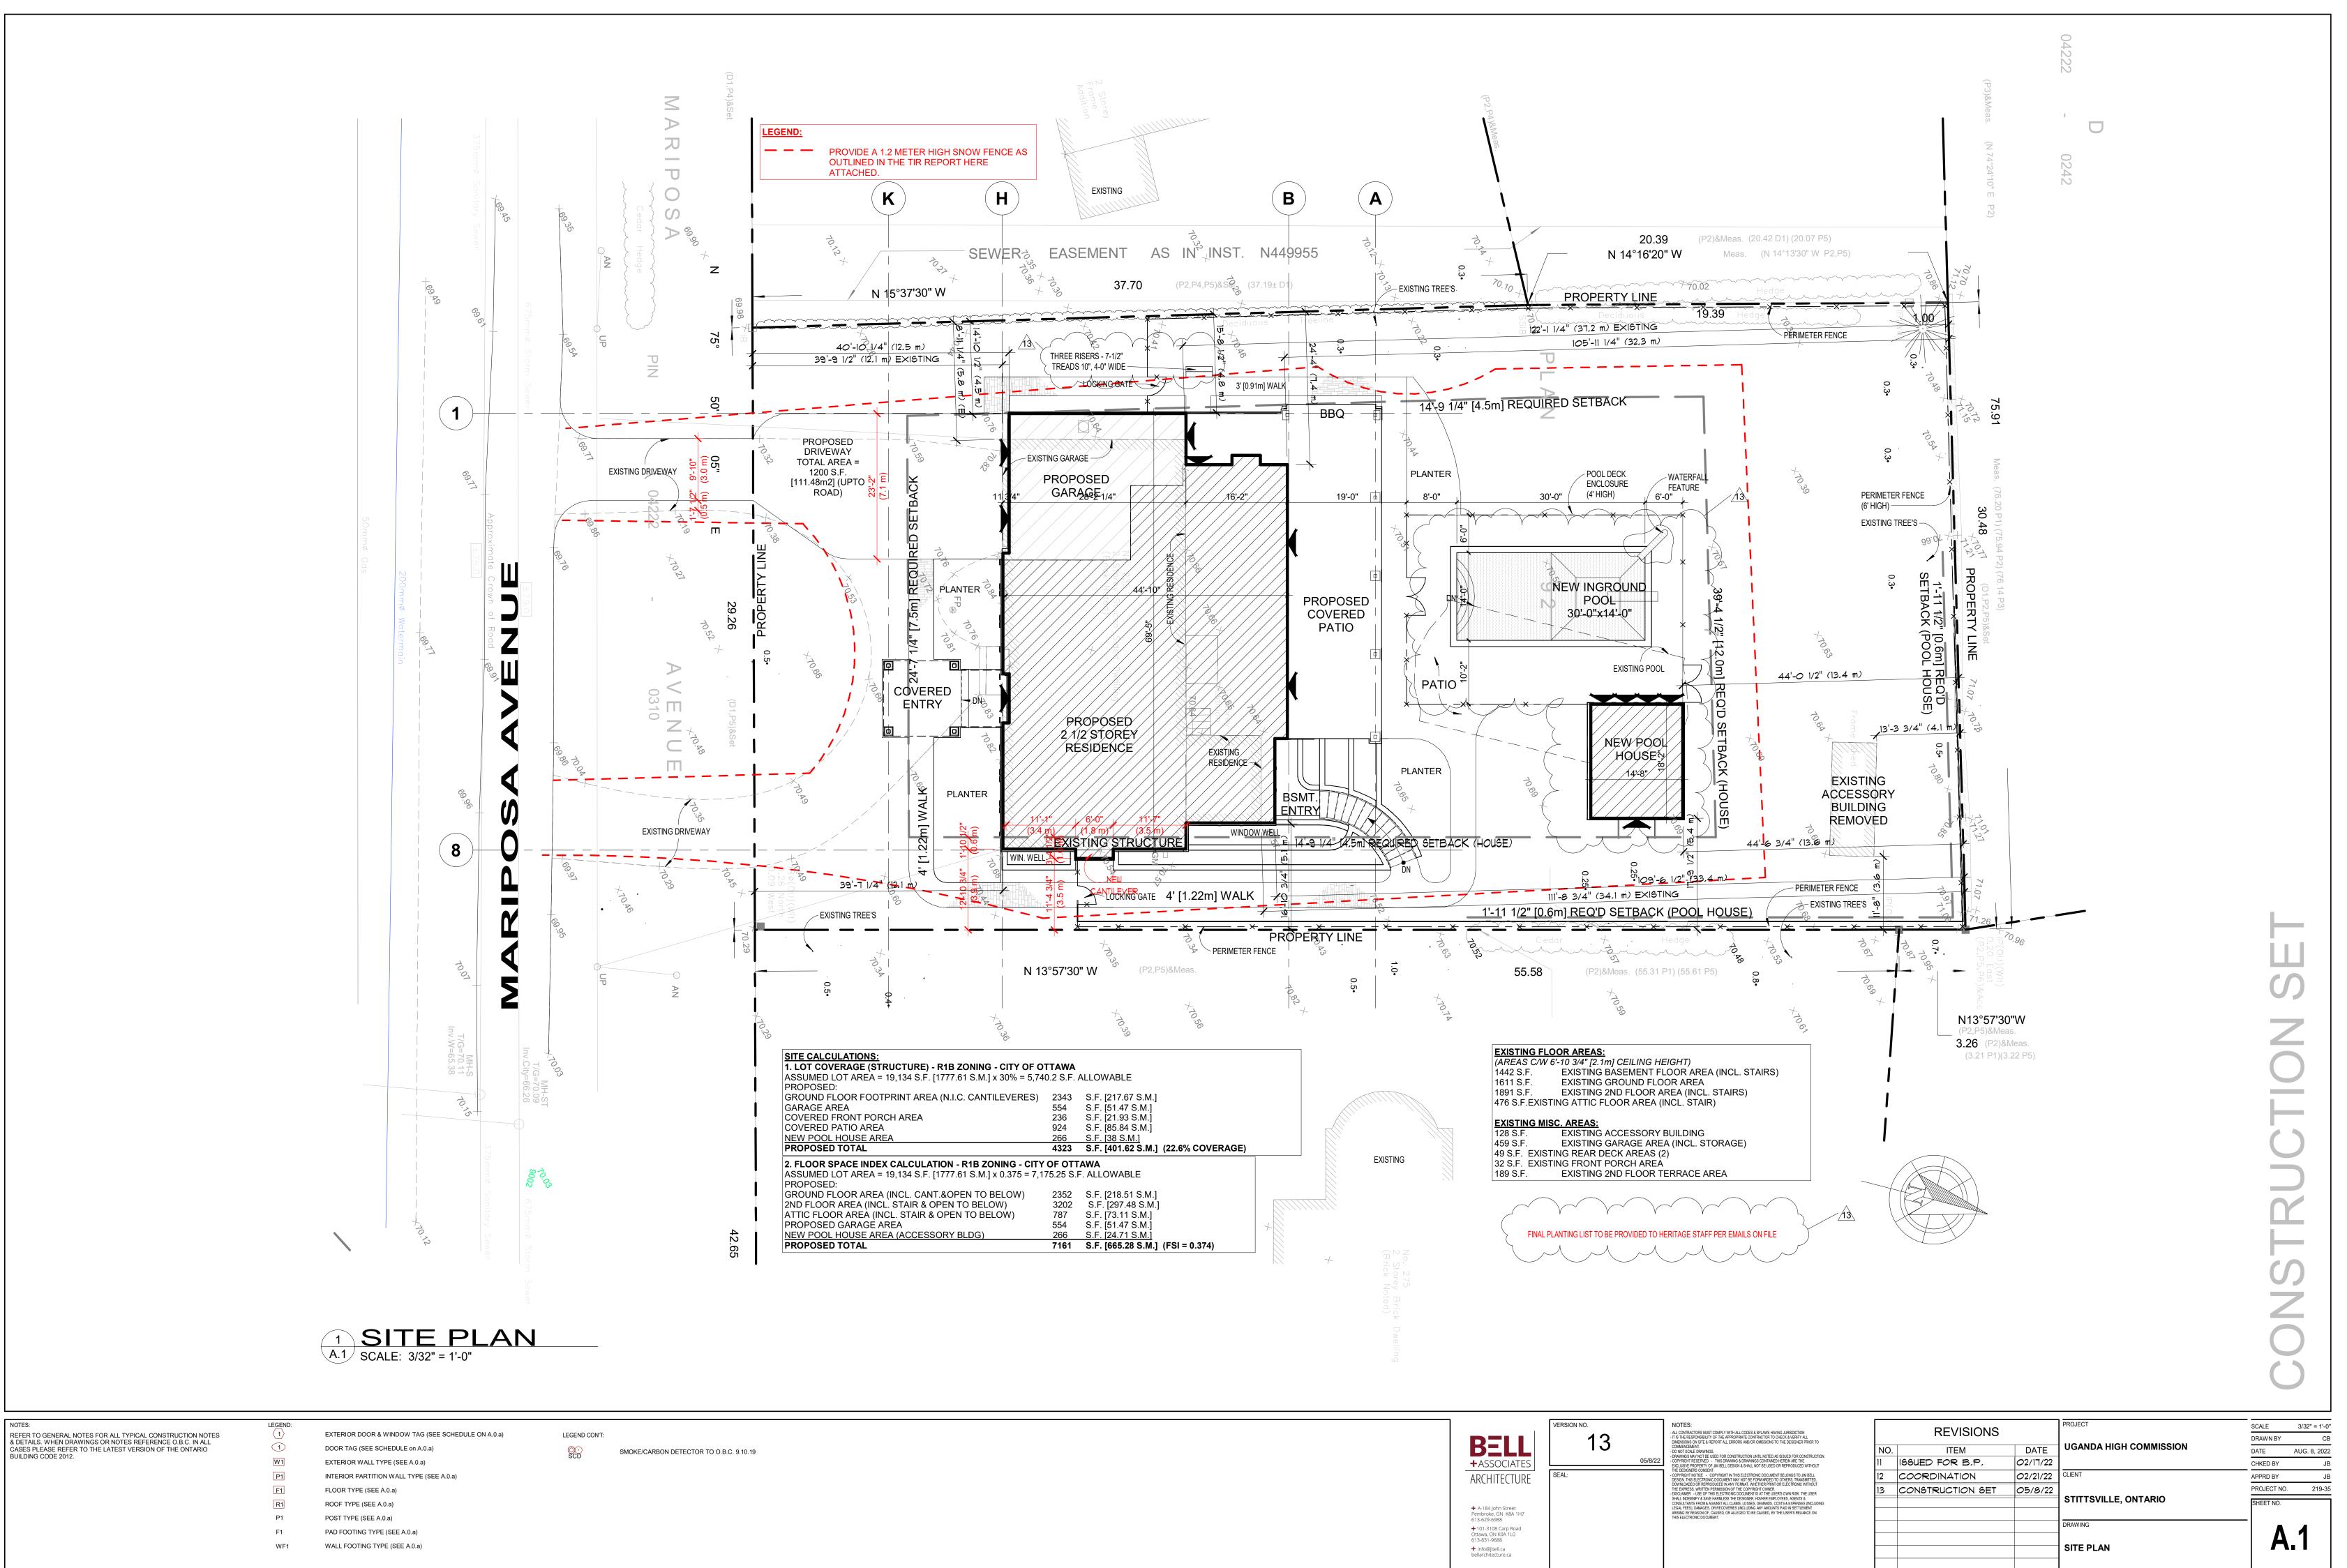
DRAWING	
						A.1
					SITE PLAN	/ * • •

There are various clusters and individual trees around the property. Trees are to be maintained during the renovation and as such a Tree Protection Plan is recommended to protect the trees and their root systems. Trees are marked as individuals or clusters in red on the attached site plan and pictures. Some sizes are approximate due to access restrictions. Red lines indicate the approximate location for tree protective fences, the distance given is from the largest tree in the cluster.

- A temporary fence 1.2 high should be erected along the Critical Root Zone (CRZ) of each tree or cluster, at a distance of 10X the listed DBH. Approximate fence locations are drawn on the accompanying site plan in red.
- Any roots > 1" in diameter that are encountered while digging should be cut cleanly with a sharp, clean saw.
- Adequate water should be given to any impacted trees during the summer to mitigate the loss of water uptake by the loss of part of its root system. No fertilizer should be applied to the trees.
- Care should be taken not to harm any other part of the trees, including trunk and branches.
