Tree Information Report

Submitted as part of Committee of Adjustment Application to the City of Ottawa

Date of Report: December 18, 2023
Property Address: 8 Bell Park Avenue
Prepared for: Eli Samra; esamra@rogers.com
Prepared by: Kevin Myers, ISA Certified Arborist; kevin.myers@dendronforestry.ca
Date of Site Visit: December 12, 2023

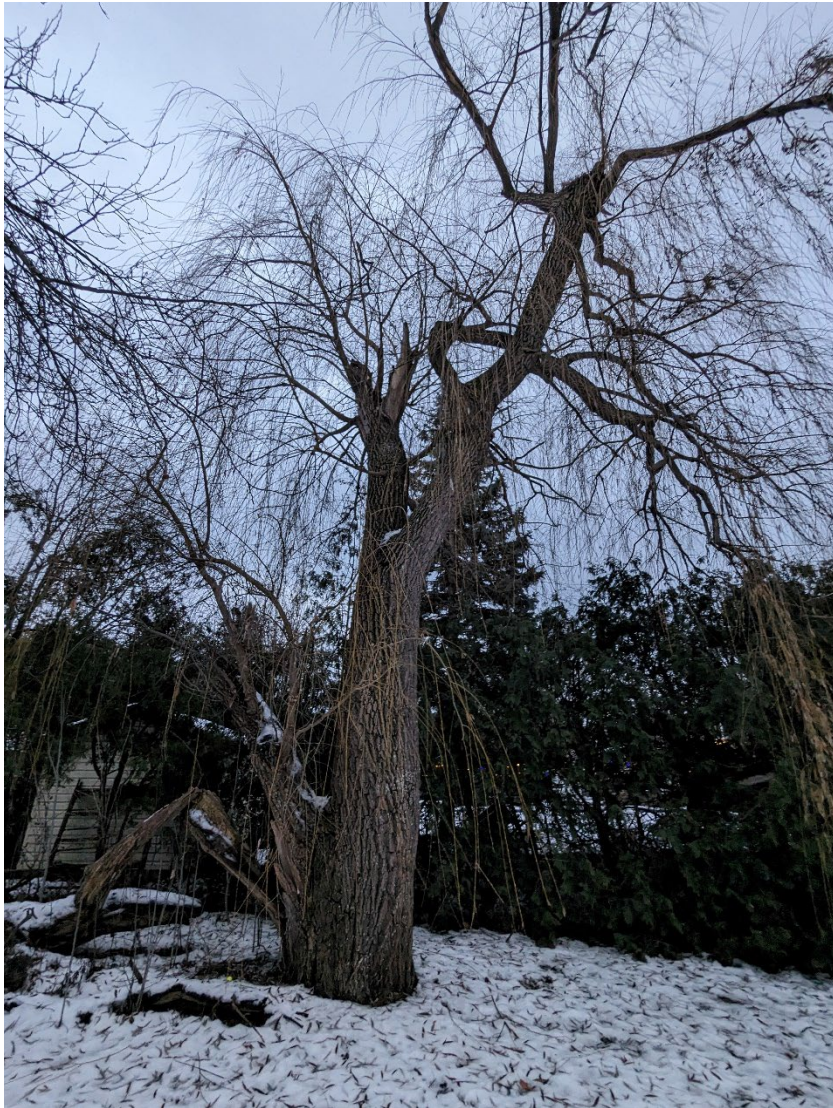
| Tree ¹ | Species | DBH (cm) | Ownership ² | Tree condition ³ | Approximate distance to excavation (m) | Action | Forester recommendation |
|---|---|---|---|---|---|---|---|
| 1 | Willow (<i>Salix spp.</i>) | 75 | Subject property | Fair/Poor: large leaders broken – wounds | No excavation proposed at this time | Retain | Retain during severance. Final determinations on retainability to be made when site plan available. |

Tree 1 - private willow to be retained.

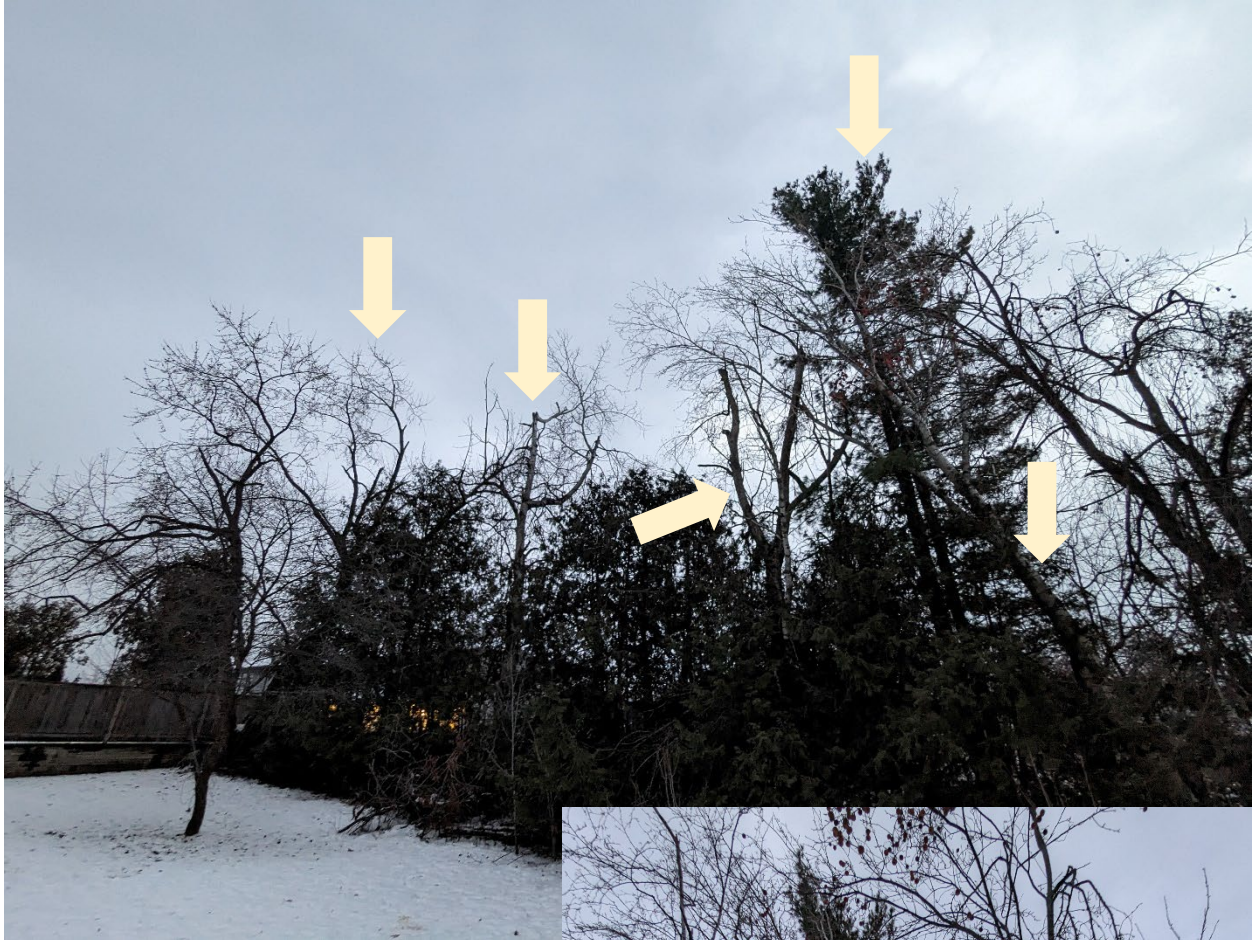
| Tree ¹ | Species | DBH (cm) | Ownership ² | Tree condition ³ | Approximate distance to excavation (m) | Action | Forester recommendation |
|---|---|---|---|---|---|---|---|
| 2 | Poplar (<i>Populus spp.</i>) | 36 | Subject property | Poor: heavy lean – root plate lifted | No excavation proposed at this time | Retain | Retain during severance. Final determinations on retainability to be made when site plan available. |
| 3 ⁴ | Poplar (<i>Populus spp.</i>) | 40 (estimate) | Adjacent – 6147 Fernbank | Poor: one living branch at top – likely an epicormic shoot – top broken off | No excavation proposed at this time | Retain | Retain during severance. Final determinations on retainability to be made when site plan available. |
| 4 ⁴ | White pine (<i>Pinus strobus</i>) | 40, 20 (estimate) | Adjacent – 6147 Fernbank | Fair: asymmetrical crown; slight lean to the south | No excavation proposed at this time | Retain | Retain during severance. Final determinations on retainability to be made when site plan available. |
| 5 ⁴ | Poplar (<i>Populus spp.</i>) | 40 (estimate) | Adjacent – 6147 Fernbank | Poor: one living branch at top – likely an epicormic shoot – top broken off | No excavation proposed at this time | Retain | Retain during severance. Final determinations on retainability to be made when site plan available. |
| 6 | Silver maple (<i>Acer saccharinum</i>) | 59, 52, 34 | Subject property | Fair/Poor: Many branches in canopy broken; large cavity in largest stem; 34cm stem grows laterally into/over rear yard of 6145 Fernbank | No excavation proposed at this time | Retain | Retain during severance. Final determinations on retainability to be made when site plan available. |

Above: (arrows right to left) Trees 2, 4, 3, 5 and 6.

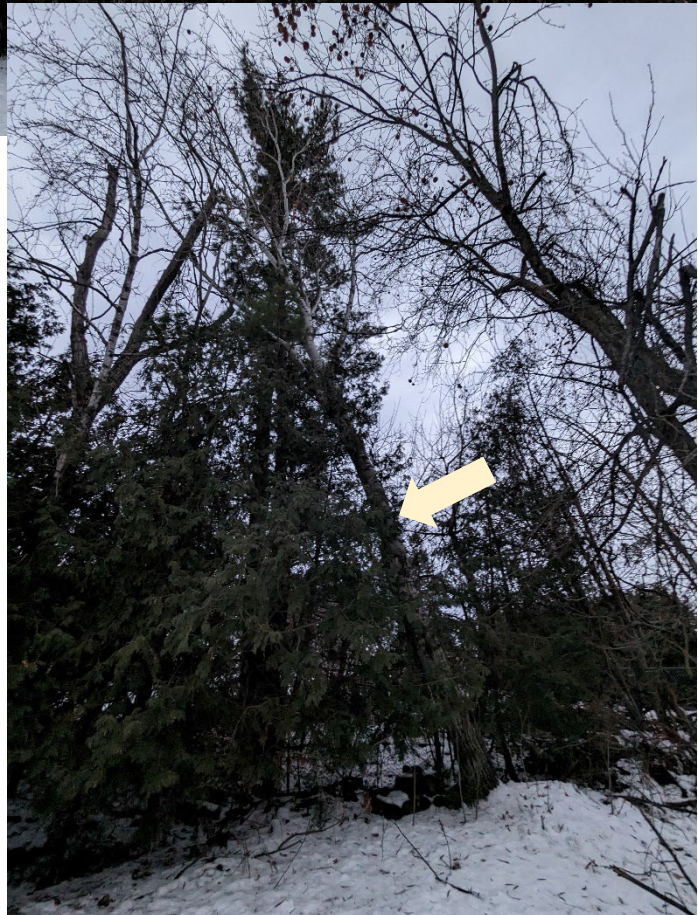
Right: Tree 2 – leaning poplar
