This document is presented in the language it was provided. Ce document est présenté dans la langue dans laquelle il a été fourni. Tree Information Report for 845 Dundee Avenue, Ottawa

Prepared by: Barbara Hemming, ISA Certification #ON 0389 613-828-3207 bhemming@sympatico.ca

Property is 845 Dundee Avenue Ottawa, ON K2B 5S8 Committee of Adjustment Received | Reçu le

Inspection dates: 2023-02-27 and 2023-06-30

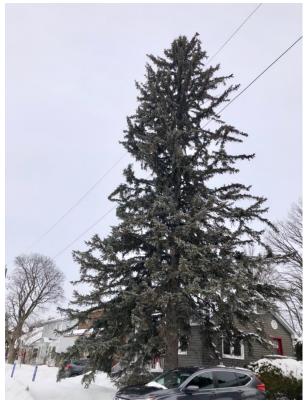
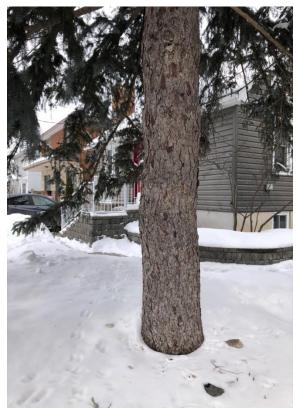
Tree #1 Colorado Spruce (Picea pungens)

Photo 1 Tree #1 Colorado Spruce

Photo 2 Tree #1 Healthy Trunk

This is a mature Colorado spruce. See photos 1 and 2, p. 3 It has a single trunk. Stem has no lean and tapers gradually. Foliage density, size and colour are all good. There is some die-back of smaller branches. There are no co-dominant stems or included bark. Crown has been raised to 3 M.

Roots may be restricted by existing paved driveway at 845 Dundee Ave.

There is currently encroachment into the CRZ from existing driveway at 845 Dundee. Excavation for the new driveway is outside the CRZ. A very small percentage (~5%) of the limit of excavation will disturb the CRZ. The tree will be able to tolerate this small amount of root loss.¹ Provide protective fencing around the CRZ as indicated in Drawing #1 p 8 and the pink dotted line in Drawing #2 p 9. Follow all the Steps to Conserve Trees p 6.

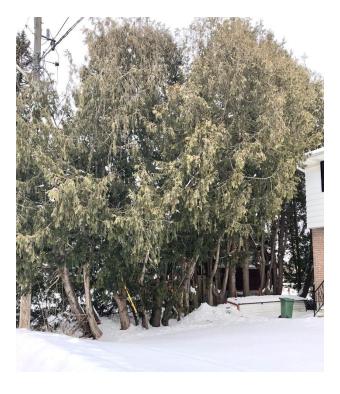
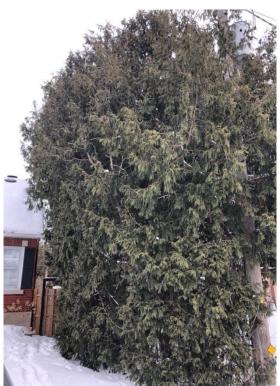
The hedgerow is mature with the cedars varying in diameter from 10 cm to 46.5 cm. The hedge has already been raised about 3 M along the south side and 3 M along a section on the north side next to the house at 845 Dundee. More cedars would have to be raised the same amount on the north side to allow access to any proposed entrances.

Photo 3: South facing side (851 Dundee) of Cedars Photo 4: Cedars (845 Dundee) North facing side

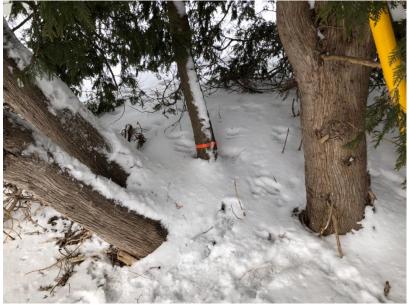
Photo 5 (left) Some cedars in the ROW

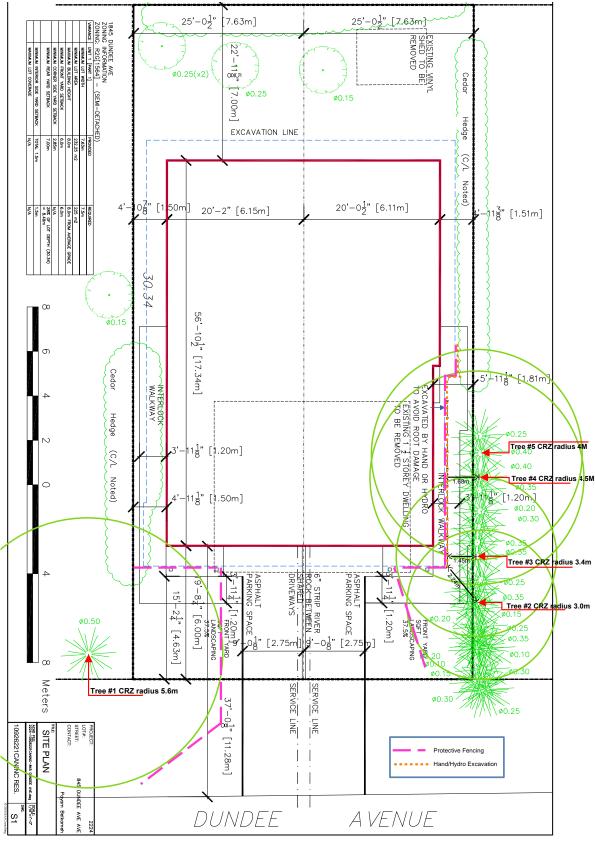
The CRZ's for these cedars extends up to the existing foundation on the side of 845 Dundee. Excavation will remove less than 20 % of the actual area of the existing roots for these two trees. As cedars show very good tolerance of root loss and infill soils, these two trees should not be adversely affected by the construction as long as all Steps to Conserve trees are followed.

This cedar has a CRZ that has been restricted by the foundation at 845 Dundee. The limit of excavation will be narrowed along the section within their illustrated CRZ's to preserve the amount of undisturbed soil extending from the base of this tree. This will leave a distance of approximately 1.68 cm which is more than the necessary considering that the closest a safe cut line can be is 1.5 M away from the trunk.

This tree could lose approximately 35% of the root zone as defined by the term CRZ in the definitions. But at least 15% of this area is limited by the presence of the existing foundation meaning that the tree will only lose about 20% of the actual root mass.

This cedar also has a CRZ that has been restricted by the house foundation. The limit of excavation is narrowed near the trunk of this tree. The narrowed cut line has been extended a further distance of 2 M easterly to accommodate the CRZ radius of 4 M from the tree trunk. This will ensure that the tree will lose only about 35% of the standard CRZ and considering part of this is restricted by the foundation it should actually amount to less than 30%. The cut line will leave a distance of approximately 1.68 M undisturbed soil from the tree trunk which will be more than necessary considering that the closest a safe line can be is 1.3 M away from the trunk.

- 3. Erect a fence with a sign identifying the trees to be protected under the by-laws, around the area of the CRZ as illustrated in the Diagram #1 p. 8, within the property lines unless otherwise indicated in this report. (See pink dotted line in Diagram #2 of Site Plan p. 9.
