# Tree Information Report v3.0

Submitted as part of Committee of Adjustment Application to the City of Ottawa

**Address:** 243-247 Bradford Street  
**Date of Report:** December 6, 2023  
**Date of Site Visit:** May 24, 2023  
**Prepared by:** Astrid Nielsen, RPF, ISA Certified Arborist  
**Client:** Rocco Manfredi; rmanfredi@royalpage.ca

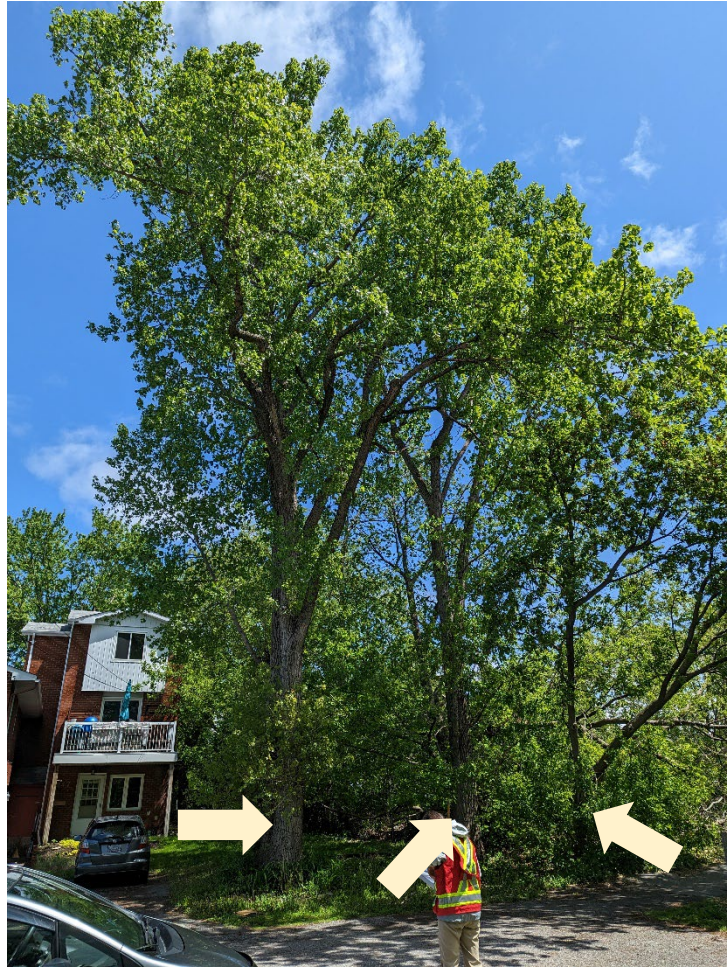
**Tree 1 and 2** are large Eastern cottonwoods (*Populus deltoides*) that are nearing the pinnacle of their growth. Retention of these trees will be difficult due to intensification on site. Excavation is expected to come no closer than 2.5m from the trees, and on one side only. Due to the available rooting space to the north and south of these trees, it is expected they will endure construction. During building permitting phase, if services are to be installed through the CRZ of Tree 1, its available rooting space will be reduced and reassessment will be required.

*From left to right: Tree 1-3*

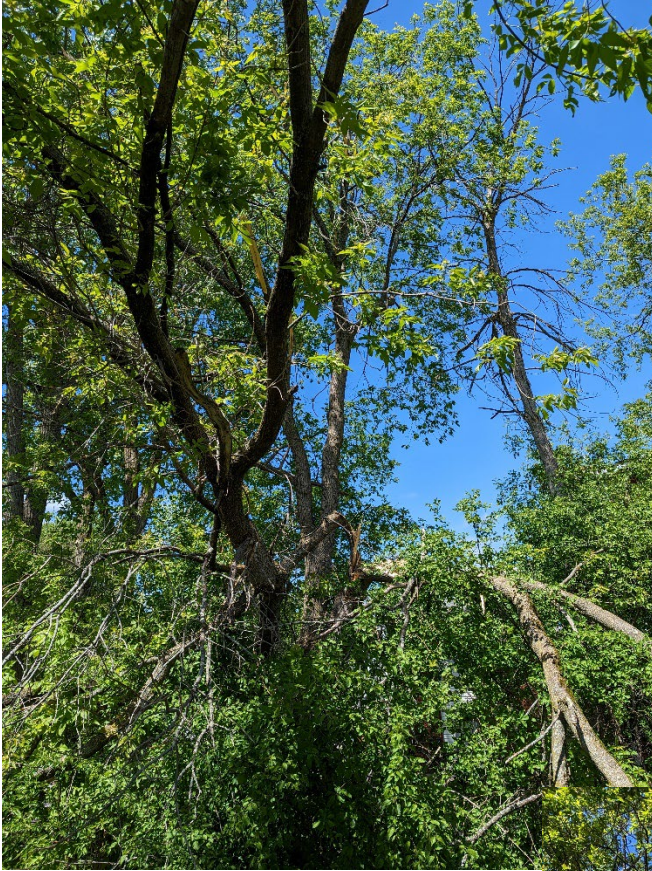
*Above: broken branch on Tree 3.*

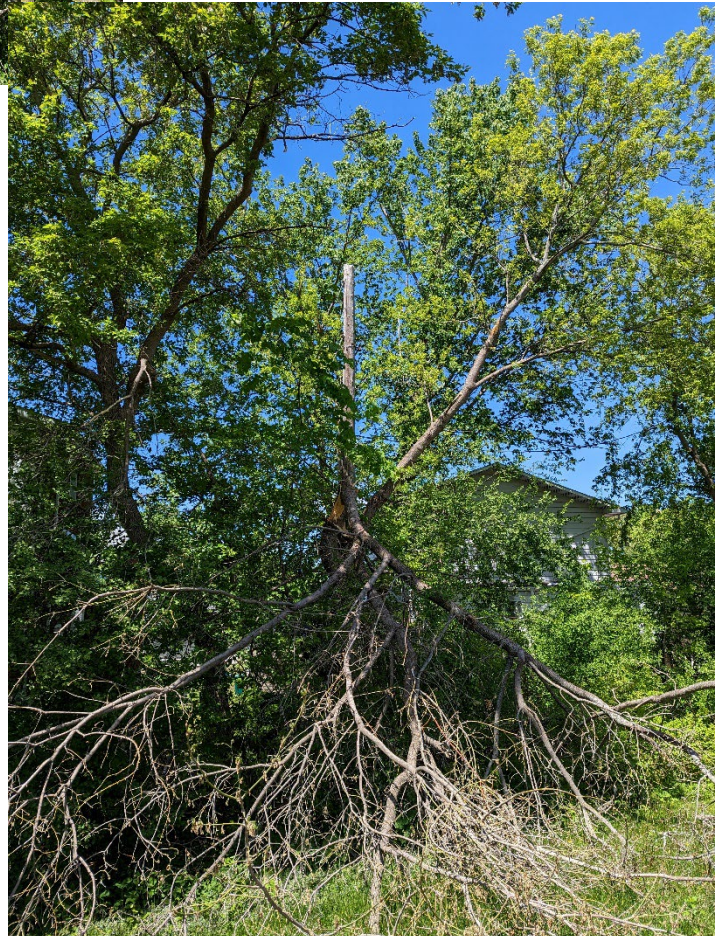
*Right: Broken top of Tree 8. Tree 7 at left of image.*

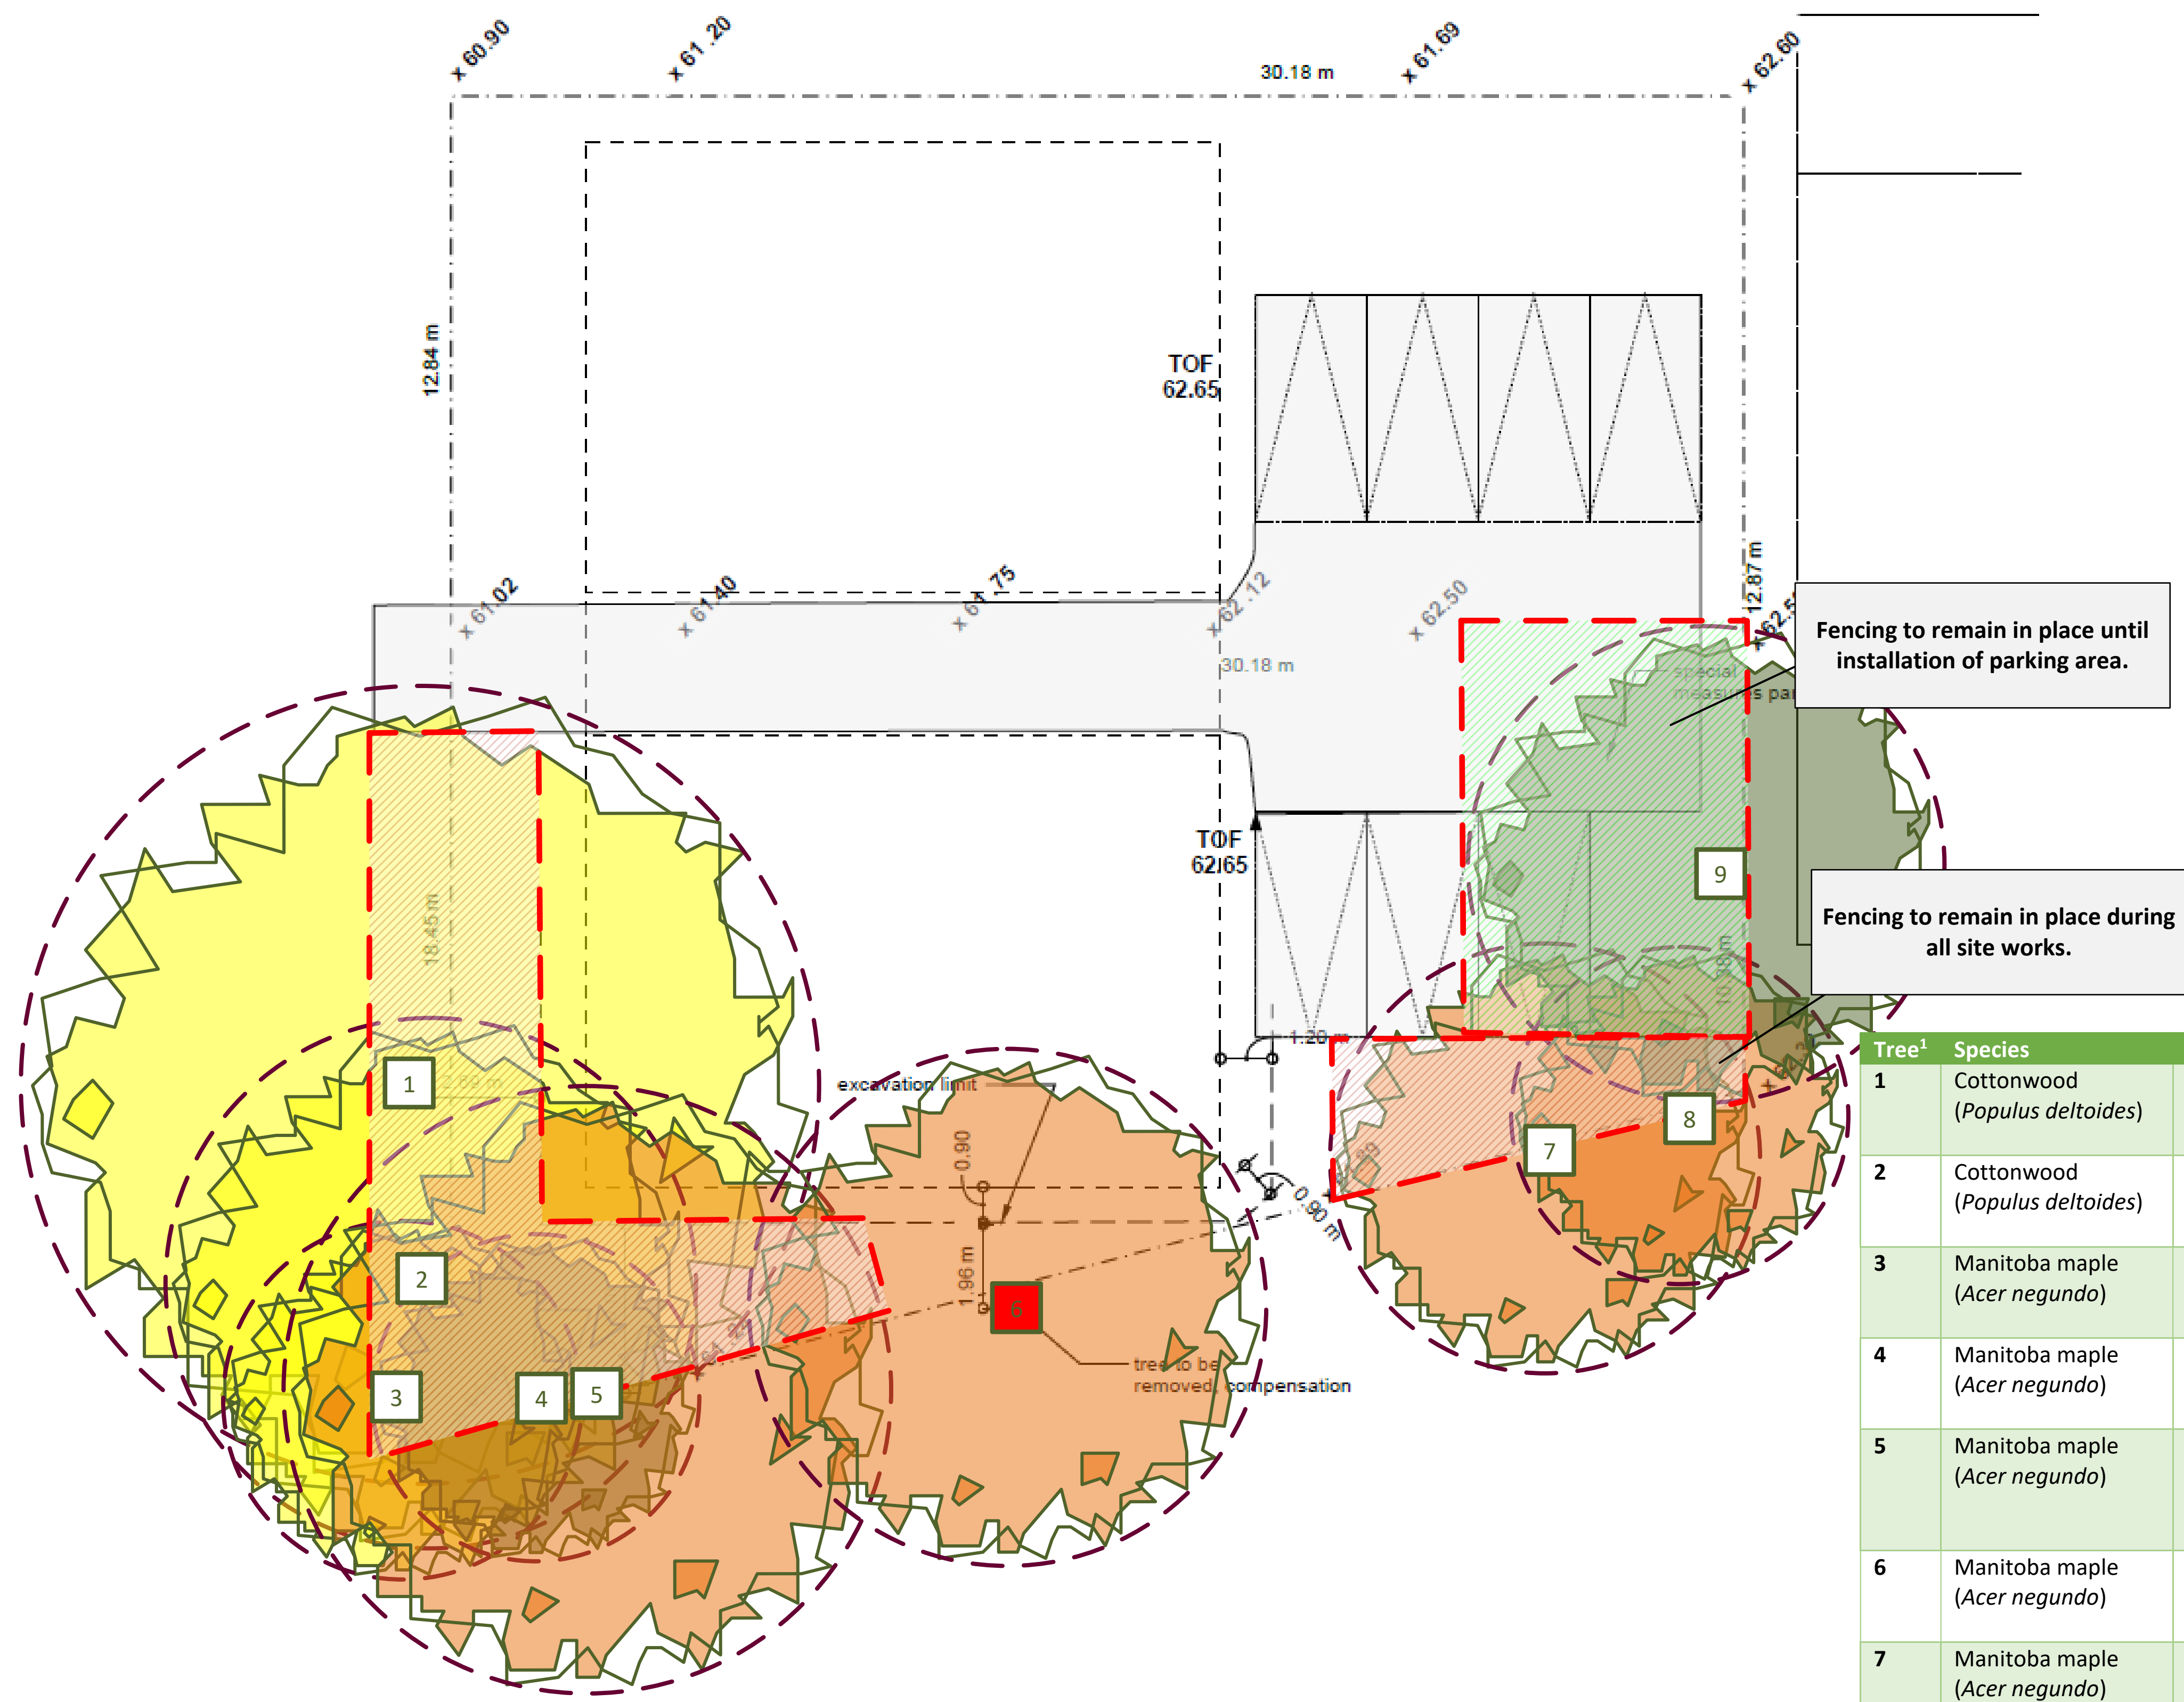
Tree <sup>1</sup>	Species	DBH (cm)	Condition	Recommendations
1	Cottonwood ( <i>Populus deltoides</i> )	52, 72	Good: some epicormic shoots; 2 small wounds (<1/8 diameter) with decay	Retain and protect as per the City of Ottawa Tree Protection Specifications (March 2021).
2	Cottonwood ( <i>Populus deltoides</i> )	59	Good	Retain and protect as per the City of Ottawa Tree Protection Specifications (March 2021).
3	Manitoba maple ( <i>Acer negundo</i> )	21, 23, 25	Fair: Largest stem lost half of crown	Retain and protect as per the City of Ottawa Tree Protection Specifications (March 2021).
4	Manitoba maple ( <i>Acer negundo</i> )	36	Poor: trunk hollow due to decay; significant lean	Retain and protect as per the City of Ottawa Tree Protection Specifications (March 2021).
5	Manitoba maple ( <i>Acer negundo</i> )	68	Fair: trunk straightens from lean; growing on fence (fence may be supporting tree); 2 large broken branches	Retain and protect as per the City of Ottawa Tree Protection Specifications (March 2021).

6	Manitoba maple ( <i>Acer negundo</i> )	57	Fair: significant lean; dead branch >1/4 diameter	Remove due to proximity of excavation. <b>Tree permit and permission from NCC required</b>
7	Manitoba maple ( <i>Acer negundo</i> )	48	Poor: decay throughout trunk; fungal bodies present	Retain and protect as per the City of Ottawa Tree Protection Specifications (March 2021).
8	Manitoba maple ( <i>Acer negundo</i> )	37	Fair/Poor: large branch broken - 1/2 crown on ground; cavity >1/4 diameter – no decay visible	Retain and protect as per the City of Ottawa Tree Protection Specifications (March 2021).
9	Silver maple ( <i>Acer saccharinum</i> )	34, 41	Good/Fair: included bark @ main union	Parking area to be built with Abweb TRP system. No surface material is to be in contact with tree trunk. Care is to be taken to not damage trunk or branches during installation.

Prior to any site works, protective fencing should be installed around the TPA as indicated in Map and maintained until all construction on site has been completed as per the City of Ottawa Tree Protection Specifications (March 2021). **Failure to install and maintain the indicated fencing may result in fines from the City.**
