Tree Information Report Version 3.0

Submitted as part of Building Permit Application for the City of Ottawa

Address: 844 Connaught
Date: December 21, 2023
Prepared by: Astrid Nielsen, RPF, ISA Certified Arborist®
131 Smirle Ave, Ottawa, K1Y 0S4
Astrid.nielsen@dendronforestry.ca

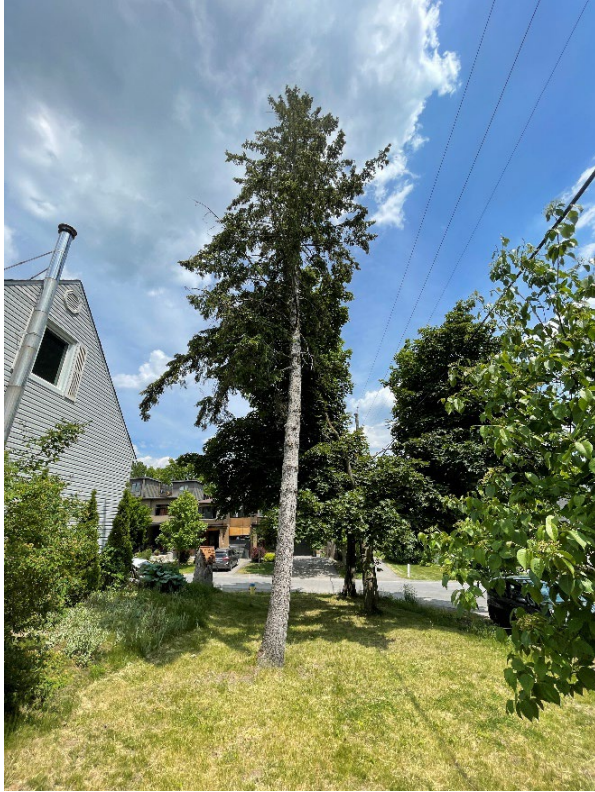
Figure 4: Tree 3, city owned white spruce to be retained

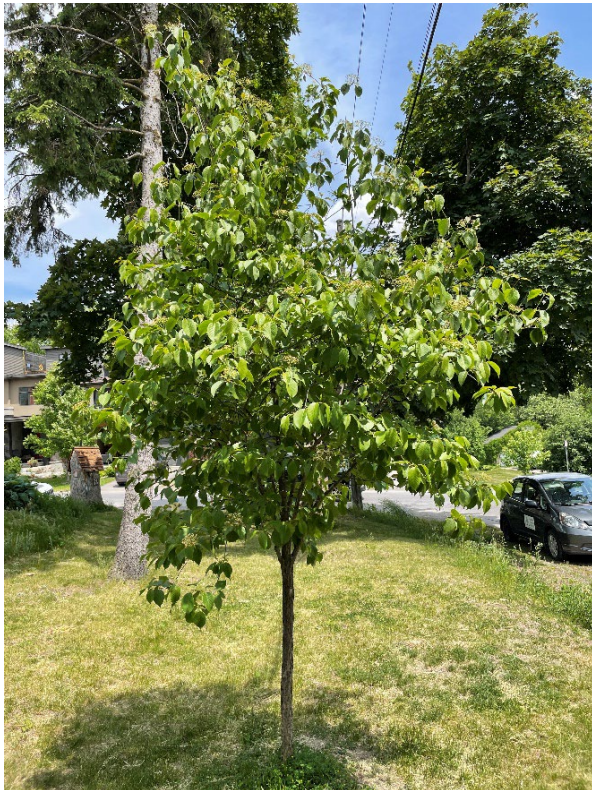
<i>glauca</i>)			root girdling on underside of lean		
4	Viburnum (<i>Viburnum lentago</i>)	5 cm	City	Good	Retain	Retain and protect with fencing as per specifications in report
5	White spruce (<i>Picea glauca</i>)	39 cm	City	Poor; topped by hydro	Retain and protect OR City should consider removing this tree based on poor health	Remove based on health and potential impact of construction; better option is to replace with a new tree post construction
6	Norway maple (<i>Acer platanoides</i>)	25, 35 cm (rough estimate)	Adjacent property at 839 Tavistock; possibly on the property line	Good (tree not very visible through fence)	Retain and protect	Avoid exposing any roots during construction of new driveway and garage

Figure 5: Tree 4, city owned Viburnum

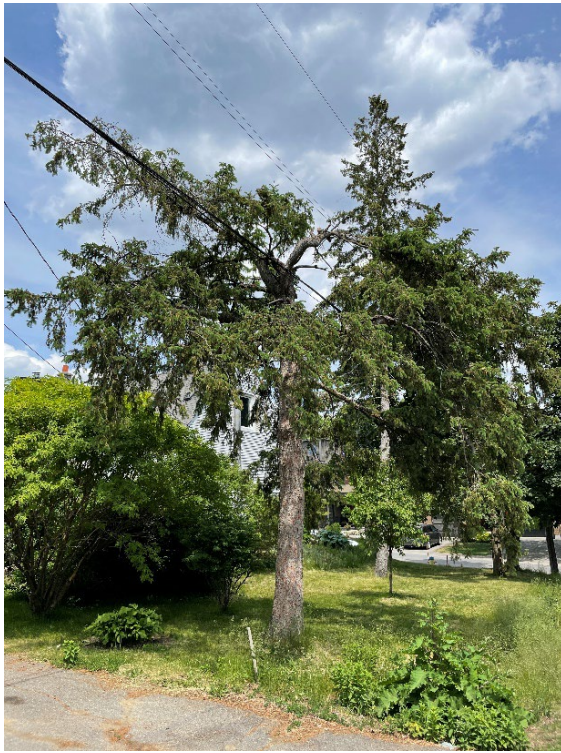
Figure 6: Tree 5, city owned white spruce in poor condition

Trees 1,2, and especially 5, are city trees in fair to poor health. It is recommended that the forestry inspector visit the site and assess these trees for potential removal by the city. The proposed driveway on Sackville Street is well within the critical root zone of tree 6, but it will be in the same location as the existing garage and driveway, so there should be limited root damage to this tree, if any.

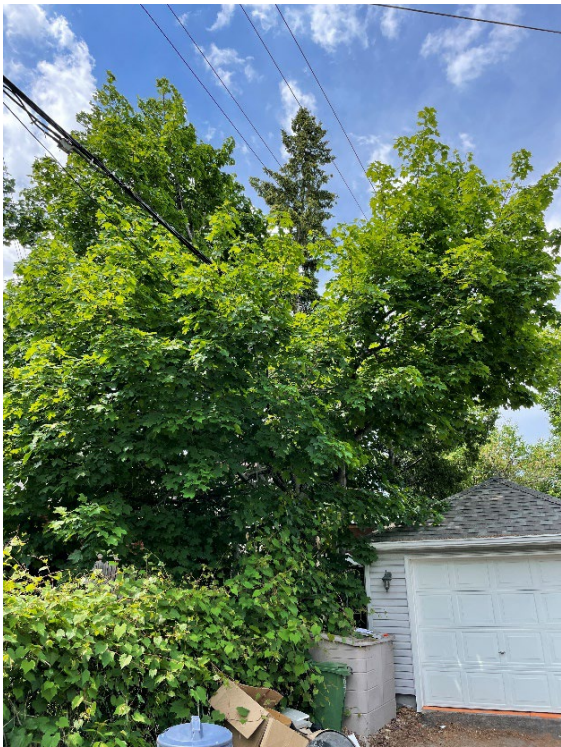
Figure 7: Tree 6, Norway maple on adjacent property at 836 Tavistock

6	Norway maple (<i>Acer platanoides</i>)	25, 35 cm (rough estimate)	Good (tree not very visible through fence)	Avoid exposing any roots during construction of new driveway and garage
