## Tree Information Report

Submitted as part of Building Permit Application for the City of Ottawa

**Address:** 372 Roosevelt  
**Date:** April 5, 2022  
**Prepared by:** Astrid Nielsen, RPF, ISA Certified Arborist ®  
 131 Smirle Ave, Ottawa, K1Y 0S4  
[Astrid.nielsen@dendronforestry.ca](mailto:Astrid.nielsen@dendronforestry.ca)  
**Prepared for:** Goli Monjazebe, golchehr.monjazebe@gmail.com  
**Site Visit:** April 5, 2022

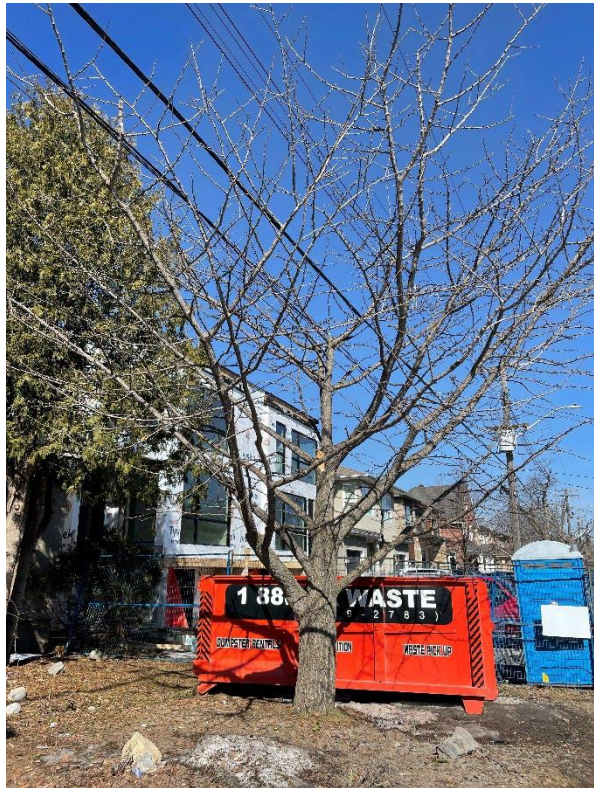
Tree <sup>1</sup>	Species	Diameter at breast height (cm)	Ownership <sup>2,3</sup>	Condition	Action	Arborist Recommendations
1	Ginkgo ( <i>Ginkgo biloba</i> )	34 cm	City	Fair/poor; growing directly under hydro lines, has been topped; 30 cm limb recently broken off leaving significant wound on trunk	Remove and replace	Remove based on poor location under hydro lines, poor condition, and conflict with proposed driveway and services. Tree Permit required for removal.
2	White pine ( <i>Pinus strobus</i> )	30.2 cm	Private – 372 Roosevelt	Fair; lost top several years ago, replaced with two codominant stems, asymmetric crown due to shading by tree 3	Remove and replace	Remove based on health and proximity to new building; distance to new building and rear staircase is approximately 3 and 1.5 m, respectively, excavation for new home would be close to the trunk. Tree Permit required for removal.

Figure 1: Tree 1, city owned Ginkgo tree growing directly under hydro lines to be removed

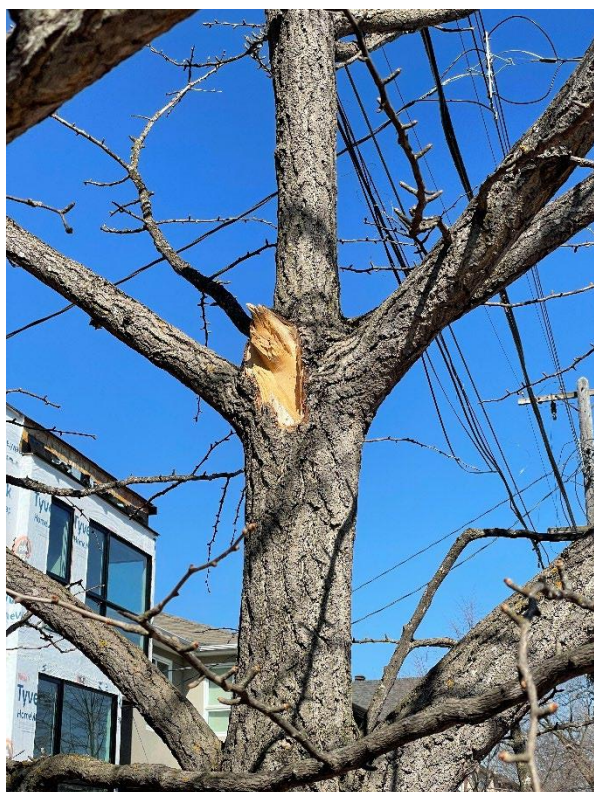
Figure 2: Tree 1, recent branch failure and wound

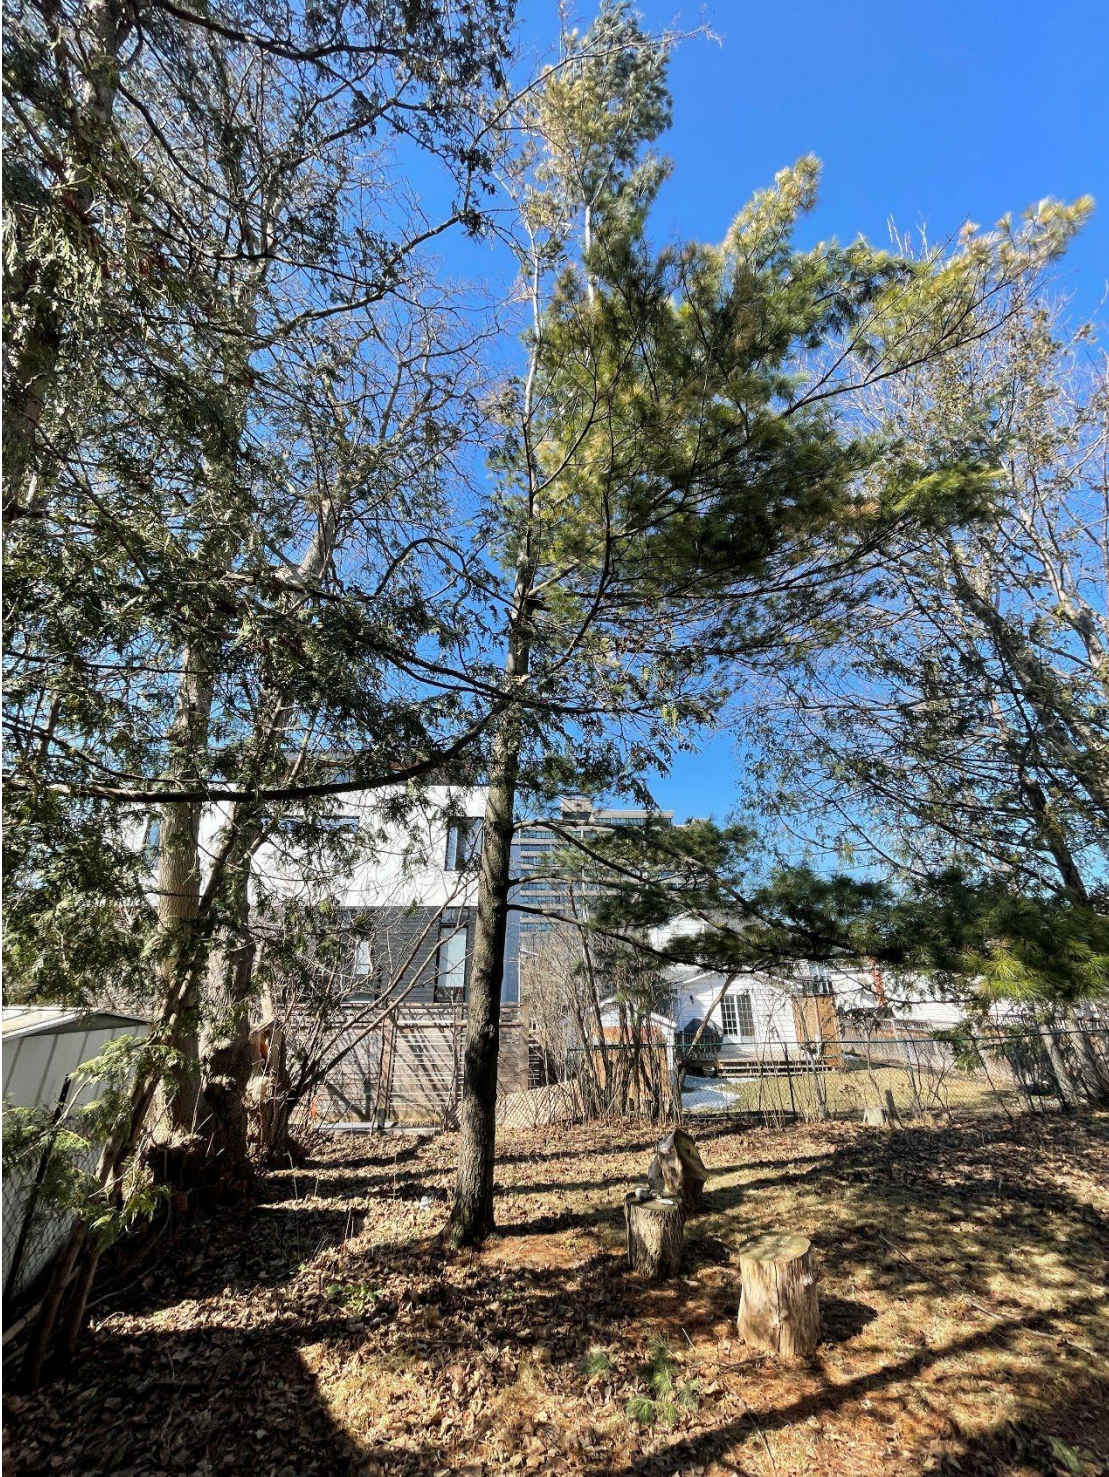
*Figure 3: Tree 2, white pine tree in rear of property to be removed*

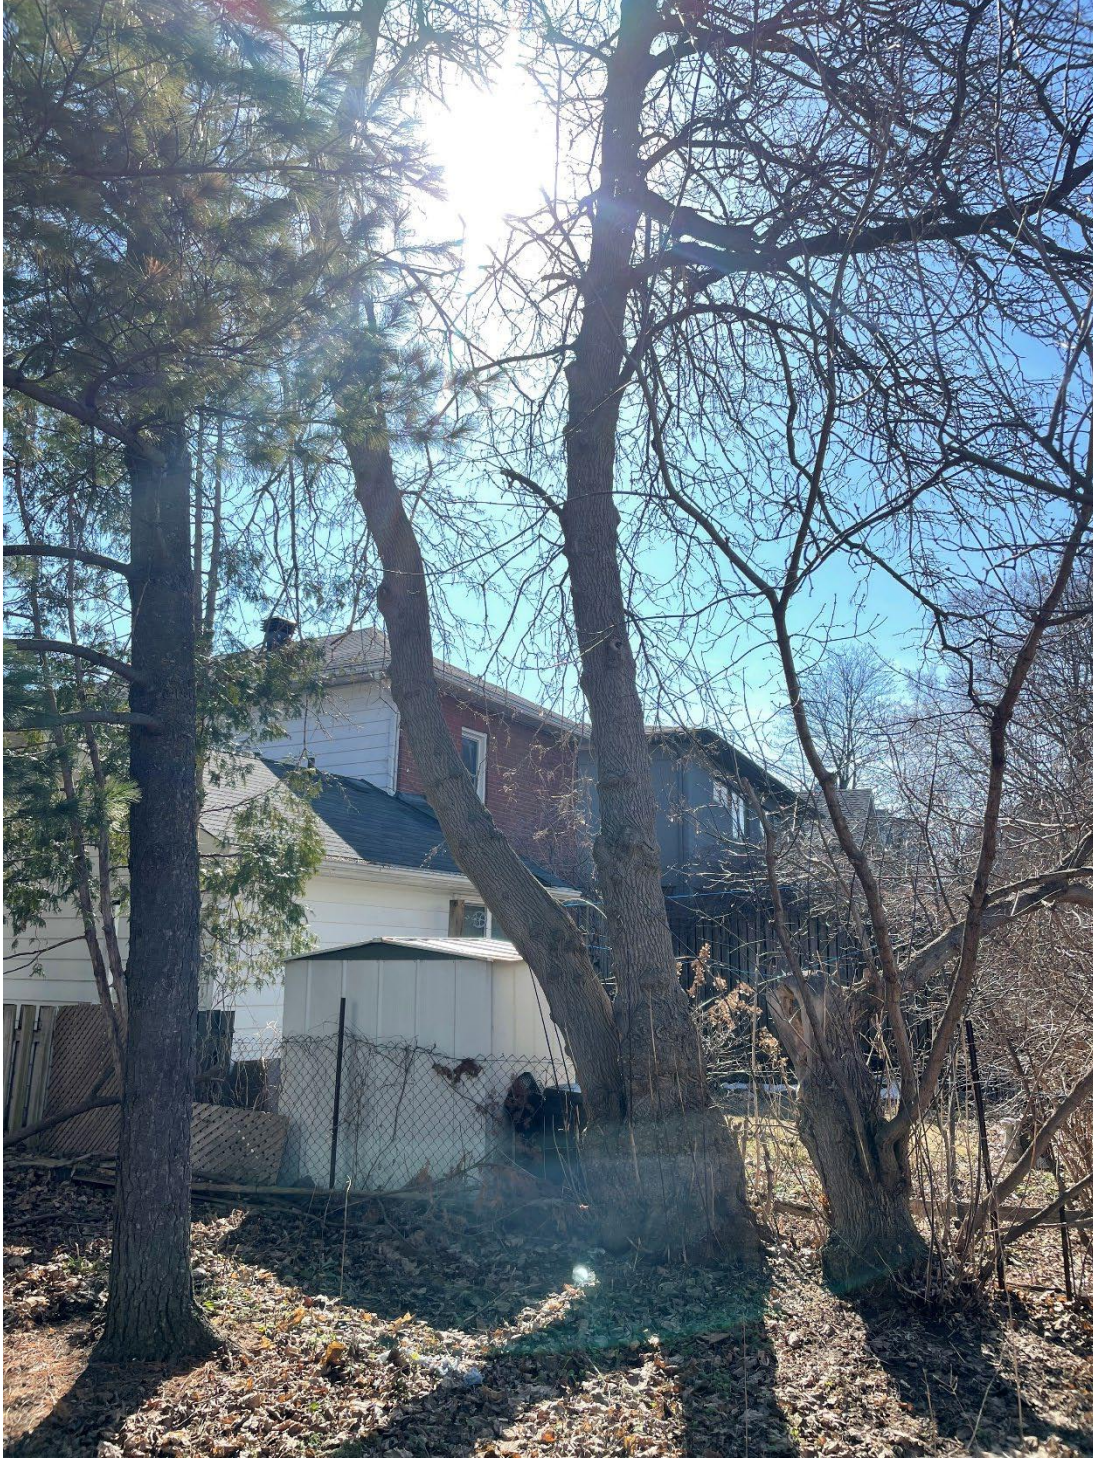
3	Manitoba maple ( <i>Acer negundo</i> )	36, 45 cm	Jointly owned with 378 Roosevelt	Fair; included bark at junction of two stems, grown into metal fence, 36 cm stem leaning towards home	Retain	Retain and protect during construction as per City of Ottawa Tree Protection Specifications (March 2021); not an ideal candidate for retention due to fair health, short life span and lean towards building (36 cm stem will be close to new building). Consider removal and replacement if adjacent property owner concurs, monitor for stability during construction
4	Norway maple ( <i>Acer platanoides</i> )	44, 38 cm	Private – 372 Roosevelt	Good/fair; girdling root 20% of circumference	Retain	Retain and protect as per City of Ottawa Tree Protection Specifications (March 2021)

*Figure 4: Tree 3, Manitoba maple*

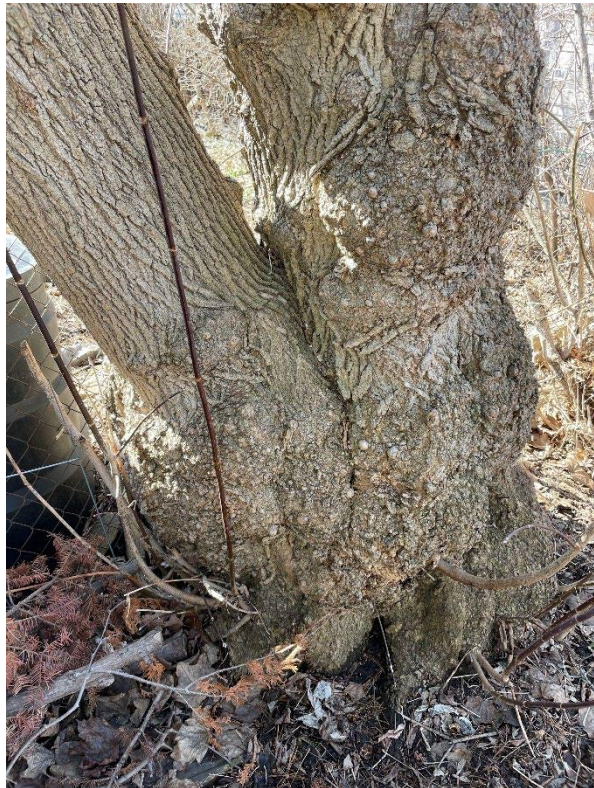
*Figure 5: Base of Manitoba maple, tree 3, showing included bark at junction of two stems*

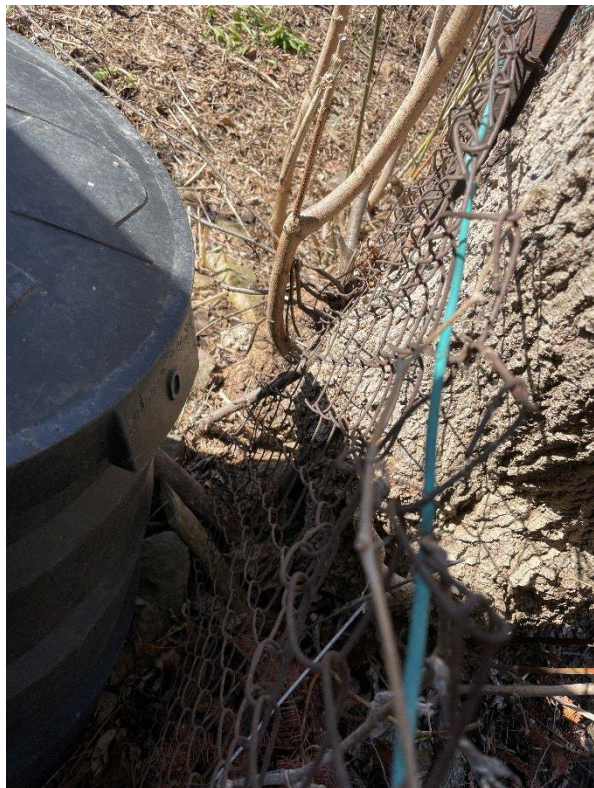
*Figure 6: Base of Manitoba maple (tree 3) growing into metal fence and post*

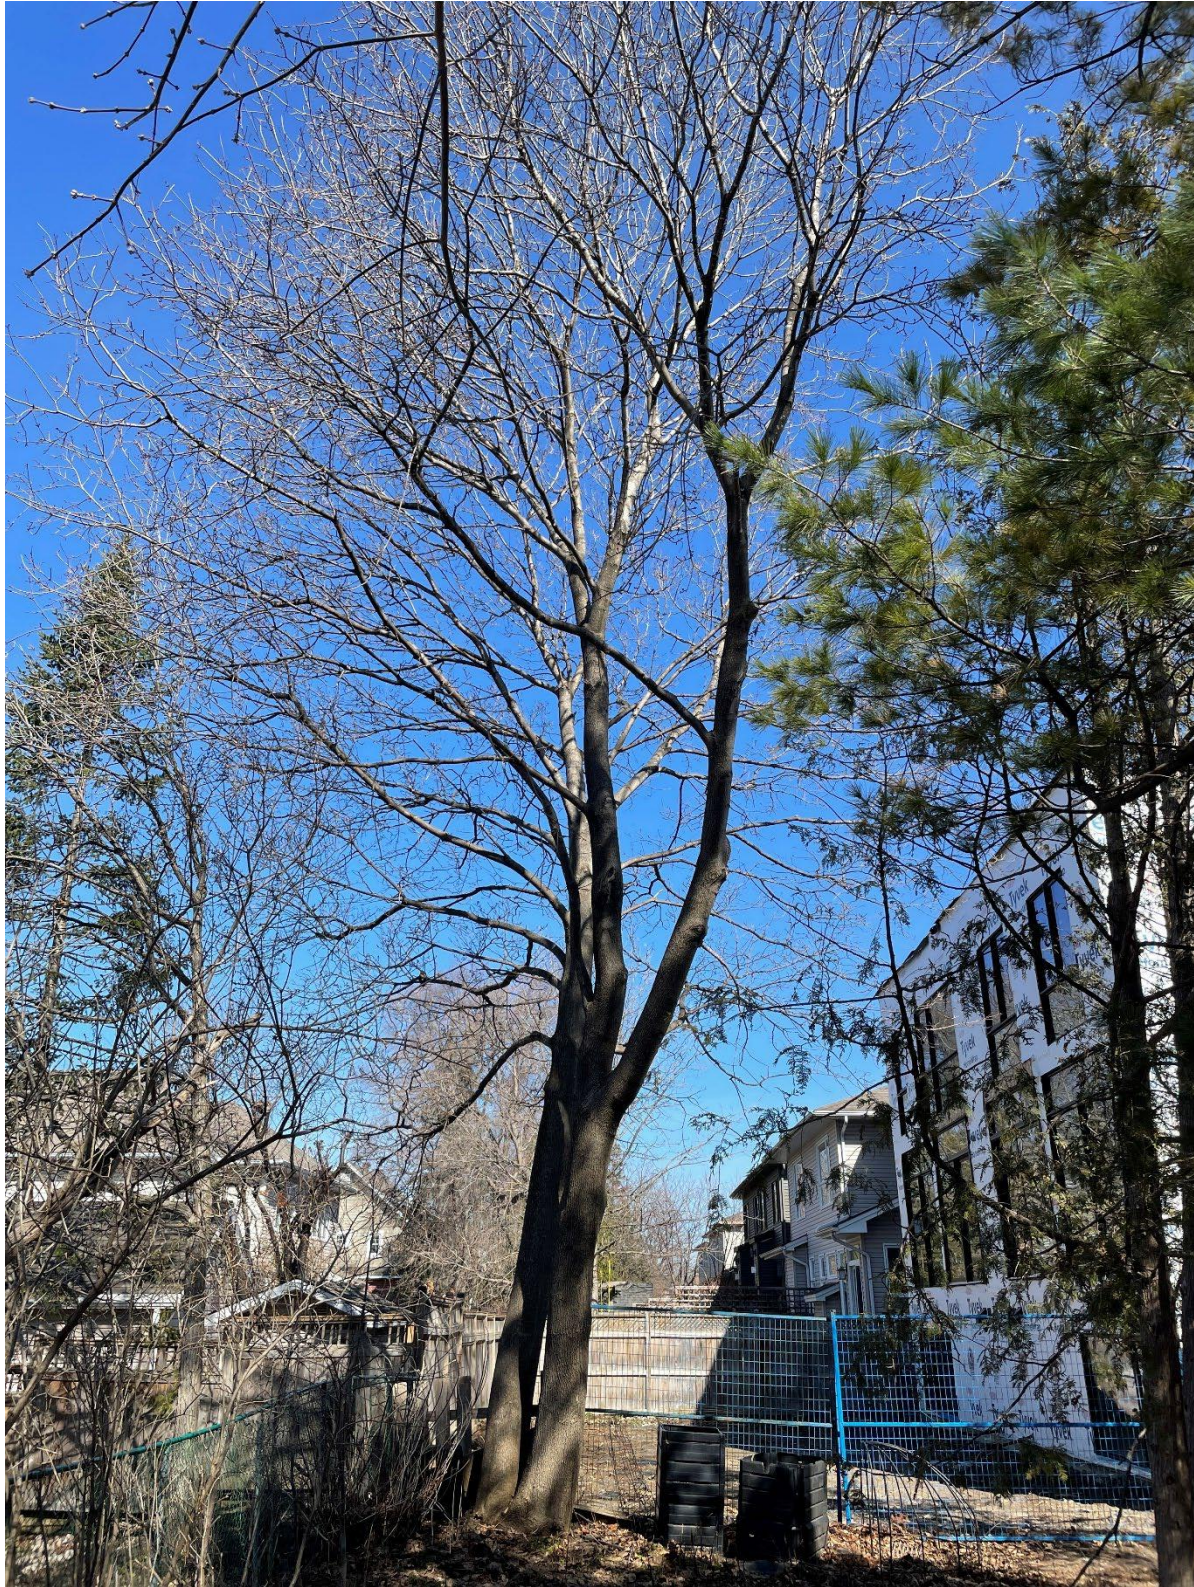
*Figure 7: Tree 4, Norway maple at the NW corner of the property to be retained*
