Tree Information Report

Submitted as part of Committee of Adjustment Application to the City of Ottawa

Date of Report: September 18, 2023
Property Address: 505 Dawson Avenue
Prepared for: Maryam Hassanzedeh; maryamsafari2004@yahoo.ca
Prepared by: Kevin Myers, ISA Certified Arborist; kevin.myers@dendronforestry.ca
Date of Site Visit: September 14, 2023

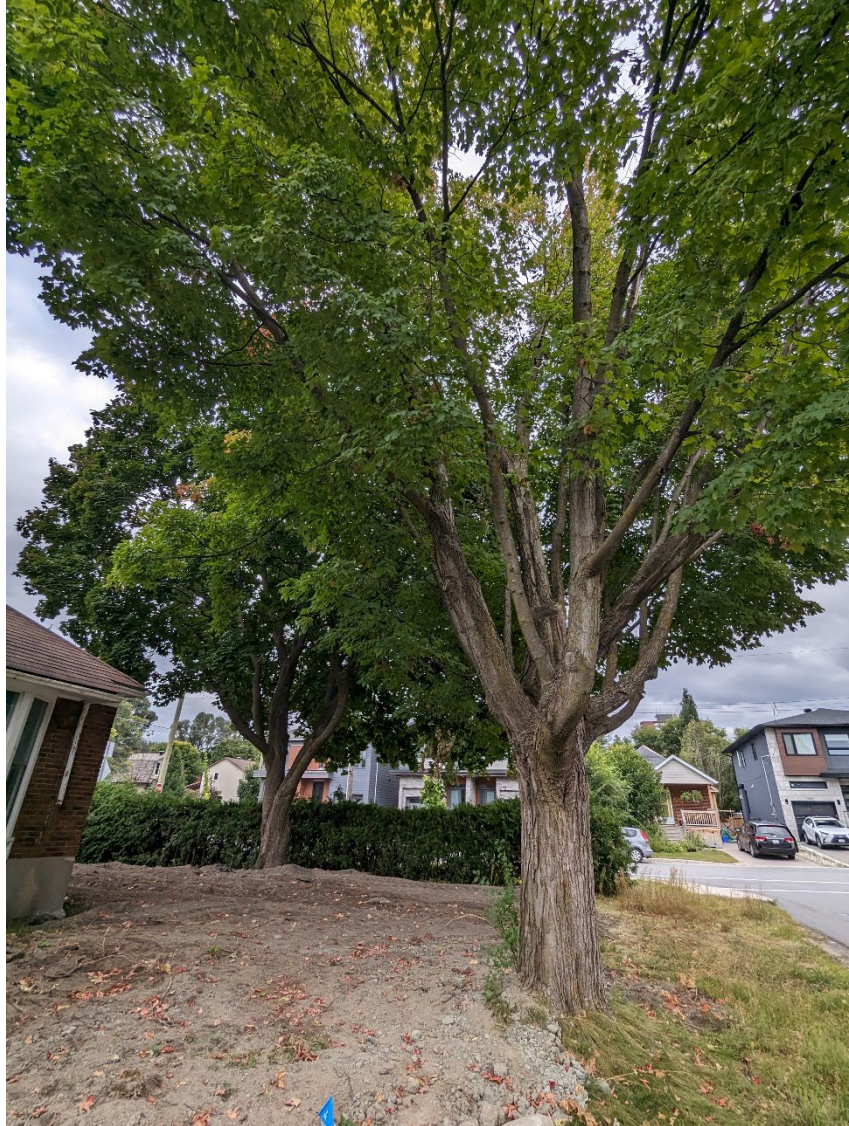
Tree 1 is a mature sugar maple (*Acer saccharum*) which is showing signs of decline: its central leader has been removed and a fungal infection is killing the tree from the center outwards. Due to the intensification on the site, it is likely the tree will decline even more quickly post construction. Because the site plan allows for space for tree planting, it is the opinion of Dendron Forestry Services that the urban forest would be better served by removing and replanting this tree.

Tree 2 is a large Norway maple. To maintain the stability of this tree, excavation is to come no closer than 2m from the edge of the trunk. The main union of this tree has included bark and a seam, both of which could represent points of potential failure. To maintain this tree as long as possible, a structural support system should be considered. Any pruning required for the new building is to be done by a certified arborist, and this arborist could be consulted on an appropriate support system for the canopy.

Tree 2 (left - in background) – private maple to be retained and Tree 1 (right - in foreground) – City maple to be removed.

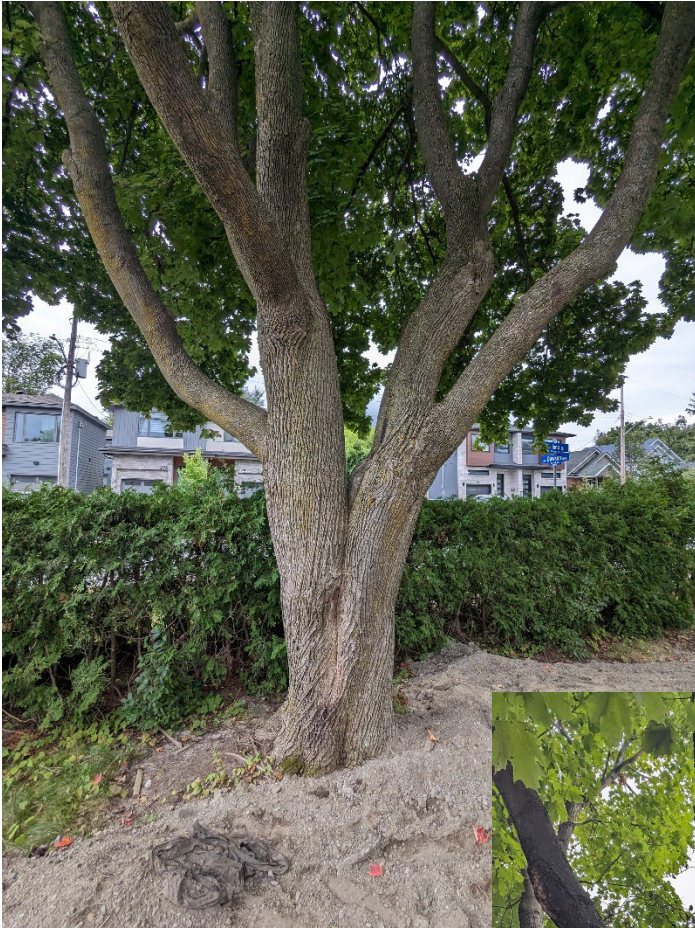
Above: trunk of Tree 2 with bad main union - view from the north.

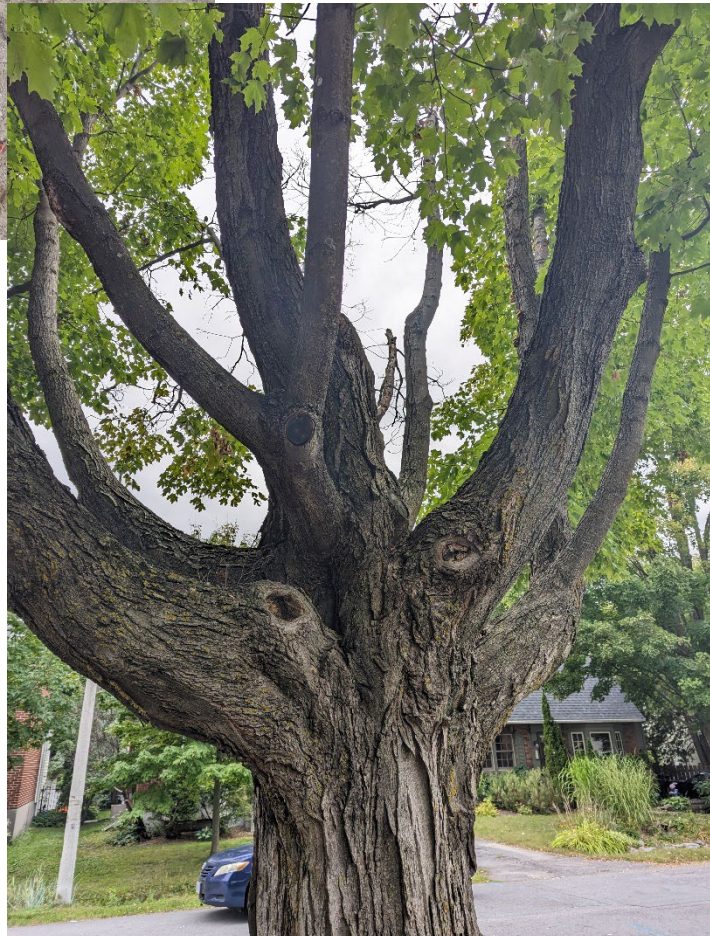
Right: Trunk of Tree 1 - view from the east.

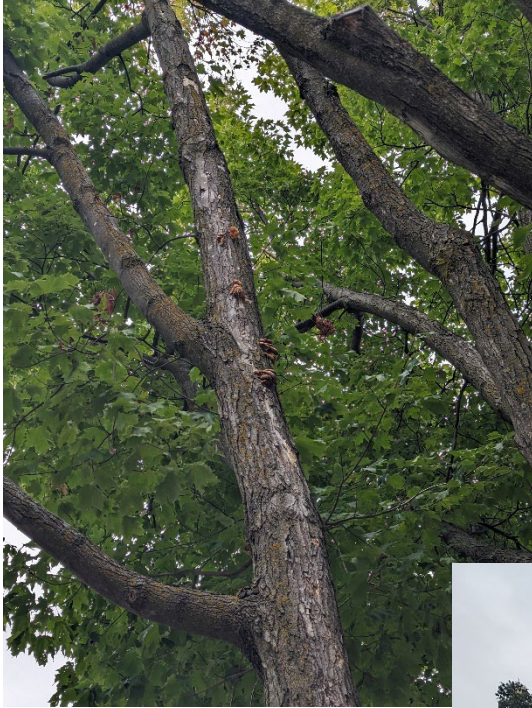
Above: fungal bodies in canopy of Tree 1.

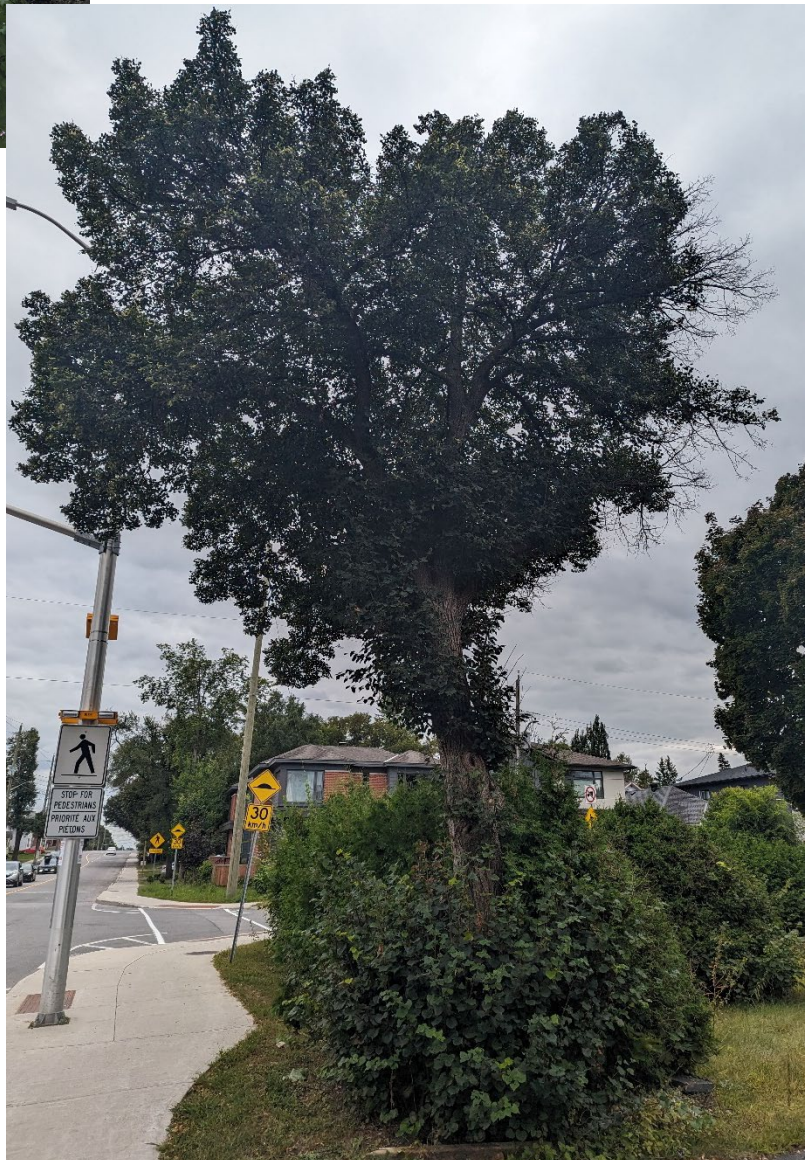
Right: Tree 3 - City linden to be retained.

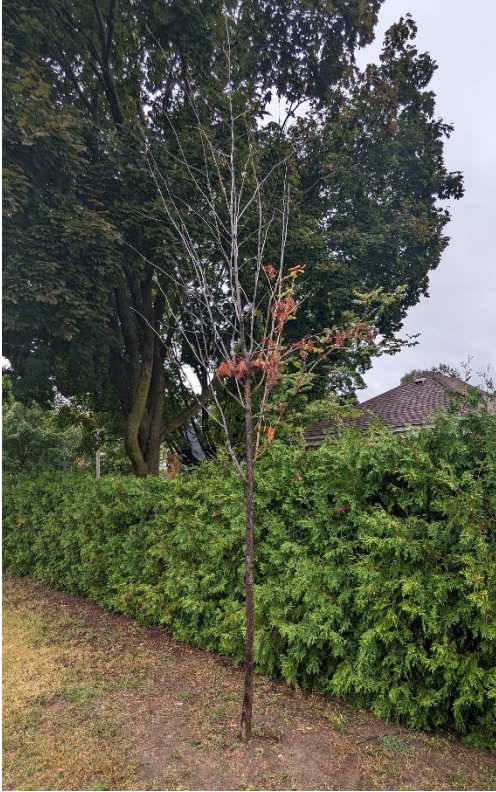
Tree 4 is a city-planted mountain ash in the ROW along Iona. This tree is in extremely poor condition and should be removed during this project to allow for tree planting in its place: contact the city for removal permission. There is another city-planted tree beside Tree 4 that is completely dead.

4 ³	Oakleaf mountain ash (<i>Sorbus thuringiaca</i>)	4	City	Fair	Poor: mechanical wounds at base	Very poor: tree almost dead – 5% LCR	6	Remove	Remove – tree is almost dead. Contact city for removal permission.

Tree 4 - City mountain ash to be removed

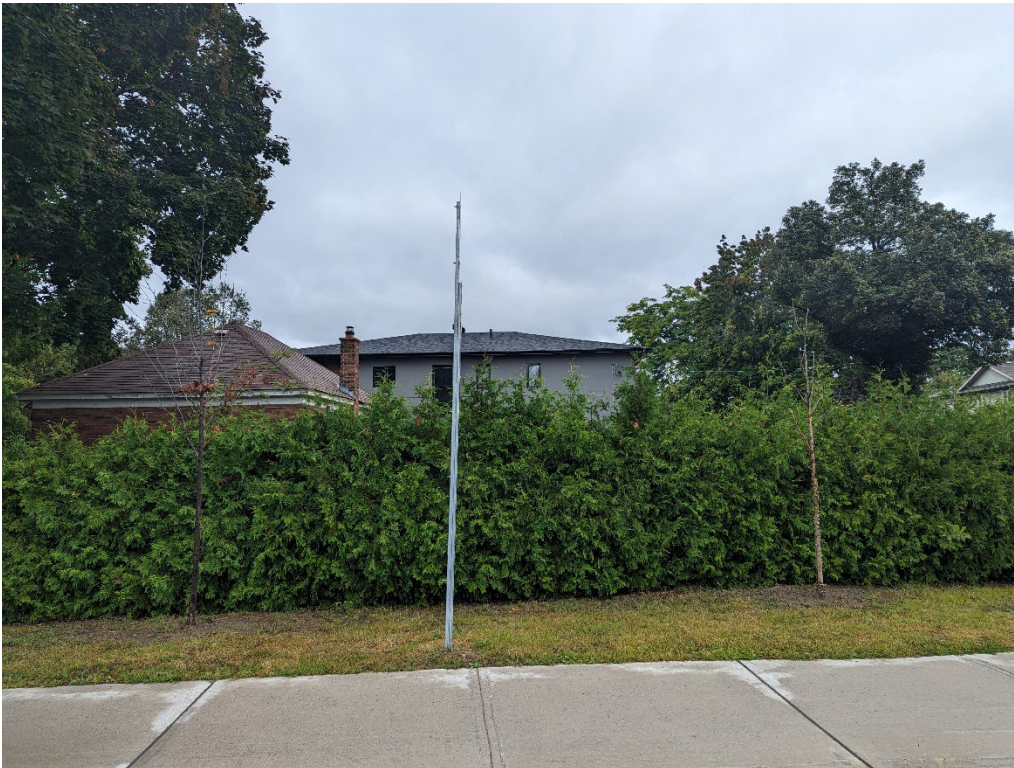
Tree 4 (left) and a dead city tree (right) in the ROW along Iona street
