## TREE INFORMATION REPORT

PROJECT NAME:	275 MacLaren Street
PROJECT NO.	23870-1
LOCATION	275 MacLaren Street, Ottawa ON, K2P 0L9
INSPECTION DATE:	26 September, 2023 Reinspection of Tree E07 , 11 March 2024* See notes by Principal Landscape Architect

PURPOSE OF REPORT	To describe the existing tree coverage on the property and to identify the trees to be removed or protected for the construction of a new building addition and associated site works.
-------------------	--

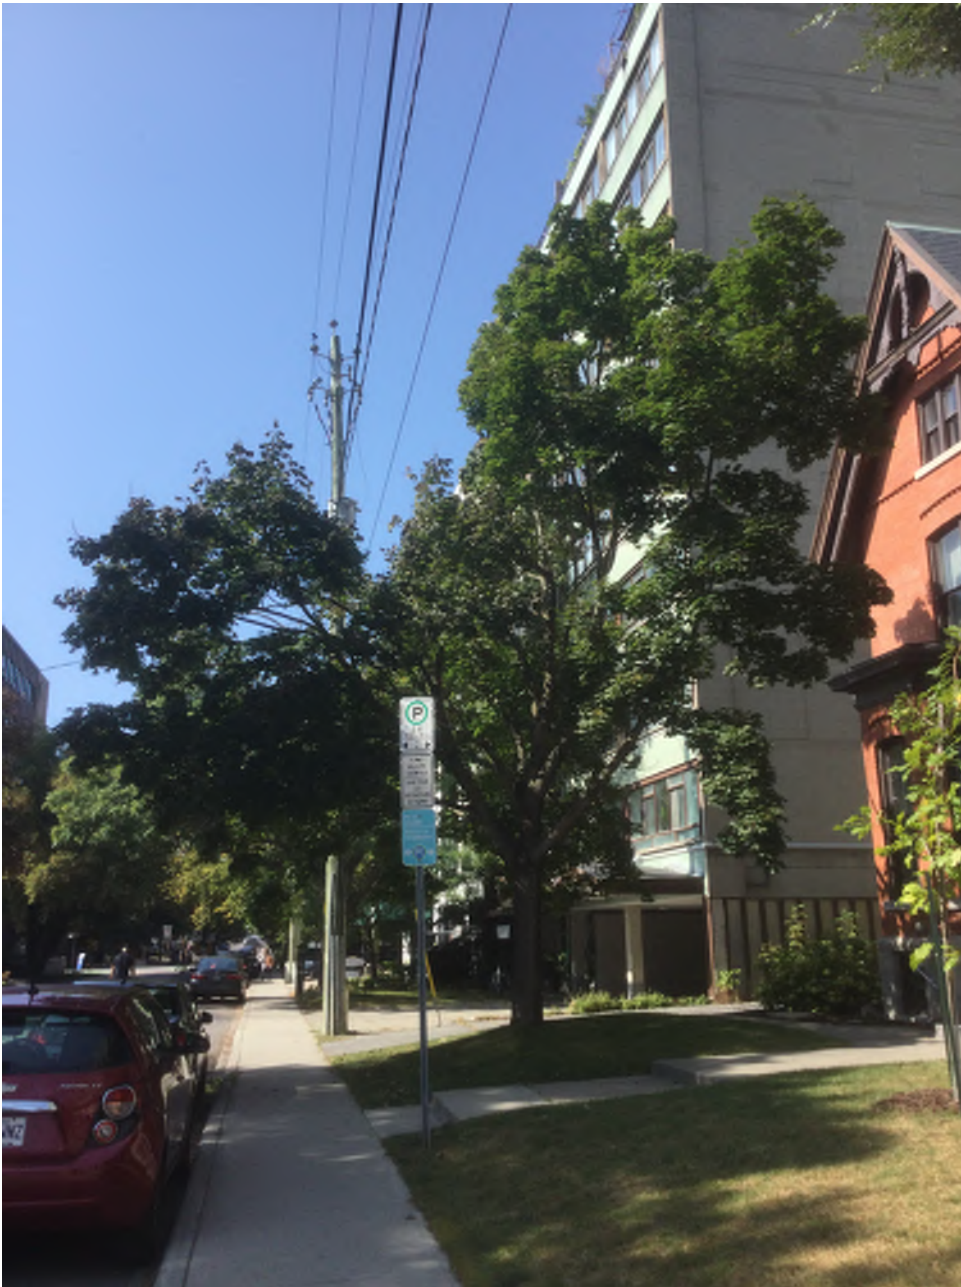
TREE NO.	TREE SPECIES	SIZE (DBH)	CONDITION AND HEALTH (GOOD, FAIR, POOR, OR DEAD)
E01	Crimson King Norway Maple / <i>Acer platanoides</i>	35cm	Poor. Large vertical split in trunk. Significant splitting in branches above crotch. Some response wood around previous pruning wounds. Dead branches in canopy.

Photo 1: Tree E01 (retain) - No conflict with proposed construction.

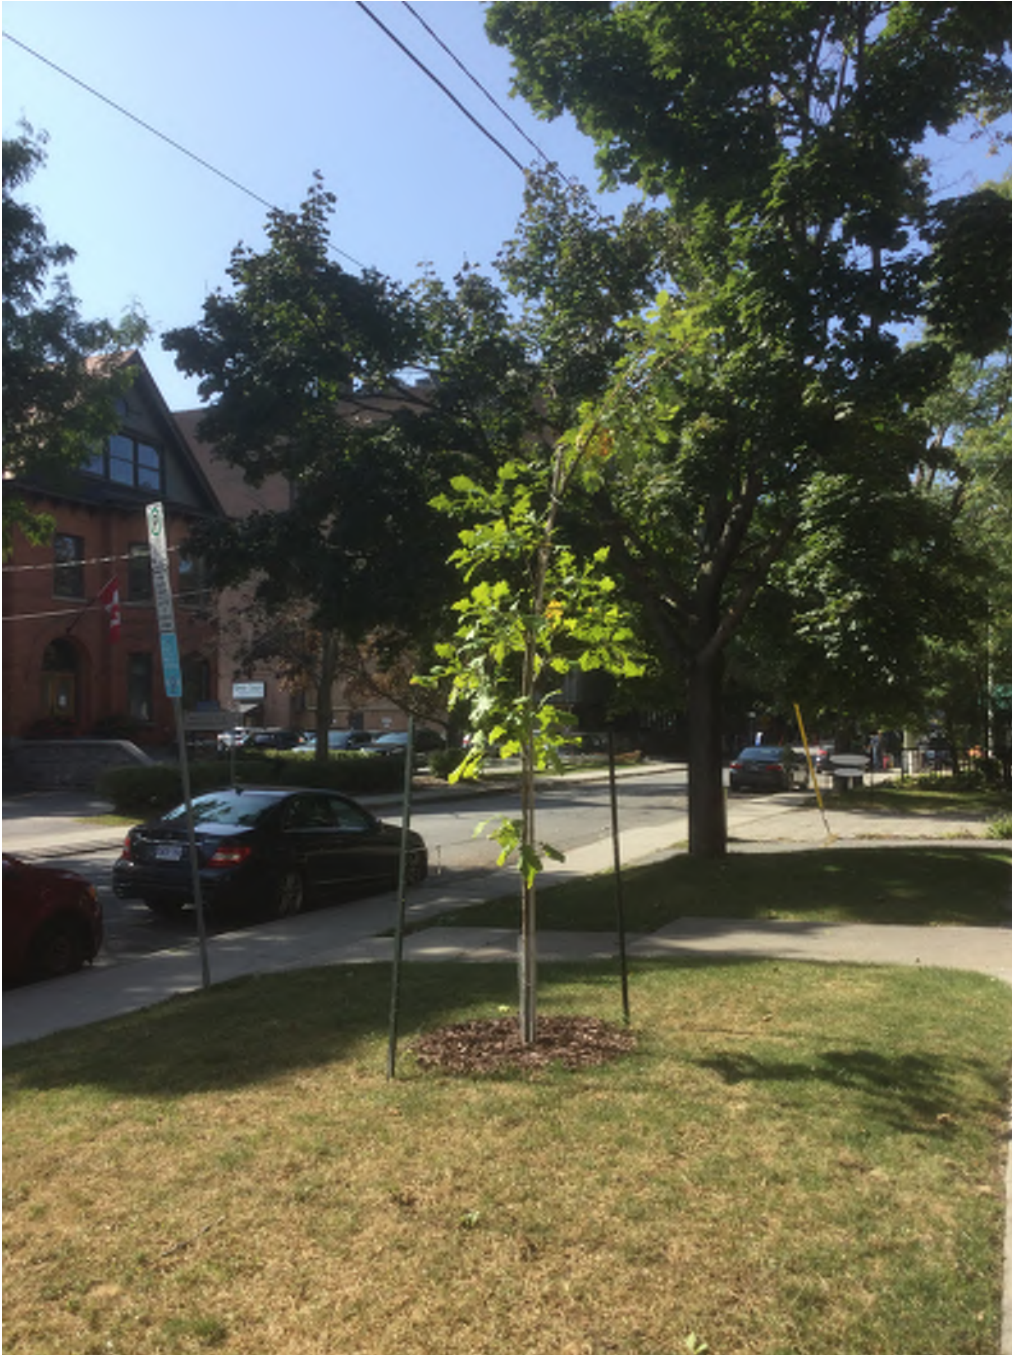
Photo 2: Tree E02 (retain) - No conflict with proposed construction.

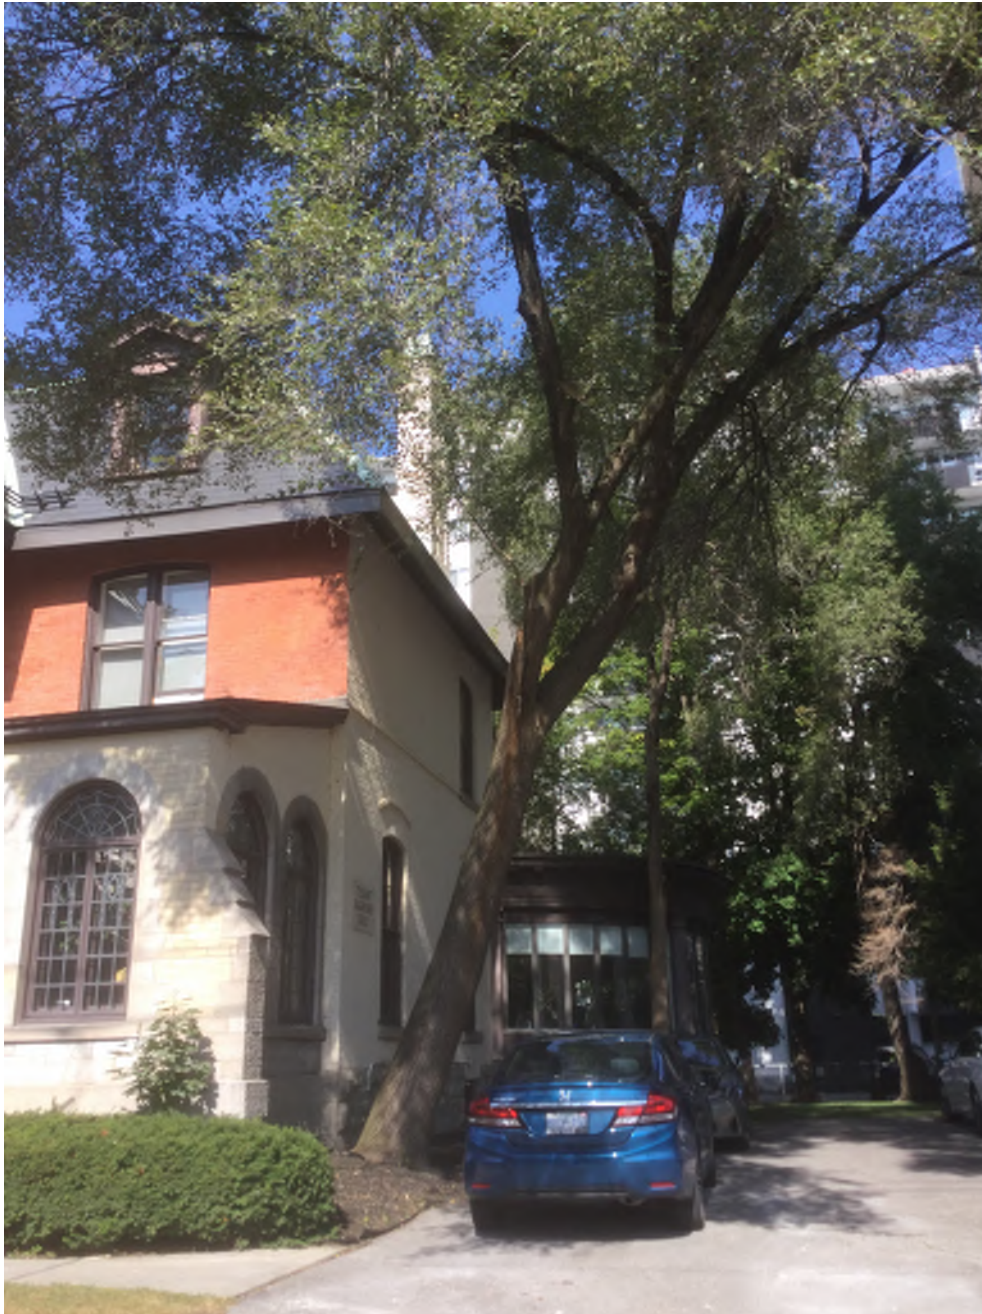
**Photo 3:** Tree E03 (remove) – Heavy leaner to east over existing driveway and conflicts with proposed accessible ramp.

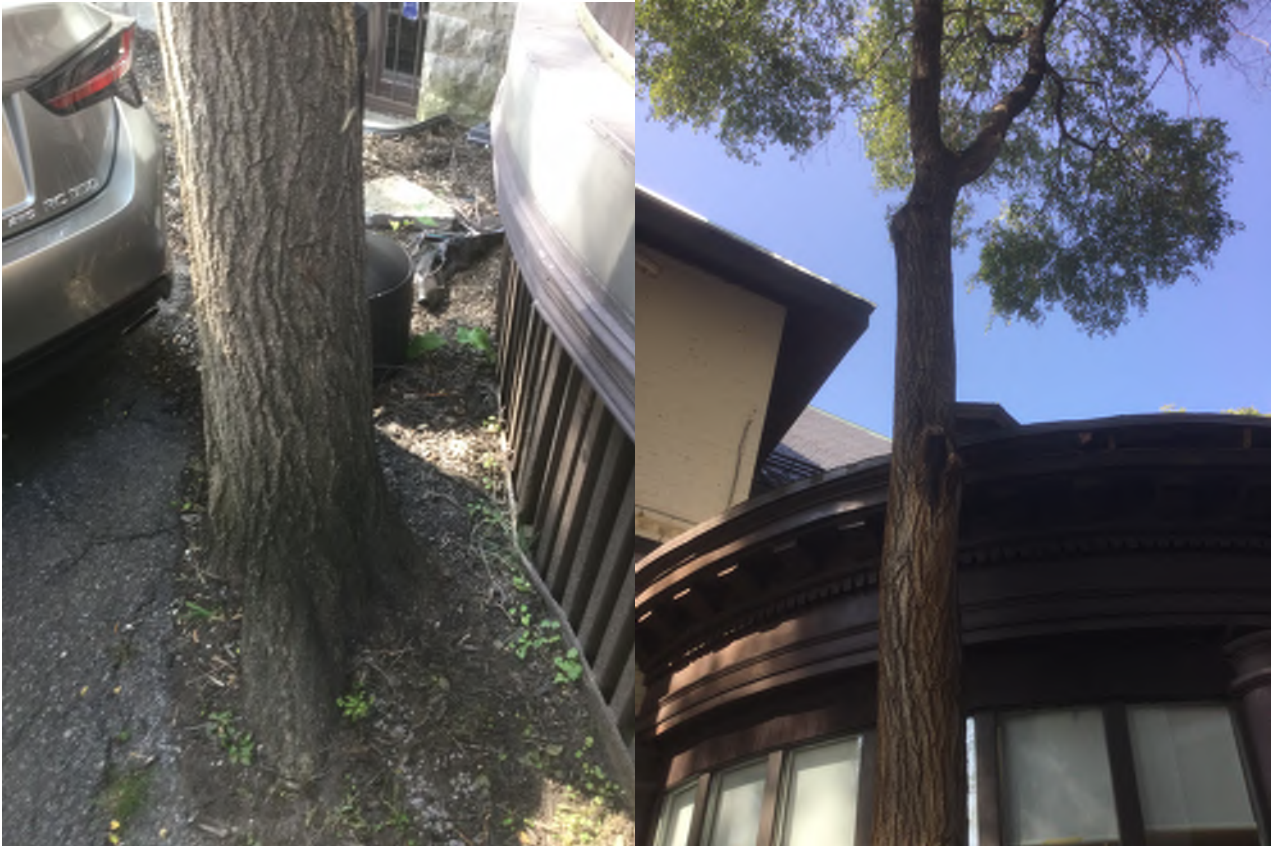
E04	Siberian Elm / <i>Ulmus pumila</i>	30cm	Good. Dead branches in upper canopy. Well-developed buttress roots.
E05	Eastern White Cedar / <i>Thuja occidentalis</i>	15cm	Fair. Some trunk damage. Response wood evident around wounds.
E06	White Spruce / <i>Picea glauca</i>	16cm	Dead.
E07	Siberian Elm / <i>Ulmus pumila</i>	44cm	Fair. East leaning stem historically removed at 0.9m. Remaining stem leans southwest over existing building. Dead branches in upper canopy. 8 Significant Branches are dead or dying in the crown*
E08	Norway Maple / <i>Acer platanoides</i>	47cm	Good. North lean over adjacent property. Conflicts with overhead wires
E09	Norway Maple / <i>Acer platanoides</i>	37cm	Fair. Heavily conflicted with overhead wires
E10	Norway Maple / <i>Acer platanoides</i>	22cm	Fair. Imbalanced crown heavily leaning to south over building. Little buttress support. Stem/upper canopy resting on E11
E11	Manitoba Maple / <i>Acer negundo</i>	46cm	Fair. Heavy lean to southeast over existing building. Intertwined with and provides structural support to E10

Photos 4 & 5: Tree E04 (remove) – Conflicts with proposed building entrance.

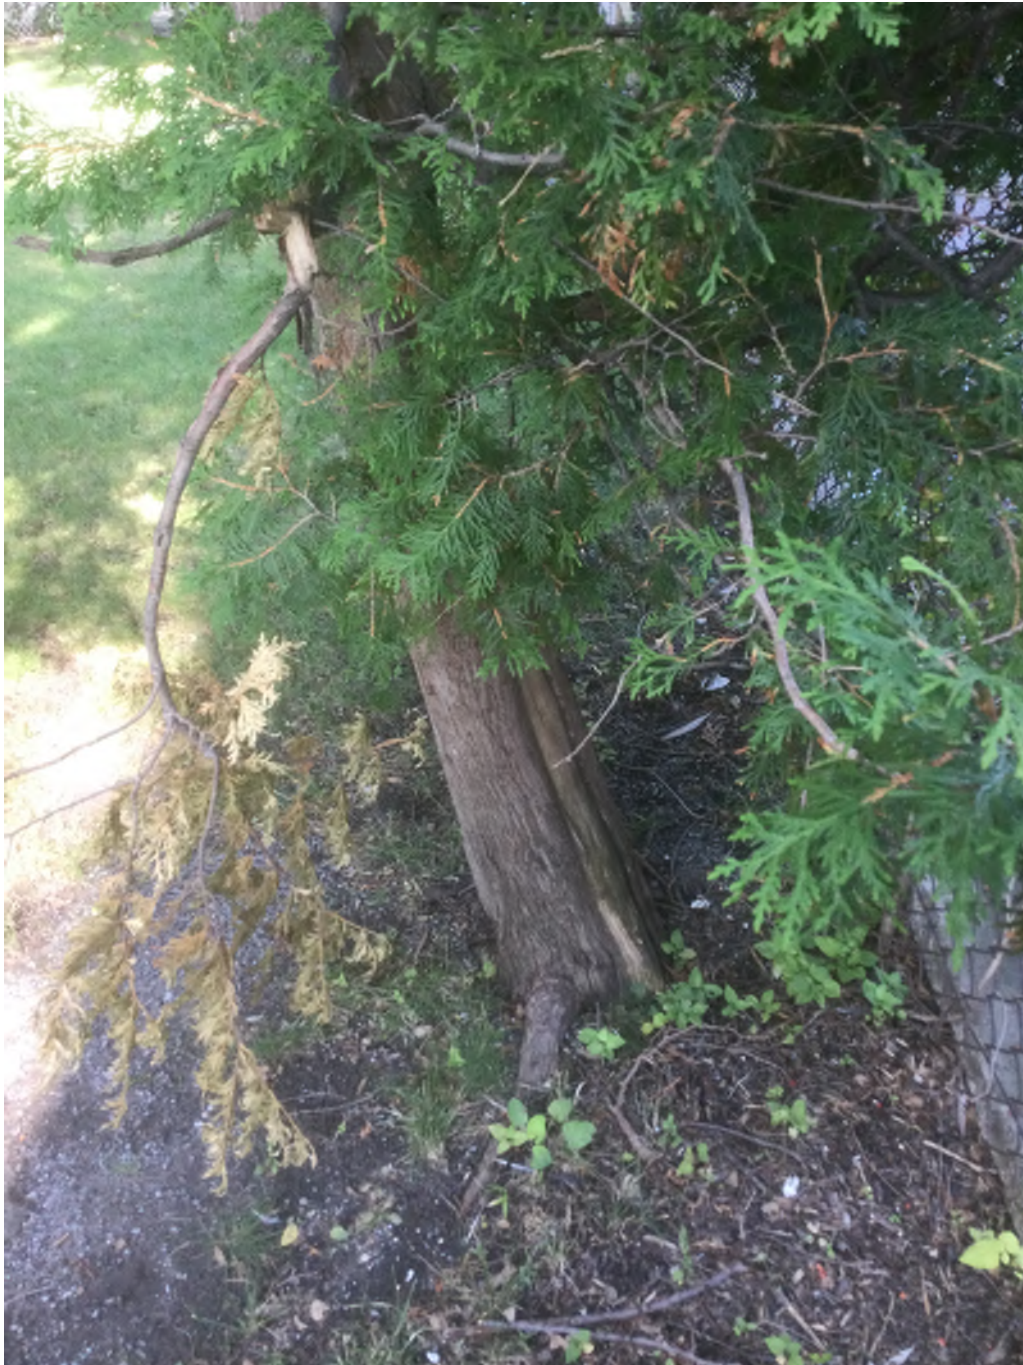
Photo 6: Tree E05 (retain) – Does not conflict with construction.

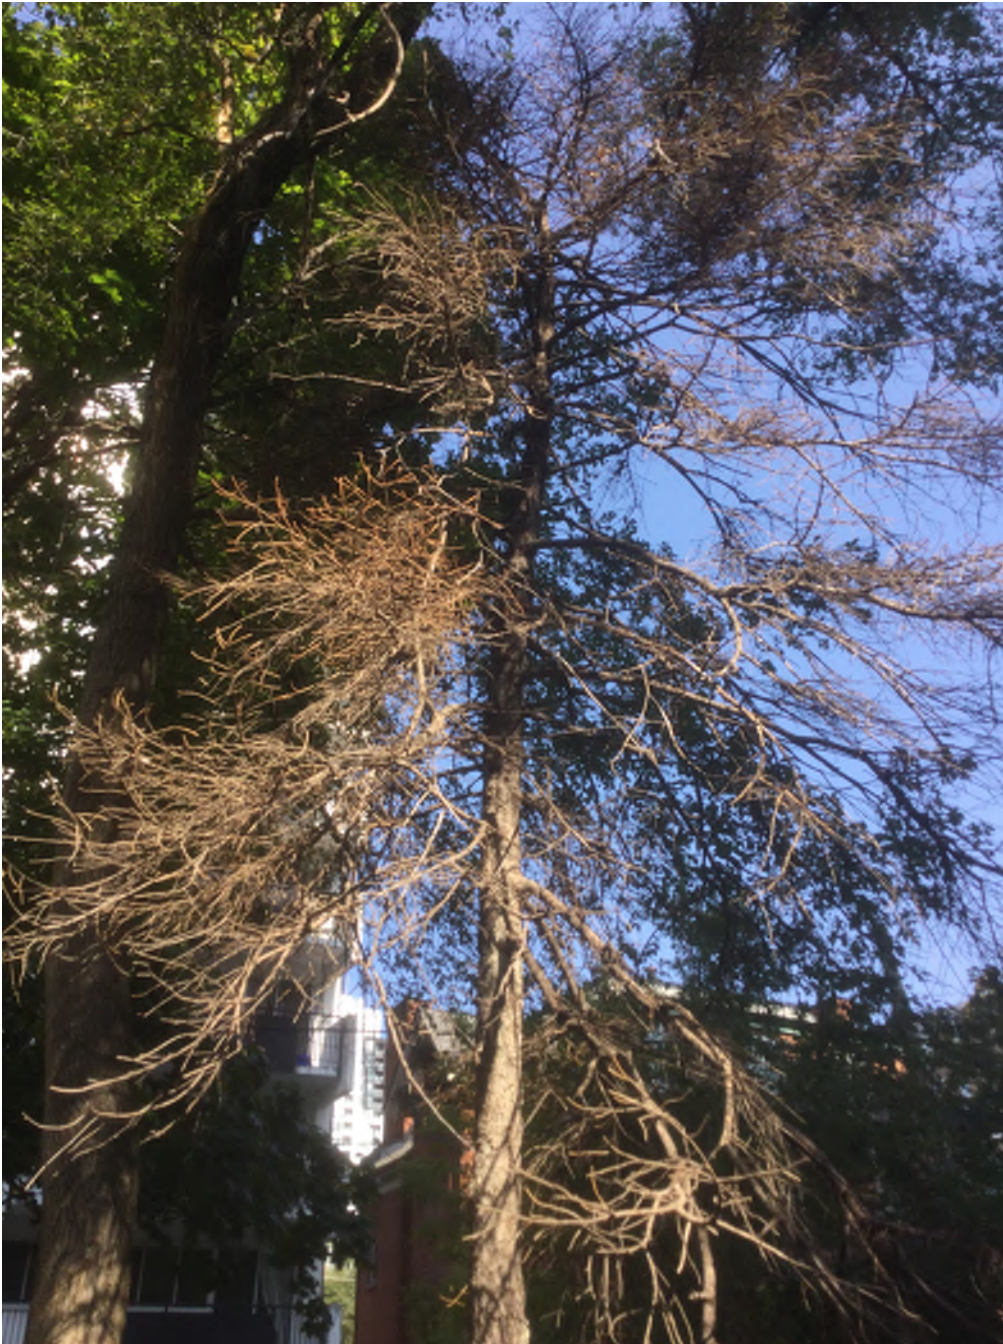
Photo 7: Tree E06 (remove) – Dead.

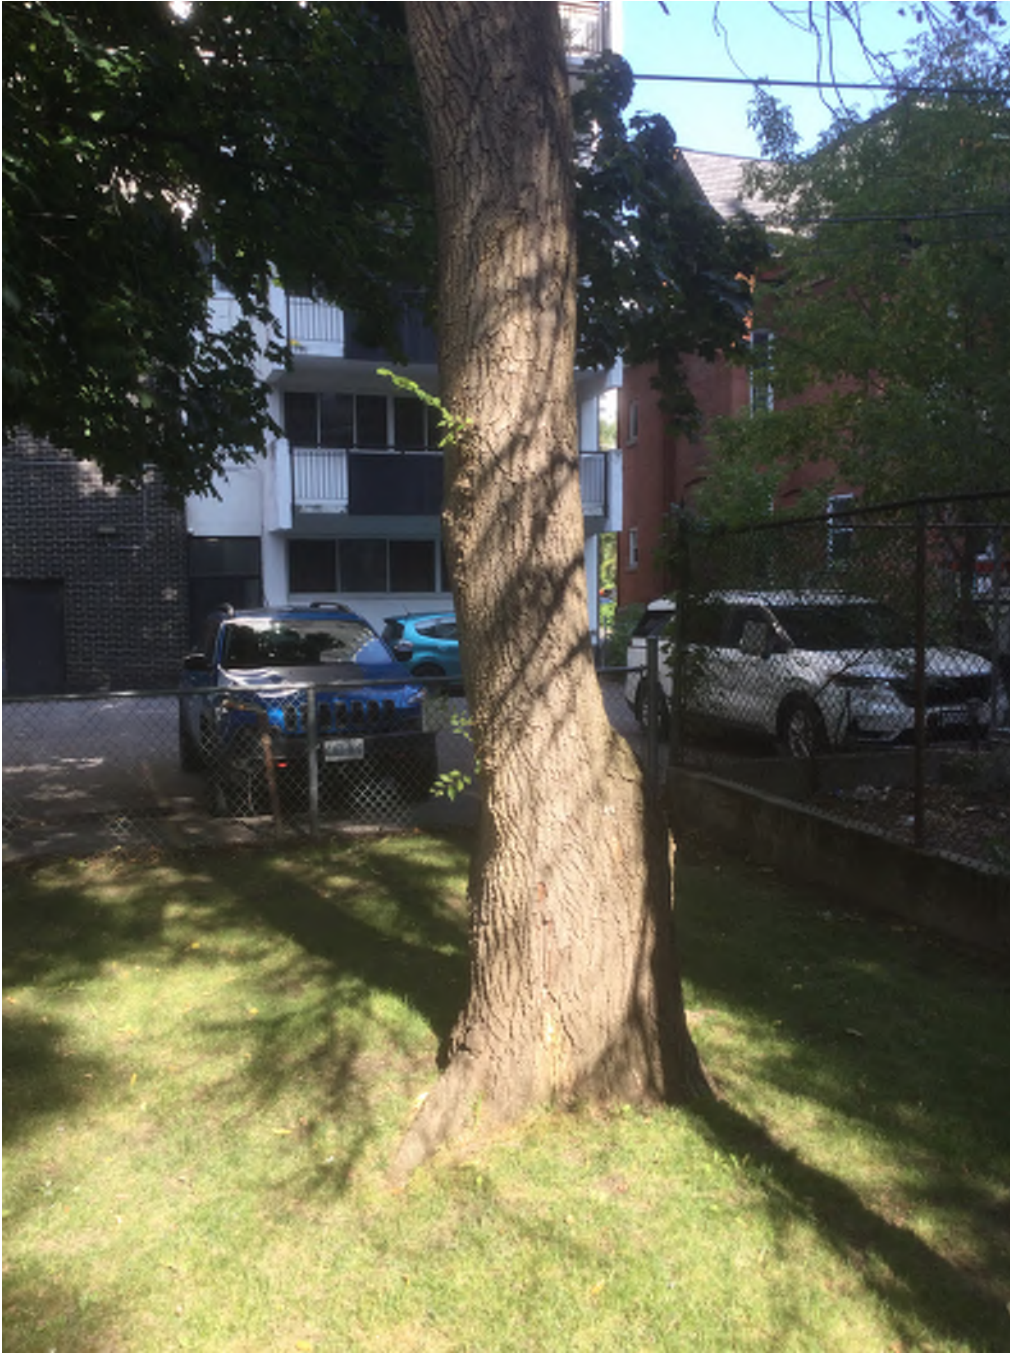
TREE NO.	RATIONALE
E03	Tree location conflicts with proposed accessible access ramp
E04	This tree conflicts with the new entrance of proposed building addition.
E06	Tree is dead.
E07*	<p>Proposed building foundation is within 1.2m of the stem and excavation for the foundation will likely create structural instability.</p> <p>PLA: There are structural roots extending SW toward the new addition foundations that will likely need to be removed to allow construction and proper backfilling of the foundations. If helical piles are used to replace the foundations, the root structure will still need to daylighted to allow assessment for the location of the piles causing stress on the tree. Considering the condition of the crown with 8 limbs affected by dieback the tree is likely to undergo more stress from any type of construction in its vicinity with a result of the tree not surviving long term.*</p> <p>Construction access, laydown space and process likely to compact surrounding soils and further damage tree.</p> <p>PLA: Further, the proximity of the centre of the tree at 1.2m from the building foundation (~0.8m at the edge of the trunk and root crown) will require some root removal. The SW lean (3 approx. 100mm/1000 mm) of the remaining stem means that by the time the trunk reaches the height of the addition roof it may affect the roof if there is wind or any movement of the stem, as well as being a hazard if it starts to drop limbs or falls during a storm.*</p>

Photo 8: Tree E07 (remove) – 1.2m from proposed building façade and foundation.

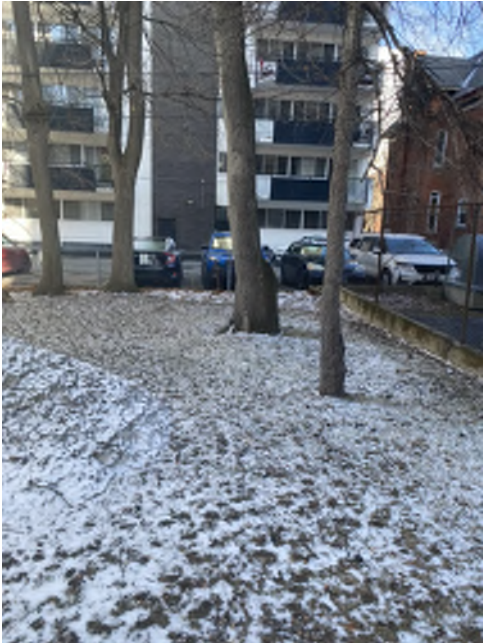
a. Leaning SW stem

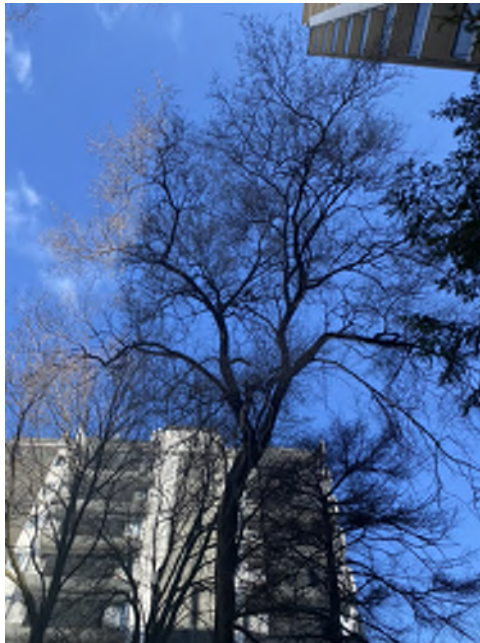
b dead branches in crown

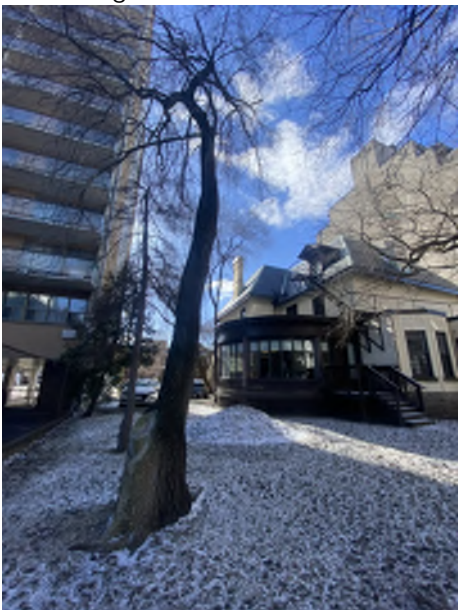
c leaning SW toward addition area

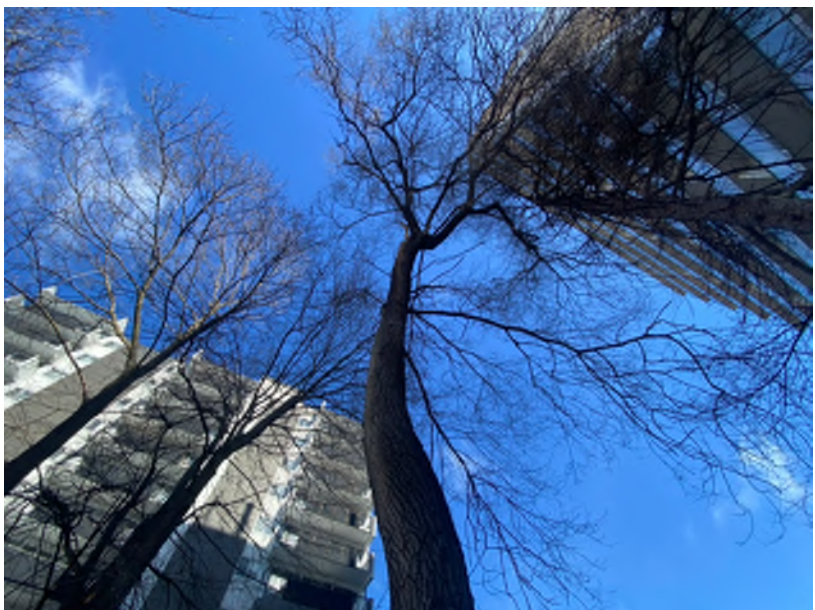
d dead branches in crown

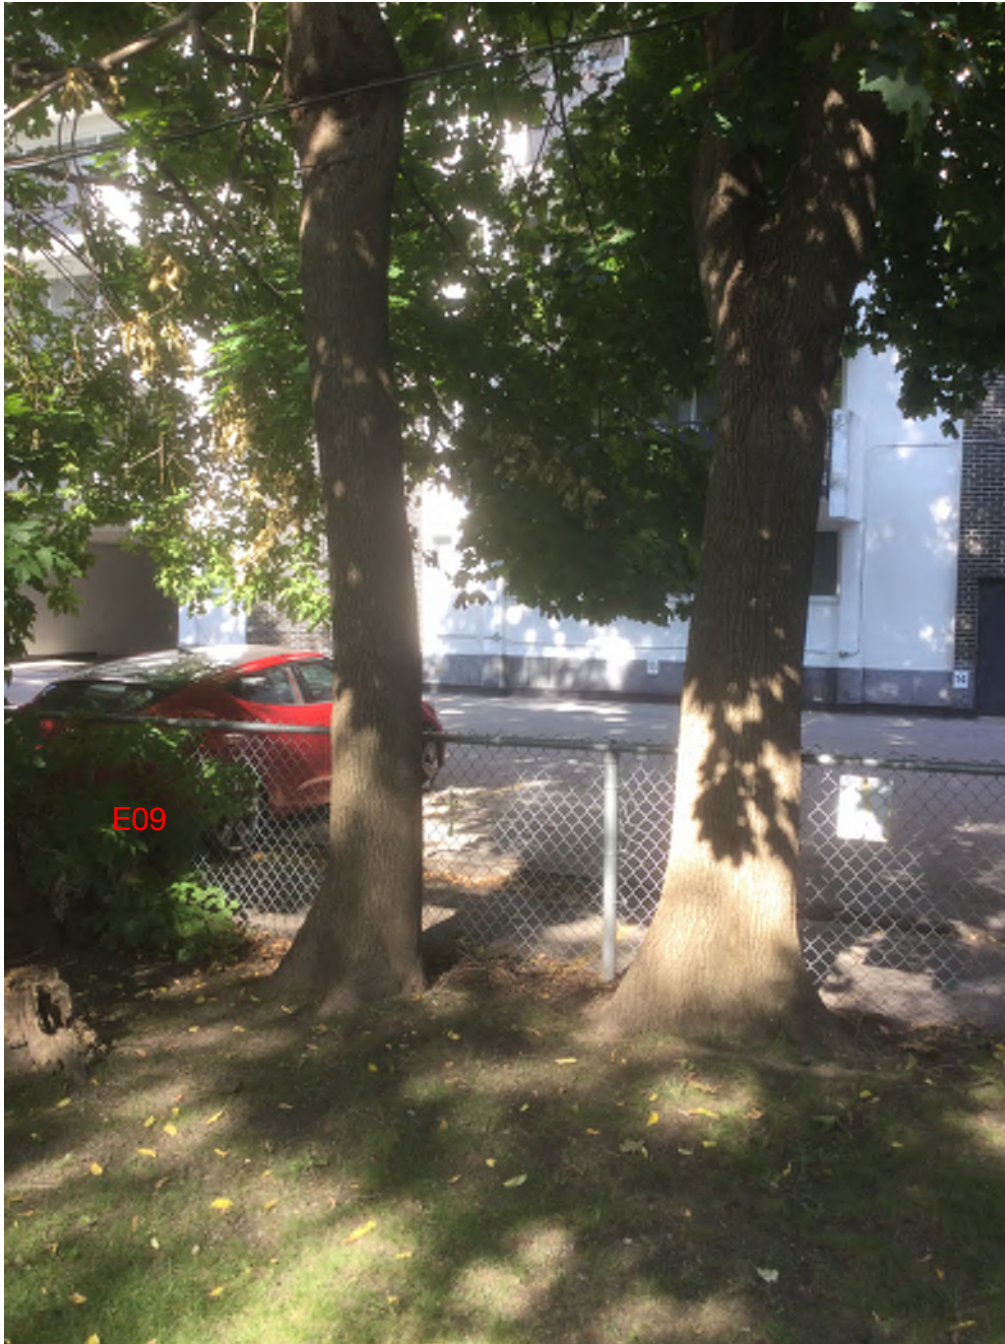
Photo 9: Trees E08 & E09 (retain) – No conflict with construction.

E05, E08, E09, E10, E11, E12	Trees exist adjacent to proposed construction activities. Trees to be protected per Standard City of Ottawa Tree Protection Measures as noted below.
---	--

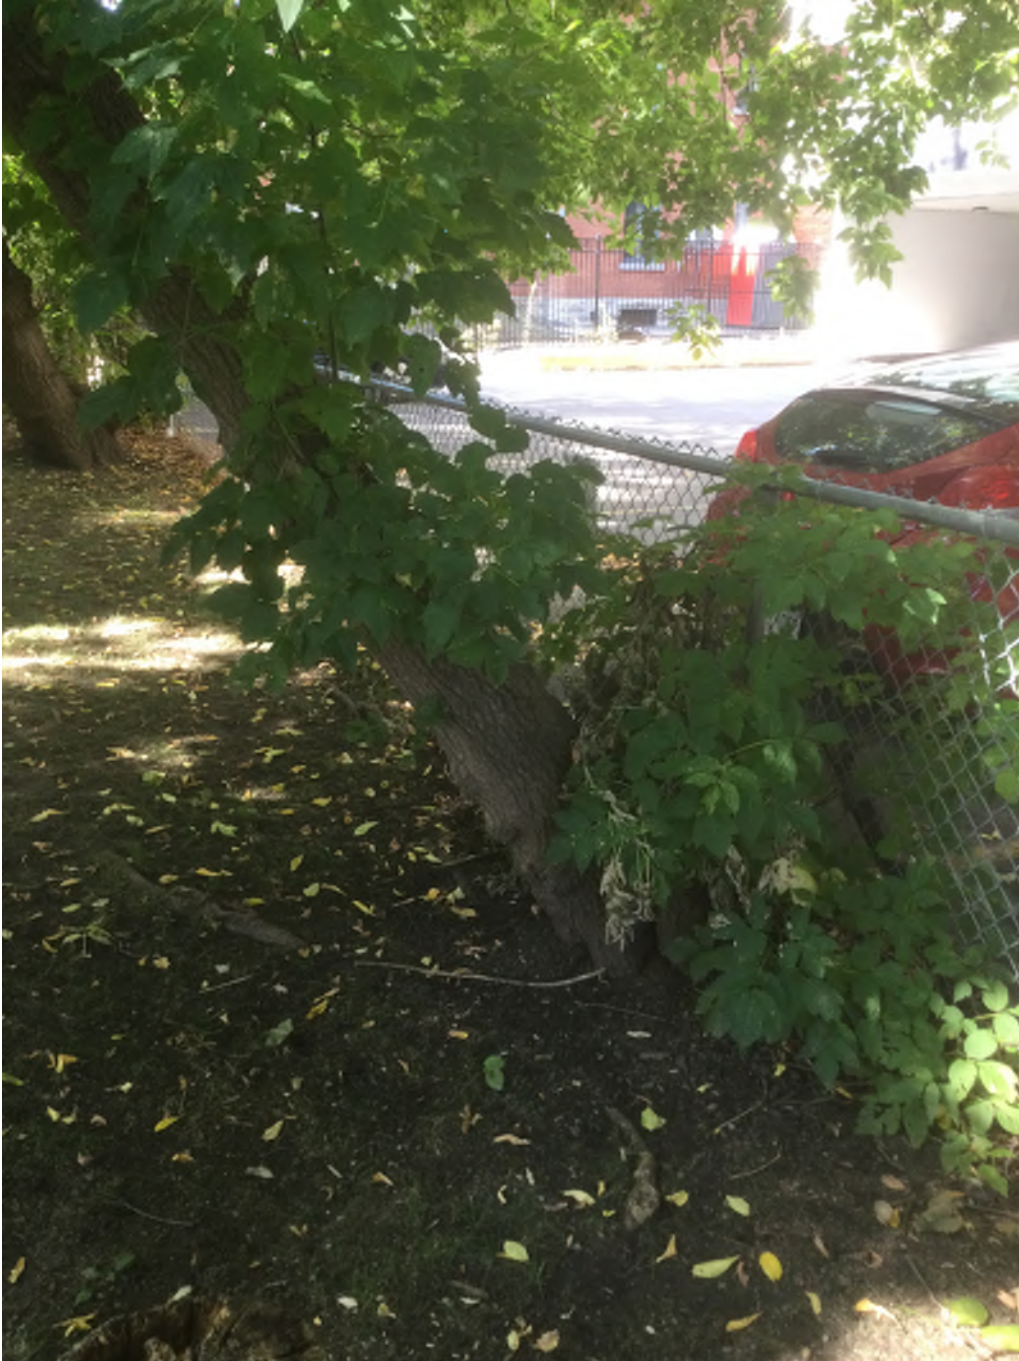
Photo 10: Tree E10 (retain) – No conflict with construction.

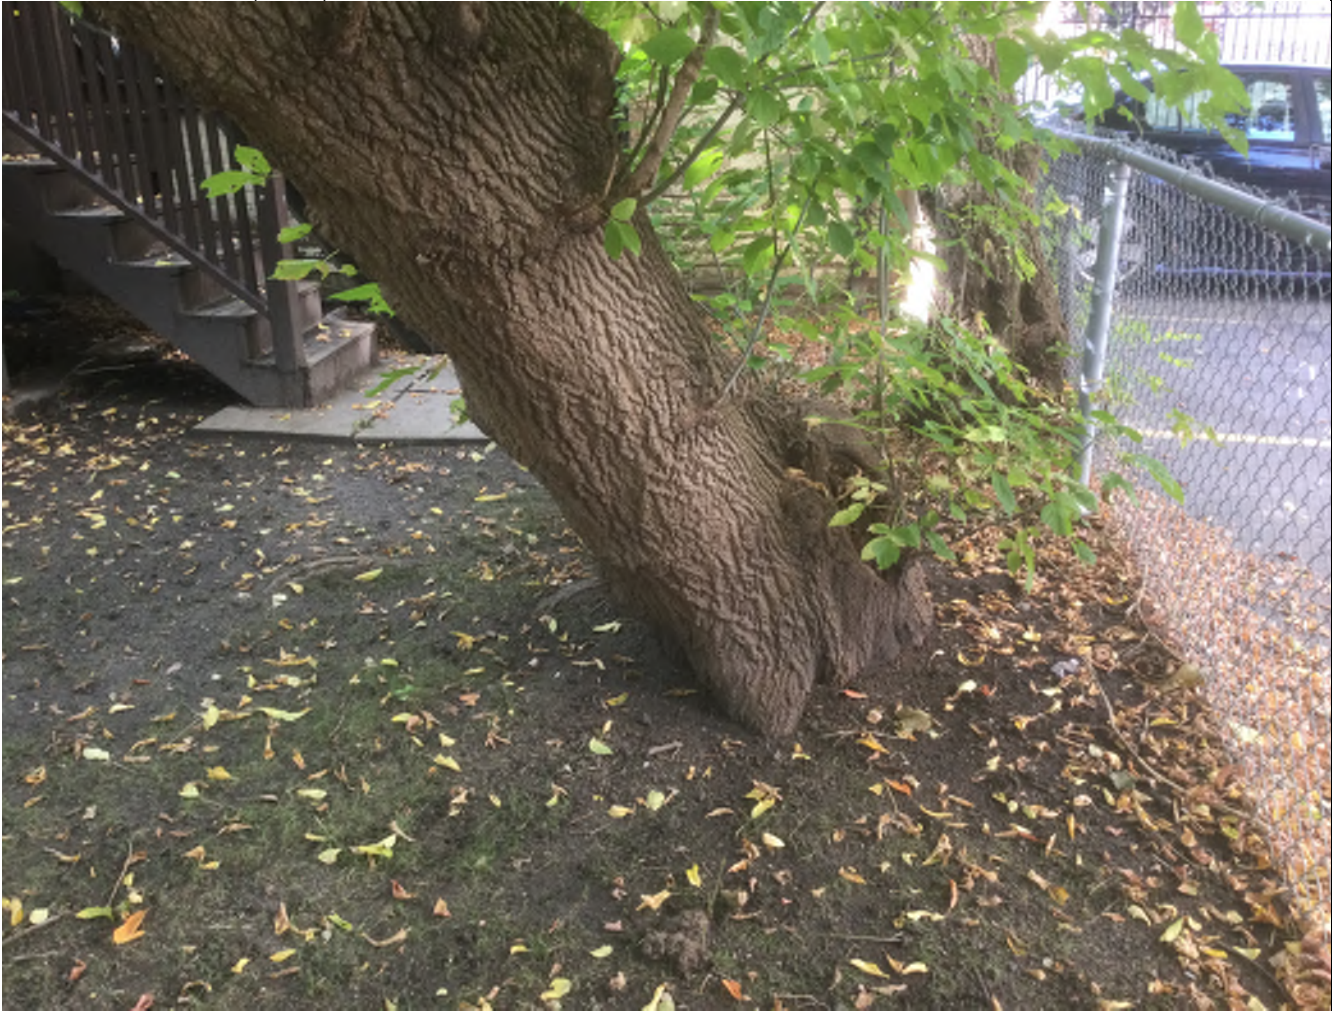
Photo 11: Tree E11 (retain) – No conflict with construction.

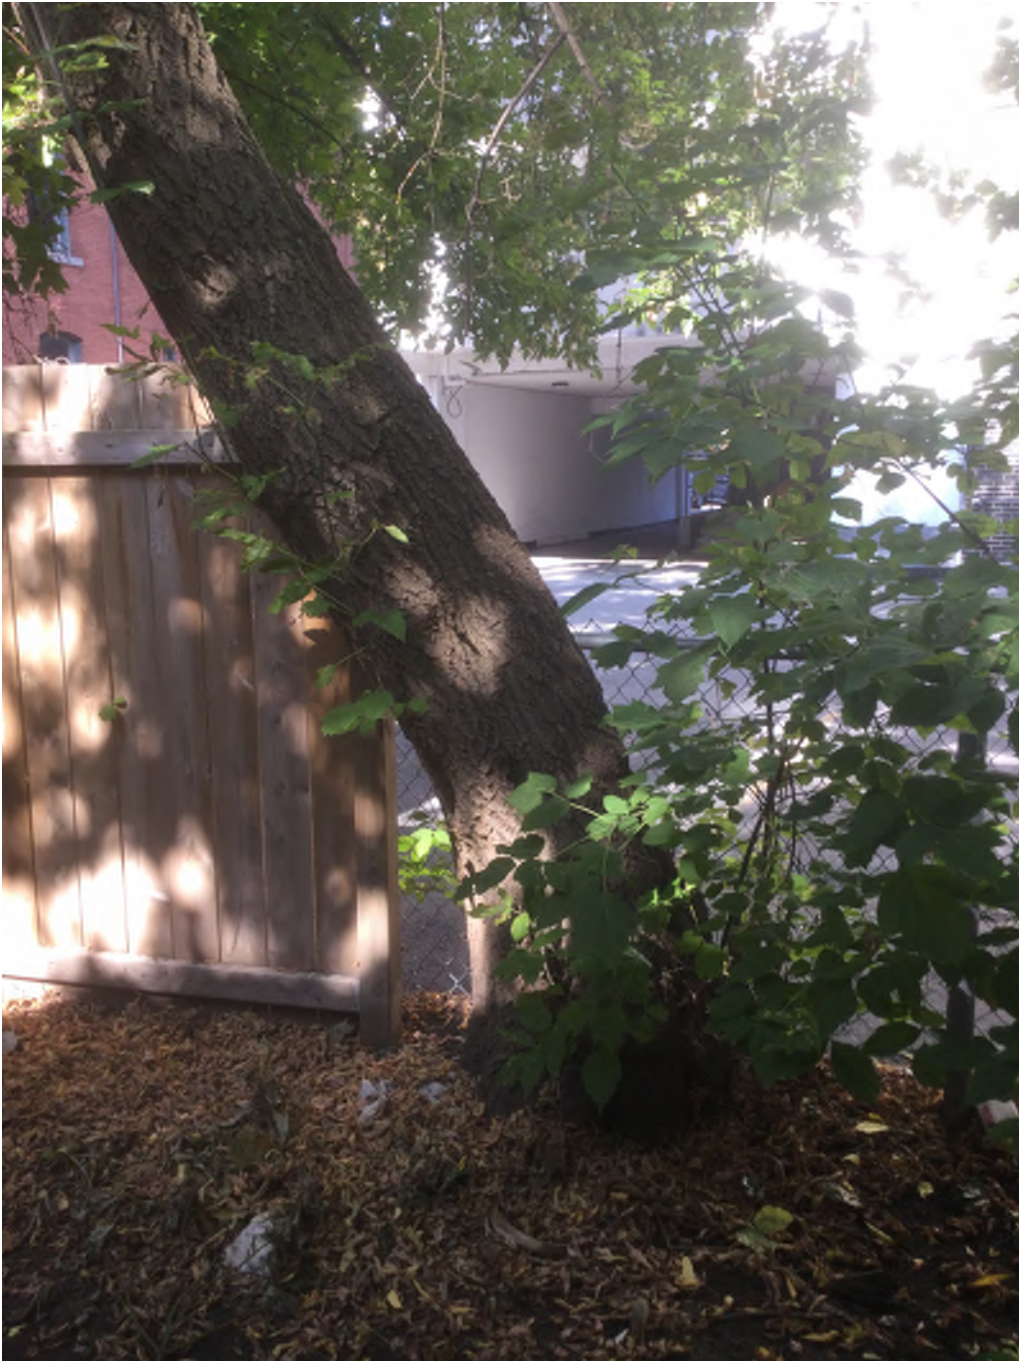
E12	Manitoba Maple / <i>Acer negundo</i>	43cm	Poor. Leans to the northwest over the building. Internal rot at base. Large broken branch hanging from tree.

Photo 12: Tree E12 (retain) – No conflict with construction.
