## Tree Information Report

Submitted as part of Building Permit Application to the City of Ottawa 2024-03-08

**Date of Report:** February 26, 2024  
**Property Address:** 1598 Prince of Wales Drive  
**Prepared for:** Roca Homes c/o Roberto Campagna; roberto@rocahomes.ca  
**Prepared by:** Kevin Myers, ISA Certified Arborist®; [kevin.myers@dendronforestry.ca](mailto:kevin.myers@dendronforestry.ca)  
**Date of Site Visit:** February 21, 2024

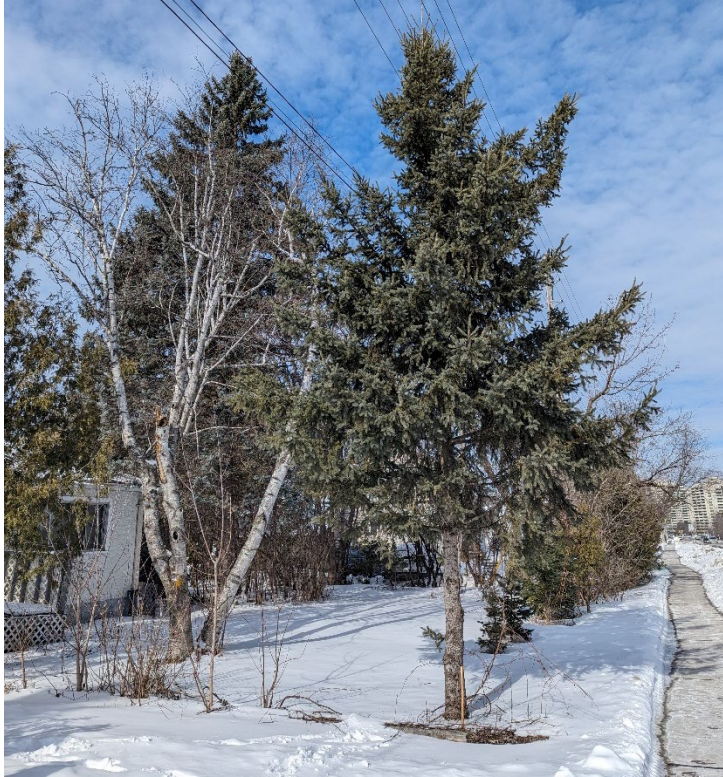
Tree <sup>1</sup>	Species	DBH (cm)	Ownership <sup>2</sup>	Tree Condition	Approximate distance to excavation (m)	Action	Forester recommendation
1	White spruce ( <i>Picea glauca</i> )	16	City	Fair/Good: pruned around wires – asymmetrical crown	Driveway: 6	Retain	Retain and protect as per the City of Ottawa Tree Protection specifications (March 2021).
2	White birch ( <i>Betula papyrifera</i> )	38, 23	Subject property	Fair/Poor: decay in large stem – small stem leaning; shorter-lived species nearing pinnacle of growth	House: 2.5	Remove	Remove due to health status and level of activity on site. <b>Tree permit required for removal.</b>
3 <sup>4</sup>	Willow ( <i>Salix spp.</i> )	100 (estimate)	Adjacent – 1589 Senio	Fair: large wound with decay	Garage: 5.5	Retain	Retain – no action required
4 <sup>4</sup>	Red maple ( <i>Acer rubrum</i> )	20, 20, 46, 15	Subject property	Good	Garage: < 1	Remove	Remove due to proximity of proposed garage. <b>Tree permit required for removal.</b>

*Tree 1 (right) - city spruce to be retained, and Tree 2 (left) - private birch to be removed.*

**Tree 1** can be preserved for future canopy on site – care is to be taken not to tear roots when removing the existing driveway – if any roots are torn the damaged portions are to be cleanly cut off by hand at the nearest union. Fencing should be installed as shown in the map and described below.

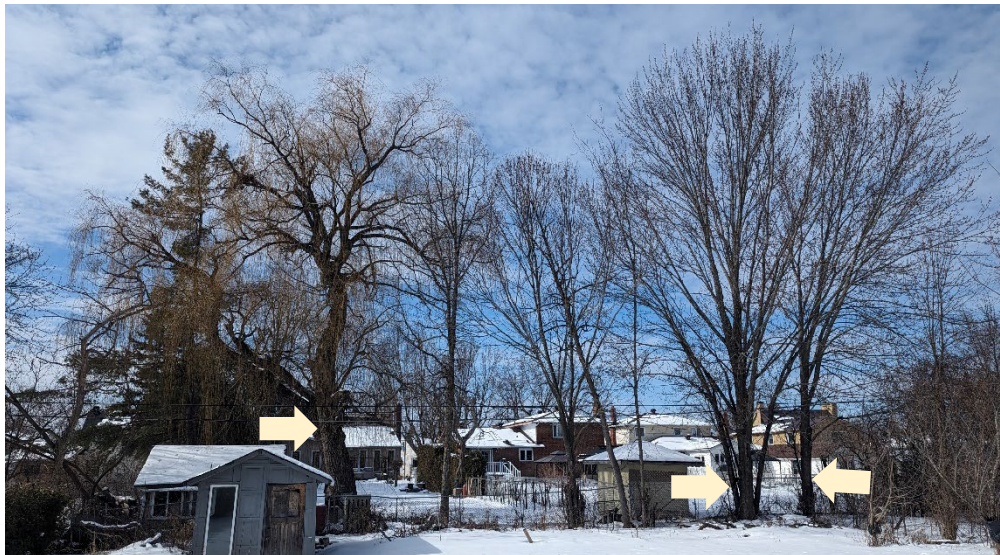
5 <sup>4</sup>	Red maple ( <i>Acer rubrum</i> )	35	Subject property	Good: slight lean to the North	Garage: < 1	Remove	Remove due to proximity of proposed garage. <b>Tree permit required for removal.</b>
6	White spruce ( <i>Picea glauca</i> )	36	Subject property	Fair/Poor: lean to East (approx. 10°); approx. 40% defoliation	0	Remove	Remove: in building footprint. <b>Tree permit required for removal.</b>
7 <sup>4</sup>	Manitoba maple ( <i>Acer negundo</i> )	24, 52, 30	Adjacent – 1590 Prince of Wales	Fair: spreading form; dead branch with decay; epicormic shoots throughout canopy; small pockets of decay	House: 3	Retain	Retain and protect as per the City of Ottawa Tree Protection Specifications (March 2021).
8	Colorado spruce ( <i>Picea pungens</i> )	53	Subject property	Fair/Good: lean corrected through growth; approx. 15% defoliation	0	Remove	Remove: in excavation footprint. <b>Tree permit required for removal.</b>

*Trees along the rear property line. Tree 3 (left) - adjacent willow to be retained. Trees 4 and 5 (right) - private red maples to be removed.*

**Tree 3** is far enough on the adjacent property that stability will not be a concern – no protection of its CRZ on the subject site will be necessary due to the large amount of rooting space it has on the adjacent property.

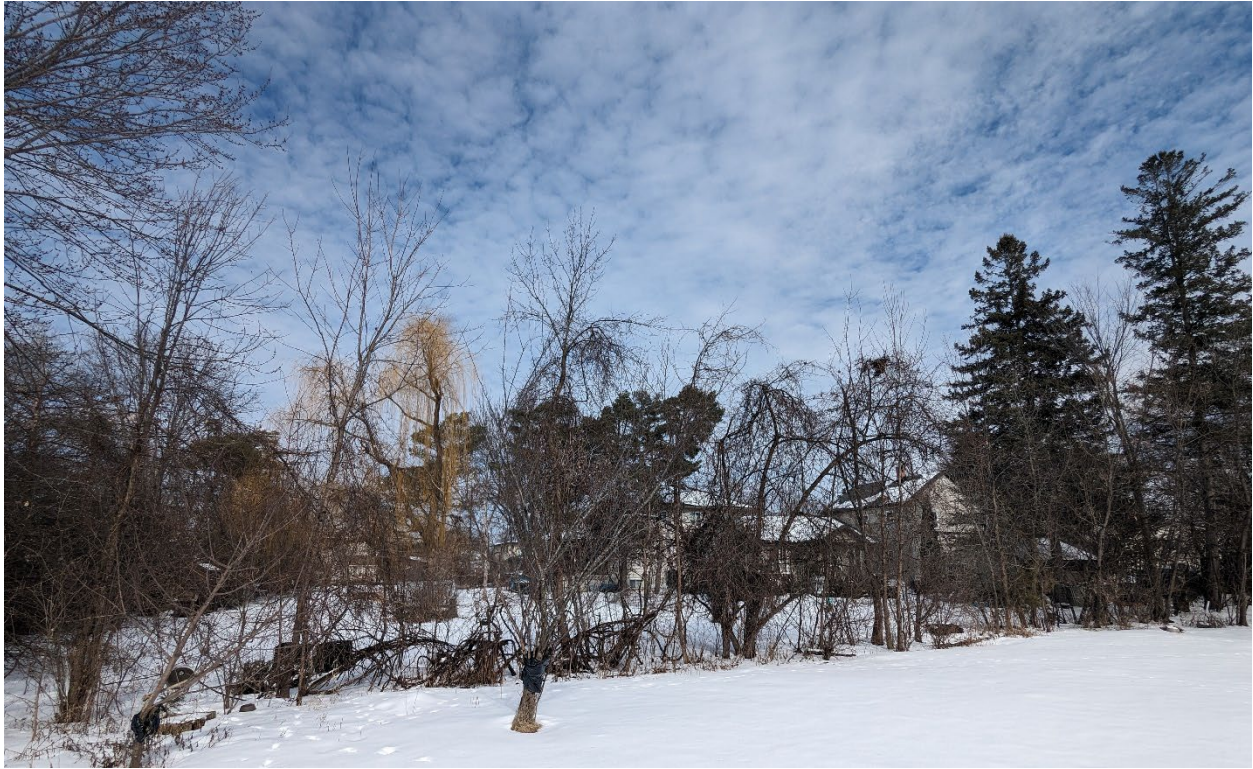
*Above: Trees along the south property line - largely unmaintained and in poor condition.*

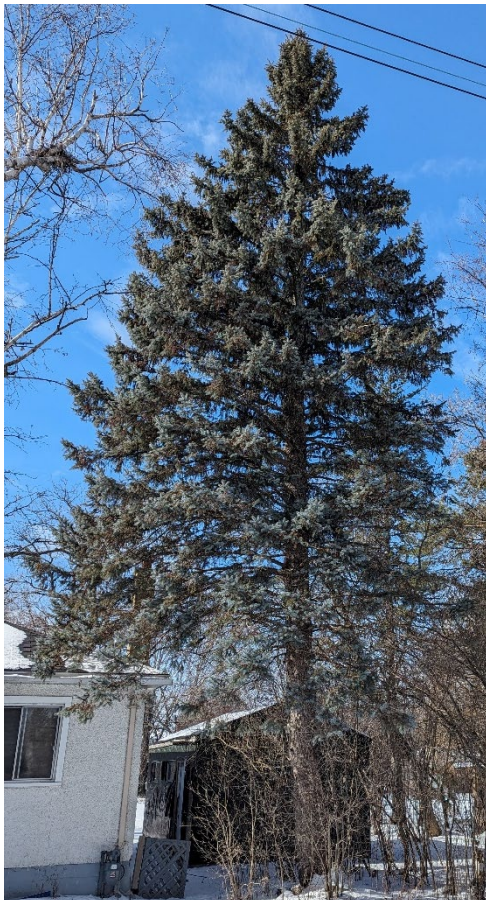
*Left: Tree 8 – private spruce to be removed.*

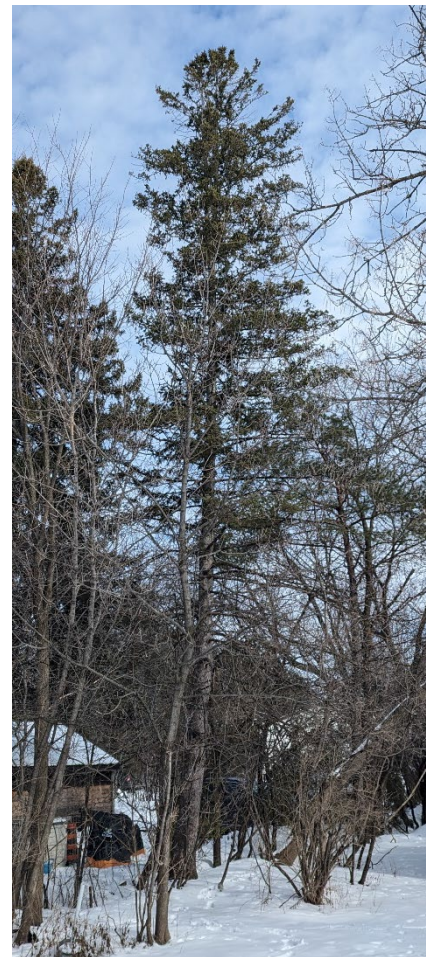
*Right: Tree 6 – private spruce to be removed.*

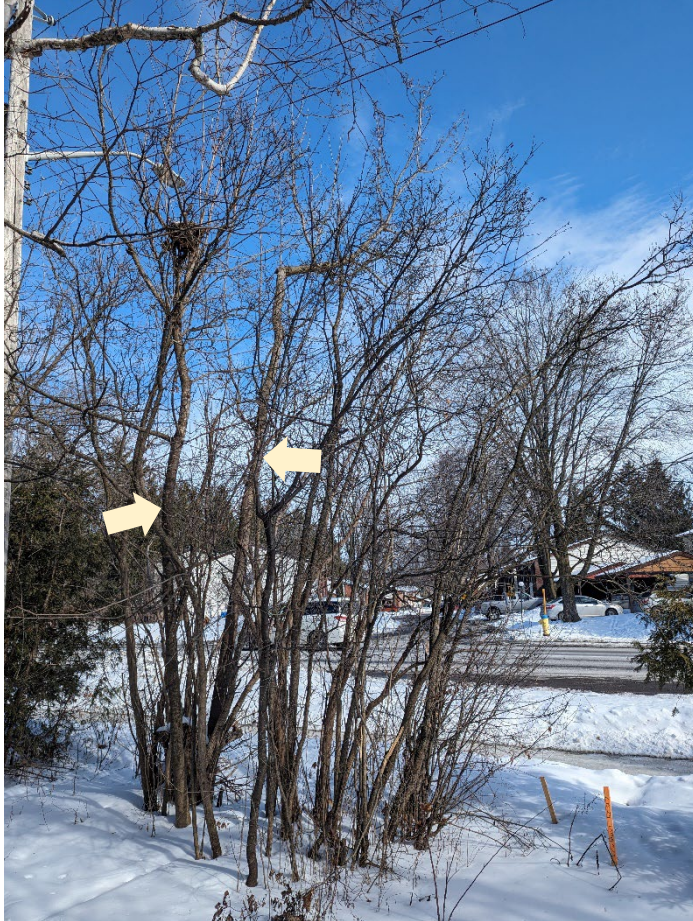
Around Trees 10 and 11 there is a clump of lilac (*S. vulgaris*). This clump falls on city property, and consists of over 20 stems below 10cm.

Northwest; dead branches in canopy			
10 <sup>4</sup>	Norway maple ( <i>Acer platanoides</i> )	10	City	Fair: growing under wires; lean to west	Driveway: 5.5	Remove	Remove due to undesirable species and level of activity on site. <b>Tree permit required for removal.</b>
11 <sup>4</sup>	Norway maple ( <i>Acer platanoides</i> )	14	City	Fair: asymmetrical crown due to pruning around wires; moderate lean to the east	Driveway: 6	Remove	Remove due to undesirable species and level of activity on site. <b>Tree permit required for removal.</b>

*Clockwise from above: clump of lilacs and Tree 10 and 11 - city trees to be removed.*

**Tree 10 and 11** are self-seeded Norway maples (*Acer platanoides*), which is an invasive species in Ontario. They are growing under wires, near a sidewalk, and are already leaning to find light from among the lilac bushes – these trees have very poor future growth conditions. It is recommended these trees be removed and replanted.

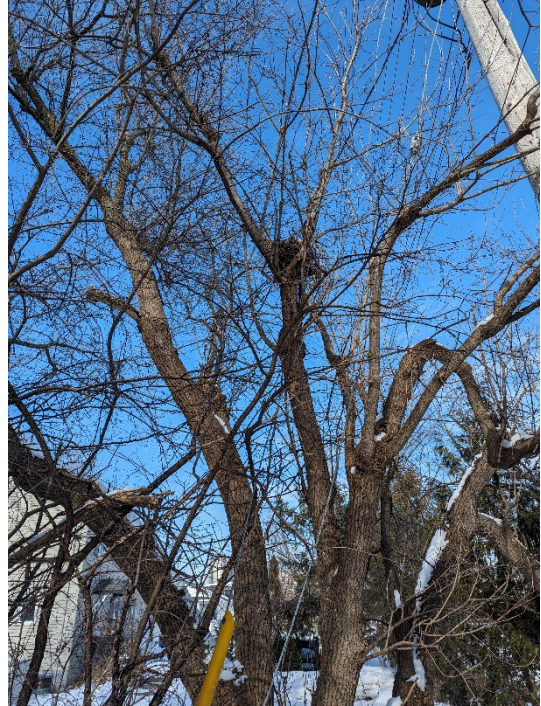
*Canopy of Tree 7.*

**Tree 7** is a multi-stemmed Manitoba maple (*Acer negundo*) – most of which is growing and leaning away from the subject property. This tree sits on the south side of an existing drainage ditch that runs along the southern property boundary. It is expected that this tree will be able to endure construction. While it is unclear how many roots may have developed past the drainage ditch, protective fencing should be erected as shown in the map to protect the CRZ on the subject site.

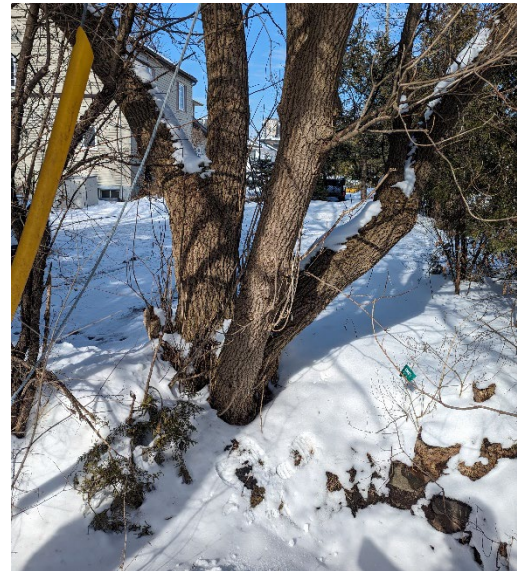
*Base of Tree 7.*

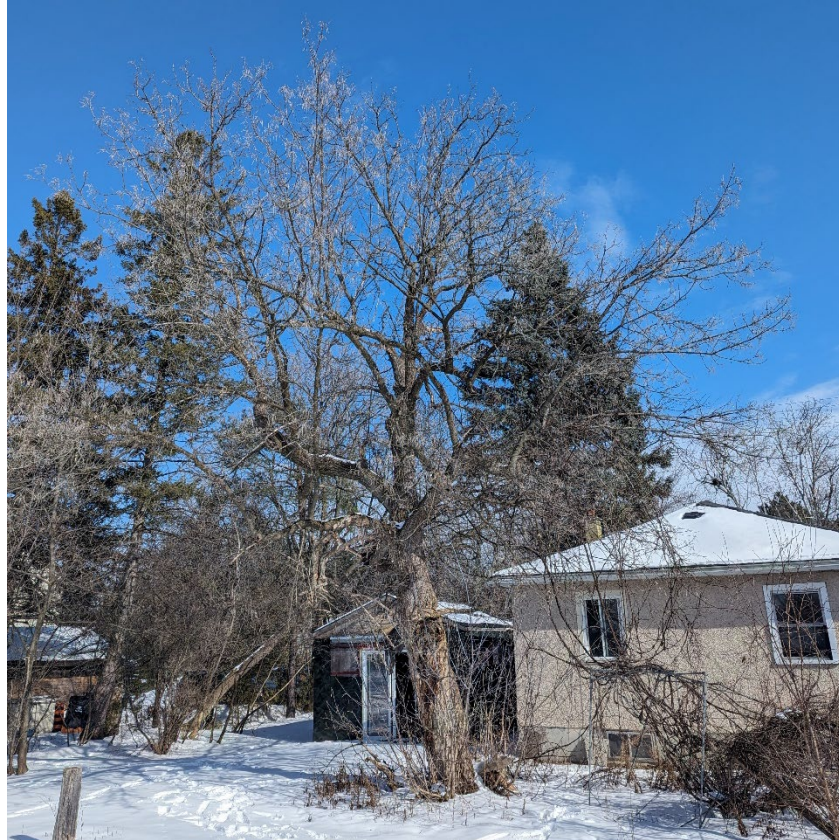
9	Manitoba maple ( <i>Acer negundo</i> )	64	Subject property	Poor: significant decay at the middle of the trunk and at base; lean to the	0	Remove	Remove due to health status.

*Clockwise from above: Tree 9 - private Manitoba maple in poor condition to be removed.*

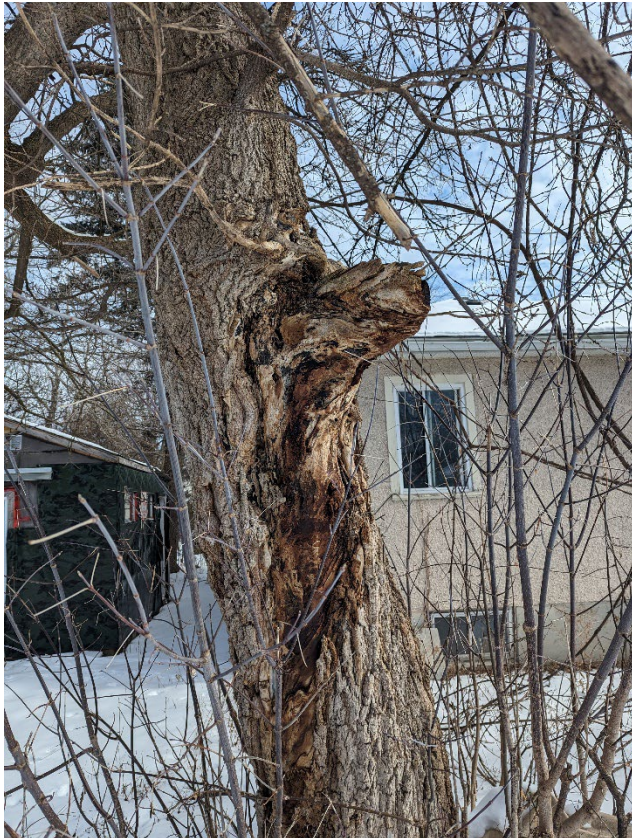
*Base of Tree 9 with decay in the small cavity.*

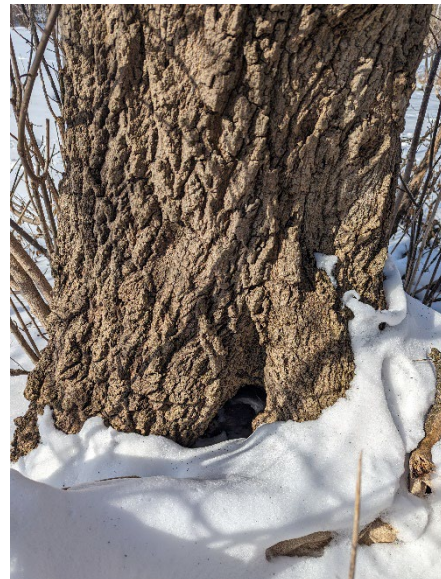
*Decay on the stem of Tree 9.*
