Tim Tree

Tree Information Report: 141 Rothesay Drive

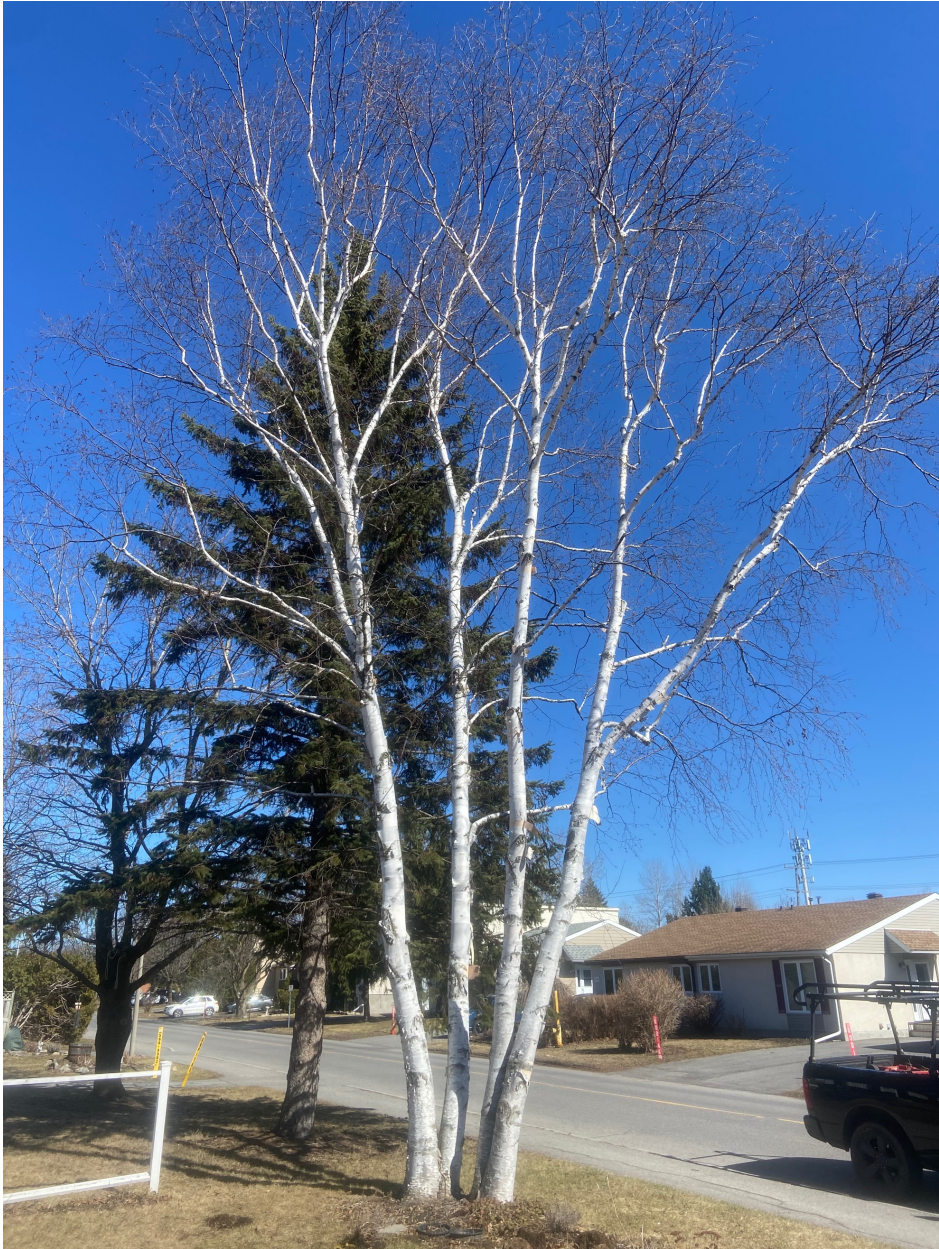
Image 2. White birch trees in front yard (Trees 1 & 2).

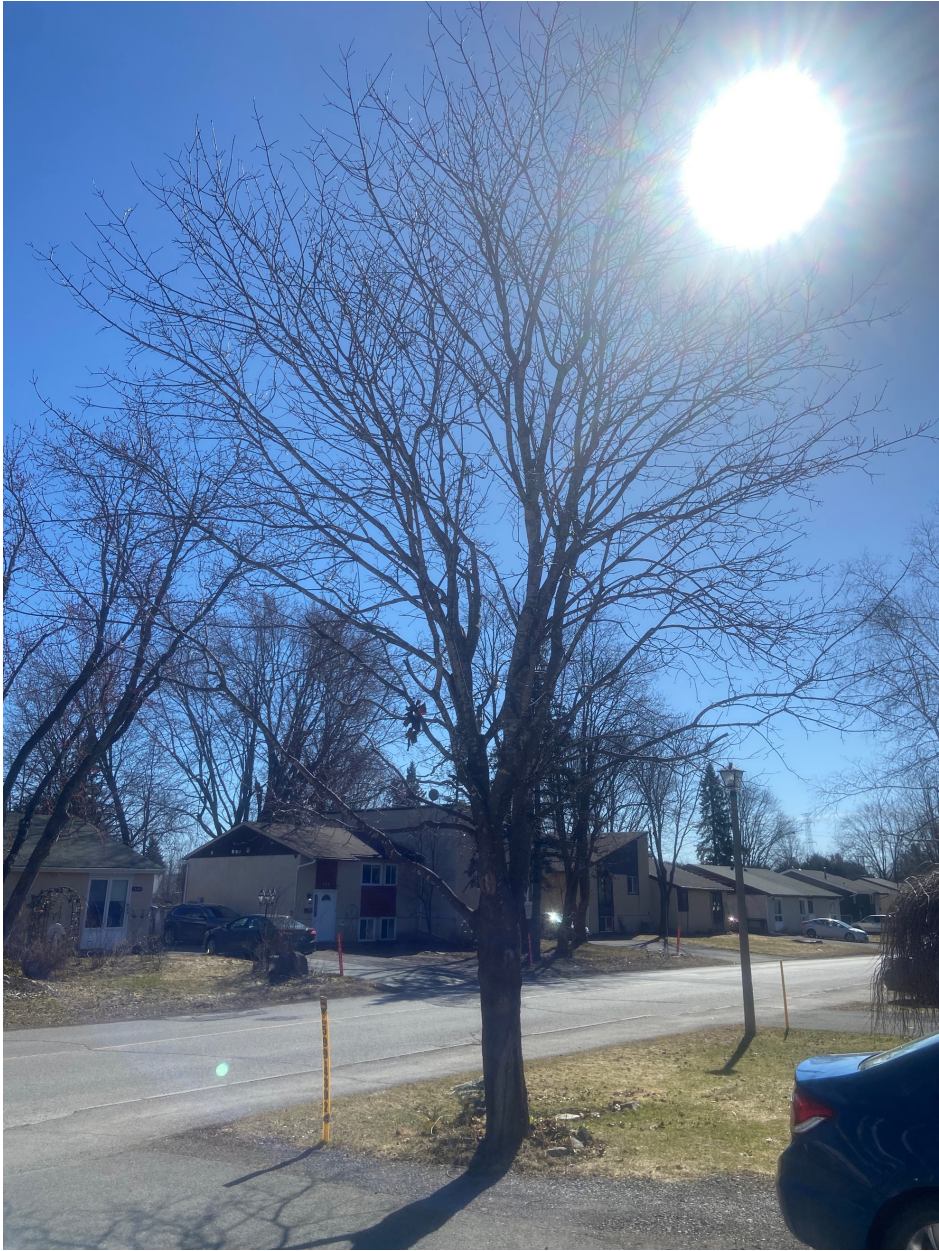
The only distinctive tree that could be negatively impacted by construction is Tree 3, which stands to the south of the driveway. This tree could potentially be damaged by storage of construction materials or other construction activities in its critical root zone (CRZ). Therefore, fencing is recommended along one side of the tree at the edge of the driveway. A full enclosure of the tree would not be necessary as the tree sits on the adjacent lot and activity is therefore unlikely in most of the CRZ.

Image 3. Municipal Norway maple (Tree 3).

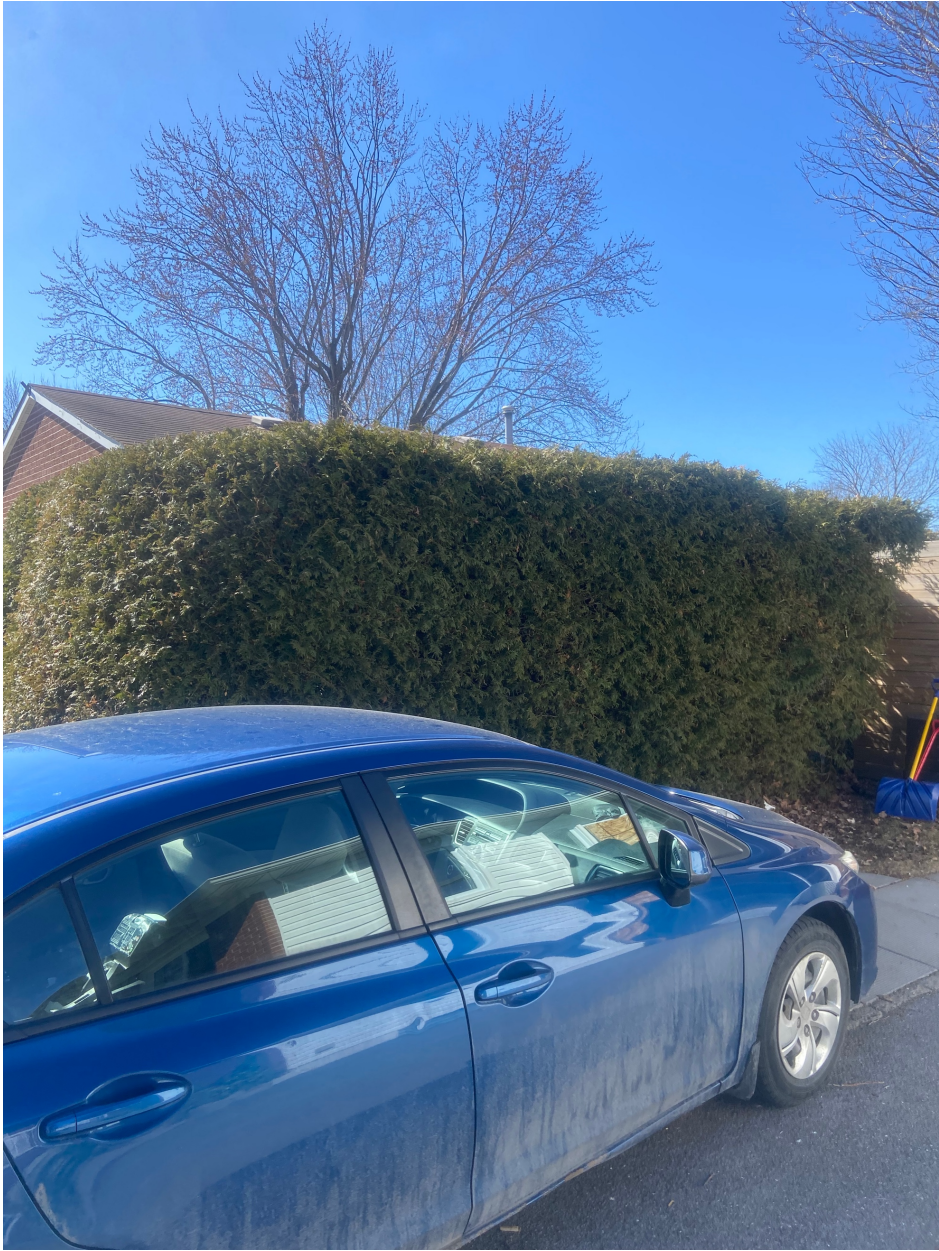
Image 4. Cedar hedge along driveway.

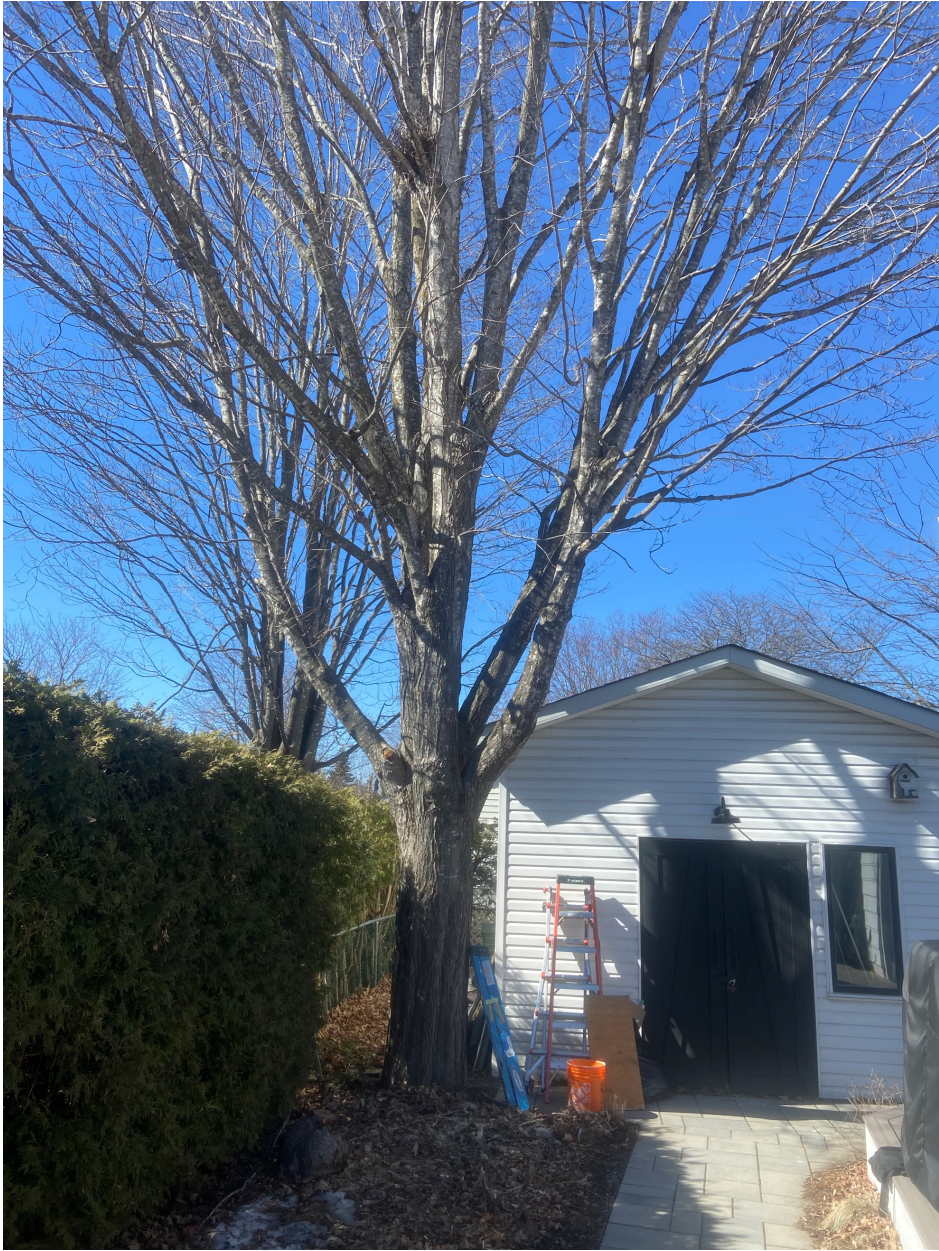
Image 5. Sugar maple in back yard (Tree 4).

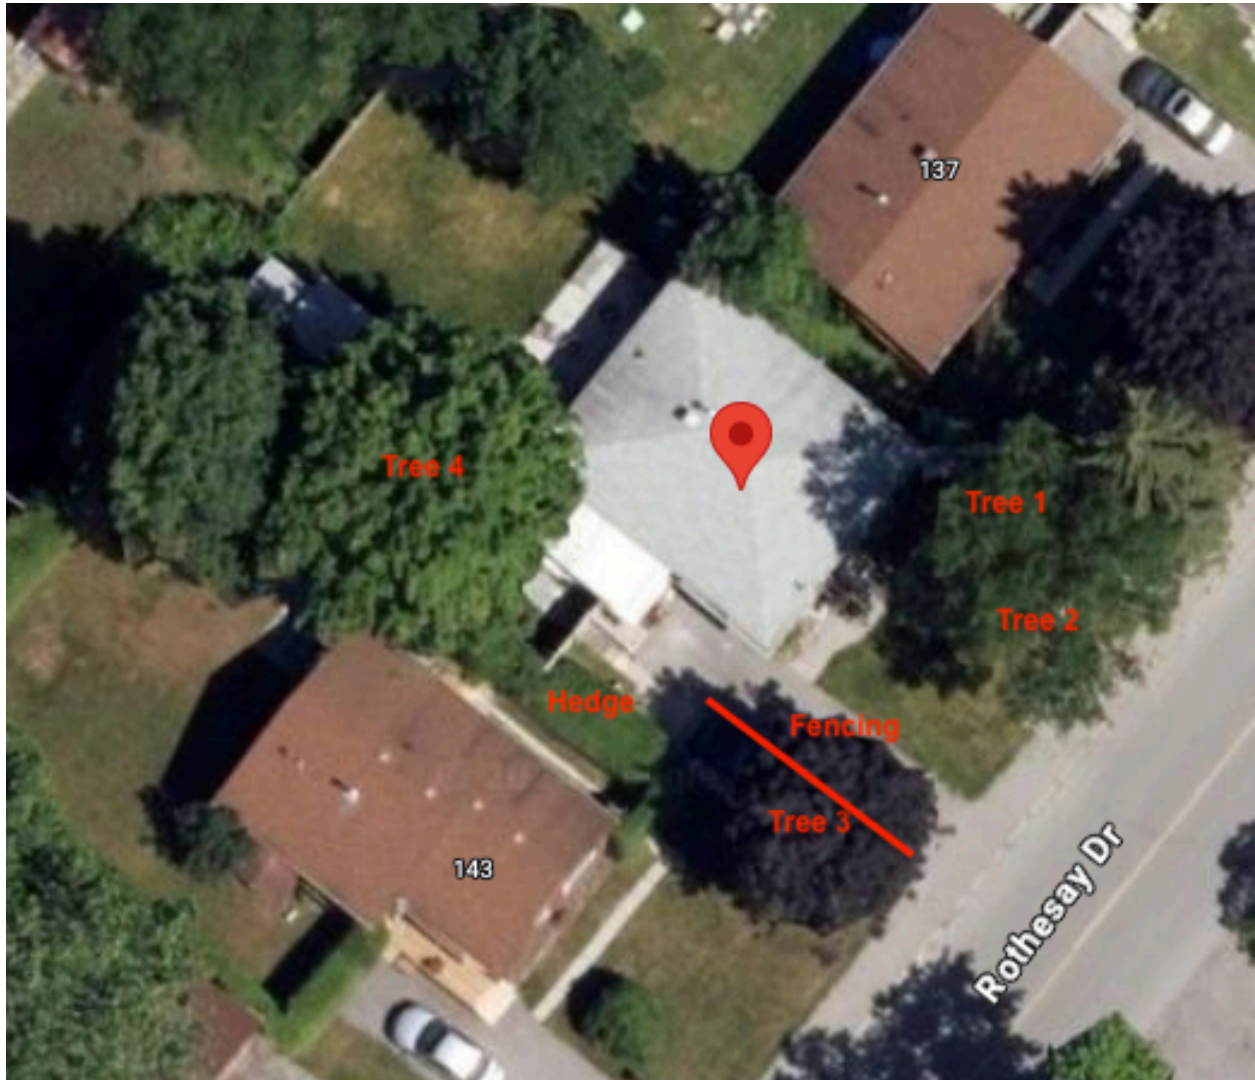
Image 8. Satellite view of property, with locations of trees and fencing.
