Tree Information Report v2.0

Submitted as part of Committee of Adjustment Application to the City of Ottawa

Date of Report: May 23, 2024

Property Address: 53 Willow Street

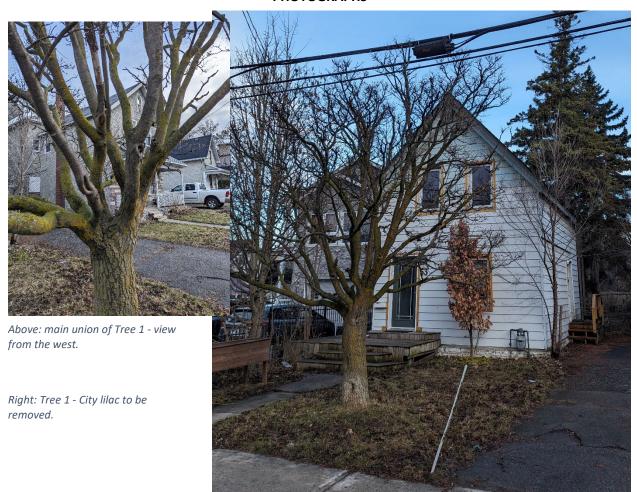
Tree ¹	Species	DBH (cm)	Ownership ²	Tree condition	Approximate distance to excavation (m)	Action	Forester recommendation
1	Tree Lilac (Syringa reticulata)	33	City	Fair/Poor: small cavities with decay in canopy; poor form – included bark at many unions; dead branches; low but consistent vigor	6	Remove	Remove due to health condition and impacts from construction. Tree permit required for removal.
2	White spruce (<i>Picea</i> glauca)	33	Subject property	Fair/Poor: upper deck built around the tree – very close to existing house; ~35% defoliation	0	Remove	Remove: within area of excavation. Tree permit required for removal.
3	White spruce (<i>Picea</i> glauca)	40	Subject property	Fair/Poor: lower deck built around the trunk – very close to existing house; ~20% defoliation	0	Remove	Remove: within area of excavation. Tree permit required for removal.
4	Colorado spruce (<i>Picea</i> pungens)	47	Subject property	Fair: lower deck built around trunk – very close to existing house; sweep in trunk	0	Remove	Remove: within area of excavation. Tree permit required for removal.

Clockwise from above: trunk of Tree 4, view from the north.

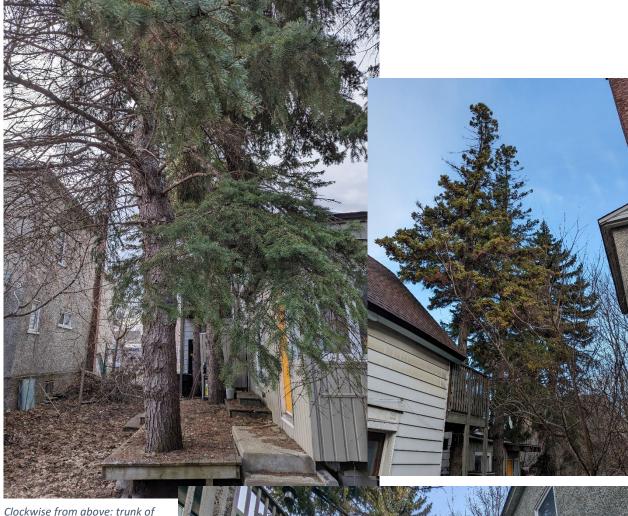
Canopies of Tree 2 and 3.

Trunks of Tree 2 (just visible at left), 3 and 4.

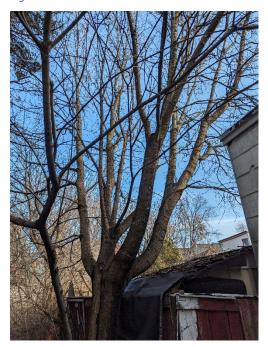
Below: canopy of Tree 6.

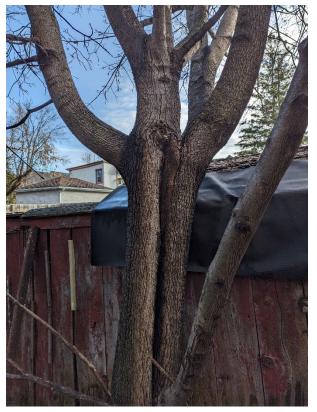
Tree 5 is a hackberry (*Celtis occidentalis*) in fair health. The site plan indicates a walkway is to be installed approximately 2.5m from the tree, which is 7.6x the DBH, at the closest point. Given that the path is to be angled, and the majority of root cutting will be further than 2.5m, stability is not expected to be compromised. To best preserve the tree's health, protection measures as described below are to be followed. Any roots that are encountered during installation of the path are to be cleanly severed by hand with a sharp implement such as secateurs, loppers, or a hand saw.

Right: broken branch stub on Tree 5.

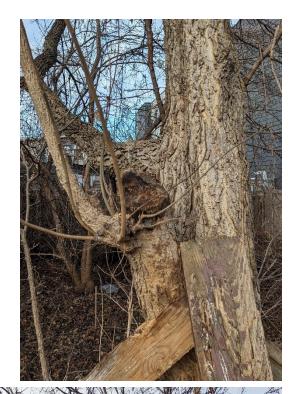
5	Hackberry (Celtis occidentalis)	38	Subject property	Fair/Good: broken branches; slight lean to the West	Walkway: 2.5	Retain	Retain and protect as per the City of Ottawa Tree Protection Specifications (March 2021). Any roots encountered during installation of the walkway are to be cleanly severed by hand.
6	Norway maple (Acer platanoides)	36	Subject property	Fair/Poor: large seam in trunk – decay probable; dead branches in canopy	0	Remove	Remove due to health condition and proximity of excavation. Tree permit required for removal.

Above: Tree 5 - private hackberry to be retained.

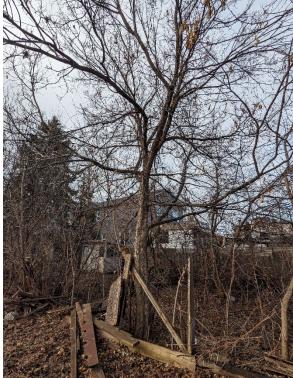
Left: Trunk of Tree 6 - private Norway maple to be removed.

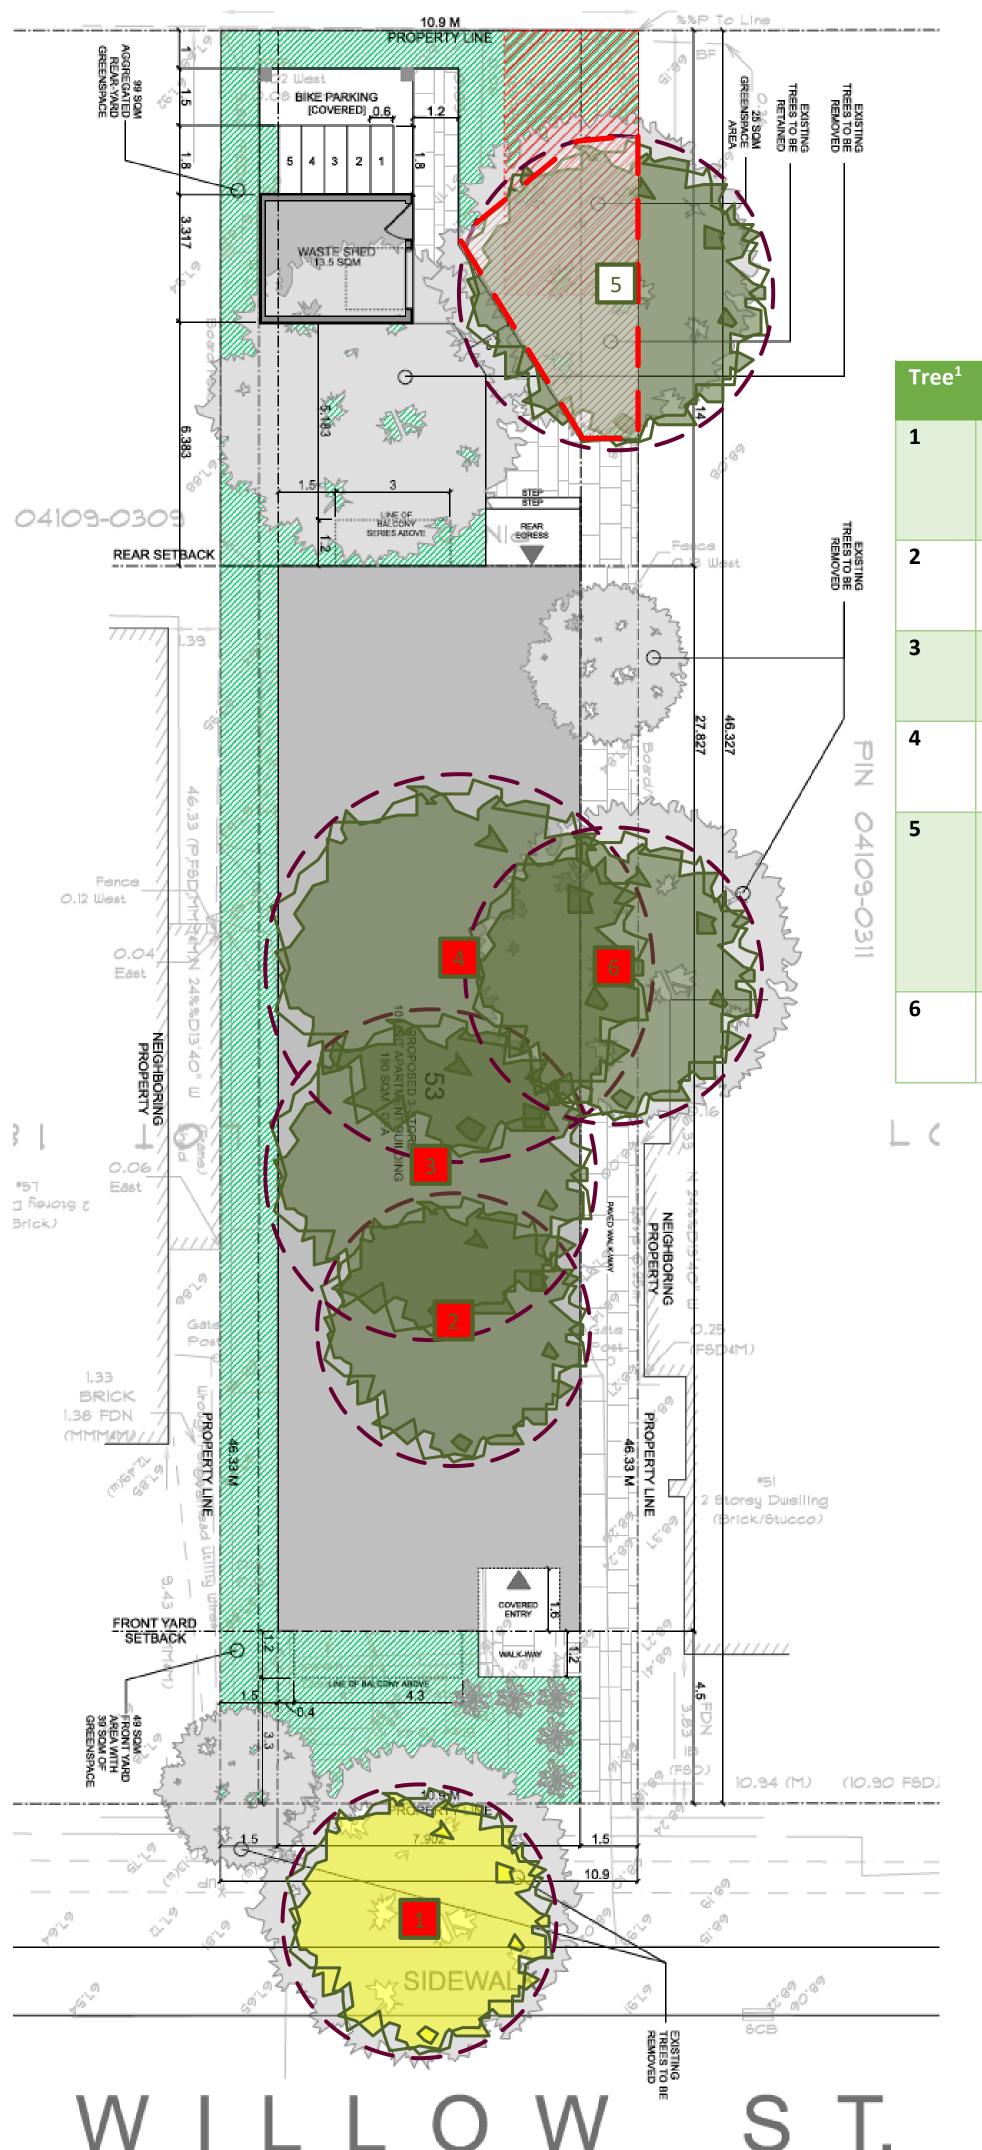
TIR Map – 53 Willow Street Tree layer prepared by Dendron Forestry Services Version 2.0, May 23, 2024

Tree ¹	Species	DBH (cm)	Tree condition	Forester recommendation
1	Tree Lilac (Syringa reticulata)	33	Fair/Poor: small cavities with decay in canopy; poor form – included bark at many unions; dead branches; low but consistent vigor	Remove due to health condition and impacts from construction. Tree permit required for removal.
2	White spruce (<i>Picea</i> glauca)	33	Fair/Poor: upper deck built around the tree – very close to existing house; ~35% defoliation	Remove: within area of excavation. Tree permit required for removal.
3	White spruce (<i>Picea</i> glauca)	40	Fair/Poor: lower deck built around the trunk – very close to existing house; ~20% defoliation	Remove: within area of excavation. Tree permit required for removal.
4	Colorado spruce (<i>Picea</i> pungens)	47	Fair: lower deck built around trunk – very close to existing house; sweep in trunk	Remove: within area of excavation. Tree permit required for removal.

5	Hackberry (<i>Celtis</i> occidentalis)	38	Fair/Good: broken branches; slight lean to the West	Retain and protect as per the City of Ottawa Tree Protection Specifications (March 2021). Any roots encountered during installation of the walkway are to be cleanly severed by hand.
6	Norway maple (Acer platanoides)	36	Fair/Poor: large seam in trunk – decay probable; dead branches in canopy	Remove due to health condition and proximity of excavation. Tree permit required for removal.

- PRIOR TO ANY WORK ACTIVITY WITHIN THE CRITICAL ROOT ZONE (CRZ = 10 X DIAMETER) OF A TREE, TREE PROTECTION FENCING MUST BE INSTALLED SURROUNDING THE CRITICAL ROOT ZONE, AND REMAIN IN PLACE UNTIL THE WORK IS COMPLETE.
