Tree Information Report

Submitted as part of Heritage Application to the City of Ottawa

Address: 1112 Lisgar/1 Maple
Date of Report: August 17, 2023
Date of Site Visit: June 8, 2023
Prepared by: Kevin Myers, ISA Certified Arborist®
info@dendronforestry.ca

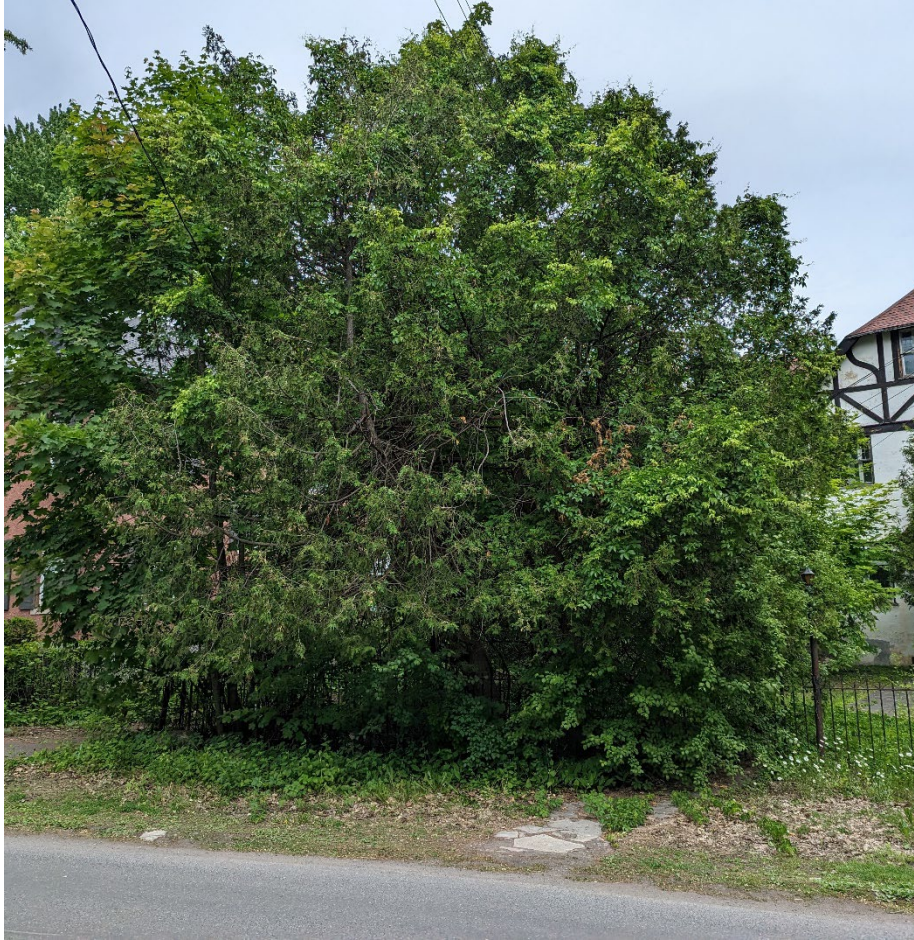
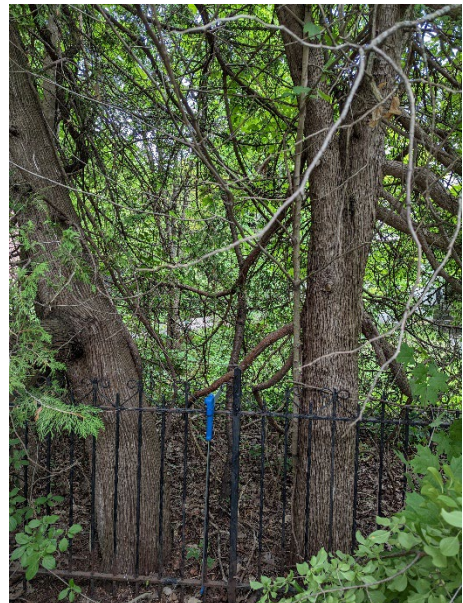
Tree 2 and 3 are large cedars growing beside an existing metal fence. They are in a clump of trees with a large number of Norway maple (*Acer platanoides*) saplings. These are invasive trees that grow quickly and will soon shade the cedars. For best preservation of the protected trees, it is recommended that the competing brush in this clump be removed as soon as possible to release the cedars to grow freely. When replacing the pathway to the south of Tree 3, similar steps as above should be followed, and constructing the path with as little excavation as possible will help maintain this tree’s health. A large percentage of the crown of Tree 3 may have to be removed to facilitate access along the existing path.

Above: Tree 2 and 3 - private cedars to be retained.

Right: trunks of Tree 2 (right) and Tree 3 (left)

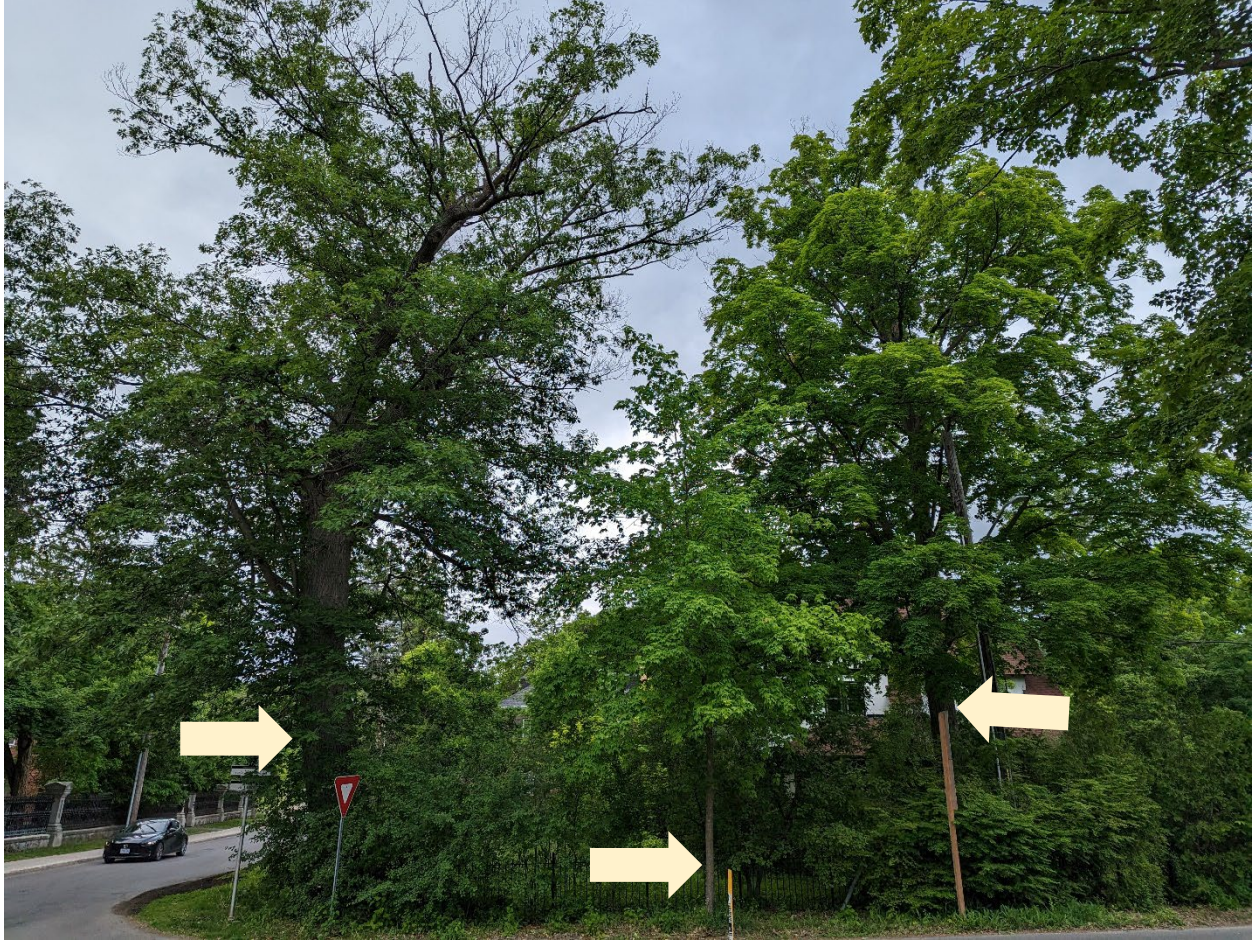
Tree 4 is a very large red oak which should be far enough from construction to protect effectively. While erecting the appropriate Tree Protection Area should keep foot traffic away from the tree, it is recommended a certified arborist be employed to prune the dead limbs from this tree for site safety. Note that since this is a city tree, any pruning would need to be pre-approved by city forestry staff.

(left to right) Tree 4 - city oak to be retained, Tree 8 - city maple to be retained, and Tree 5 - private maple to be retained.

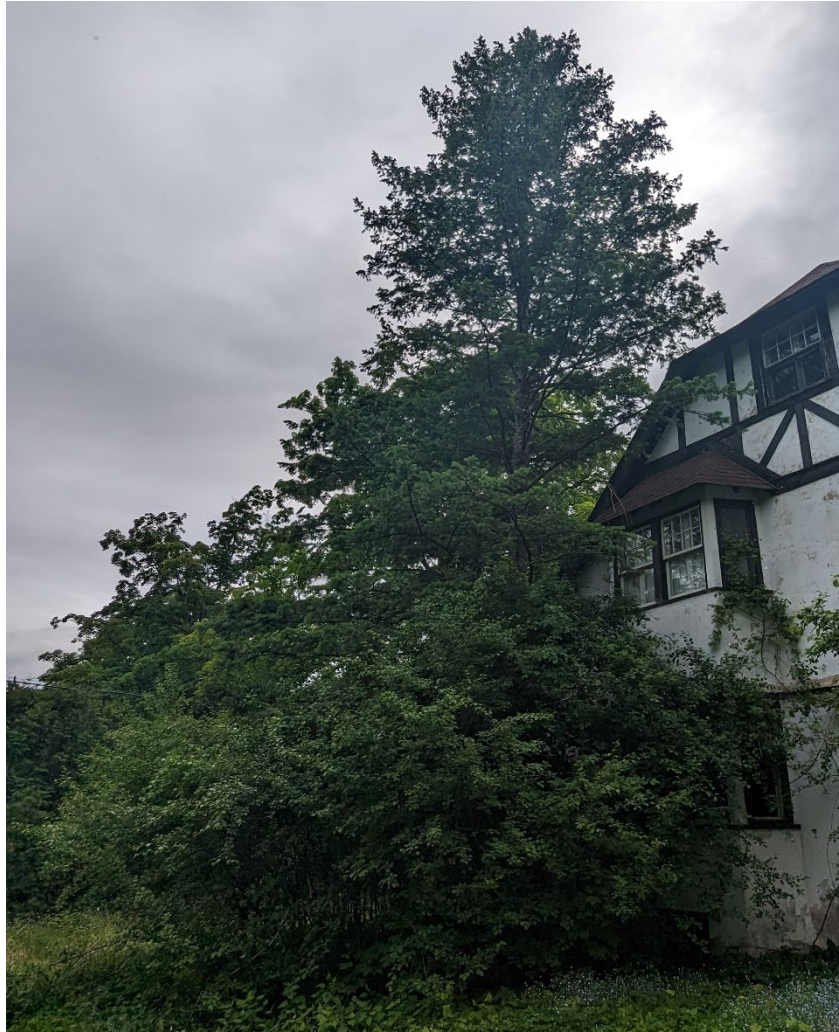
The only tree recommended for removal at this site is **Tree 6**. This is a large spruce growing directly beside the existing dwelling. It would be operationally difficult to renovate this building without damaging the tree, let alone construct a new building.

Tree 6 - private spruce to be removed - base surrounded by buckthorn thicket

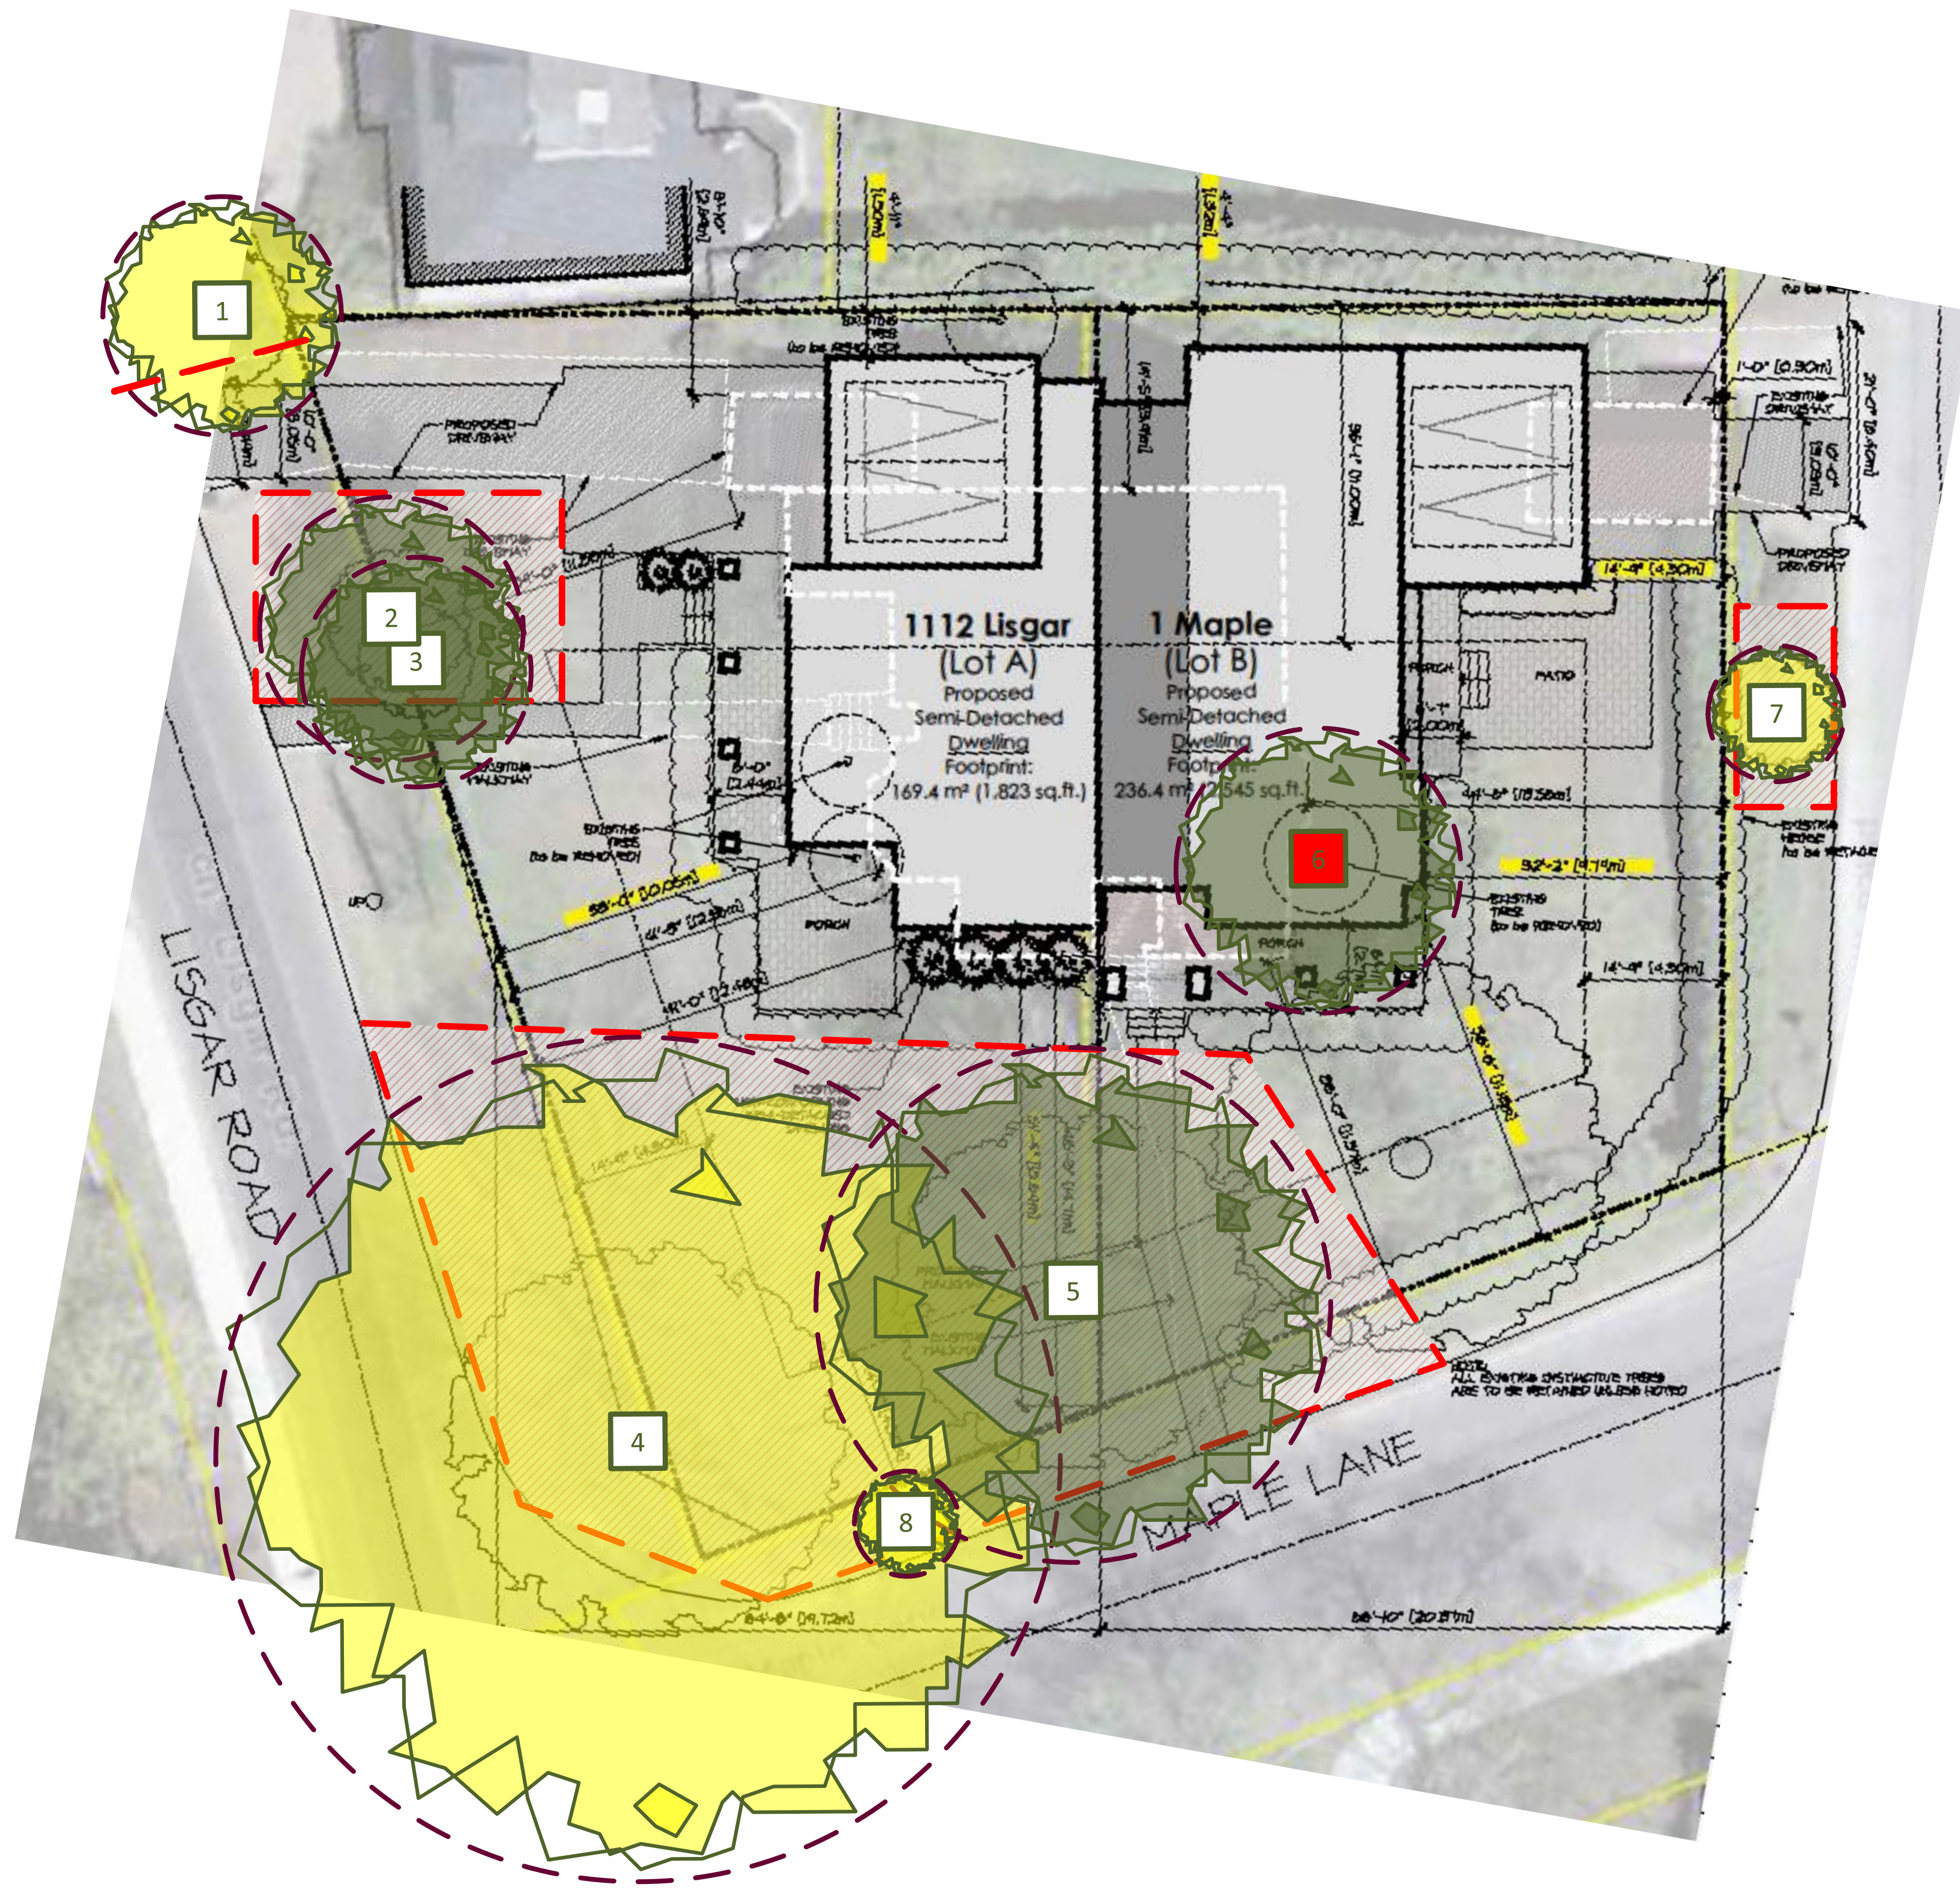
Tree Information Report – 112 Lisgar/1 Maple Lane
 Tree layer prepared by Dendron Forestry Services
 Version 1.0, August 17, 2023
 For more information, please contact info@dendronforestry.ca

Tree ¹	Species	DBH (cm)	Condition	Recommendations
1	White spruce (<i>Picea glauca</i>)	36	Fair/Good: <25% defoliation	Retain. Care is to be taken to not tear roots when removing the existing driveway. Any roots that are torn should be cleanly severed by hand and immediately covered by a moist organic material such as burlap or soil.
2	Eastern white cedar (<i>Thuja occidentalis</i>)	40	Good/Fair: asymmetrical crown; leaning towards road; being shaded by Norway maple growth	Retain and protect as per the City of Ottawa Tree Protection Specifications (March 2021).
3	Eastern white cedar (<i>Thuja occidentalis</i>)	35	Good/Fair: asymmetrical crown; leaning towards road; being shaded by Norway maple growth	Retain and protect as per the City of Ottawa Tree Protection Specifications (March 2021).
4	Red oak (<i>Quercus rubra</i>)	128	Fair/Good: dieback in crown <30%; minor lean corrected by growth	Retain and protect as per the City of Ottawa Tree Protection Specifications (March 2021).

5	Sugar maple (<i>Acer saccharum</i>)	78	Good: growing near wires	Retain and protect as per the City of Ottawa Tree Protection Specifications (March 2021).
6	White spruce (<i>Picea glauca</i>)	43	Good	Remove: tree is growing directly beside existing building. Tree permit required for removal.
7	Crabapple (<i>Malus spp.</i>)	21	Fair/Poor: asymmetrical crown due to shading by cedar hedge; lean to road; mechanical wound at base <1/4 diameter – not sealing well; sprout at base becoming new tree	Retain and protect as per the City of Ottawa Tree Protection Specifications (March 2021)
8	Sugar maple (<i>Acer saccharum</i>)	14	Good: slight lean to road	Retain and protect as per the City of Ottawa Tree Protection Specifications (March 2021)

Prior to any site works, protective fencing should be installed around the TPA as indicated in Map and maintained until all construction on site has been completed as per the City of Ottawa Tree Protection Specifications (March 2021). **Failure to install and maintain the indicated fencing may result in fines from the City.**

The tree protection fencing must be 1.2 m in height and constructed of a rigid or framed material (e.g. modulus – steel, plywood hoarding, or snow fence on a 2"X4" wood frame) with posts 2.4 m apart such that the fence location cannot be altered. All supports must be placed outside of the CRZ and installation must minimize damage to existing roots.
