Property is 845 Dundee Avenue
Ottawa, ON
K2B 5S8

The owner is applying for a permit to demolish the existing structure and build four attached two-story residential units.

Inspection date: 2023-02-27

Tree Information Report for 845 Dundee Avenue, Ottawa

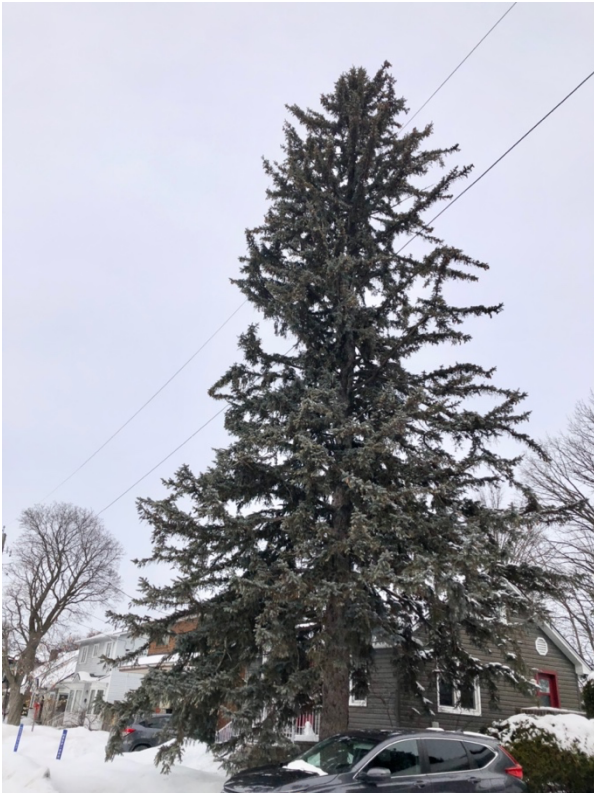
Photo 1 Tree #1 Colorado Spruce

Dbh 56 cm

This is a mature Colorado spruce. See photos 1 and 2, p. 3

It has a single trunk.

Stem has no lean and tapers gradually.

Foliage density, size and colour are all good.

There is some die-back of smaller branches.

There are no co-dominant stems or included bark.

Crown has been raised to 3 M.

Roots may be restricted by existing paved driveway at 845 Dundee Ave.

There is currently encroachment into the CRZ from existing driveway at 845 Dundee. Excavation for the new driveway is outside the CRZ. A very small percentage (~5%) of the limit of excavation will disturb the CRZ. The tree will be able to tolerate this small amount of root loss.¹

Provide protective fencing around the CRZ as indicated in Drawings #1 p 8 and the pink dotted line in #2 p 9. Follow all the Steps to Conserve Trees p 6.

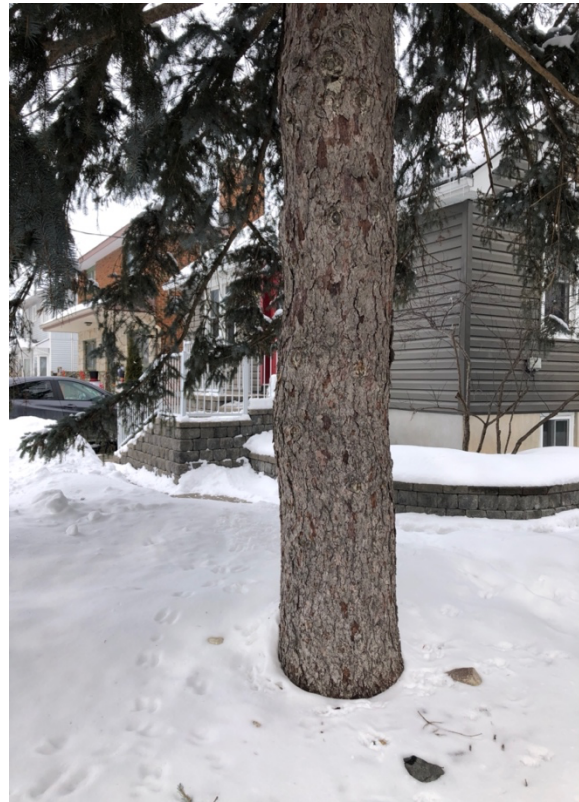
Photo 2 Tree #1 Healthy Trunk

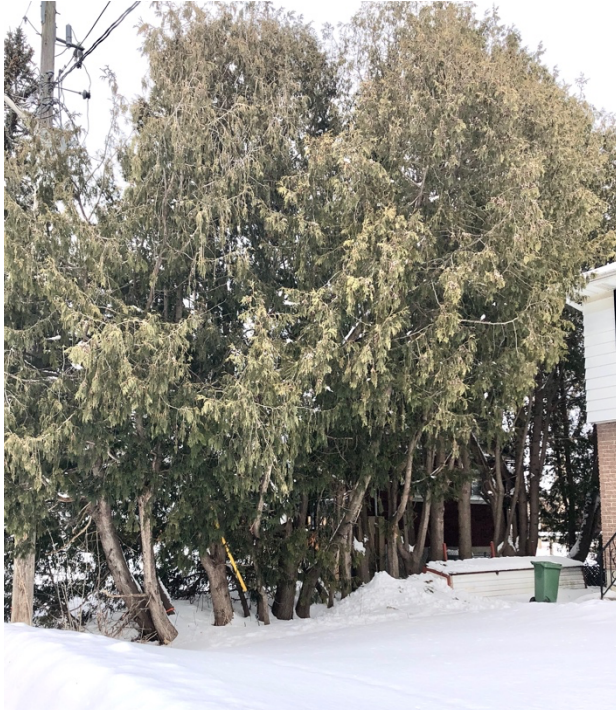
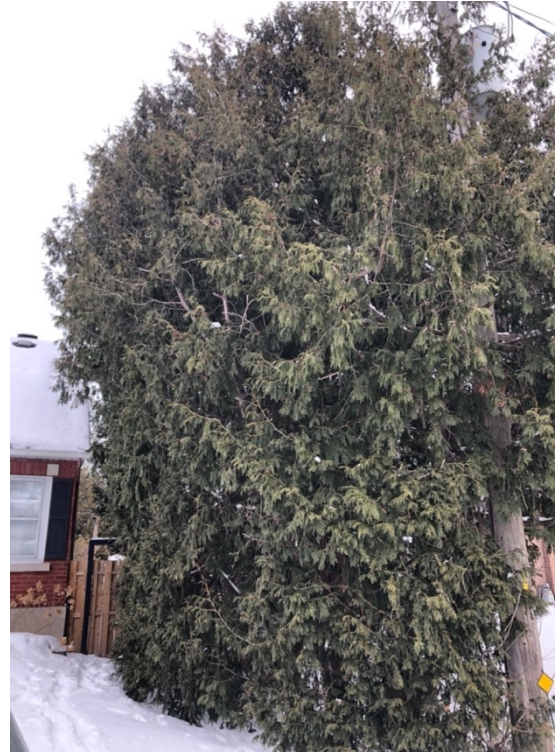
There is a row of cedars at 851 Dundee close to the boundary with 845. A few are growing in the ROW. See Photos 3 to 5 below.

The hedgerow is mature with the cedars varying in diameter from 10 cm to 46.5 cm. They have been raised about 3 M on the south side to allow access to the side entrance to 851 Dundee. They would have to be raised the same amount on the north side to allow access to a proposed side entrance.

Photo 3: South facing side (851 Dundee) of Cedars Photo 4: Cedars (845 Dundee) North facing side

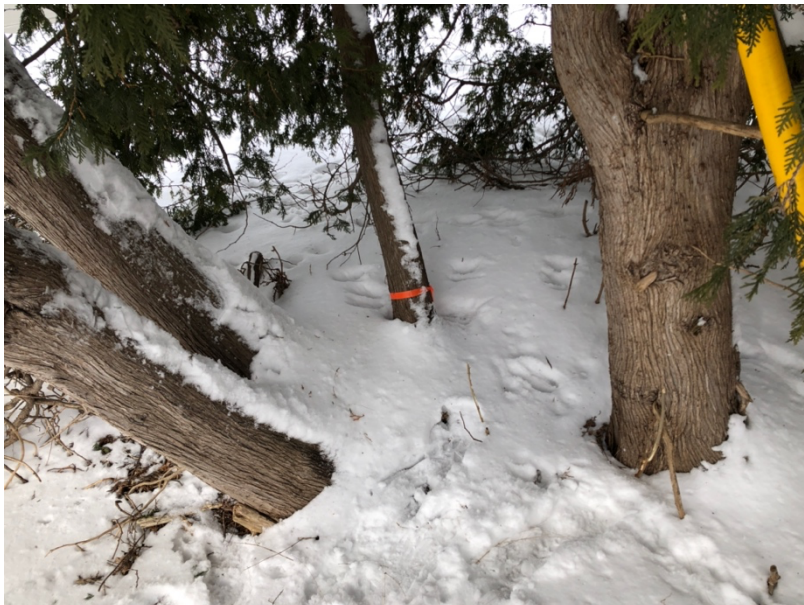
Photo 5 (left)
Some cedars in the ROW

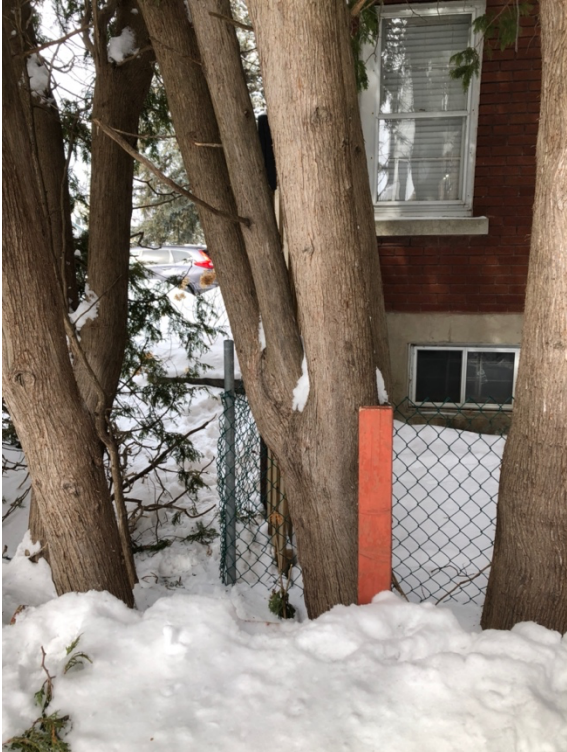
Photo 6: Tree #2 Cedar

The CRZ's for these cedars extends up to the existing foundation on the side of 845 Dundee. Excavation will remove slightly more than 10 % of the actual area of the existing roots for these two trees. As cedars show very good tolerance of root loss and infill soils, these two trees should not be adversely affected by the construction as long as all Steps to Conserve trees are followed.

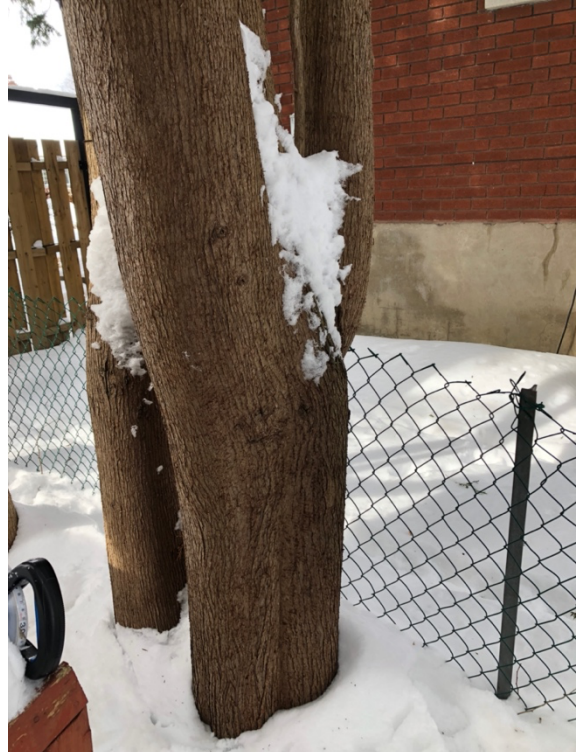
Photo 7: Tree #3 Cedar

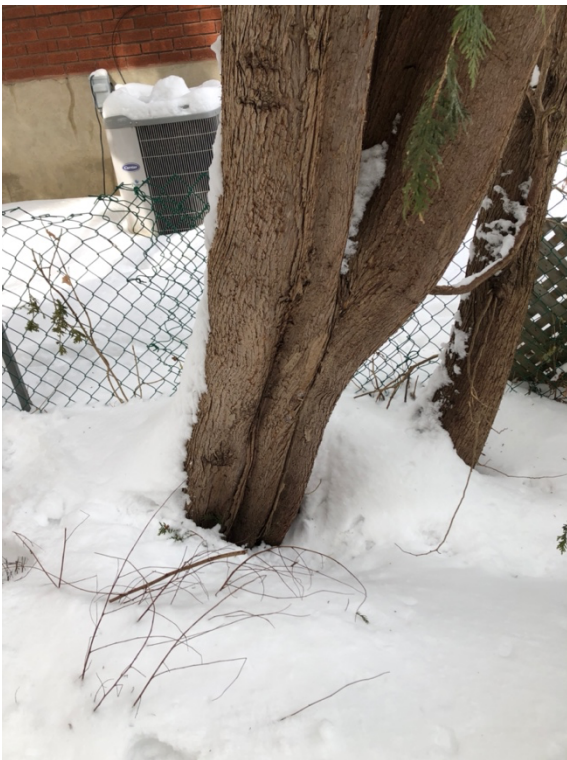
Photo 8: Tree #4 Cedar

These two cedars have CRZ's that have been restricted by the foundation at 845 Dundee. The limit of excavation will be narrowed along the section within their illustrated CRZ's to preserve the amount of undisturbed soil extending from the base of these two trees. This will leave a distance of 120 cm which is equivalent to 30% of the CRZ based on the tree diameters at breast height. In order to mitigate damage to their roots in this zone, a mechanical shovel is not to be used there. (See orange dotted line in Diagram #2). Excavation will be carried out by hand with a sharp spade or by using hydro pressure with special attention to No. 6 and 7 of Steps to Conserve Trees. It is anticipated that by following these steps Cedars #4 and #5 will be able to tolerate the work.

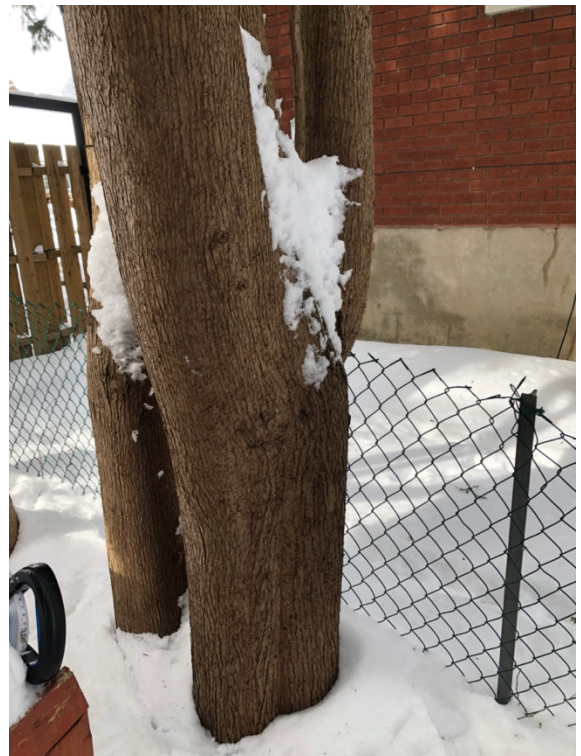
Photo 9: Tree #5 Cedar

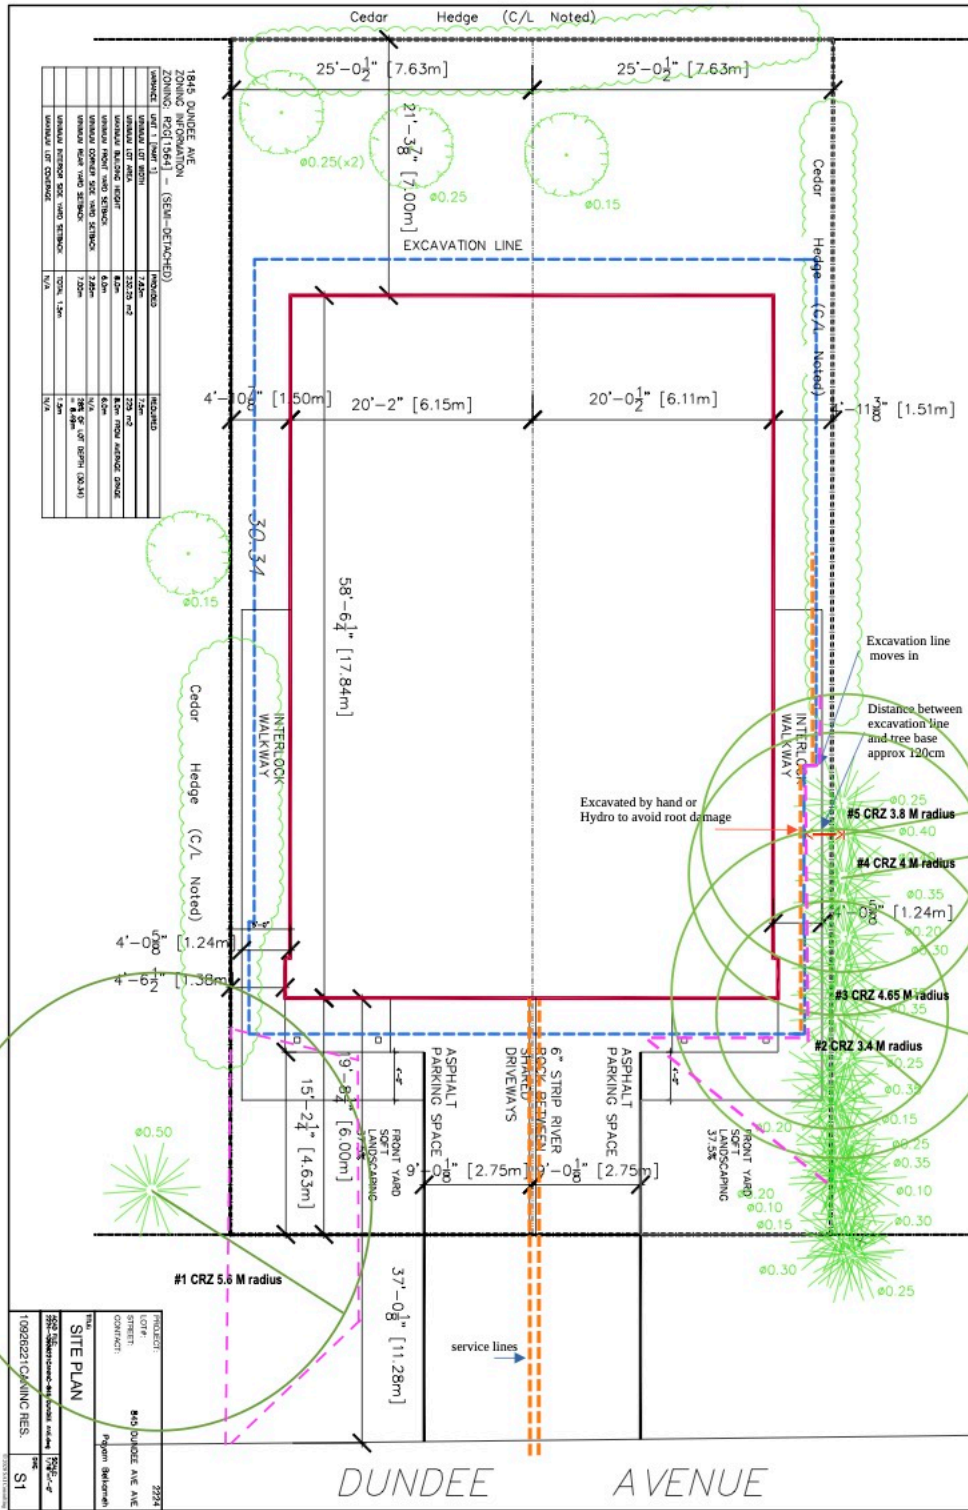
Diagram 2

The existing foundation is 2.86 M from the boundary line between 845 and 851 Dundee. This has limited the space for the existing cedar roots to less than standard dimension for CRZ's.

The limit of excavation for the new dwelling will leave a width of 1 M of soil undisturbed up to the boundary line, leaving a total of a 1.25 M at least from the base of the 4 protected cedars to the proposed limit of excavation at 845 Dundee.

Cedars #2 and #3 (See attached Diagram No.2.)

Cedars #4 and #5 (See attached Diagram No.2.)
