Tree Information Report v3.0

Submitted as part of Committee of Adjustment Application to the City of Ottawa

Address: 243-247 Bradford Street
Date of Report: December 6, 2023
Date of Site Visit: May 24, 2023
Prepared by: Astrid Nielsen, RPF, ISA Certified Arborist
Client: Rocco Manfredi; rmanfredi@royalpage.ca

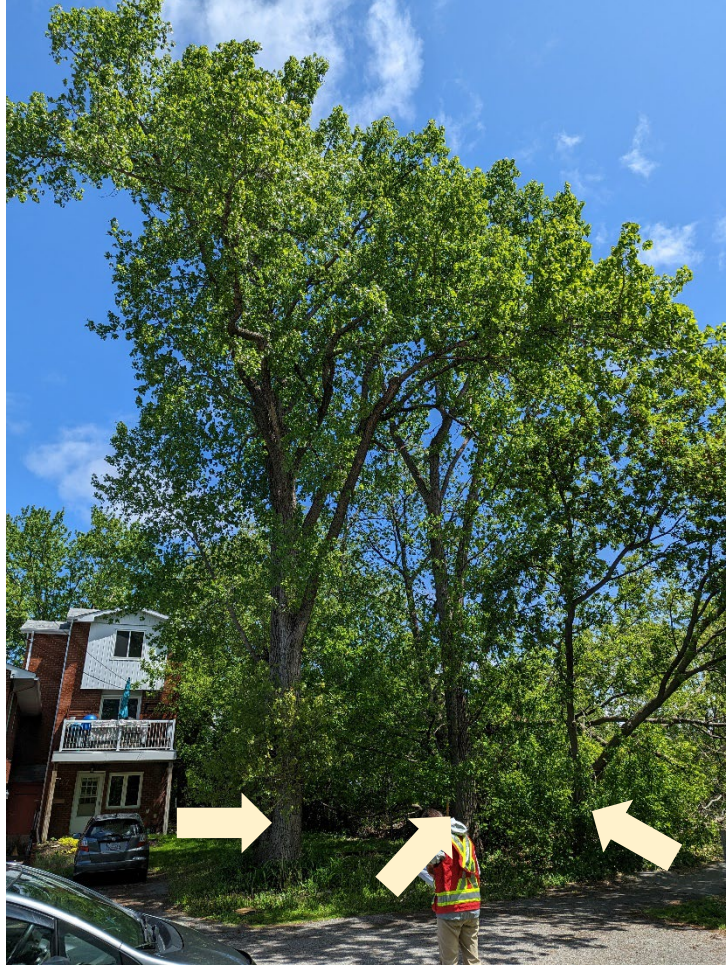
From left to right: Tree 1-3

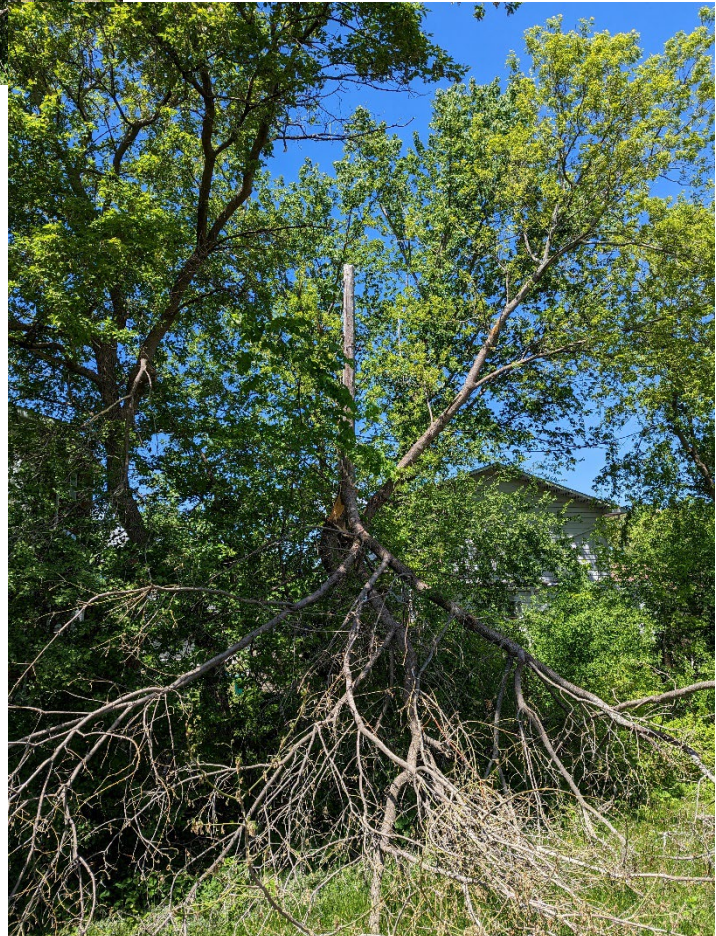
Right: Broken top of Tree 8. Tree 7 at left of image.

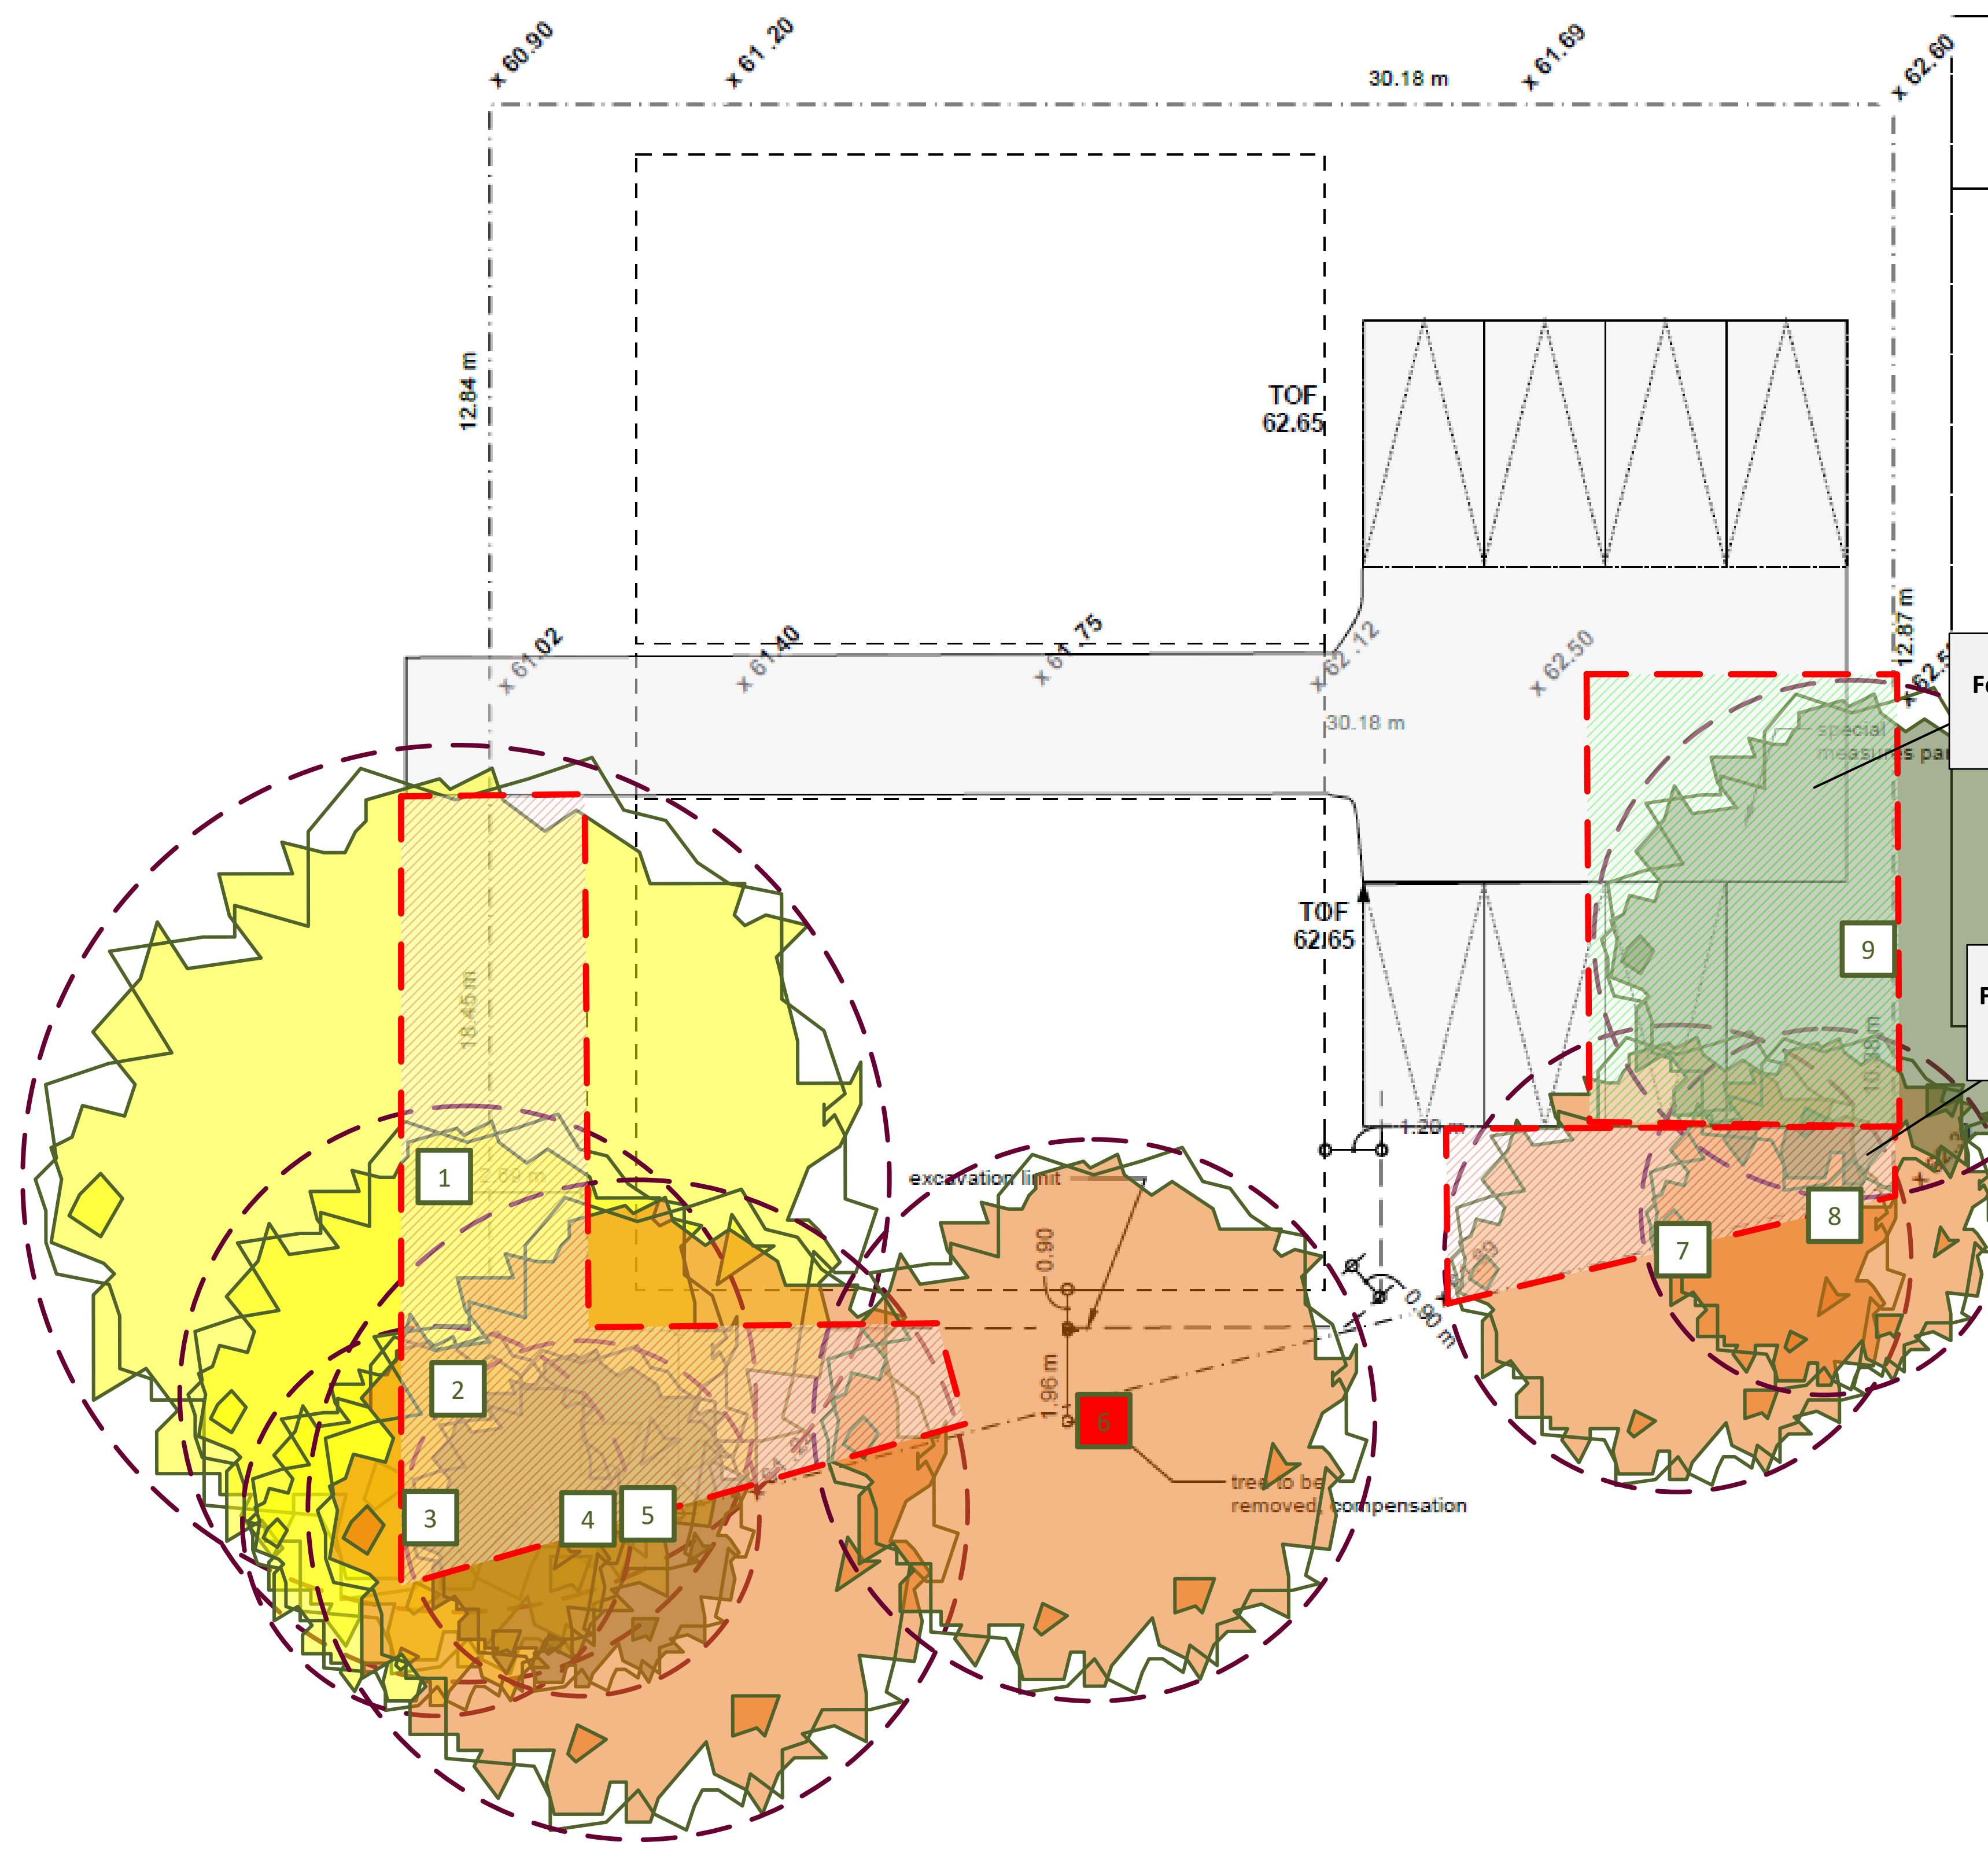
Tree ¹	Species	DBH (cm)	Condition	Recommendations
1	Cottonwood (<i>Populus deltoides</i>)	52, 72	Good: some epicormic shoots; 2 small wounds (<1/8 diameter) with decay	Retain and protect as per the City of Ottawa Tree Protection Specifications (March 2021).
2	Cottonwood (<i>Populus deltoides</i>)	59	Good	Retain and protect as per the City of Ottawa Tree Protection Specifications (March 2021).
3	Manitoba maple (<i>Acer negundo</i>)	21, 23, 25	Fair: Largest stem lost half of crown	Retain and protect as per the City of Ottawa Tree Protection Specifications (March 2021).
4	Manitoba maple (<i>Acer negundo</i>)	36	Poor: trunk hollow due to decay; significant lean	Retain and protect as per the City of Ottawa Tree Protection Specifications (March 2021).
5	Manitoba maple (<i>Acer negundo</i>)	68	Fair: trunk straightens from lean; growing on fence (fence may be supporting tree); 2 large broken branches	Retain and protect as per the City of Ottawa Tree Protection Specifications (March 2021).

6	Manitoba maple (<i>Acer negundo</i>)	57	Fair: significant lean; dead branch >1/4 diameter	Remove due to proximity of excavation. Tree permit and permission from NCC required
7	Manitoba maple (<i>Acer negundo</i>)	48	Poor: decay throughout trunk; fungal bodies present	Retain and protect as per the City of Ottawa Tree Protection Specifications (March 2021).
8	Manitoba maple (<i>Acer negundo</i>)	37	Fair/Poor: large branch broken - 1/2 crown on ground; cavity >1/4 diameter – no decay visible	Retain and protect as per the City of Ottawa Tree Protection Specifications (March 2021).
9	Silver maple (<i>Acer saccharinum</i>)	34, 41	Good/Fair: included bark @ main union	Parking area to be built with Abweb TRP system. No surface material is to be in contact with tree trunk. Care is to be taken to not damage trunk or branches during installation.

Prior to any site works, protective fencing should be installed around the TPA as indicated in Map and maintained until all construction on site has been completed as per the City of Ottawa Tree Protection Specifications (March 2021). **Failure to install and maintain the indicated fencing may result in fines from the City.**

The tree protection fencing must be 1.2 m in height and constructed of a rigid or framed material (e.g. modulus – steel, plywood hoarding, or snow fence on a 2"X4" wood frame) with posts 2.4 m apart such that the fence location cannot be altered. All supports must be placed outside of the CRZ and installation must minimize damage to existing roots.
